Arboricultural Report
Trees at Proposed Site at
Tinakilly
Ashford
Co Wicklow

July 2023

The Tree File Ltd
Consulting Arborists
4 Mulberry Court
Castleknock
Dublin 15
D15 F2V4
086-3819011

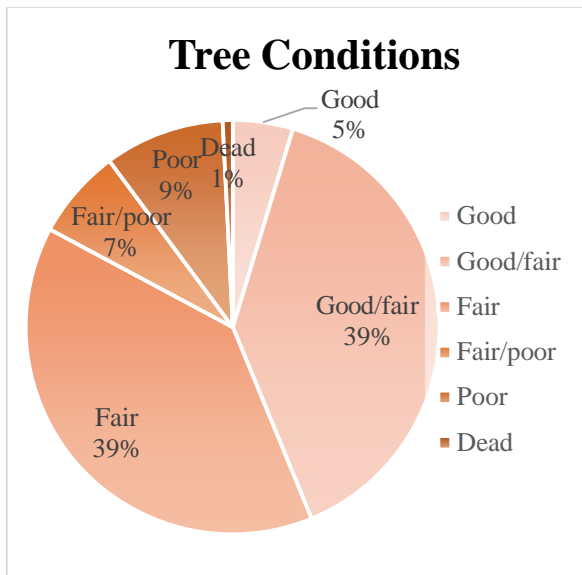
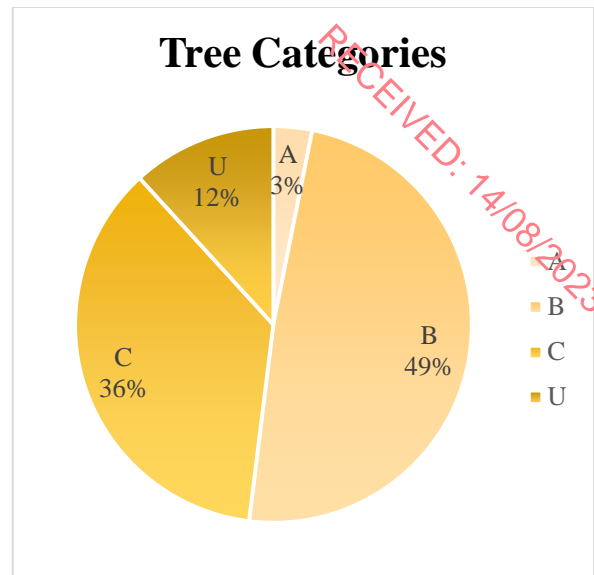
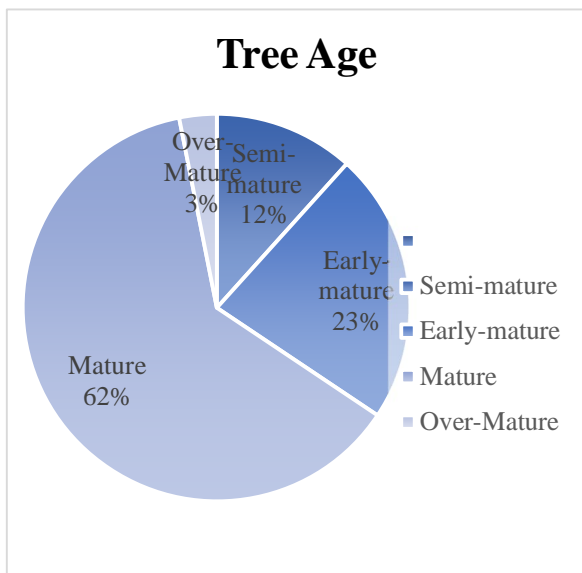
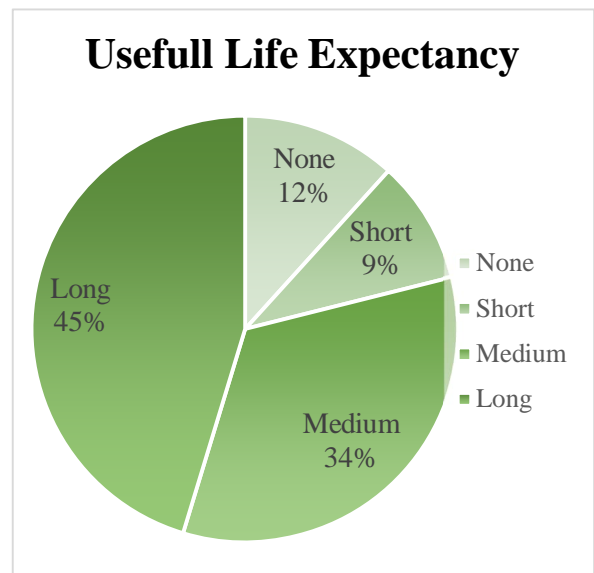
4.10 As can be seen from the graphs at Figs 1 to 4 above, tree conditions and categorisation compare well, as does the generally good sustainability illustrated by the “useful life expectancy” graph at Fig 4. This would appear at odds with the tree age profile, which is dominated by mature and overmature trees. Notwithstanding this apparent anomaly, it is likely that it illustrates ongoing and regular management of the site, whereupon any faulty trees are removed in a timely manner.

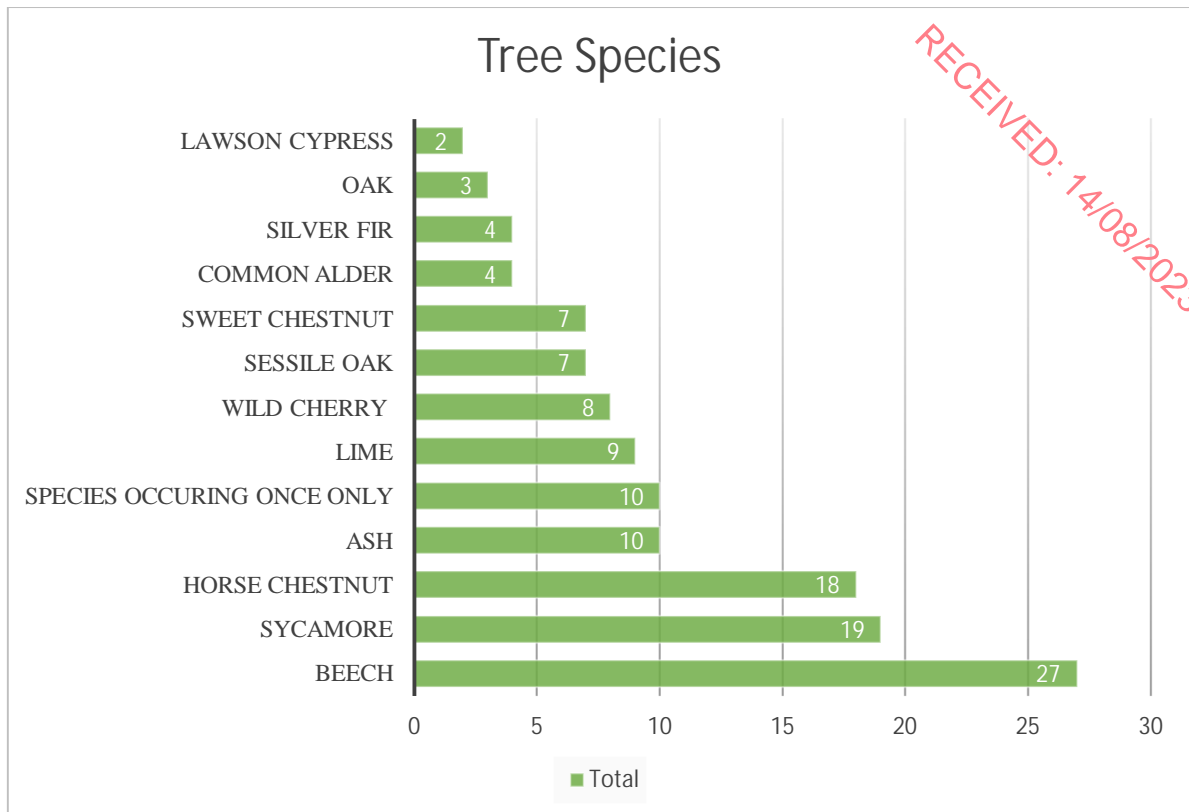
4.11 Fig 5 illustrates what is a substantially artificial tree population heavily dominated by Beech. The Beech, together with the Oak, Sweet Chestnut, Silver Fir, Horse Chestnut and Lime would all be species regularly associated with period house plantings from the 18th century onwards. Closer scrutiny notes that Ash and Sycamore afford notable numbers, however, these tend to involve younger trees, most of which appear to be naturally arising, as opposed to being any part of an original planting.

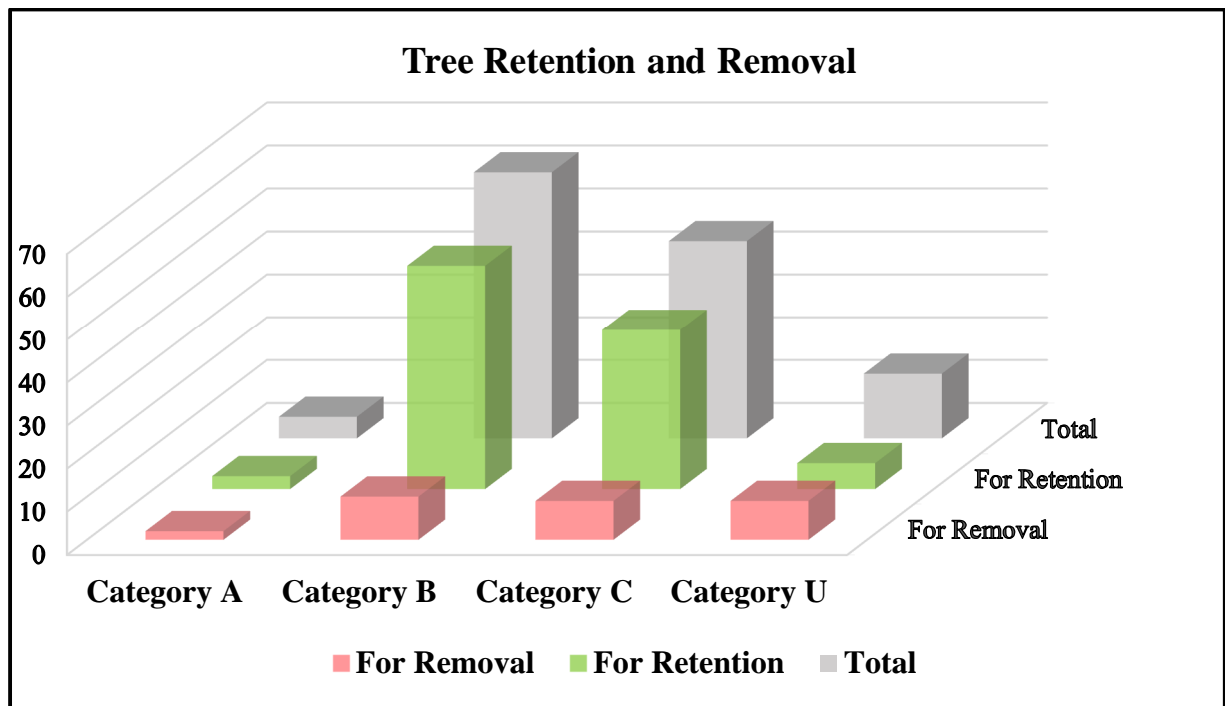
Fig 5 Graphic Representation of Tree Loss/Retention Scenario

12.4 Of the site's category "A" trees, the development will result in the loss of tree nos.1708 and 1901.

- 12.5 Of the site's good quality category "B" trees, the development will result in the loss of tree nos.1746, 1773, 1774, 1775, 200, 201, 202, 1204, 1902 and 1903.
- 12.6 Of the site's category "poor" quality "C" trees, the development works will require the removal of nos. 1715, 1719, 1769, 1770, 1782, 1783, 1203, 1905a and 1906.
- 12.7 The tree loss breakdown for the proposed developemnt will be-
- 2 Category "A" items
 - 10 Category "B" items
 - 9 category "C" items
 - 9 category "U" tree
