Client: **DLA DILLIGENCE CABLE OVERVIEW SHEET 2/5**

PUNCH Consulting Engineers
 201-164-002 PRT
 201-164-002 PRT

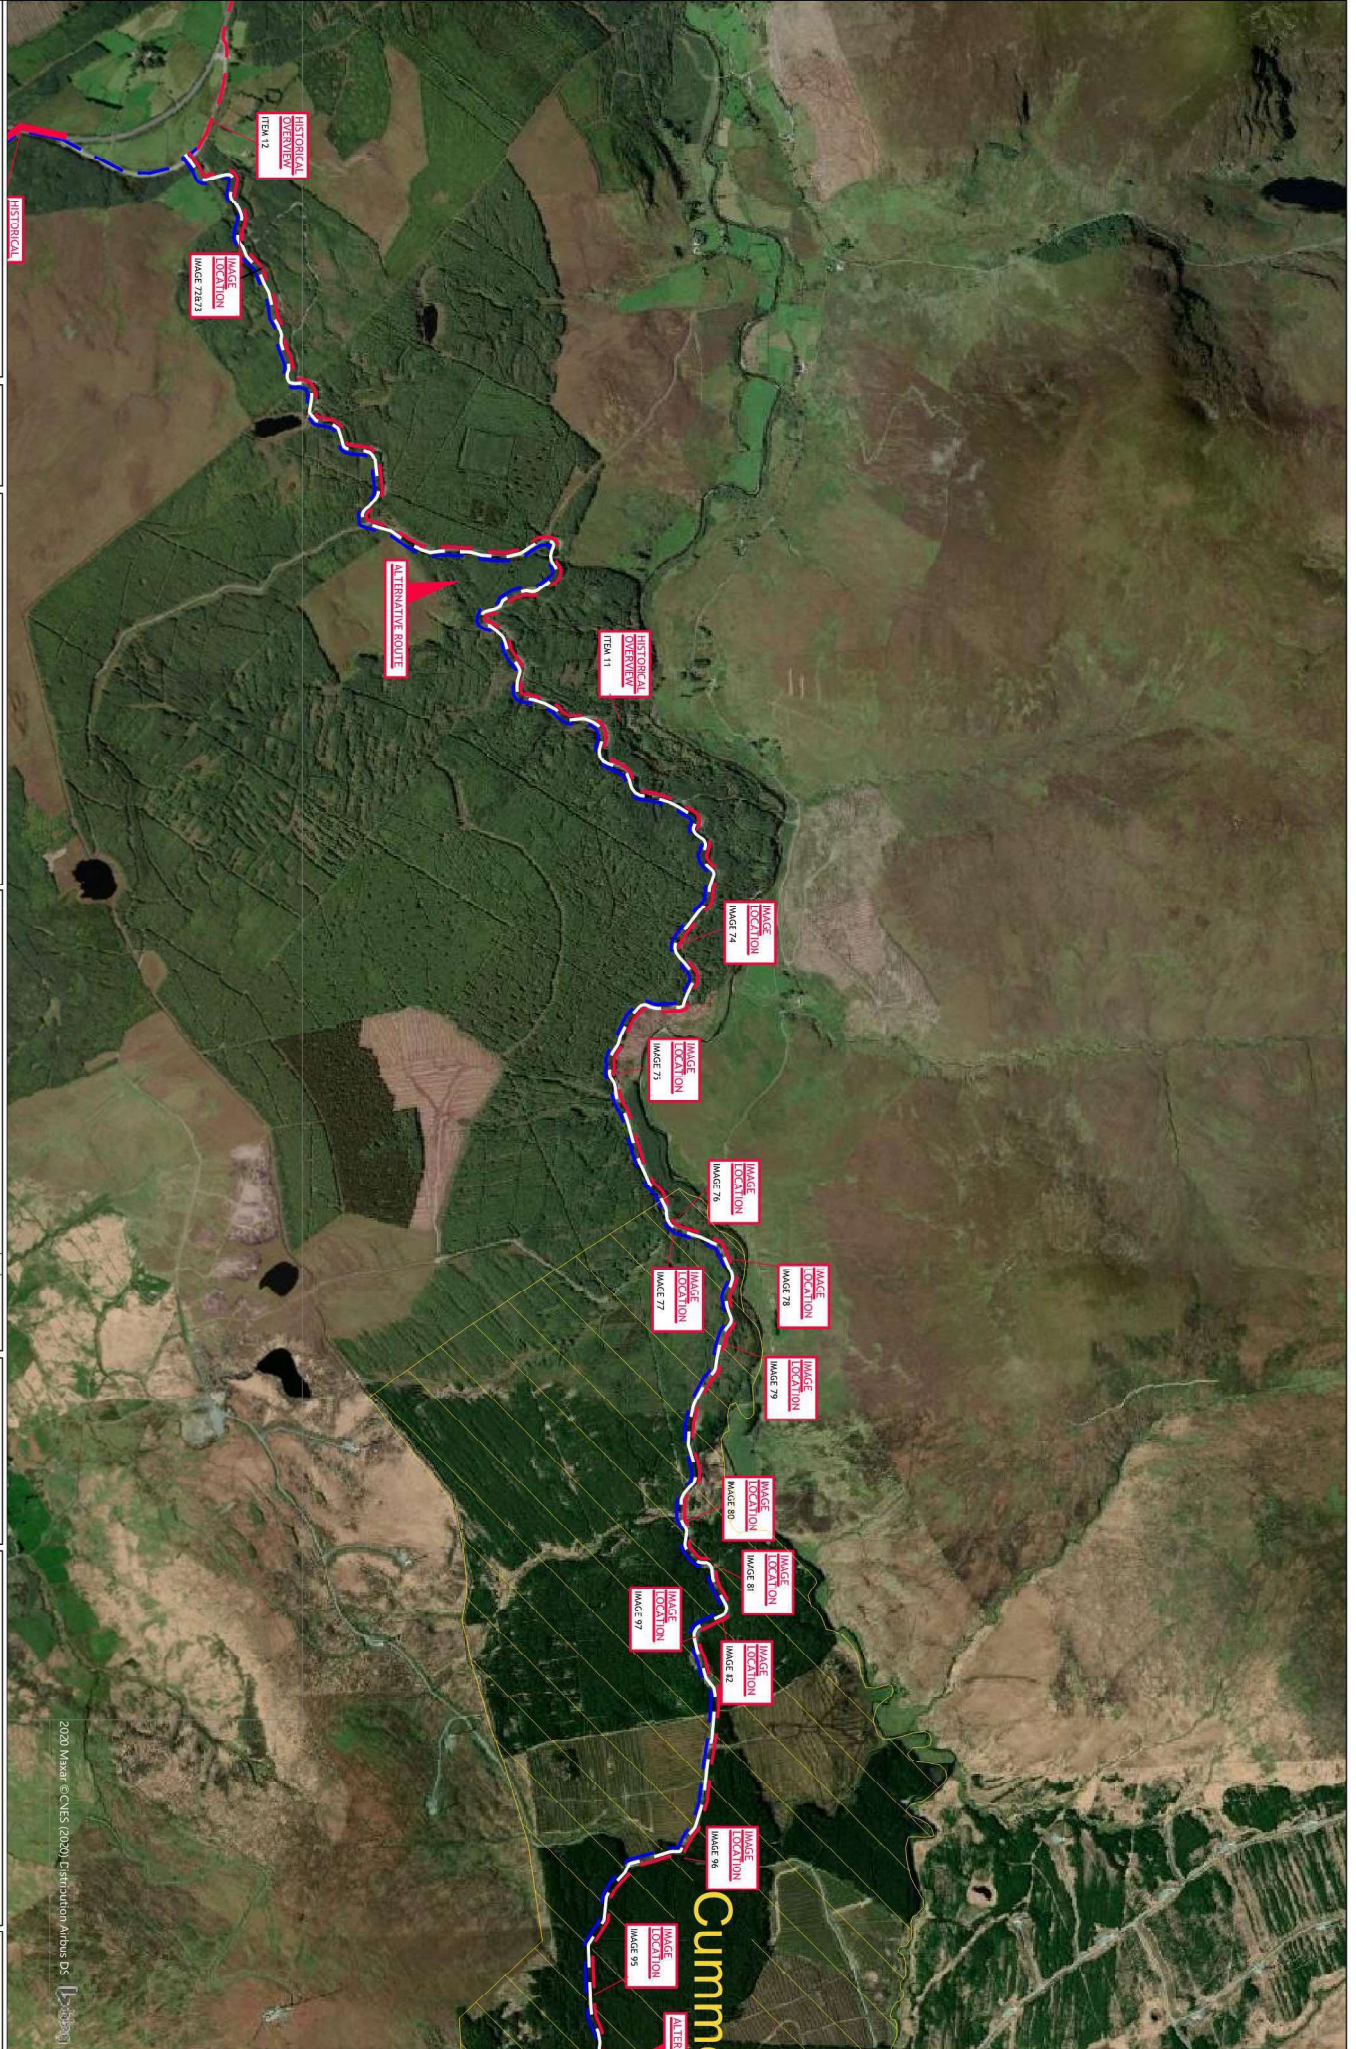
© PUNCH Consulting Engineers

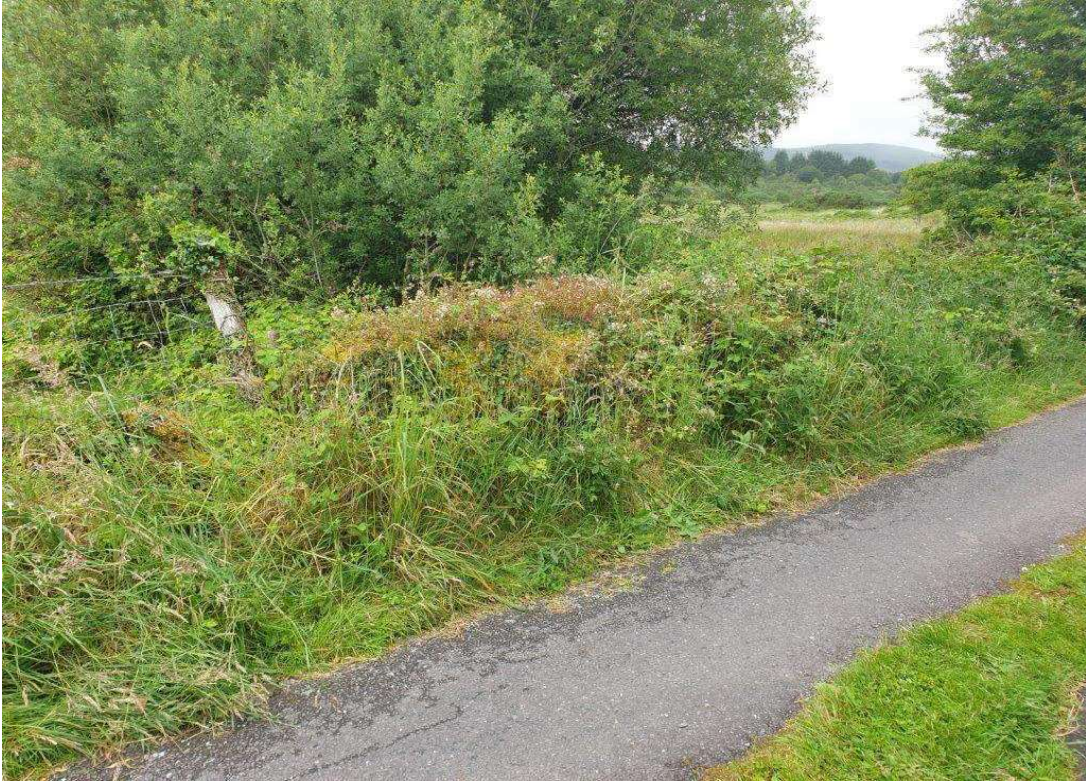
Stone masonry wall on the D/S side of the bridge in poor condition and very overgrown with vegetation. Masonry block wall on the U/S side of the bridge as seen in previous image,

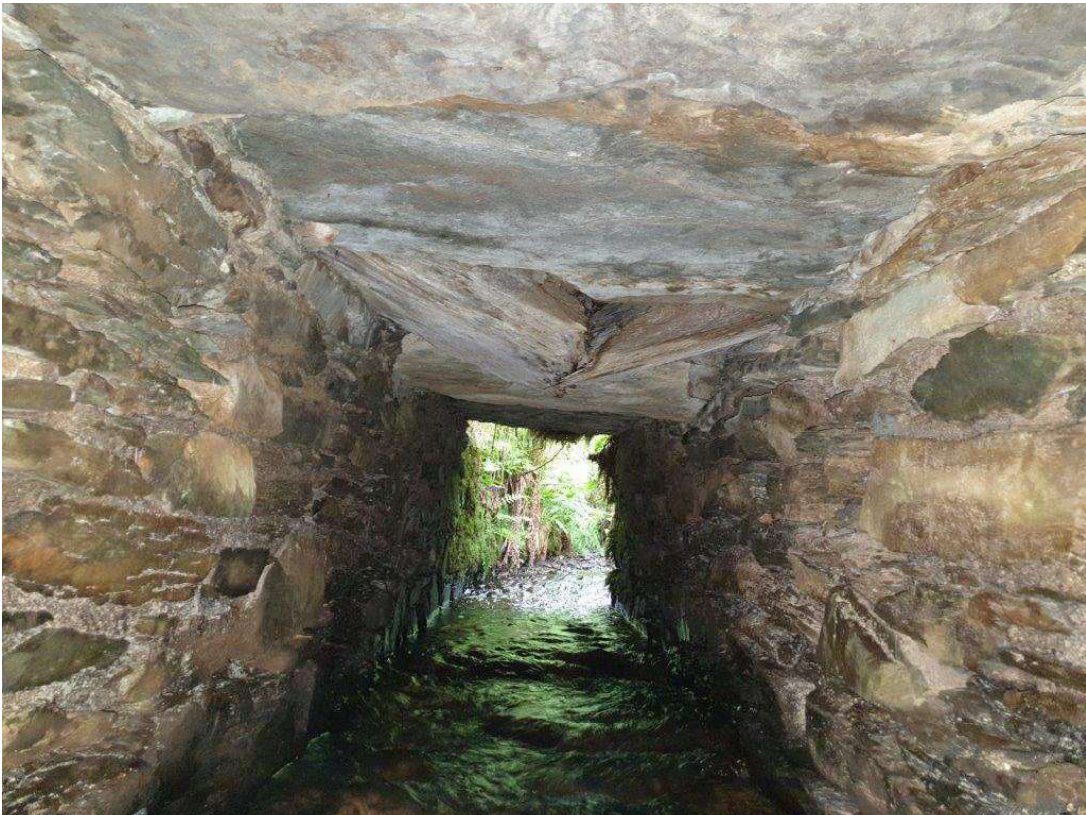
Soffit of bridge deck/box stone culvert. Flag stone is damaged and has collapsed as seen viewed from U/S (north span).

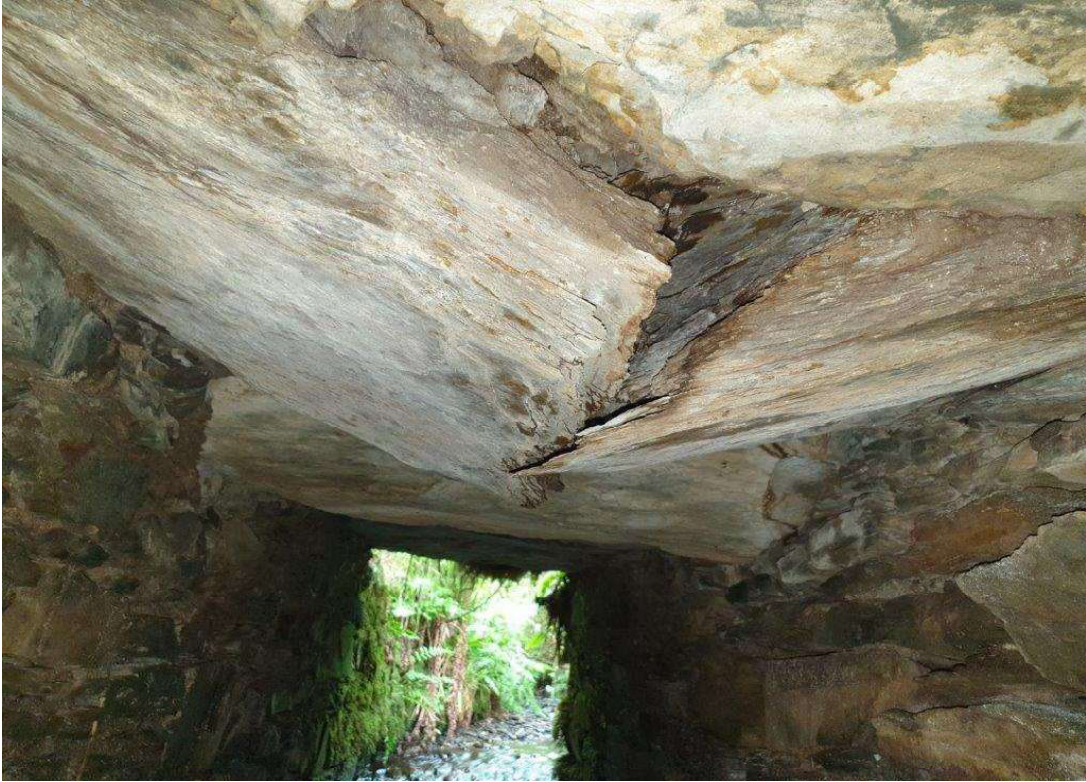
Soffit of bridge deck - viewed from D/S. Collapsed Flagstone (north span)

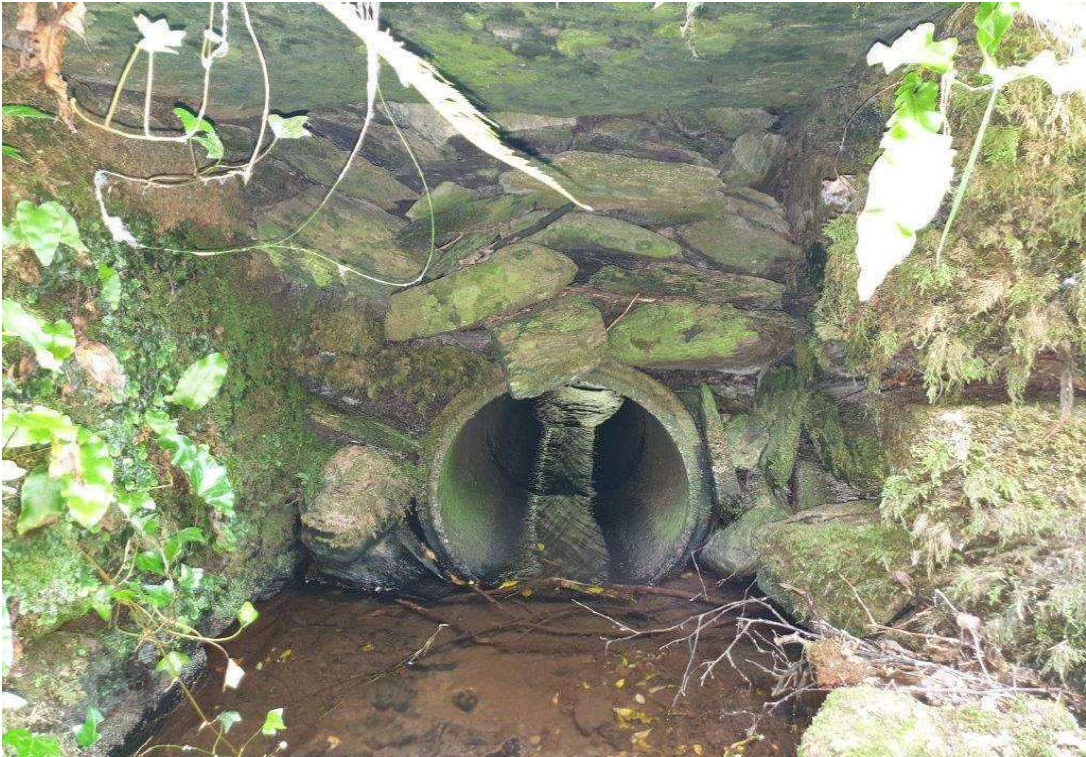
Repair to existing culvert with a 450mm concrete drainage pipe (south span).

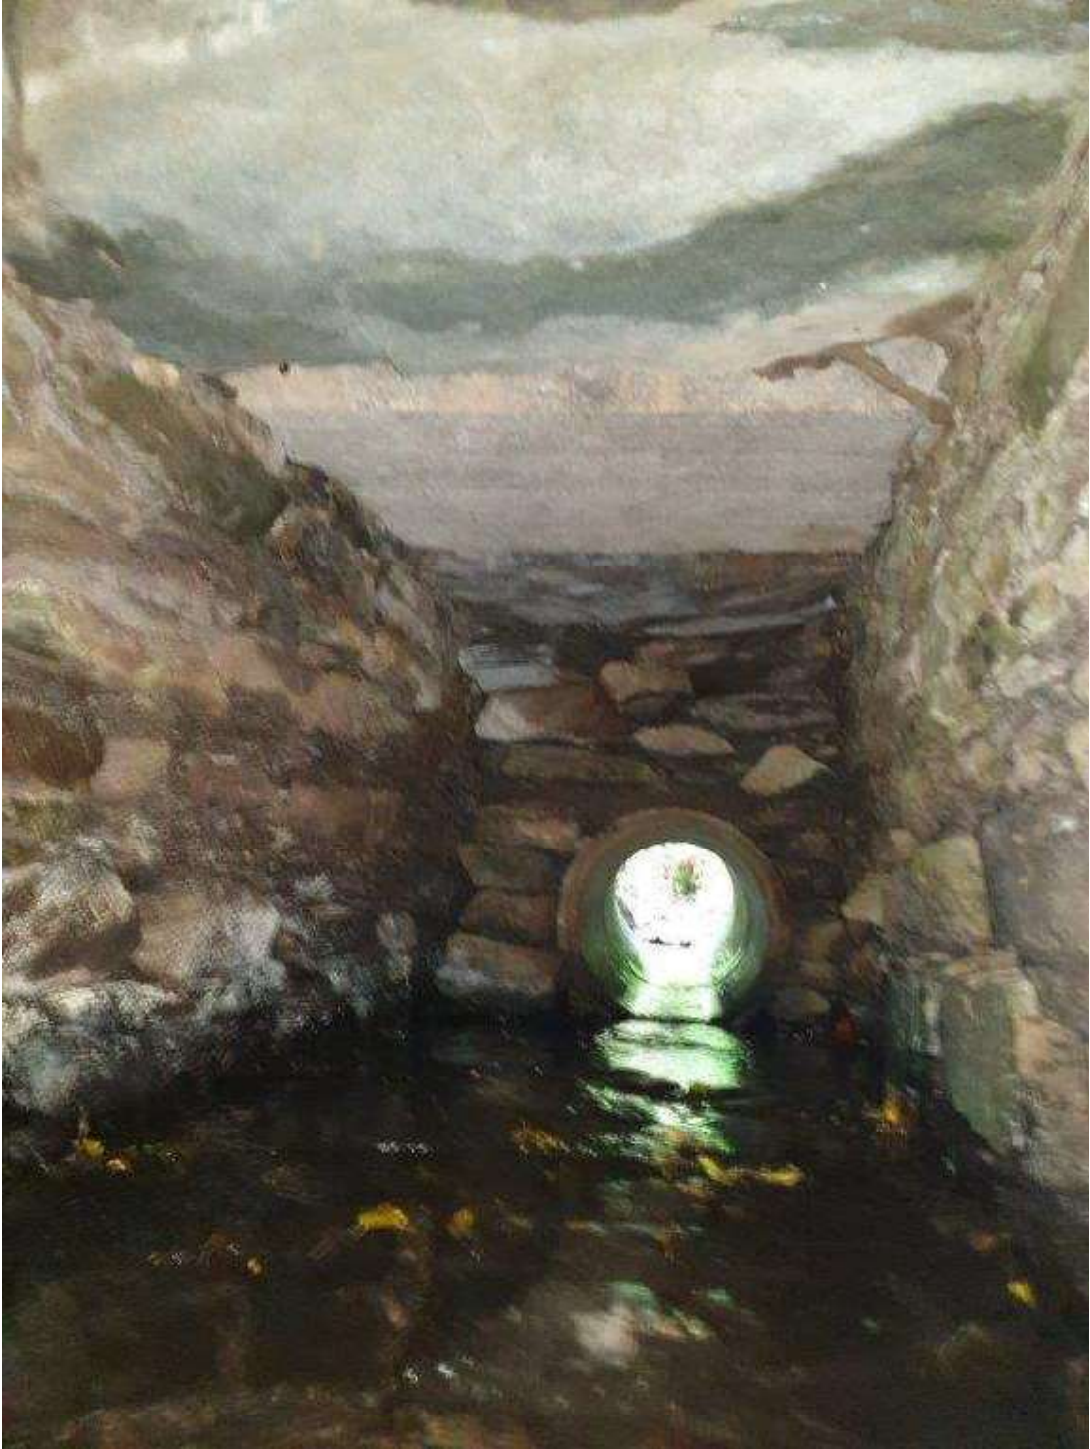
View of south span from the west

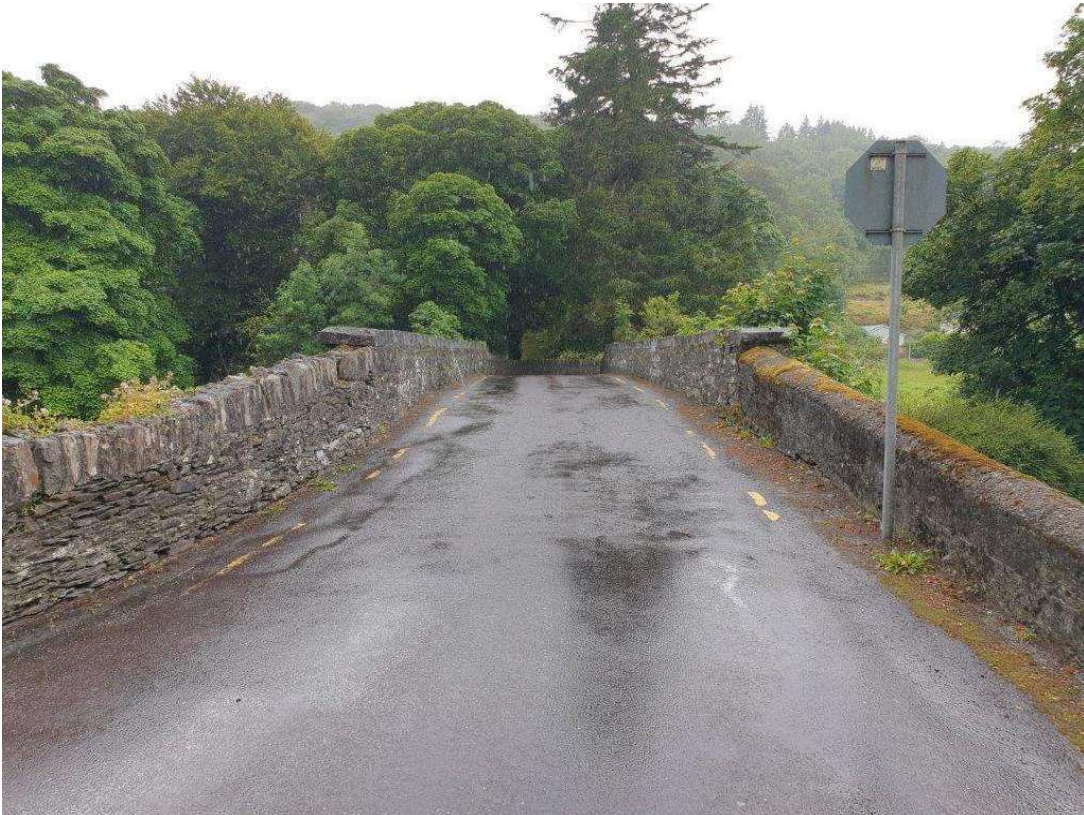
Road surface showing wear, abrasion and some rutting

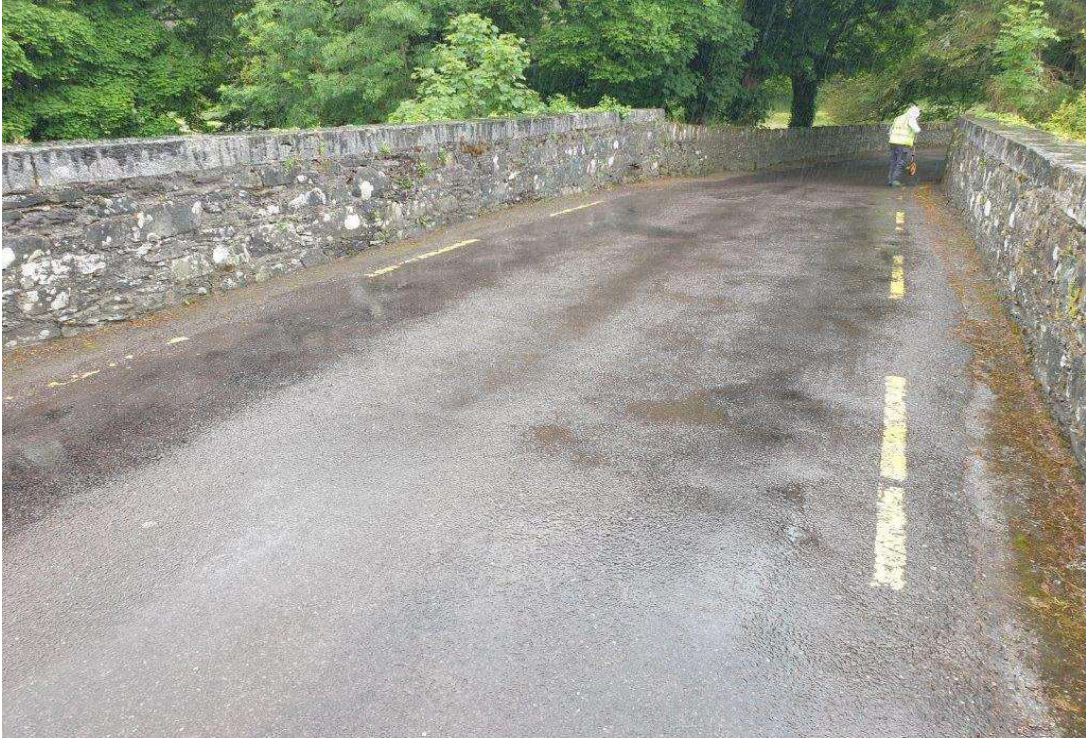
Road surface showing wear, abrasion and some rutting

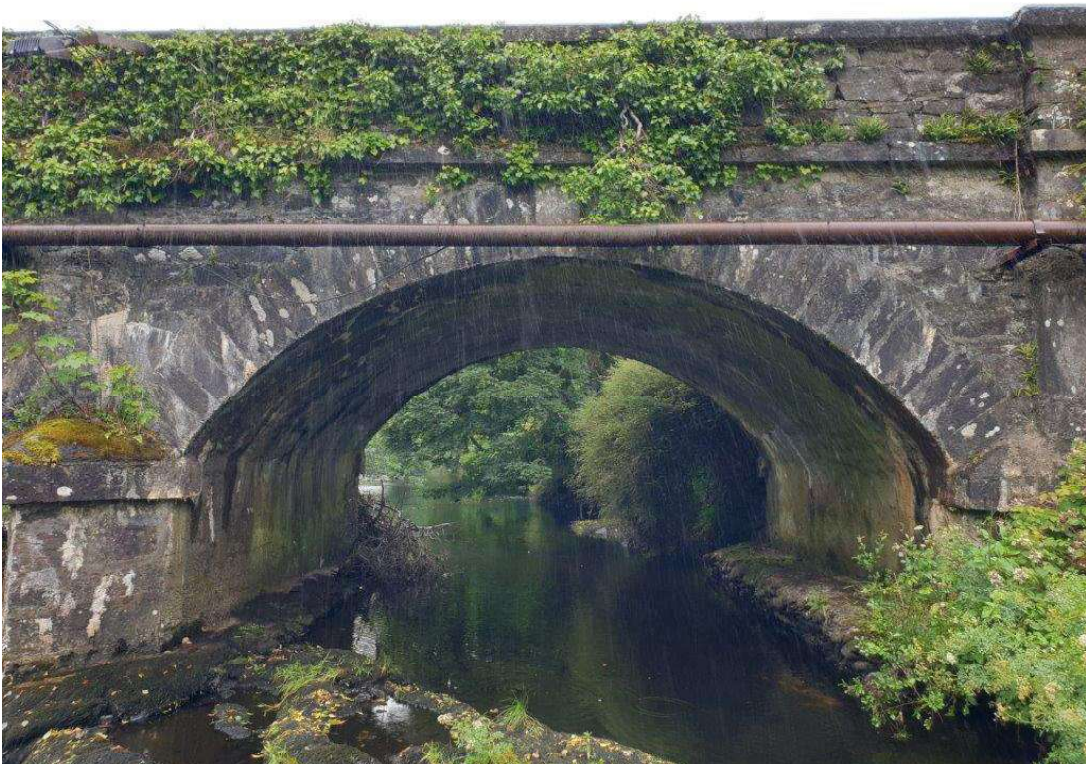
General view of the eastern span, looking upstream

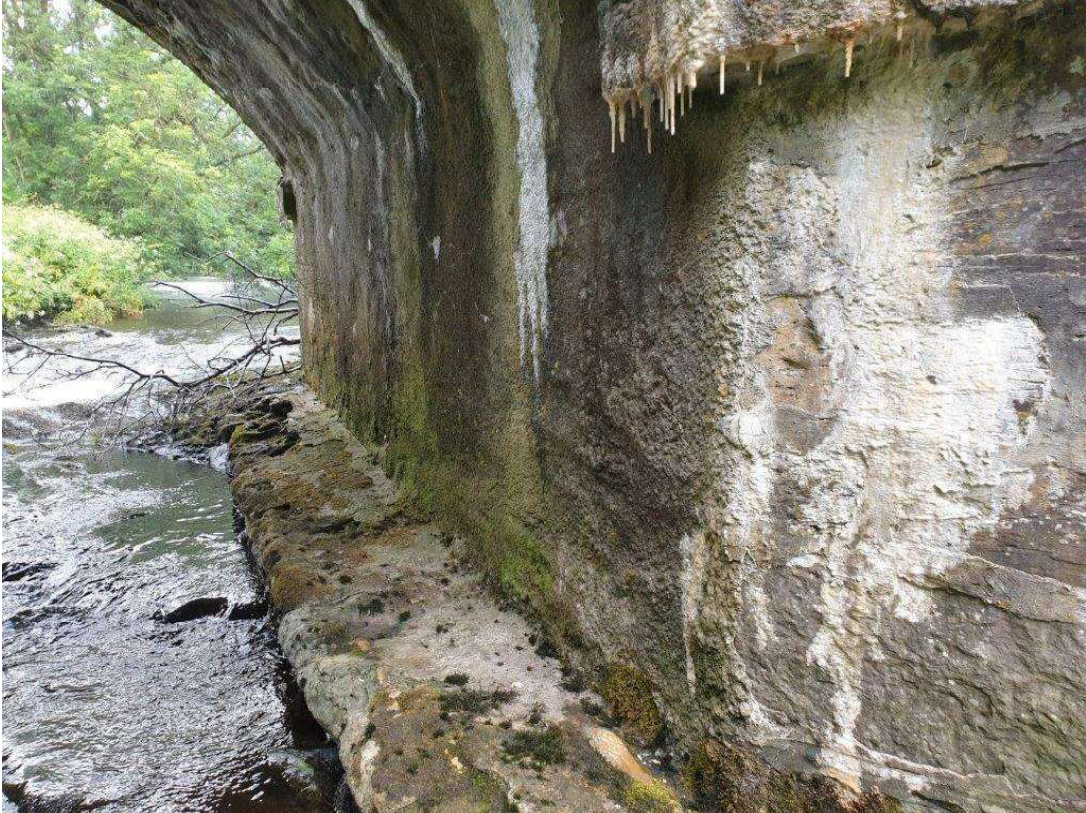
Typical pier condition

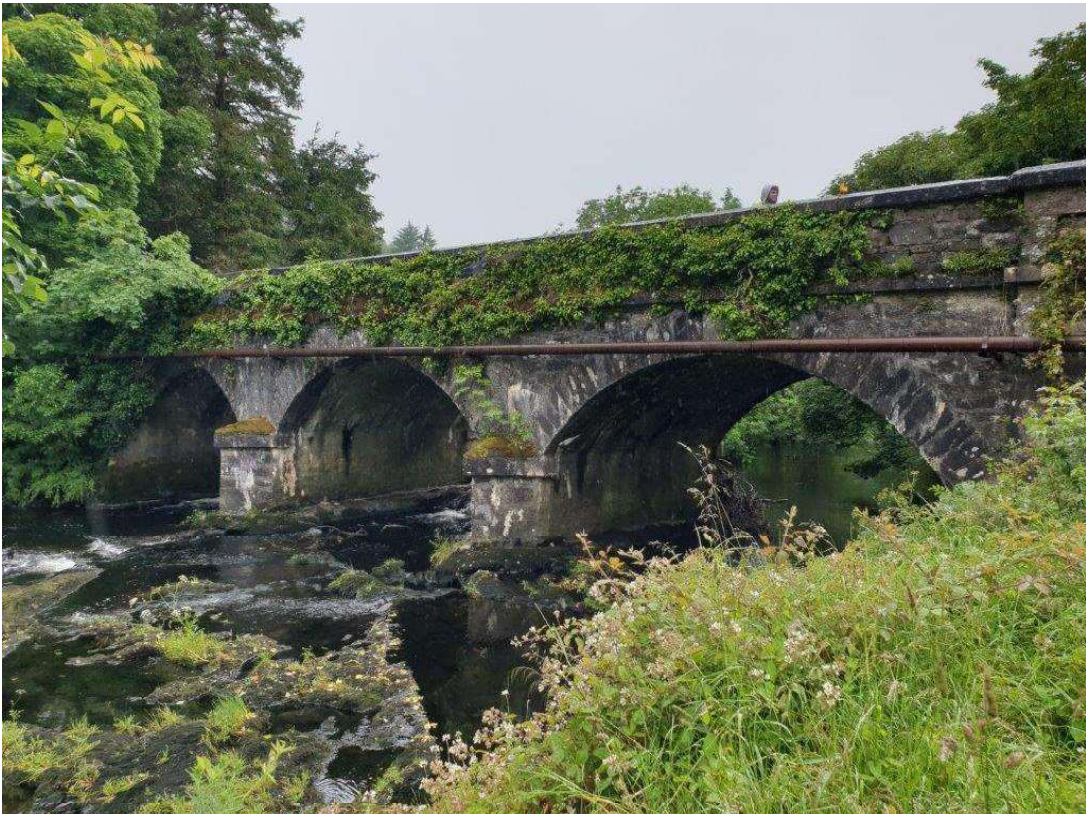
General view of the south elevation

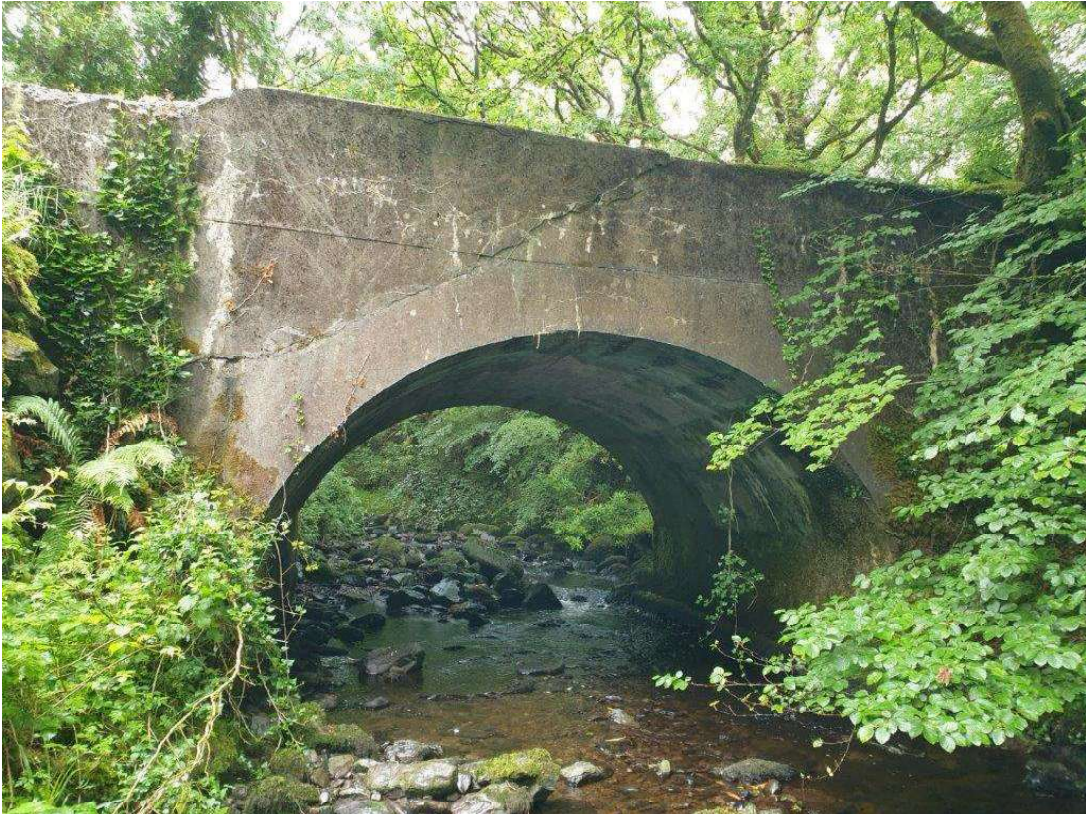
General view of the south elevation, note damage to parapet and west spandrel

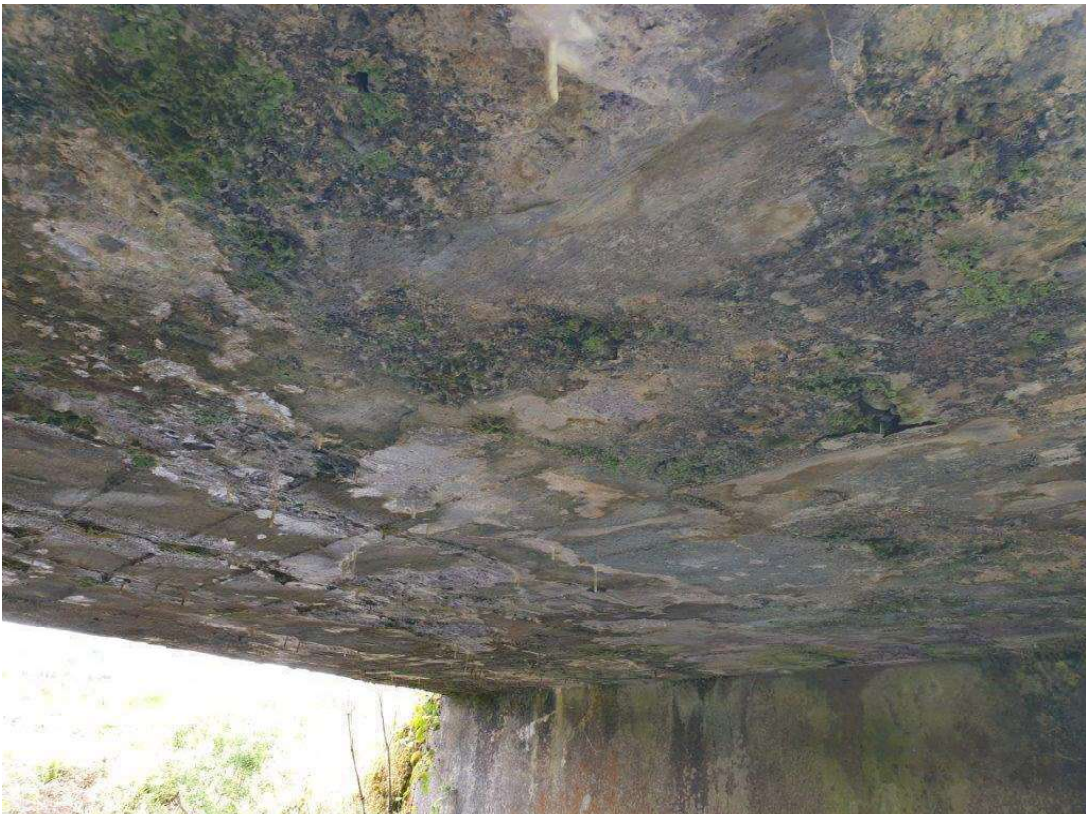
General view of the soffit of the bridge deck showing typical condition

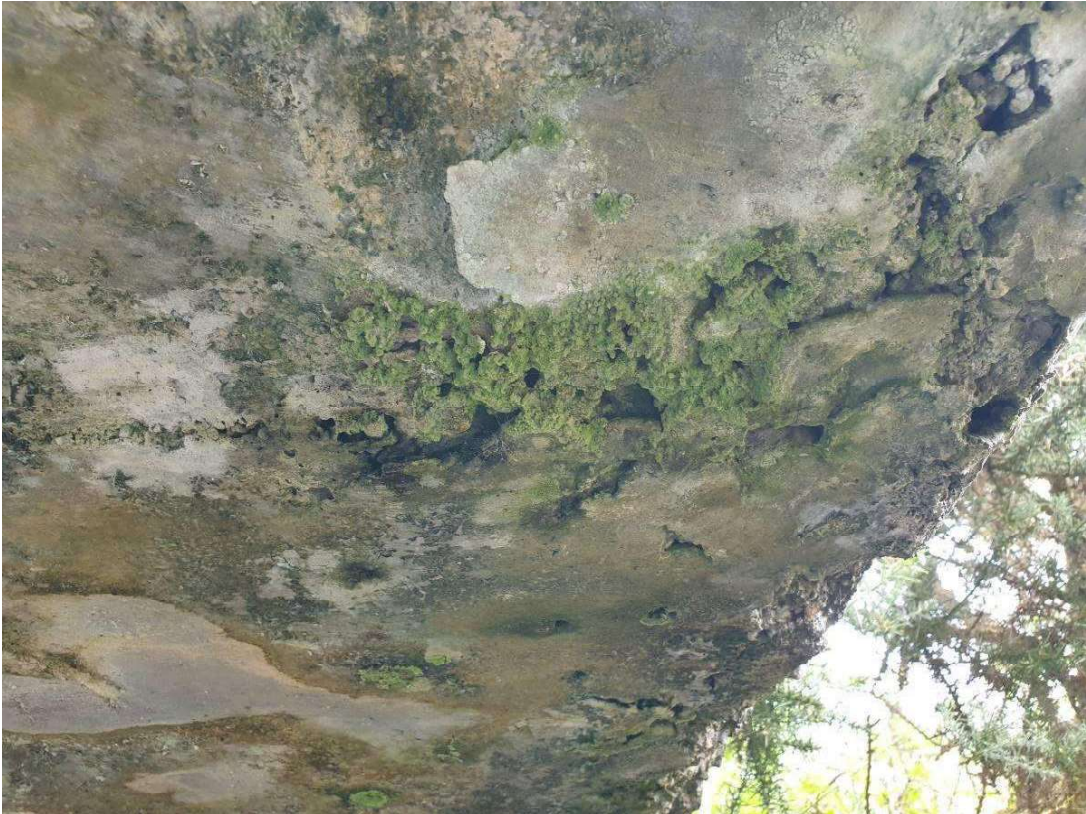
Local scaling of the soffit of the bridge deck

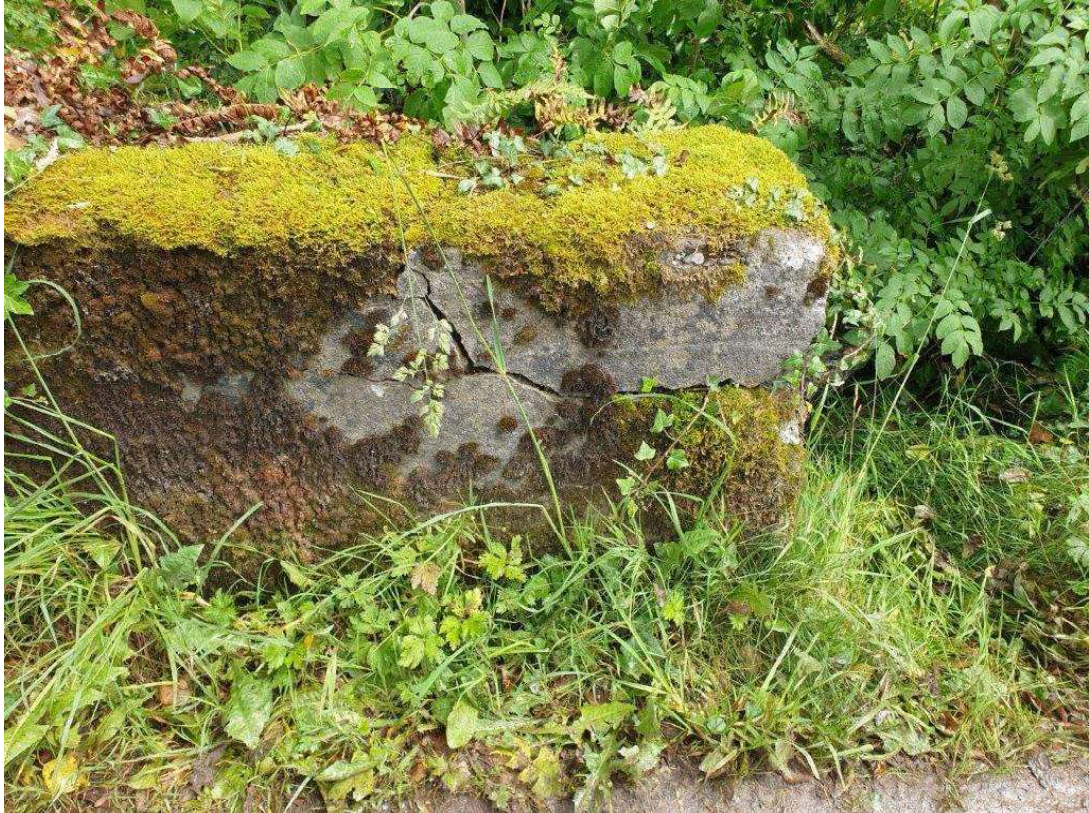
Local damage to the west parapet

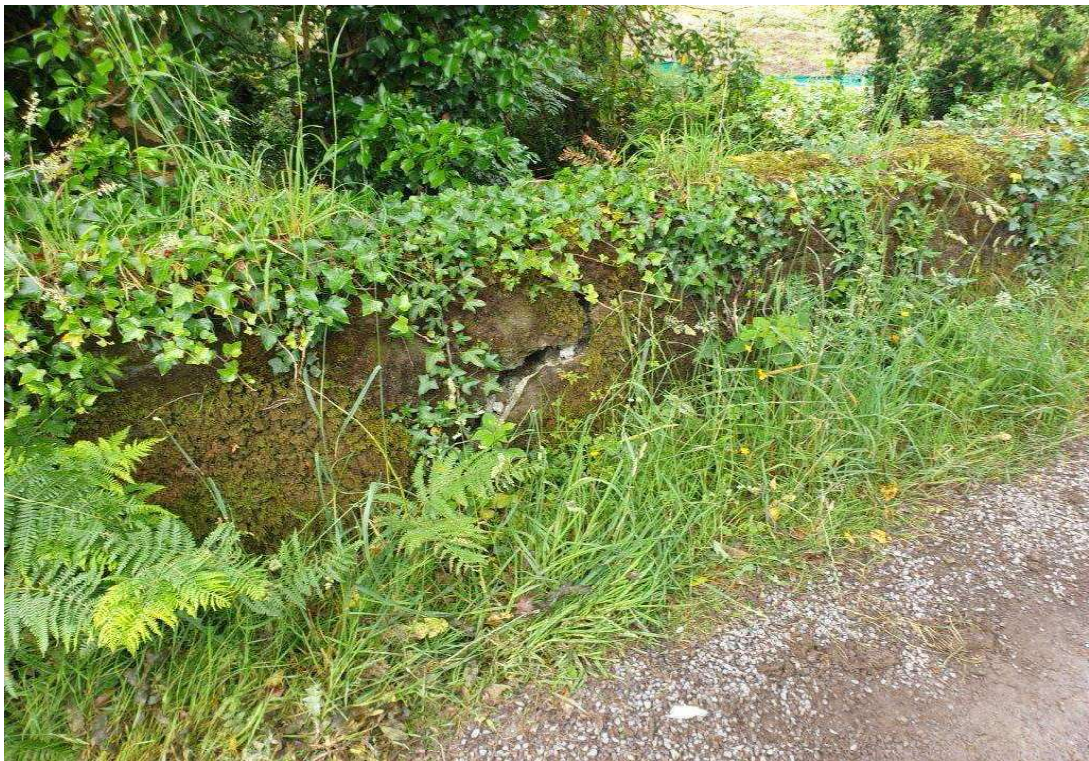
General view of the south end of the east parapet

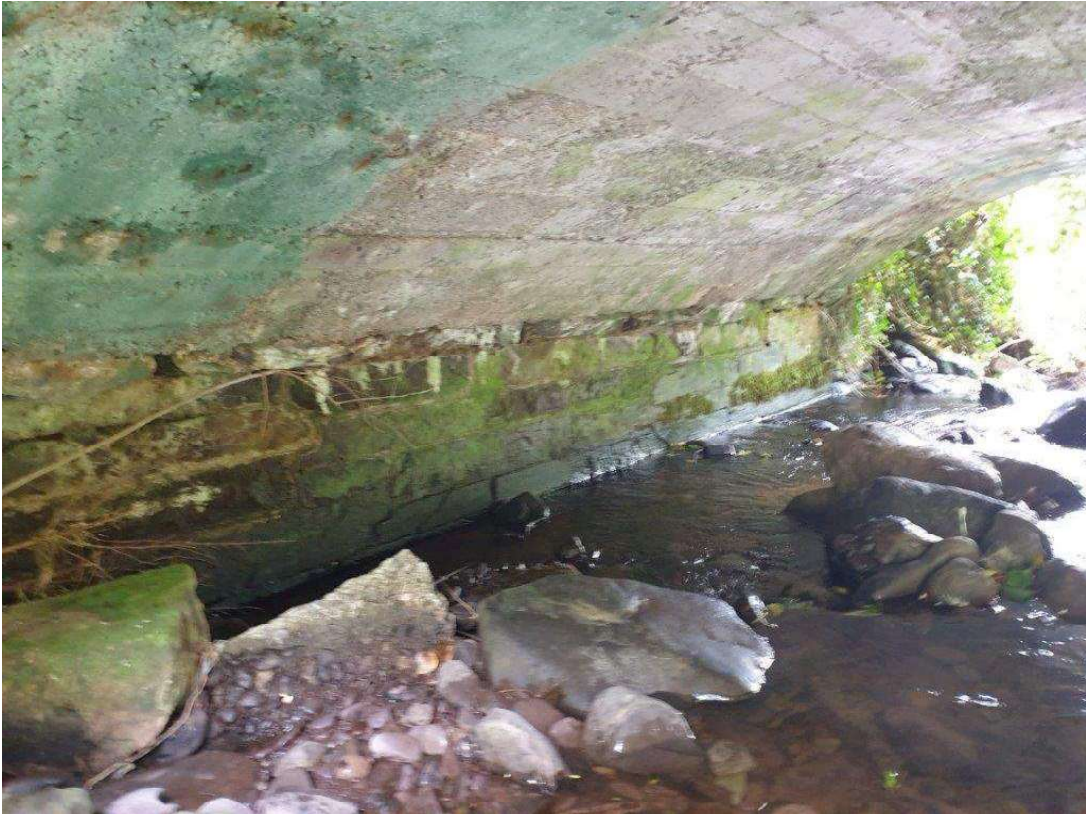
Typical condition of abutment & arch barrel

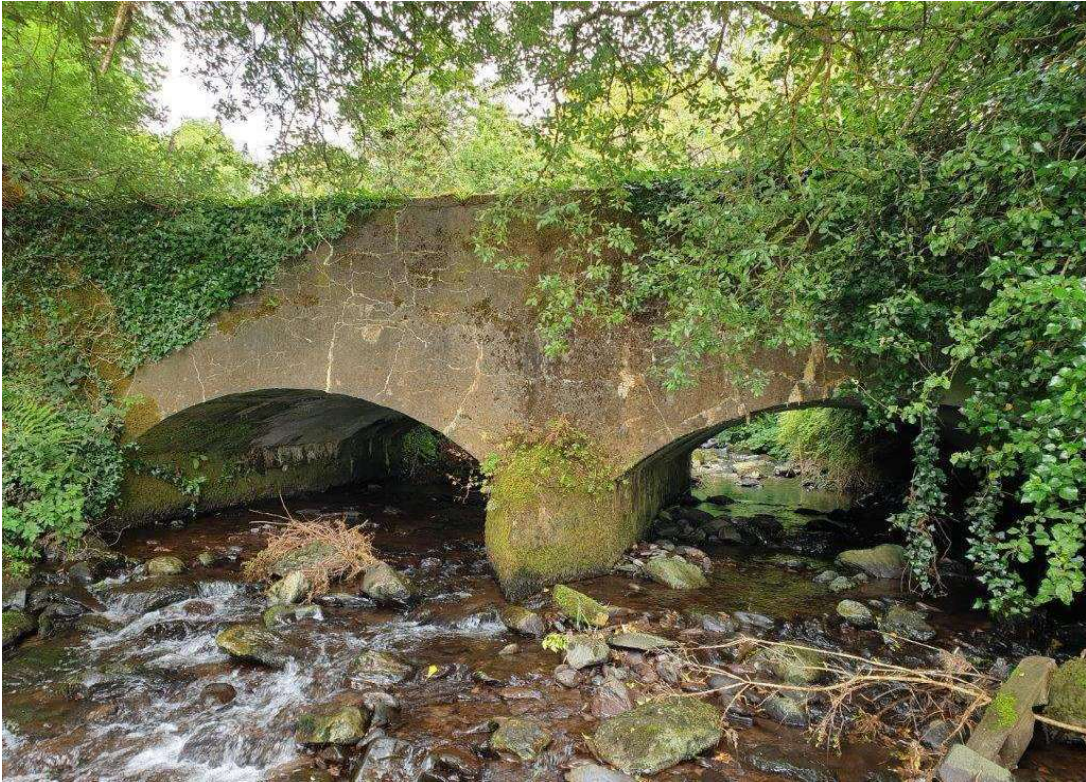
General view of south elevation

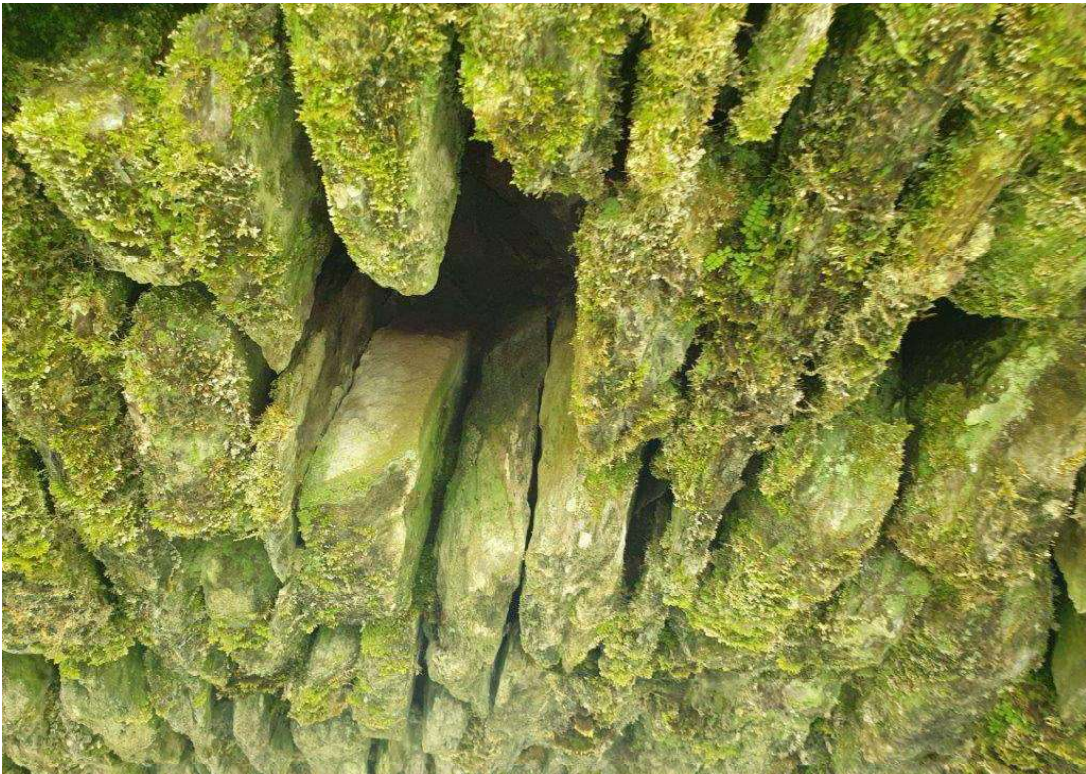
Dropped / missing stones in the arch barrel towards the north face of the bridge

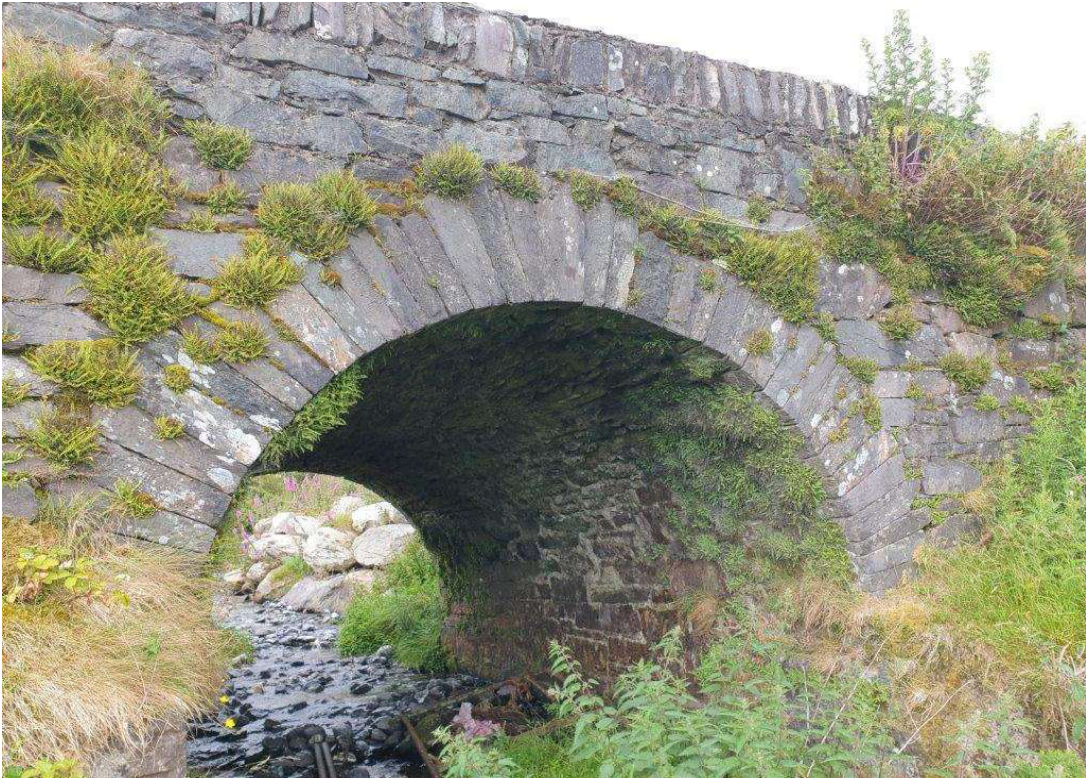
General view of the south elevation
