Bridge No. 9 Inspection Report

Coillte CGA & SSE 110kV Grid Route at  
Gortyrhilly, Inchamore and  
Cummeennabuddoge (CMBG)

Document Number: 201-164-BIR-09

Bridge No. 10 Inspection Report

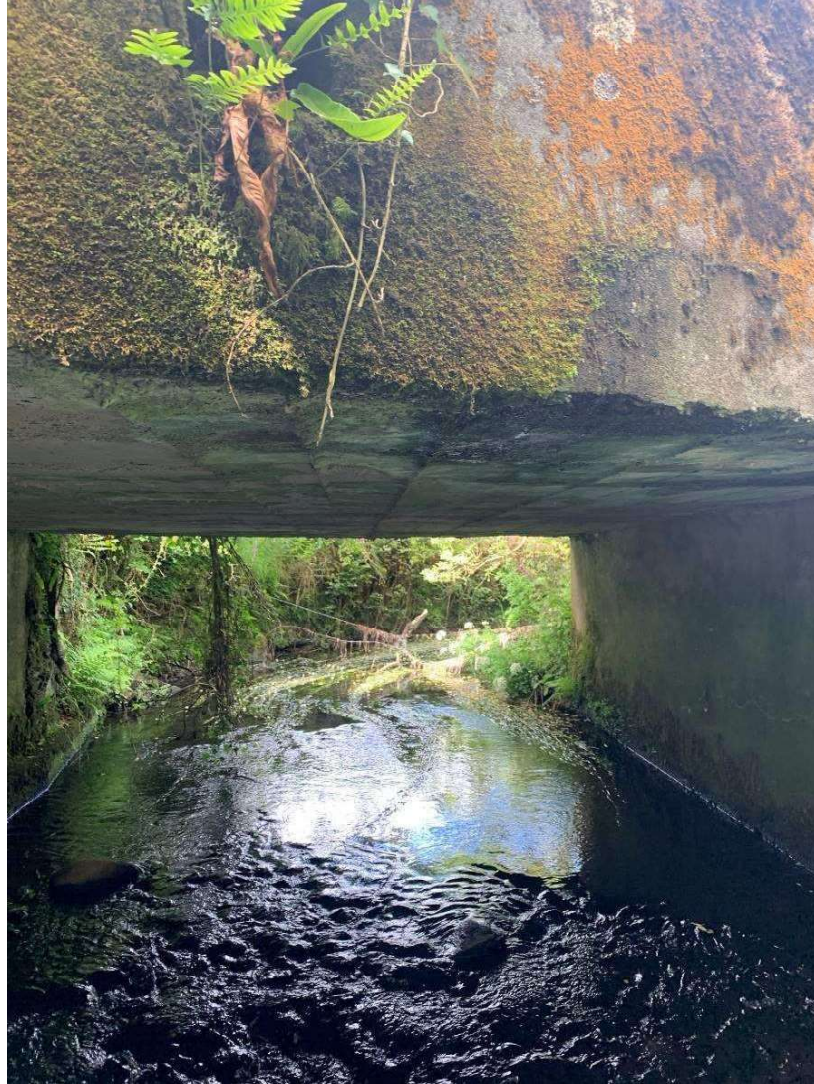
Some minor water ingress is evident locally at the junction between the slab and abutments.

General view of the deck soffit

The source of the water ingress between the concrete deck and abutments should be investigated.

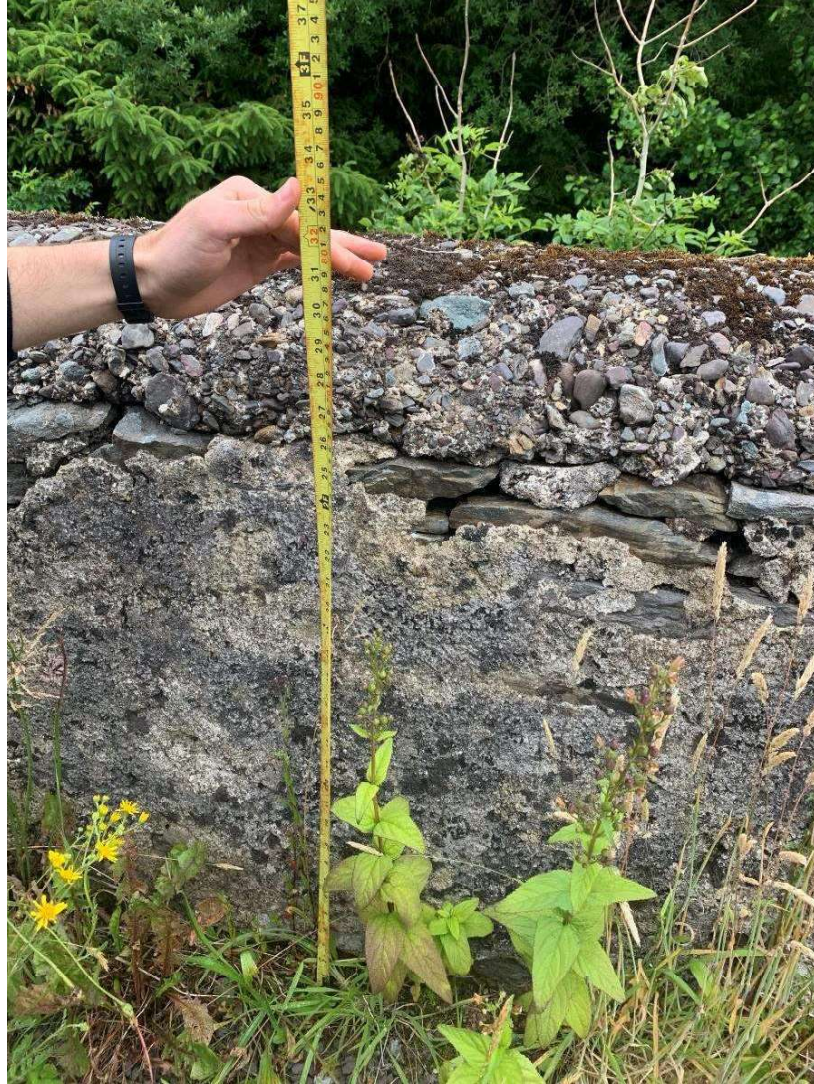
The existing parapets are constructed in stone masonry with a concrete capping and some concrete repairs. The parapets are between 800mm and 900mm high above the road surface and are approximately 450mm thick.

Vegetation is present on both external faces of the parapets. A loss of mortar was noted in the visible areas.

Parapet with concrete coping and repairs, open joints in exposed masonry

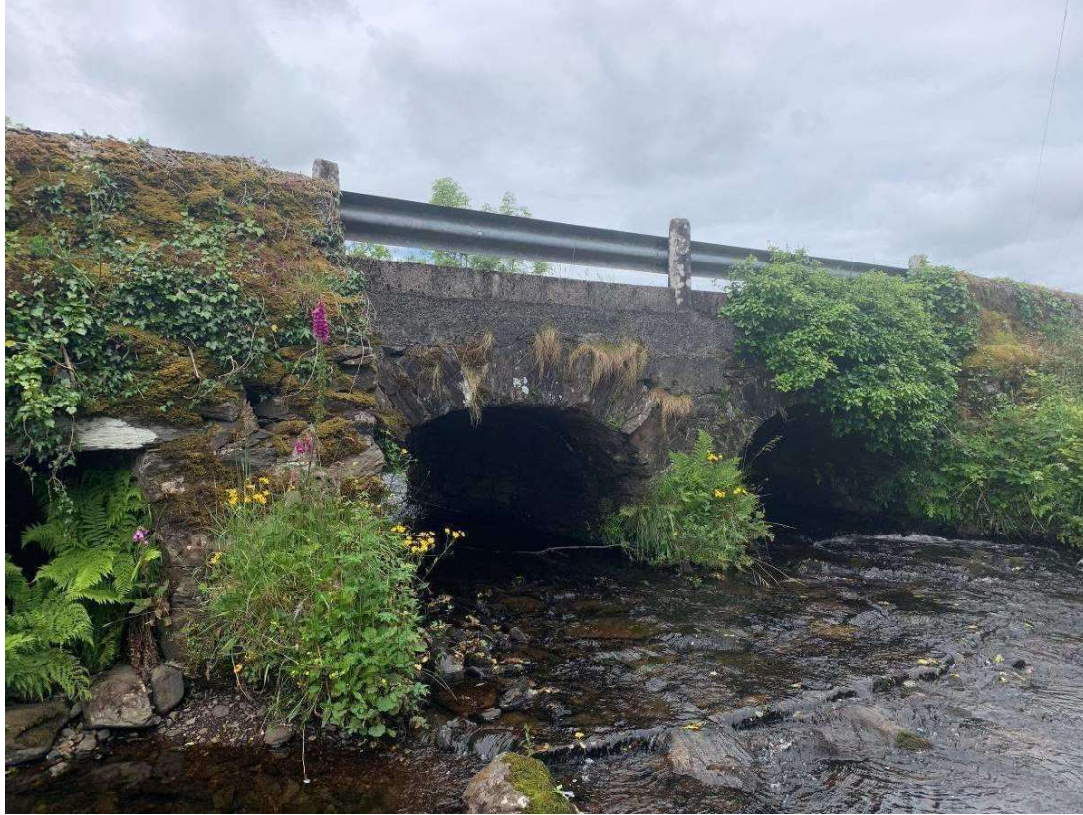
The arch barrels are generally in good condition. Full access to the culverts was not possible due to vegetation growth and dropped masonry, however, the areas that could be inspected appeared to be in poor condition with damaged and missing stones noted.

General view of bridge elevation, relief culvert shown to the left

The culverts are in poor condition and further investigation is required to confirm the full extent of the damage noted. This investigation should include removal of vegetation from the retaining walls.

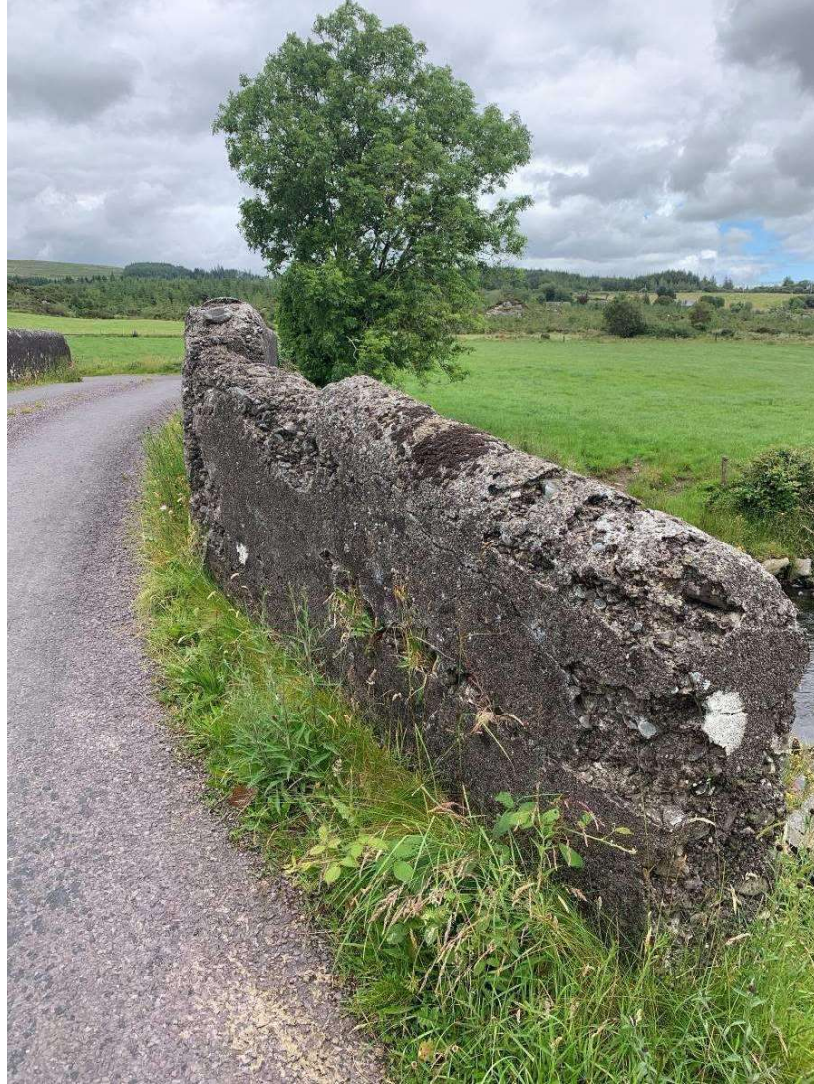
The parapets are generally in good condition. Local damage to the concrete capping was noted.

Close up of parapet showing concrete damage

Overall the structure is in good condition with few defects found. General maintenance works are required, including concrete repairs to the abutments, piers and parapets.

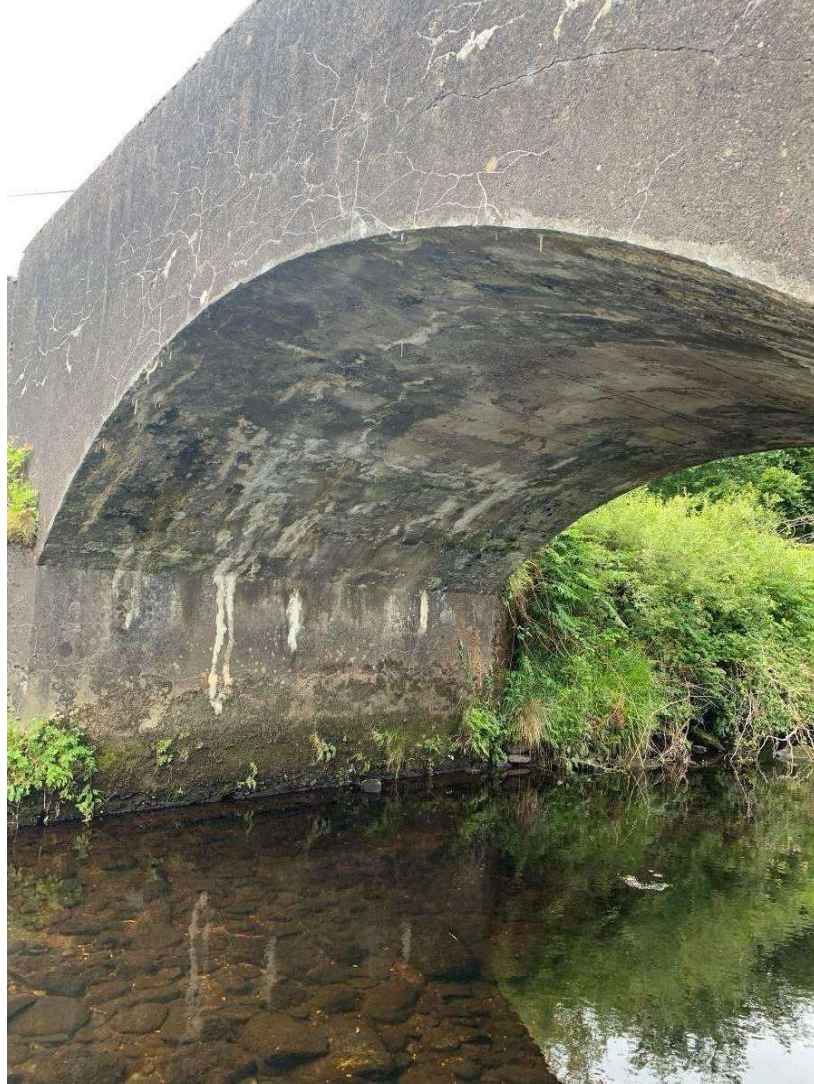
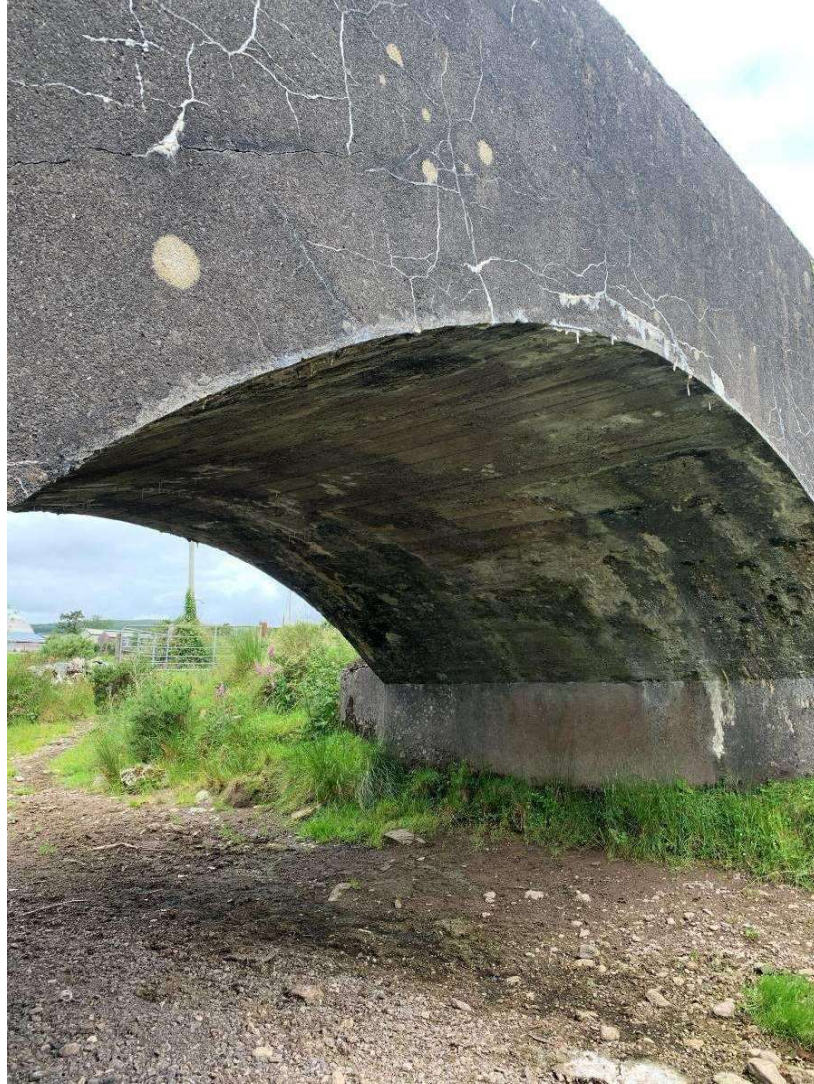
The abutments are generally in good condition. Some minor washout of the concrete is evident towards the abutment footings; however, no undermining or significant loss of material has occurred.

General view of bridge span showing typical condition of arch barrel and abutment

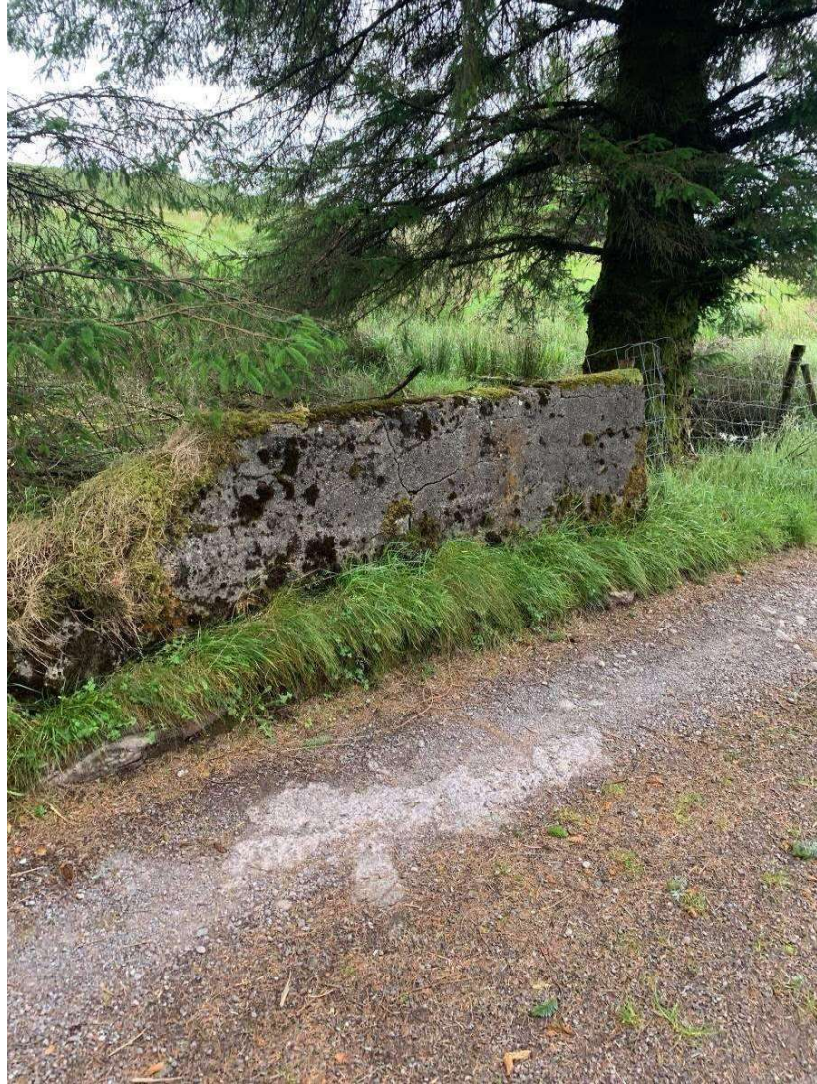
Both parapets have been damaged with parts missing and structural cracking noted.

Upstream parapet with knocked section and structural cracking

Overall the structure is in fair condition with the defects mentioned above. Repairs to the parapets and abutments are required. The waterproofing of the bridge deck should be investigated with consideration to given to removing the soft verges to limit water ingress to the structure.

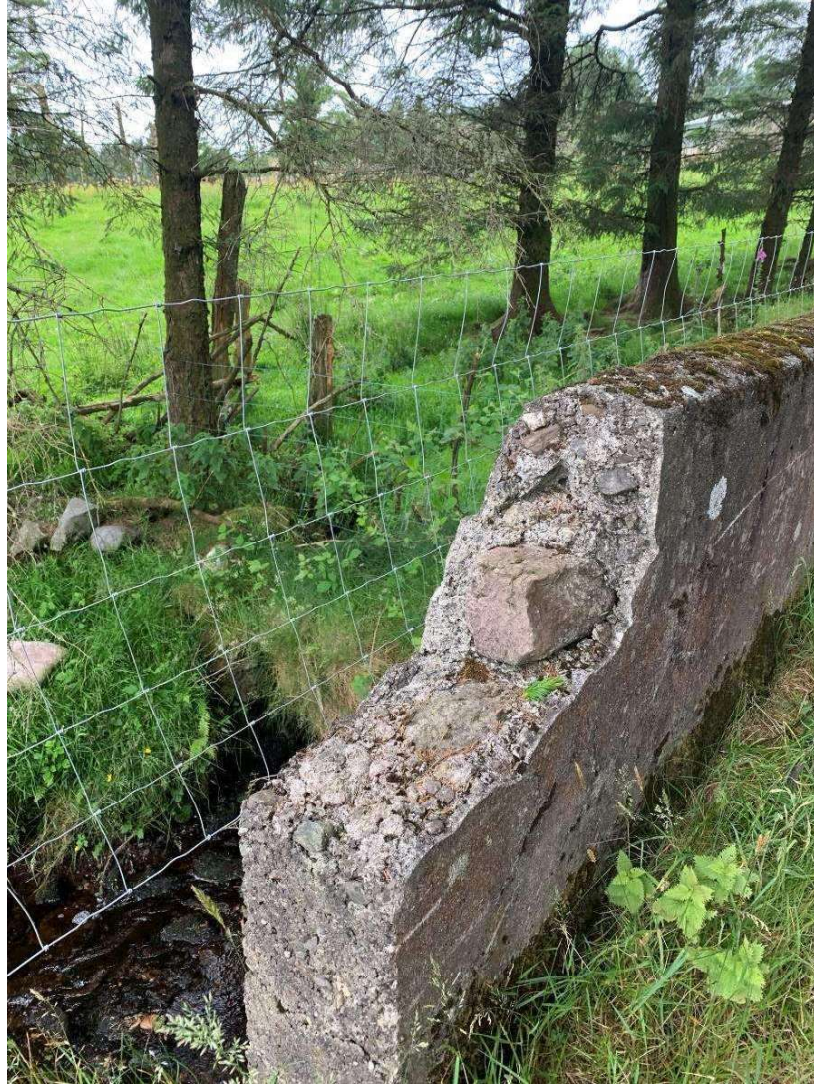
Knocked section of the downstream parapet

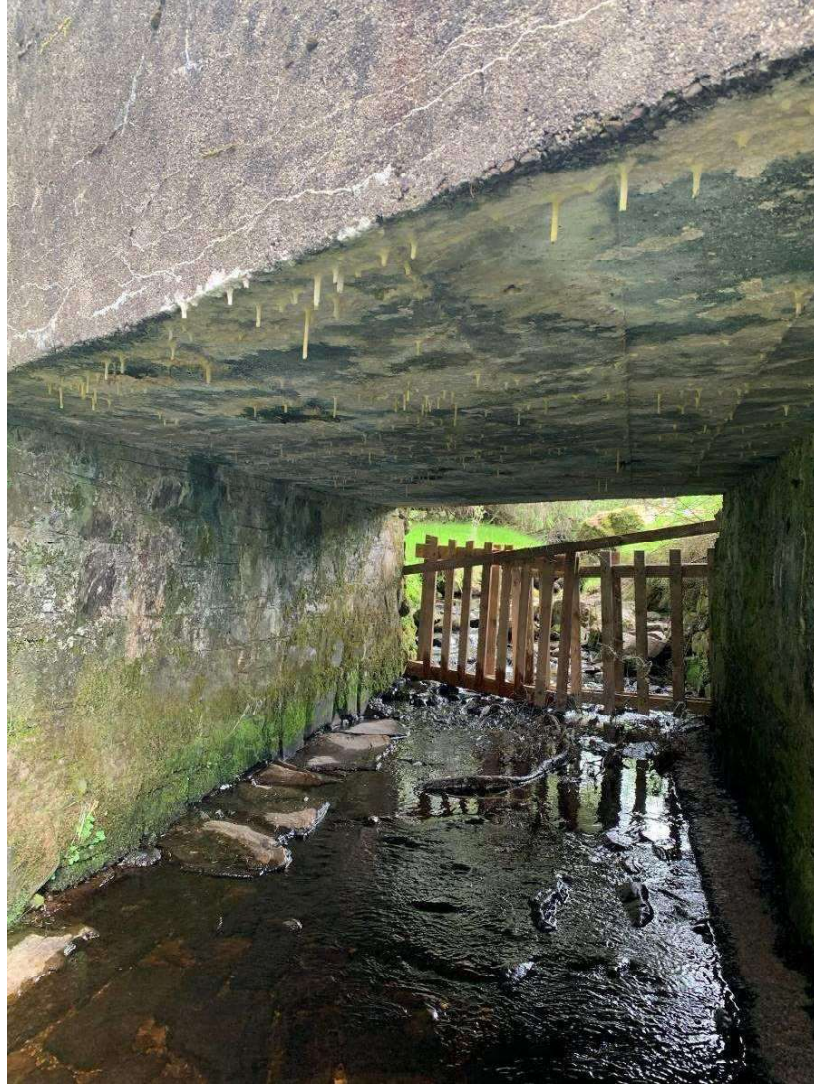
The abutments are constructed in stone masonry. Concrete repairs are evident. Some washout of joints has occurred along the base of both abutments.

No information to the exact construction of the deck slab was available. No significant structural details were noted. Water ingress and calculi staining was evident.

General view through the bridge showing the deck and abutments
