**Report Ref: P2970\_Issue 2**

**Preliminary Risk Assessment**

**Cavan Regional Sports Campus, Cavan,  
County Cavan**

**Issued: March 2024**

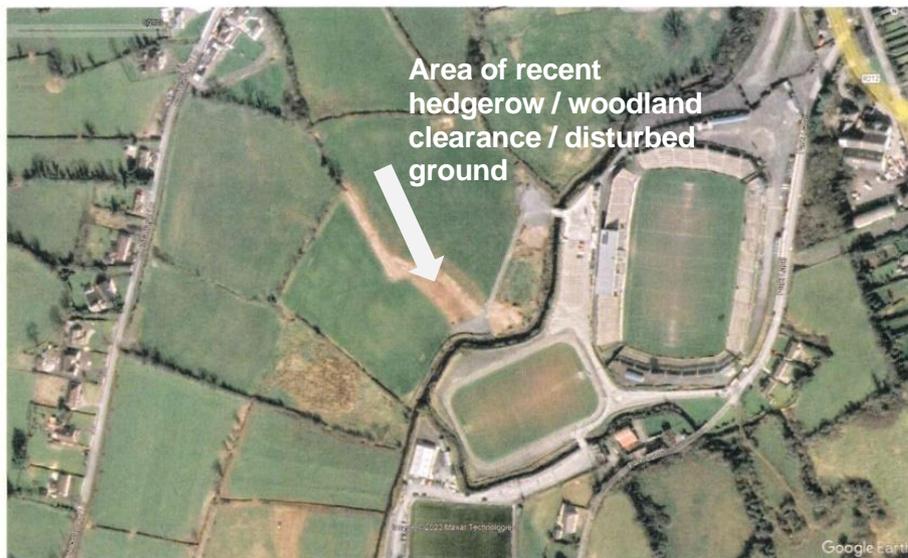
**Figure 4: Area of Recent Ground Disturbance**

The field boundary and associated small area of woodland observed to exist between Field 9 and Field 11, as observed by comparing aerial photography dated between 2021 and 2022 (Figure 4), has recently been removed creating a strip of bare / disturbed cleared ground now partly occupied by the new playing field.

Google Aerial 2023	The area of recent hedgerow / woodland clearance / disturbed ground is evident. The field boundary and associated small area of woodland observed to exist between Field 9 and Field 11, has been removed creating a strip of bare / disturbed cleared ground now partly occupied by the new playing field. Work has begun on the creation of the car park in Field 9.

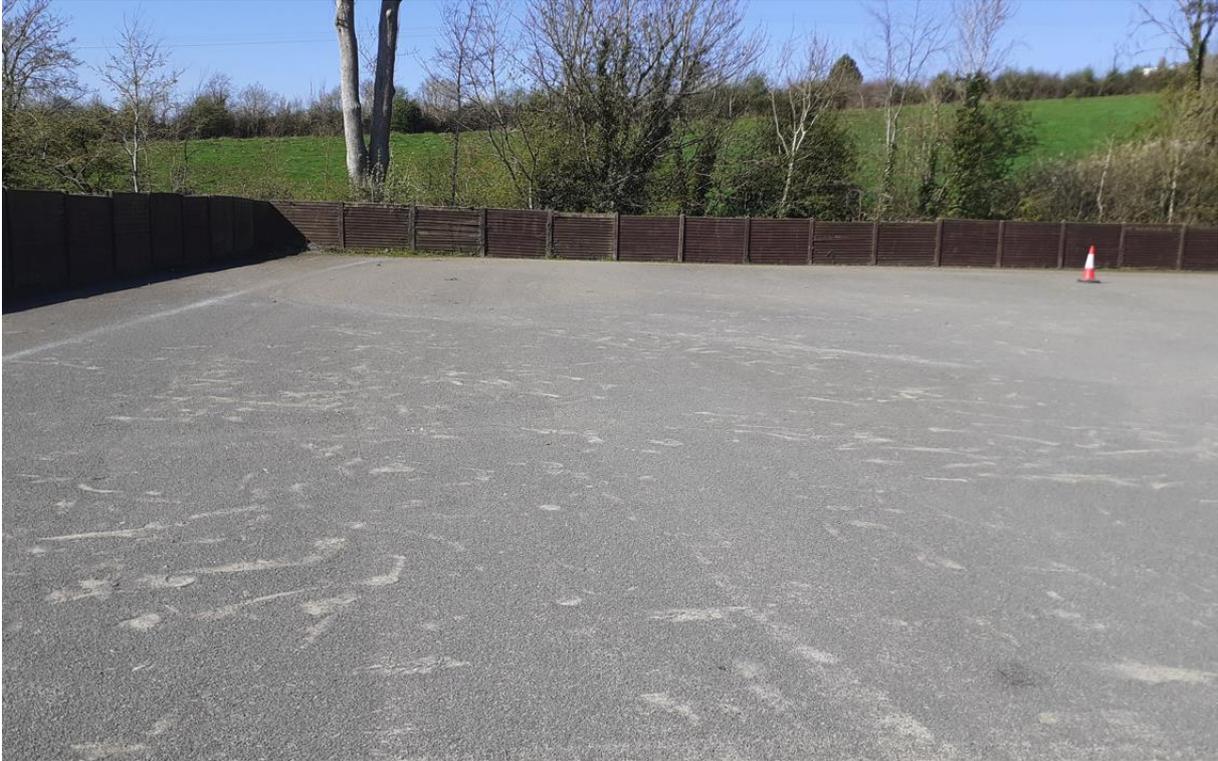
Plate 1: Gravel Playing Pitch looking west

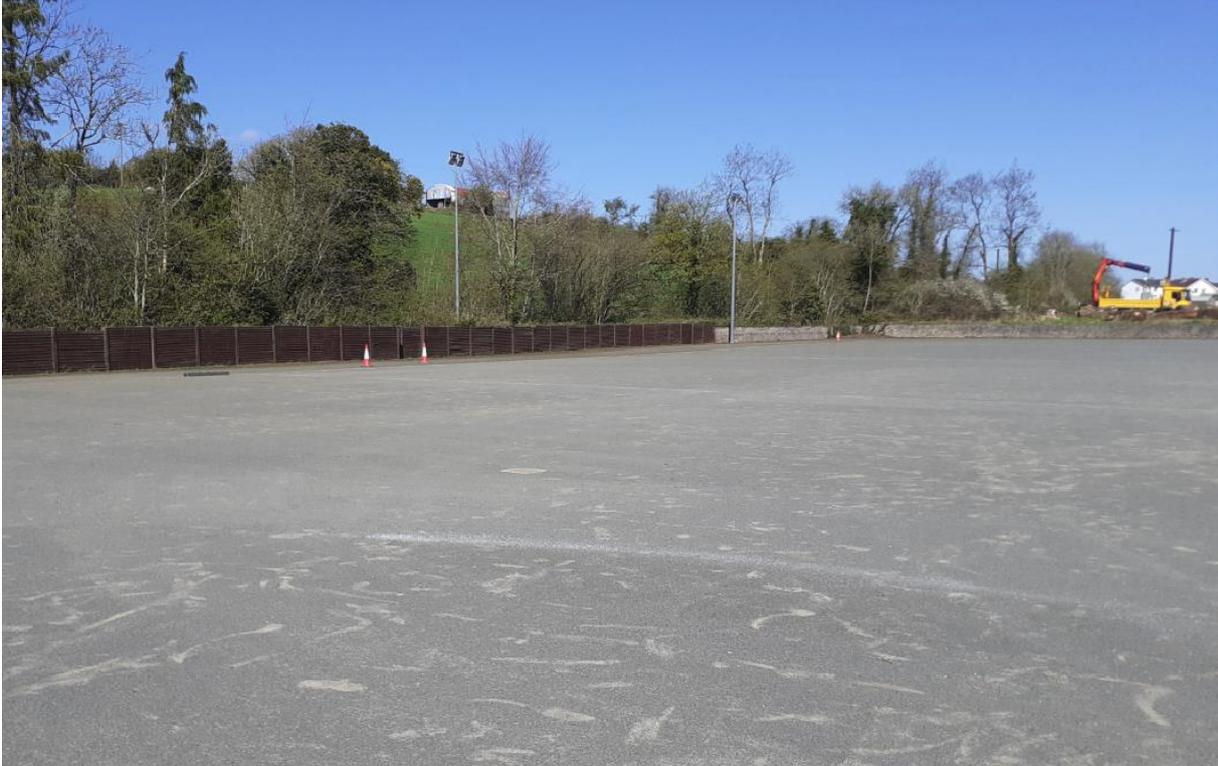
Plate 2: Gravel Playing Pitch looking north west

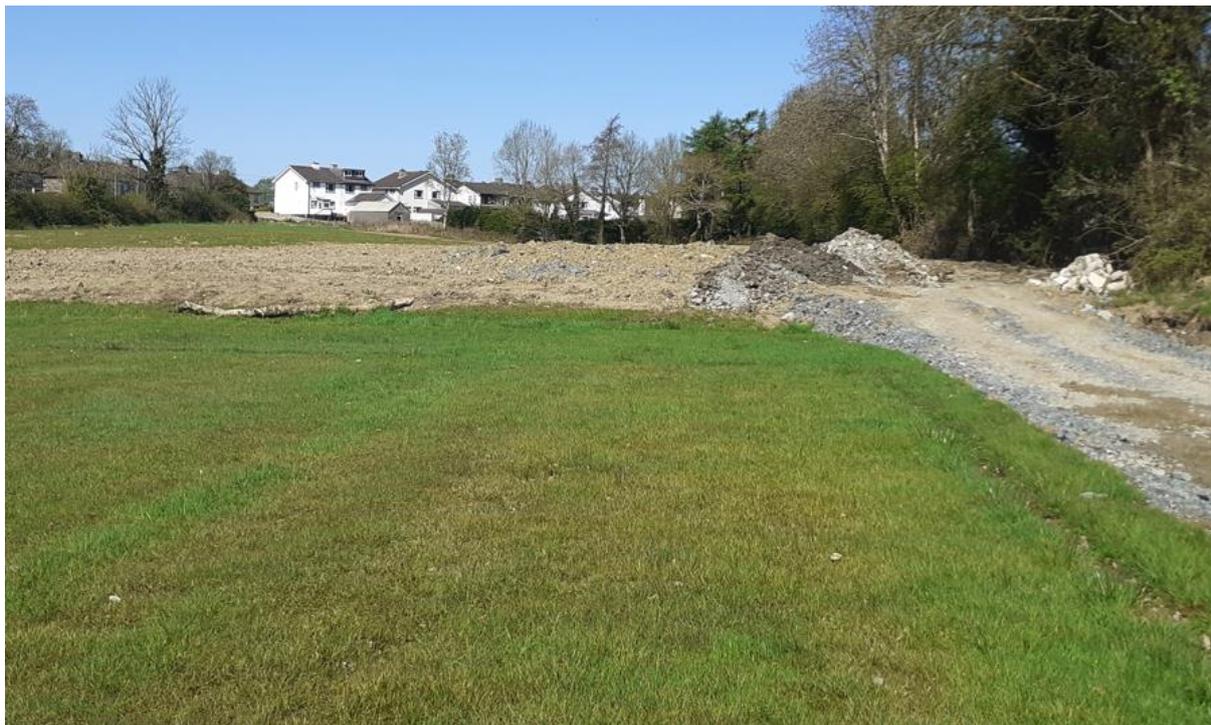
**Plate 13: Field 3 looking north. Construction landraise material evident**

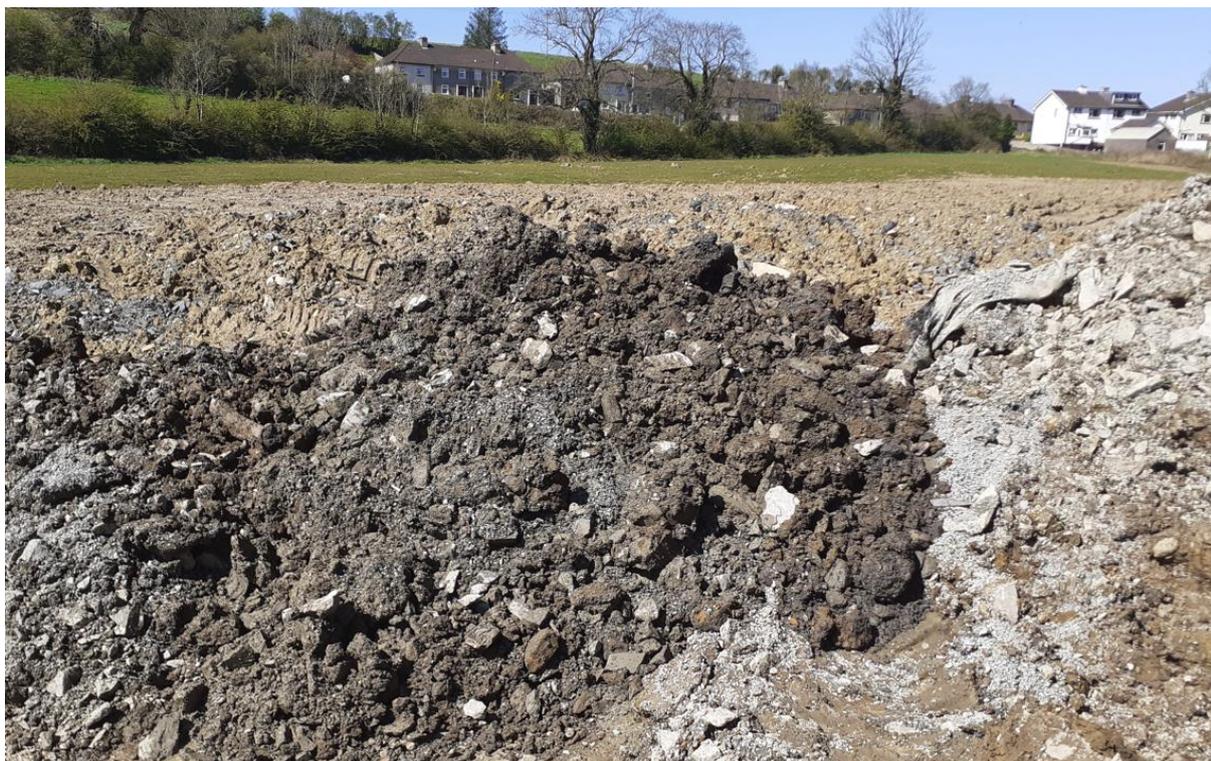
**Plate 14: Landraise material in Field 3**

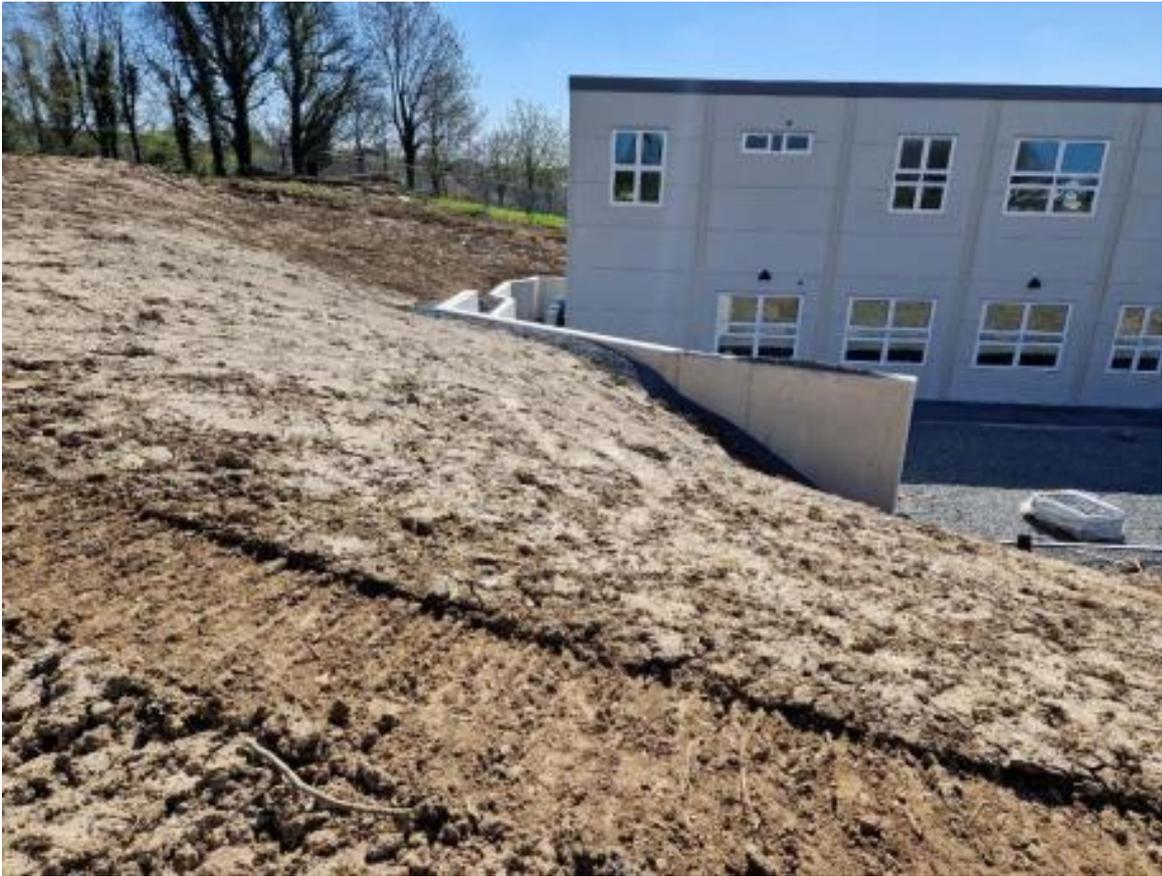
**Plate 17: New school building with recently constructed retaining wall, note cutting made into ground to accommodate building**

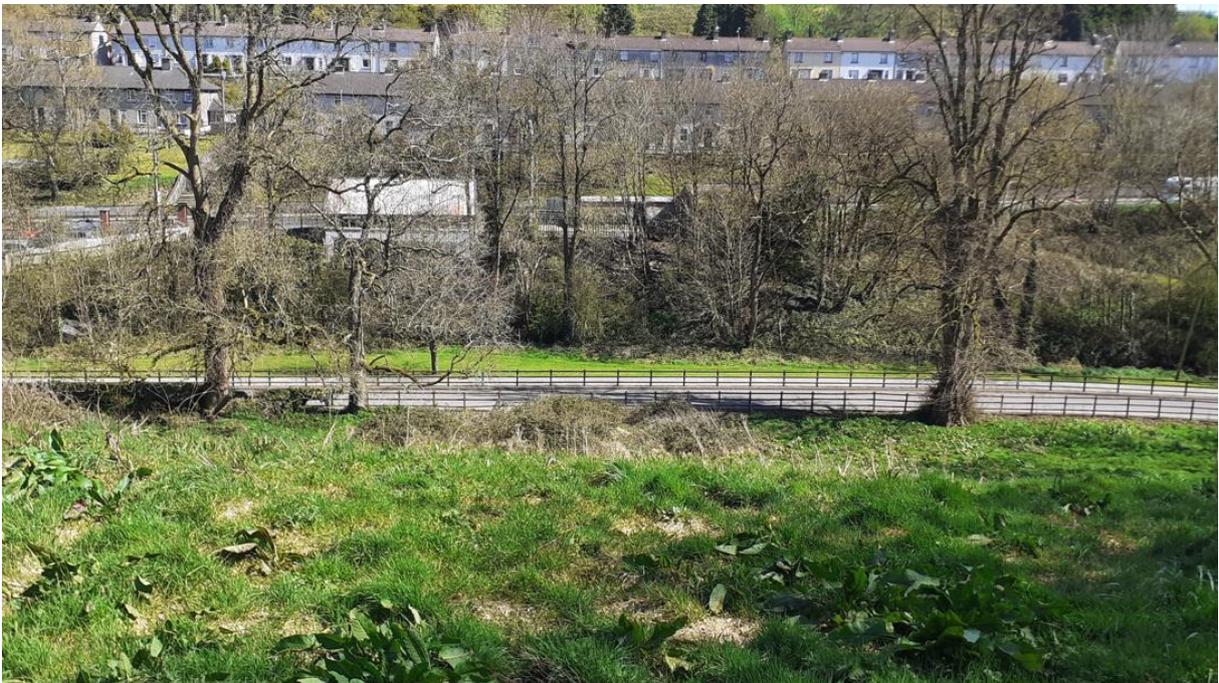
**Plate 18: Field 3 looking east. Steep decline in topography eastwards**

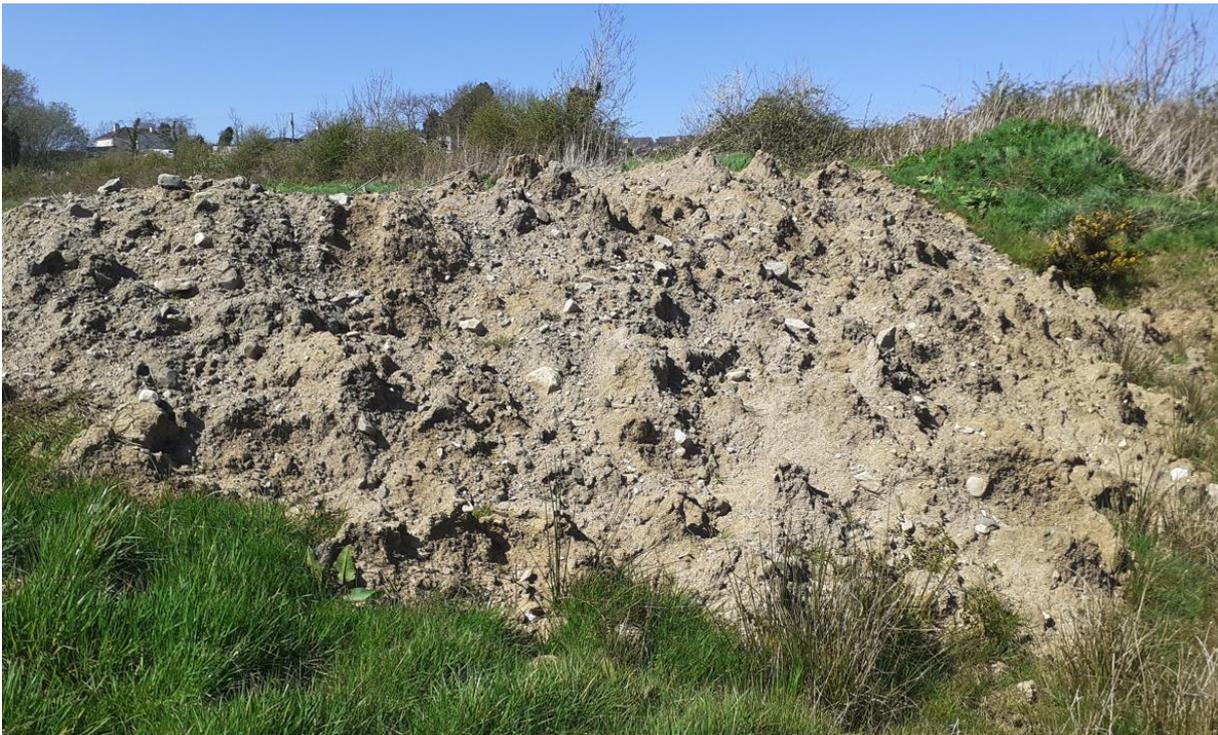
**Plate 22: Clay Stockpile in Field 9**

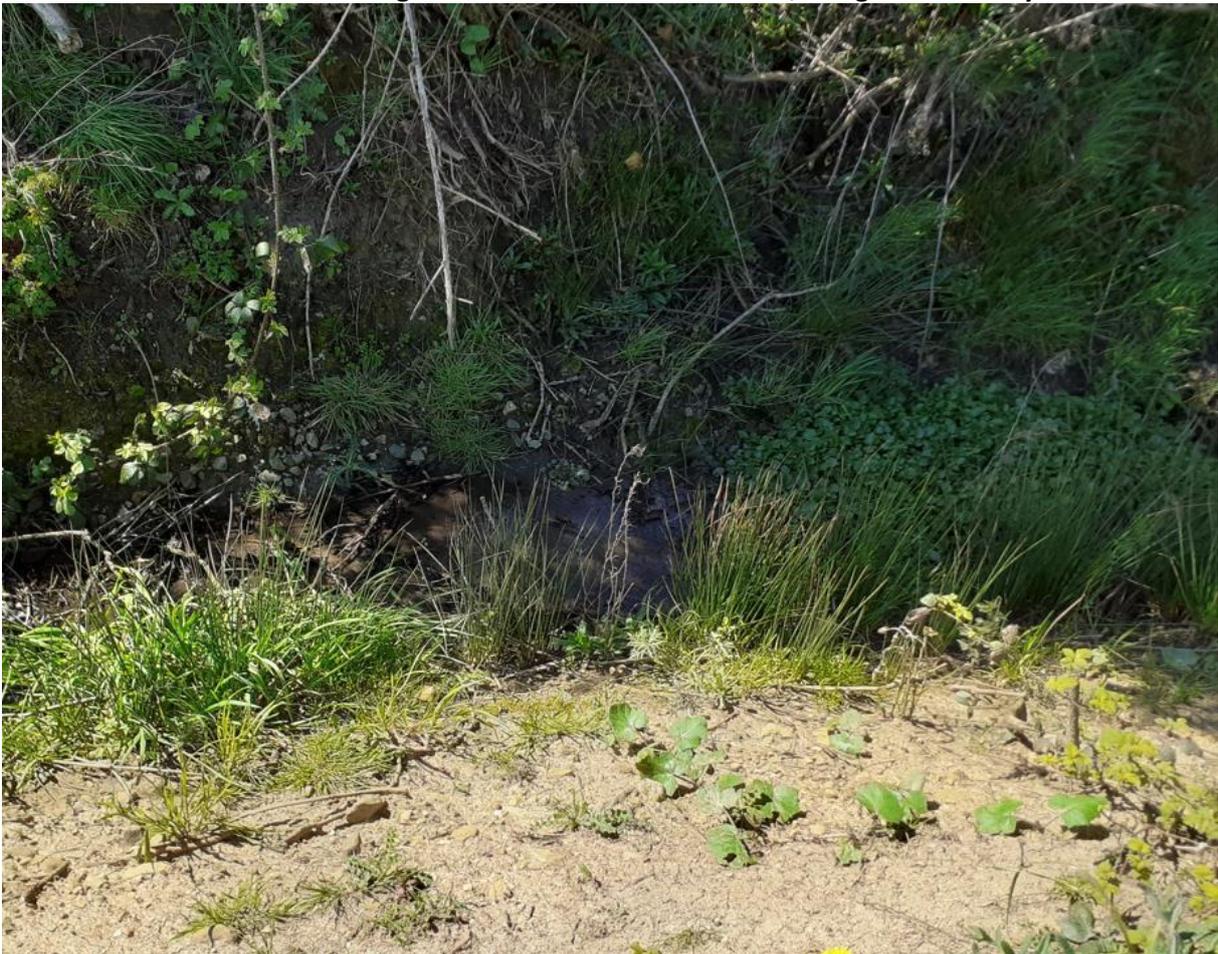
**Plate 24: Watercourse entering the north west corner of Field 9, along the boundary with Field 8**

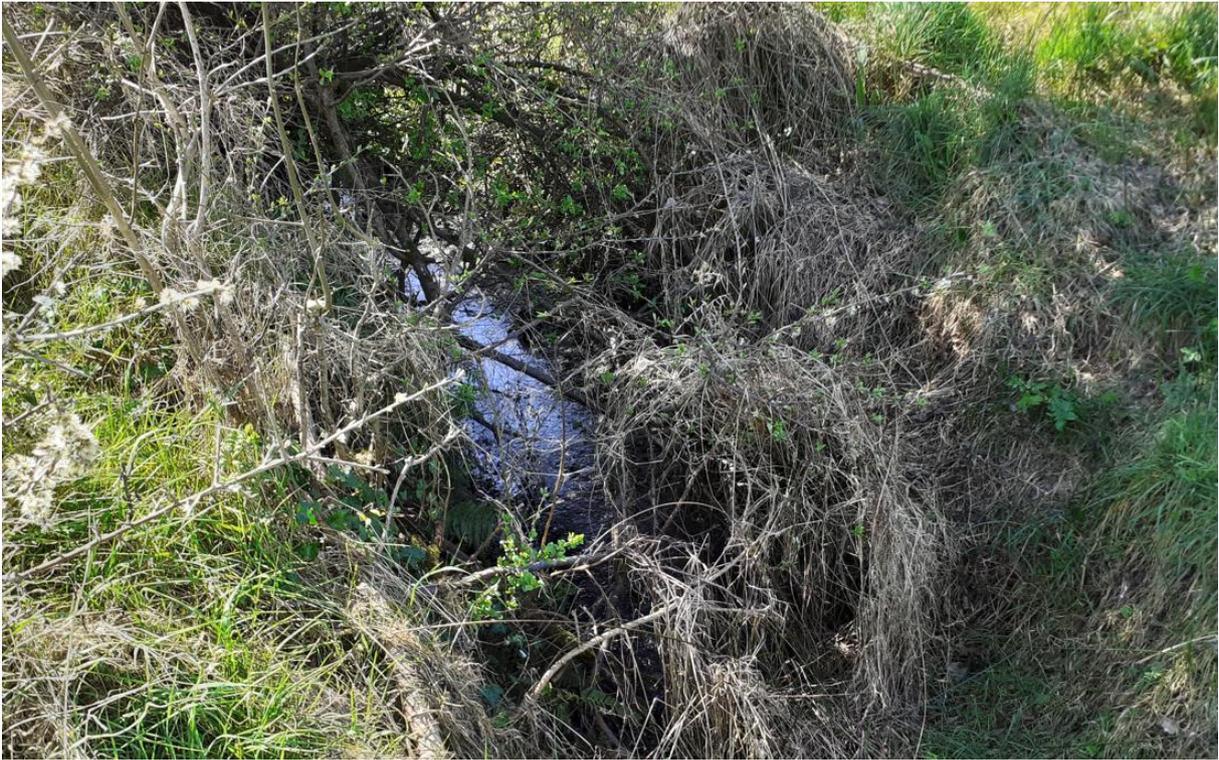
**Plate 25: Ditch on Boundary of Field 10 and Field 11**

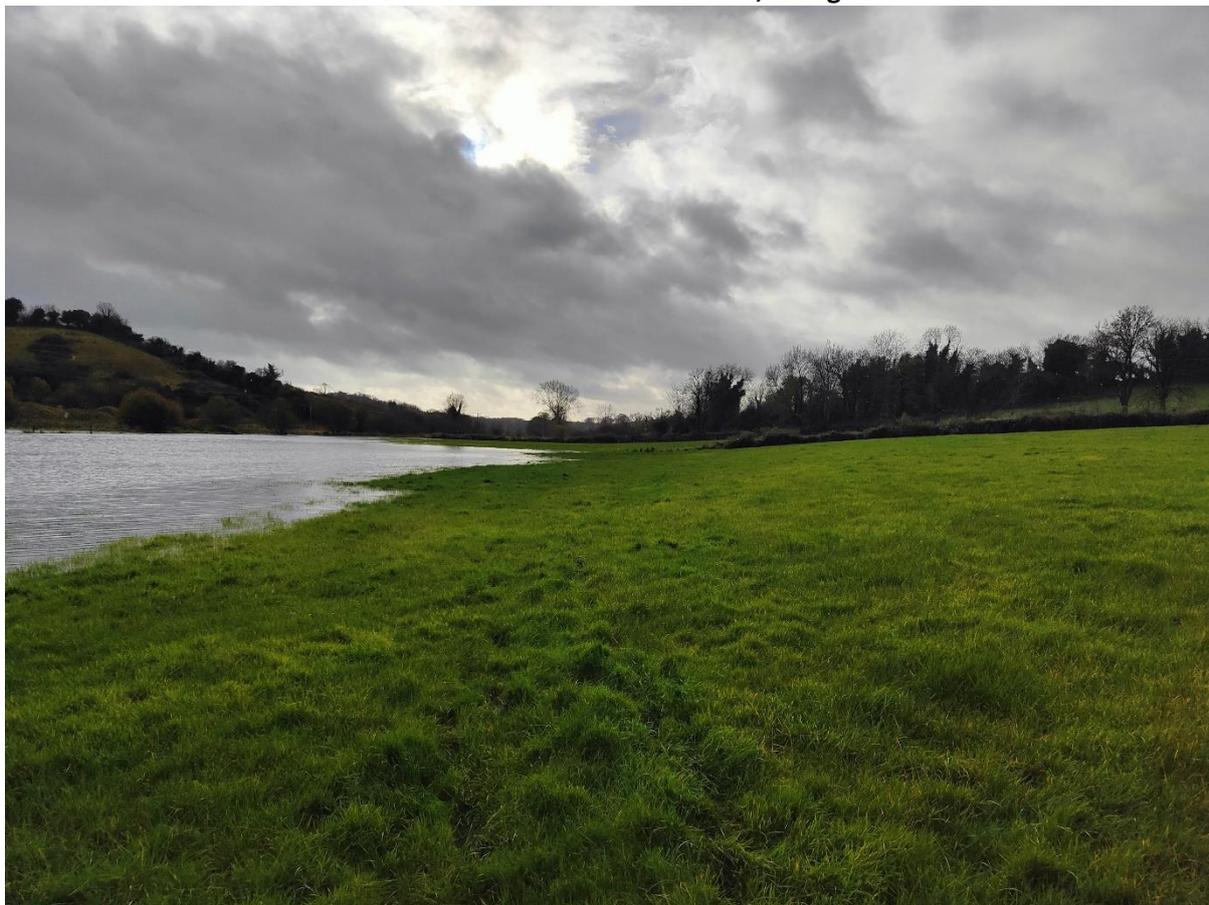
**Plate 31: Flood extent on Fields 13-15, facing south**

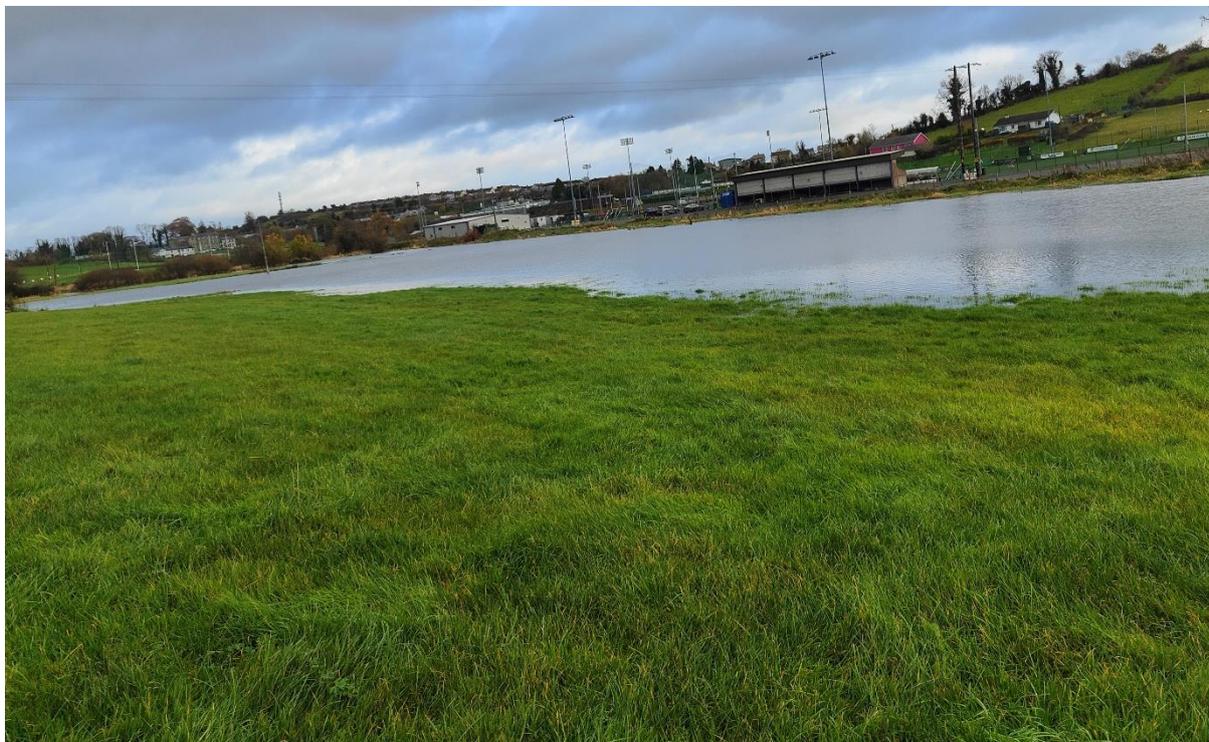
**Plate 32: Flood extent on Fields 13-15**

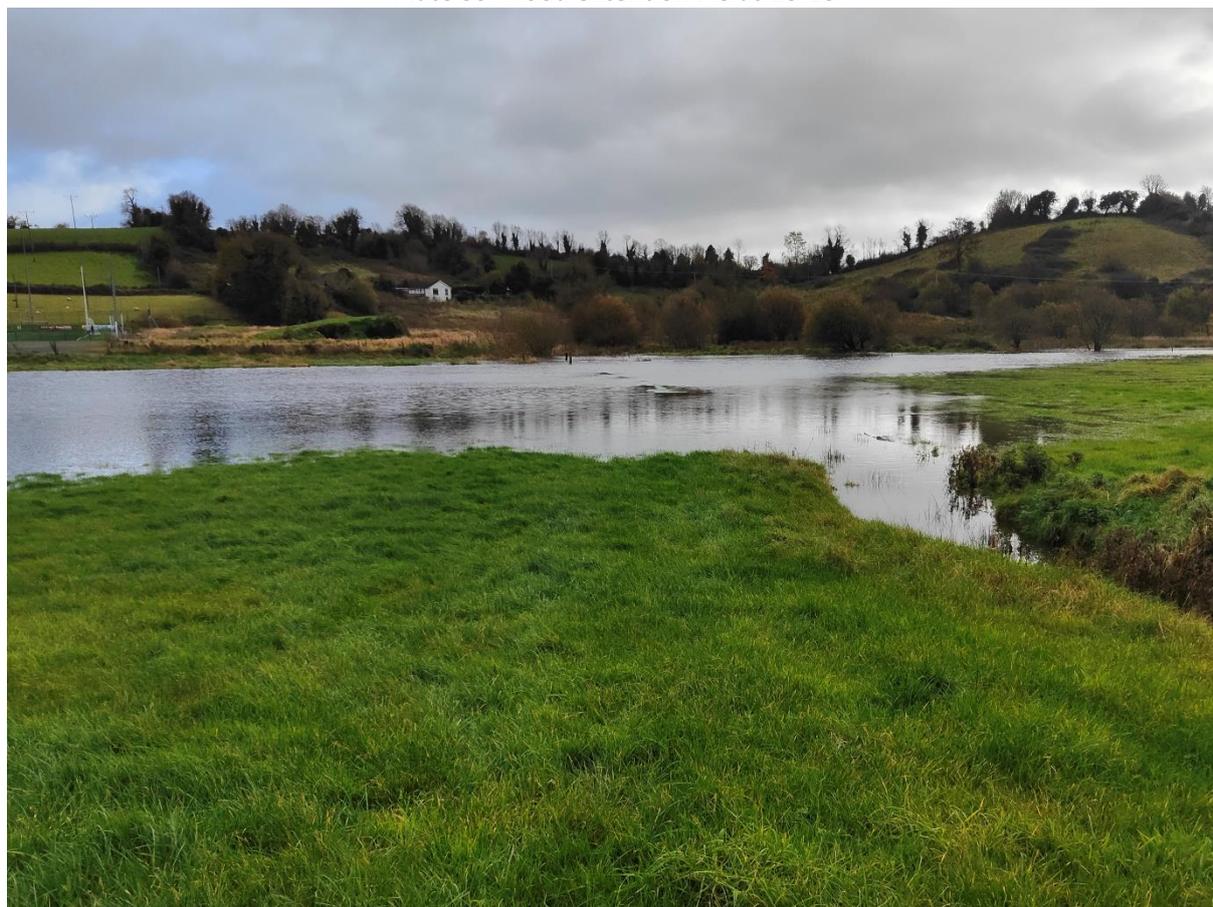
**Plate 33: Flood extent on Fields 13-15**
