**Fehily Timoney Peat
Stability Assessment of
Meenbog Wind Farm Site
(2021)**

Meenbog Wind Farm

Peat Stability Assessment of Meenbog Wind Farm Site

Abstract: This assessment addresses the stability of the site of the Meenbog Wind Farm, County Donegal following a peat failure at the site on 12 November 2020.

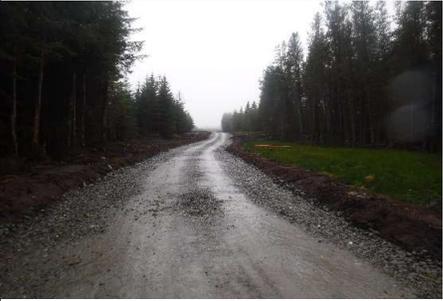
T14 access track	Side casting both sides, 6 degree slope, <1m side cast. No evidence of stability issues.

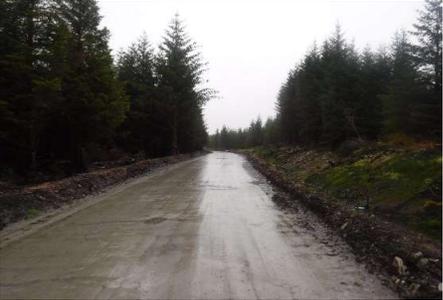
T15-T19	Founded section of track, rock visible in drain on upslope side. No evidence of stability issues.

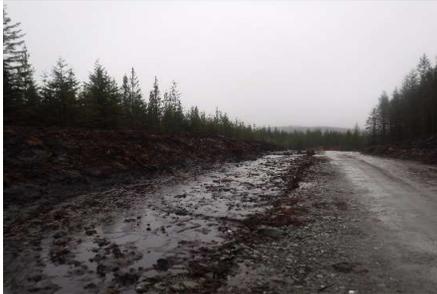
T19	Side casting alongside track. 2-3 degree slope, peat up to 2m in height, not sealed.

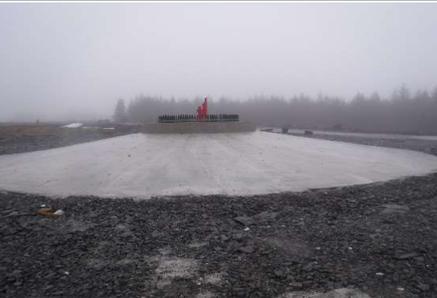
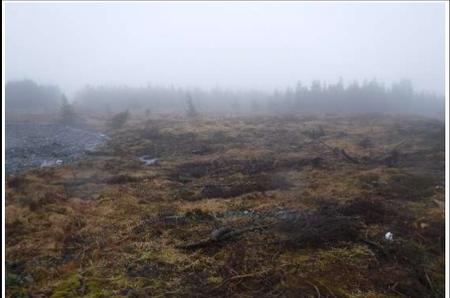
<p data-bbox="1293 464 1434 488">T4 Hardstand</p>	
T5	3 degree slope around hardstand. Evidence of instability around hardstand - tension cracks visible to 25-30m away from hardstand.

<p data-bbox="1646 813 1986 837">Tension cracks around hardstand</p>
T6	5 degree slope around hardstand. Minor side casting of peat (<0.5m). No evidence of stability issues.

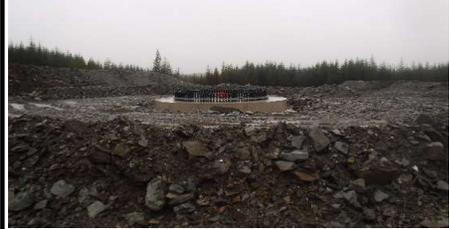
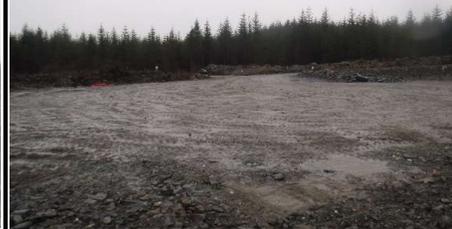
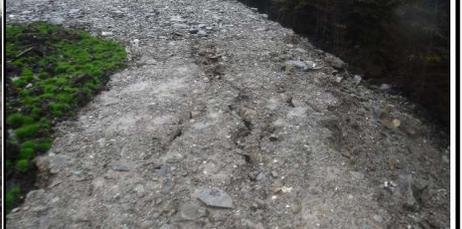
<p>T15</p>	<p>2-4 degree slope around hardstand. Peat stored both north and west of the hardstand. Area to the north shows signs of movement in perimeter berm.</p>

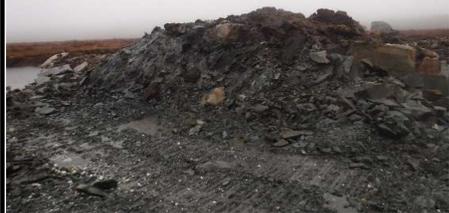
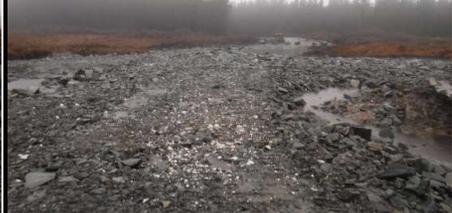
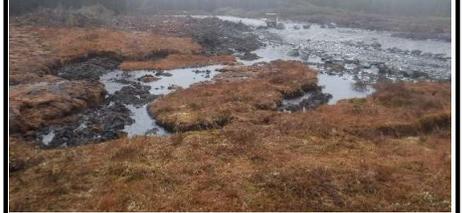
<p>T16</p>	<p>3 degree slope around hardstand. Small failure between cut-off drain and hardstand in peat. Water from drain now draining into hardstand.</p>

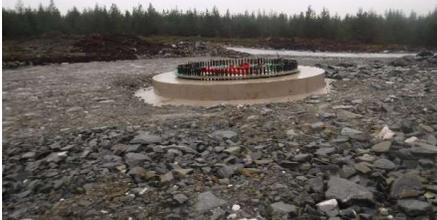
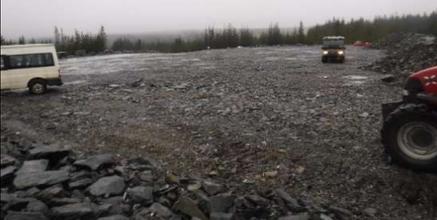
<p>T17</p>	<p>3 degree slope around turbine and hardstand. Peat side cast upslope and hardstand. Peat storage area downslope, berm shows evidence of minor movement.</p>

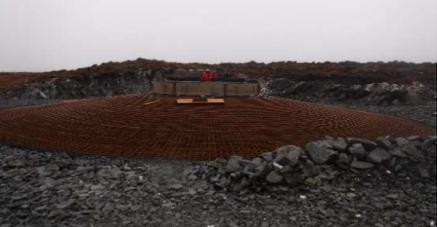
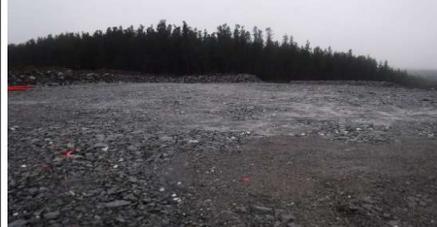
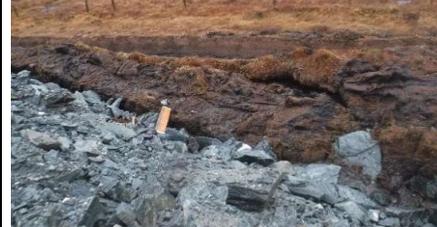
<p>T19</p>	<p>2-3 degree slope around hardstand. Rock at surface at turbine location, 1.5-2m of peat adjacent to hardstand. Minor slump between cut-off drain and hardstand.</p>

<p>T19 Turbine</p>	<p>T19 Hardstand</p>	<p>Minor failure along edge of drain</p>

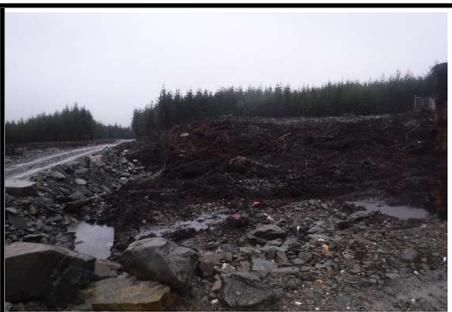
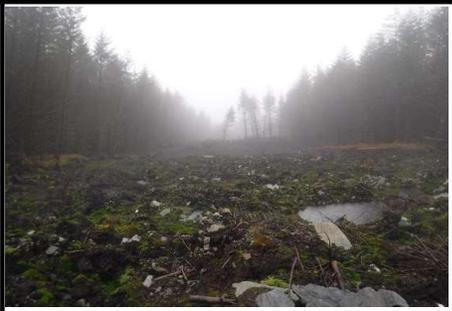
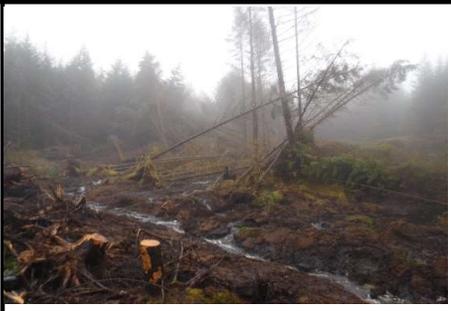
<p>Failure T6-T8</p>	<p>General views of peat failures - see report text for details</p>

<p data-bbox="756 803 1060 844">Downslope at head of failure</p>
