**SITE INSPECTION  
TECHNICAL NOTE (2023)**

## **Meenbog Wind Farm Site Inspection Technical Note**

20 October 2023

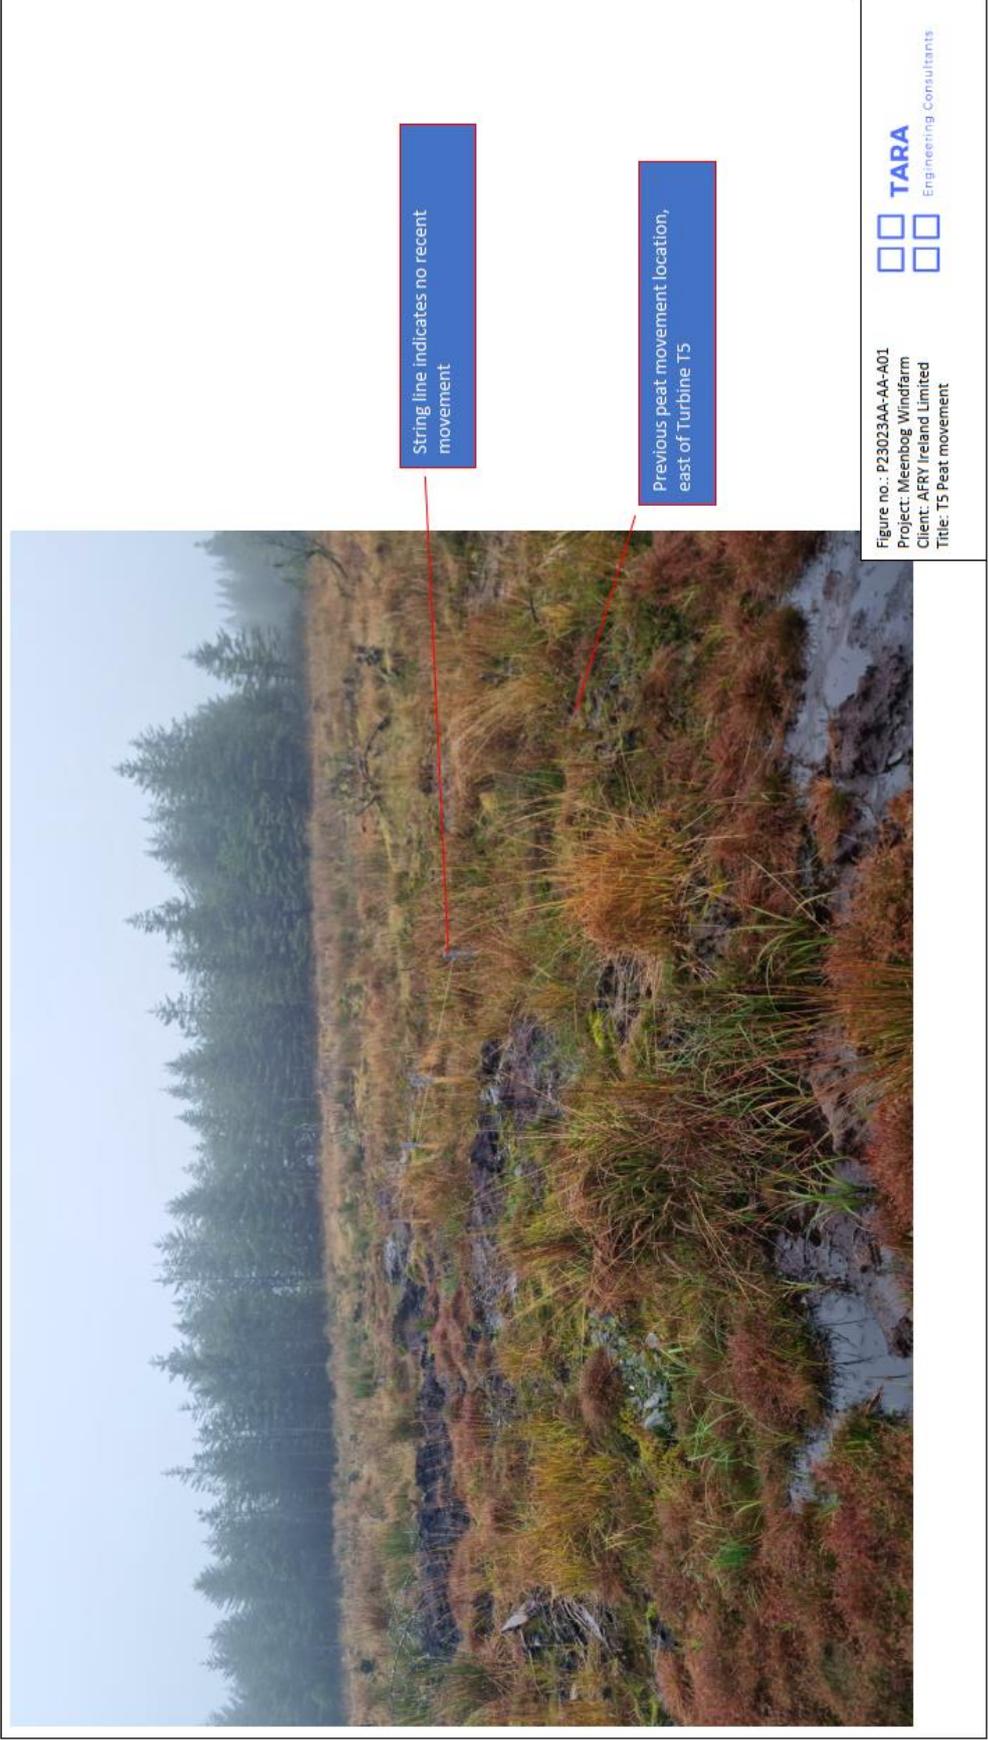
Movement monitoring locations which included string line posts (installed after the 2020 movement) were inspected and signs of recent movement were not observed. Please see attached photographs showing the string line posts attached at Appendix A.

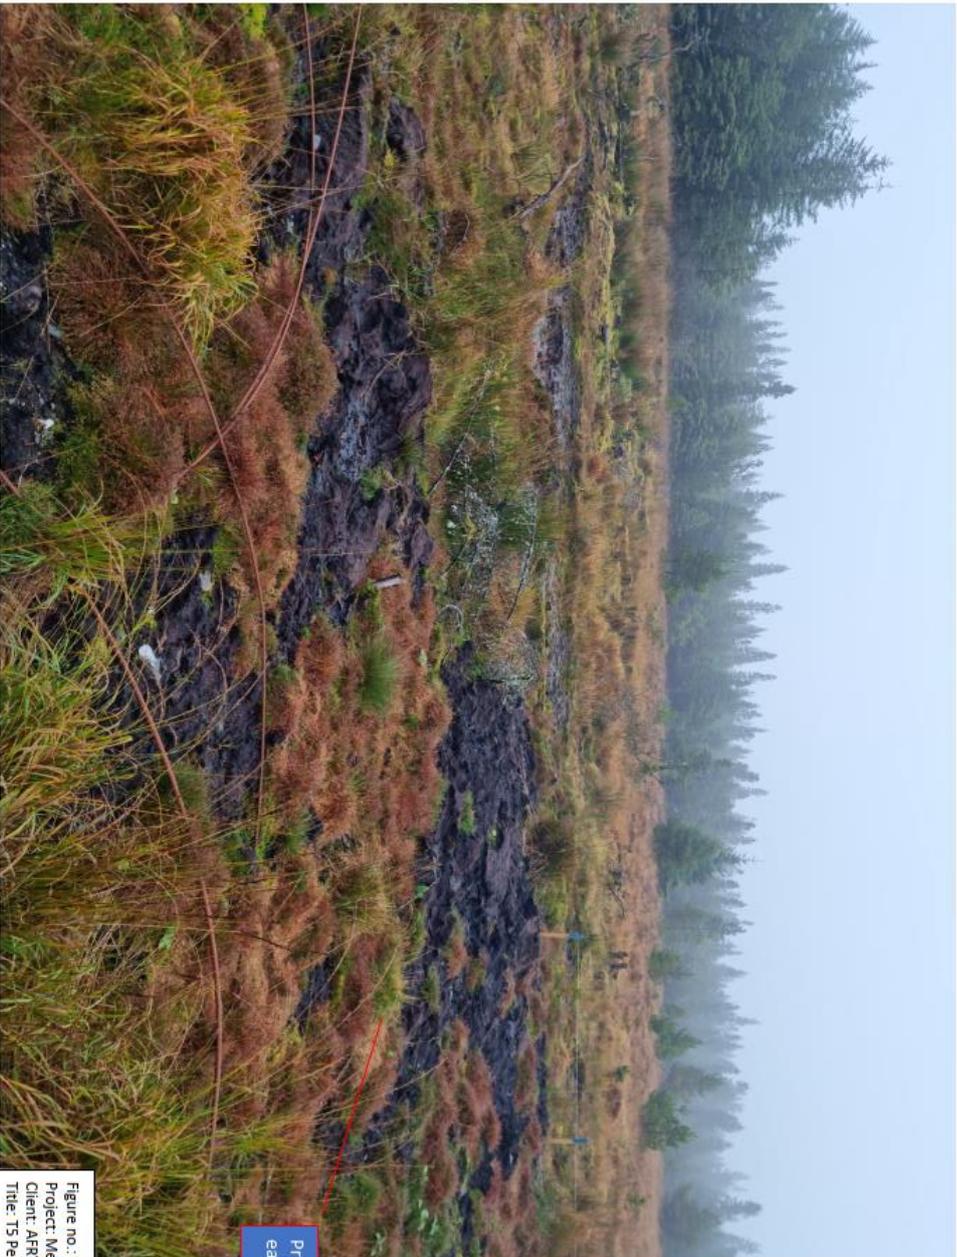
Figure no. : P23023AA-AA-A02  
Project: Meenbog Windfarm  
Client: AFRY Ireland Limited  
Title: T5 Peat movement

Previous peat movement location,  
east of Turbine T5

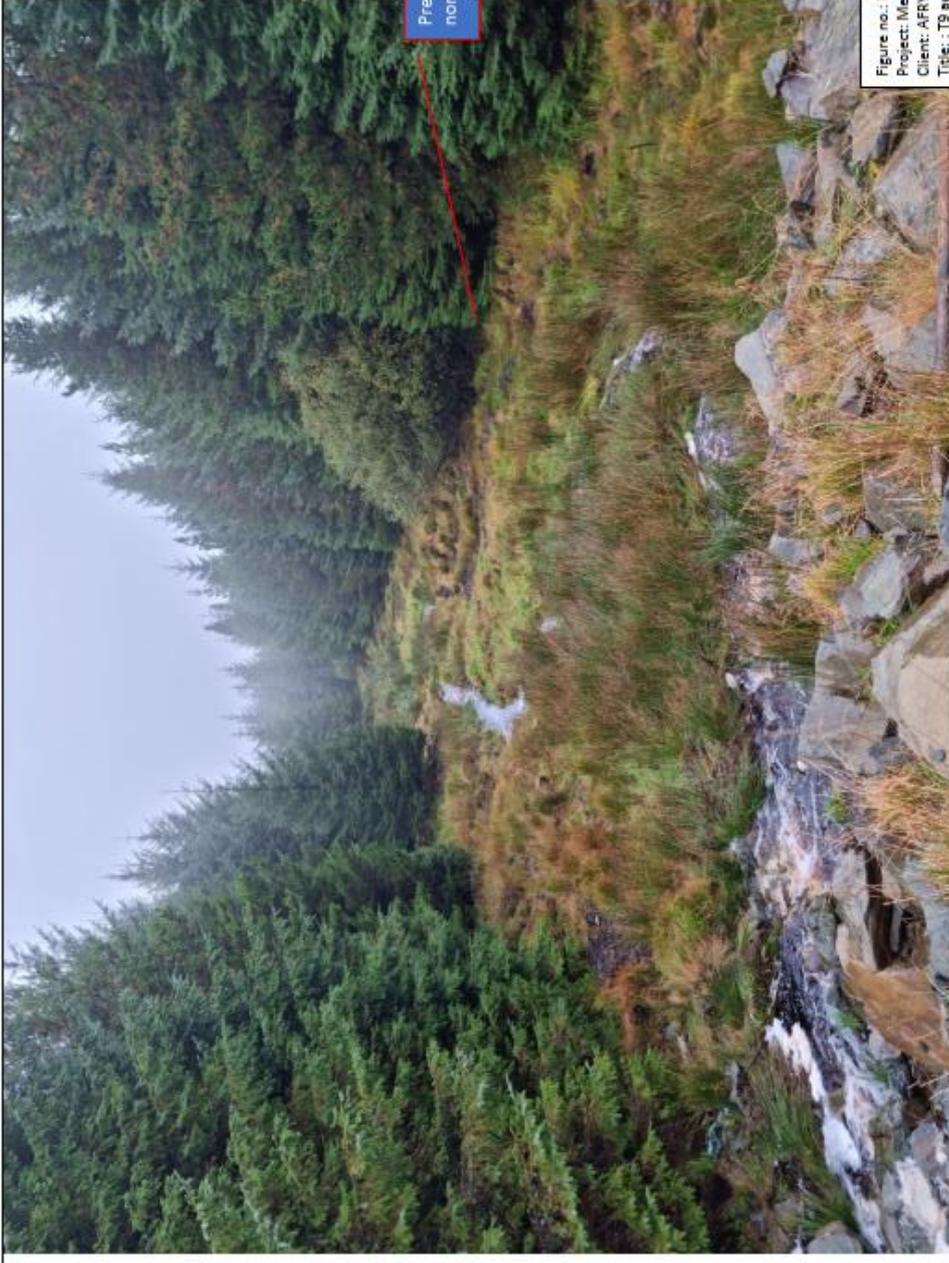
Figure no.: P23023AA-AA-A06  
 Project: Meenbog Windfarm  
 Client: AFRY Ireland Limited  
 Title: T9 access road peat movement

Previous peat movement location, view to northeast of T9 access road

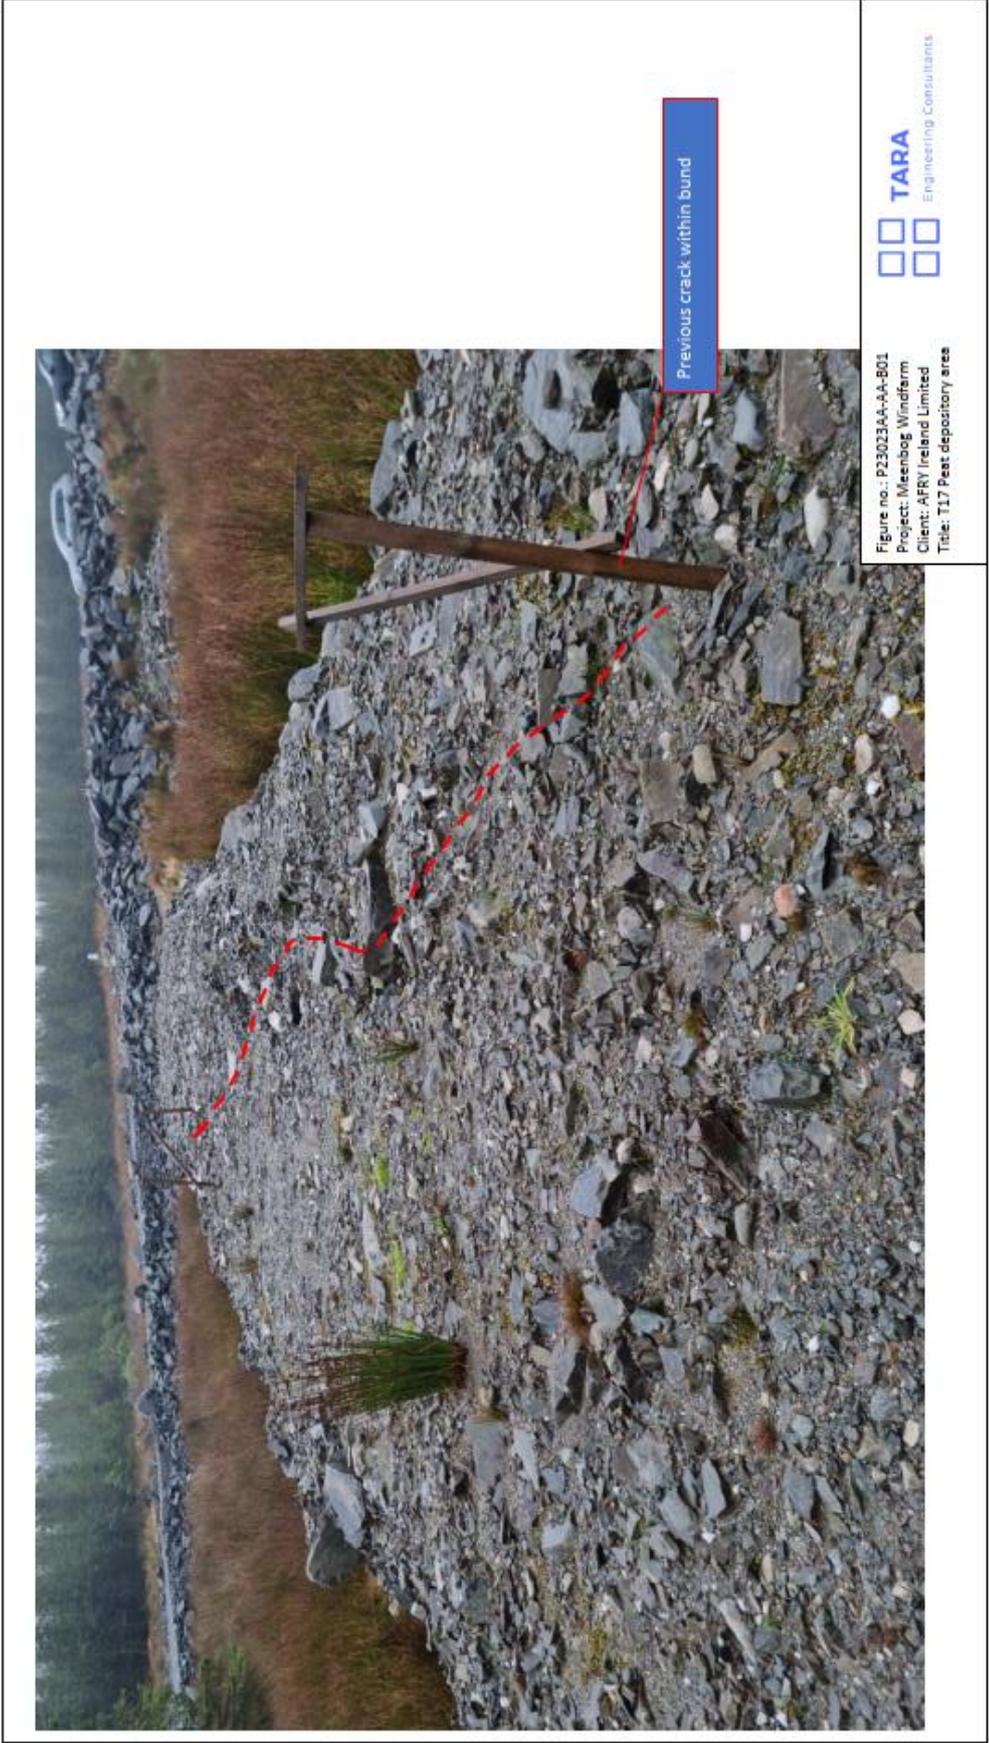
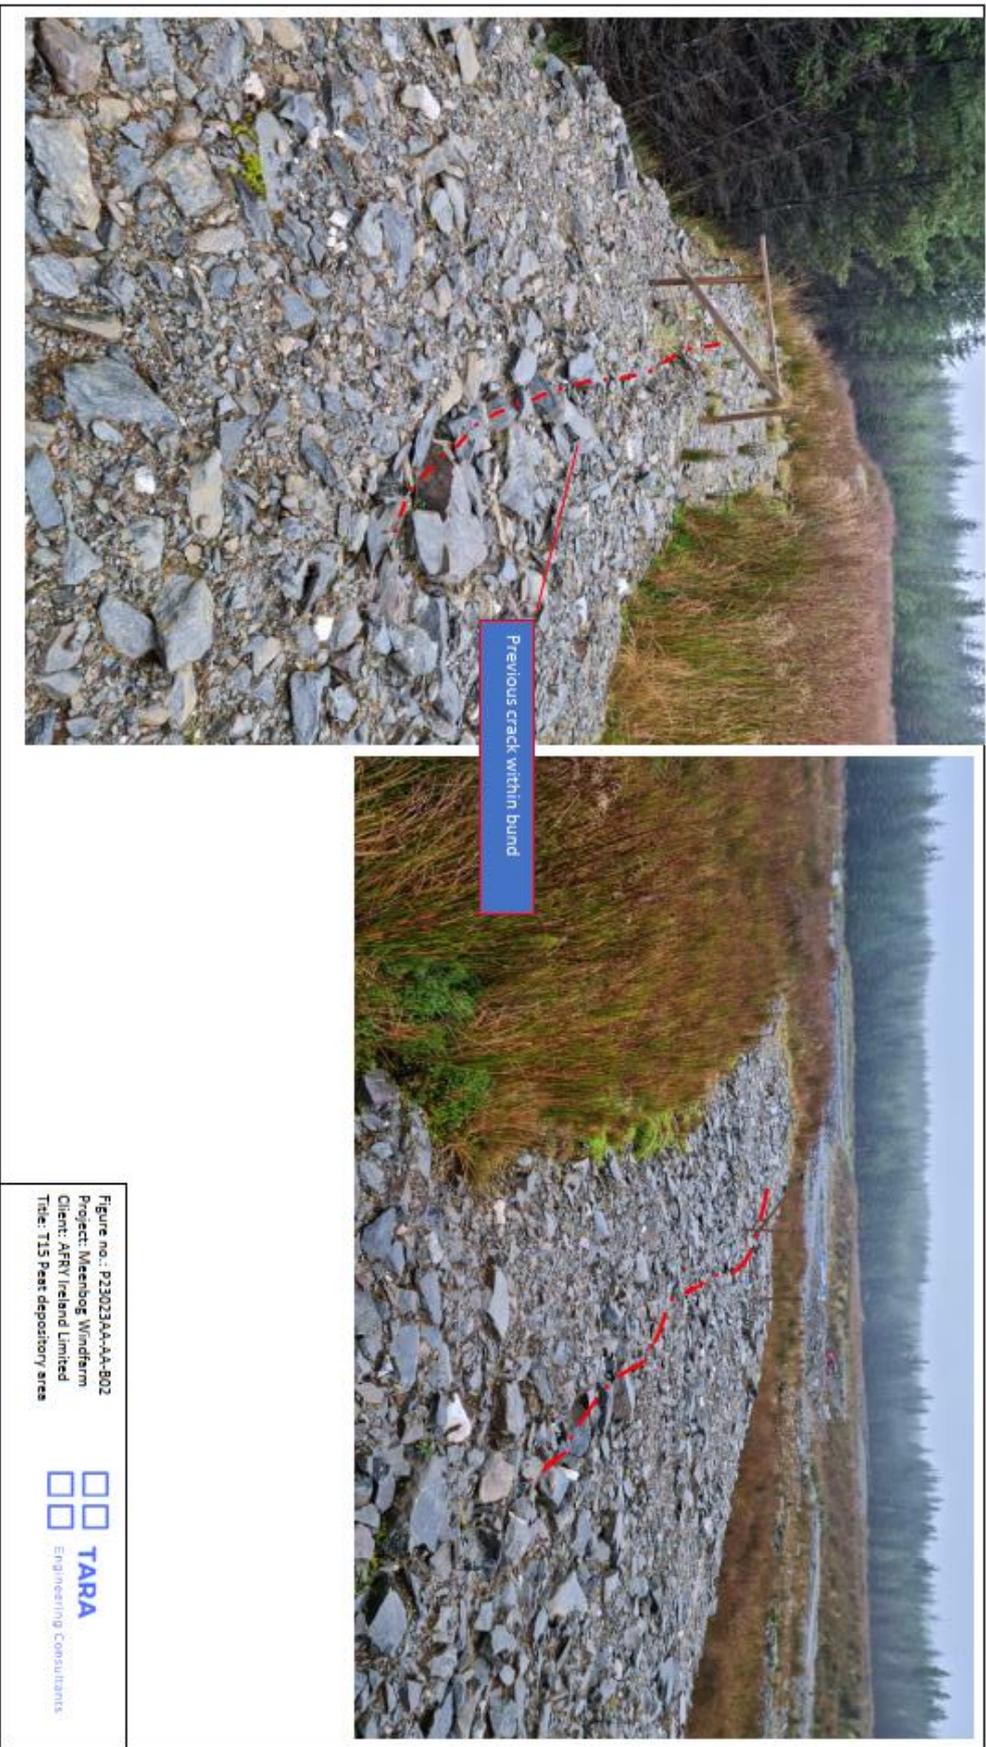
Figure no.: P23023AAA-AA-B02  
 Project: Meenbog Windfarm  
 Client: AFRY Ireland Limited  
 Title: T15 Past depository area

At two of the peat depository areas located at T15 and T17, cracks parallel to the embankment crest were recorded in the Ionic 2021 Report. The Tara and AFRY engineers inspected the cracks during the site visit. We did not observe any additional or recent movement at these areas which appear to have settled. This was confirmed by the inspection of monitoring posts which were installed at both depository areas in 2021. We observed that there is considerable vegetation growth within both depository areas which would further indicate that the areas have settled and are stable. Please see photographs included at Appendix [ ].
