Arboricultural Assessment, Arboricultural Impact and Tree Protection Strategy Report

Stocking Avenue,
Dublin 16

Project No.	TSTO004	Date	18/03/21
Project Name	White Pines East	Revision	A

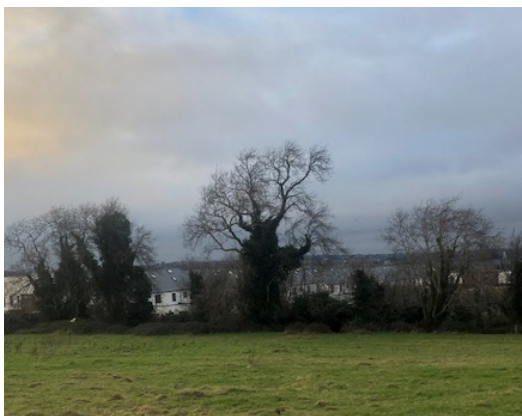
Image 2. Ash on Northern boundary. Note dilapidated nature of hedgerow and extensive ivy growth up trees.

The ash trees which are located within a derelict hedgerow on a section of the northern boundary are mixed in terms of their condition. Typically, they have been coppiced resulting in them becoming multi-stemmed specimens. There is a tendency for the regrowth from this

management system to produce trees with large boles but congested boles which may be structurally weak. This has occurred in this instance with occasional cavities at points of stem removal/failure. Very heavy ivy growth has made assessment of most of the ash trees difficult and may contribute to tree failure due to additional weight particularly during wet weather. The quality of the ash trees is low overall.

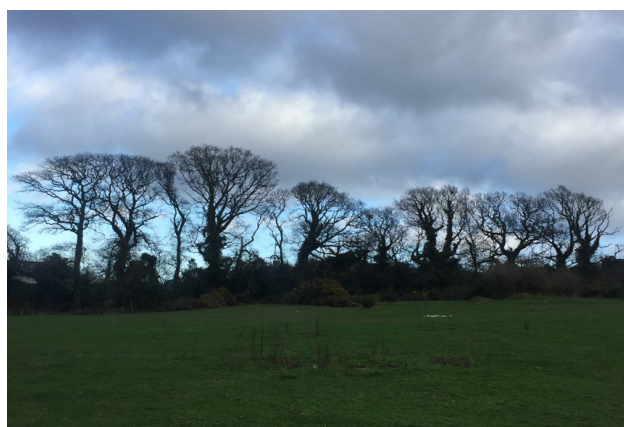
Image 3. Oak on Eastern boundary.

The percentage of category A trees is particularly high. This is down to the presence of oak trees located on the eastern boundary which form a strong sylvan edge to this section of the site. The majority of these trees are in good condition however a number are in poor condition and have been recommended for removal. The removal of these trees would not diminish the landscape character of the remaining trees or the potential for these trees to be successfully incorporated into any redevelopment of the site.

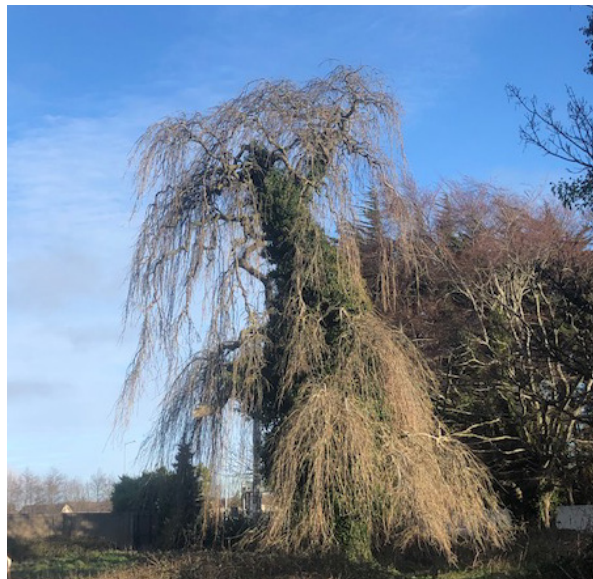
Image 5 Weeping ash (#5) to north of site .

5	Weeping ash <i>Fraxinus excelsior</i> 'Pendula'	Good	Mature	B2	A well developed specimen though very heavy ivy growth up trunk obscuring view for assessment. At this age this cultivar often has decay present at points of limb loss but no visible defects at present.	Cut ivy and re-assess	20-30	16	1200	4,6,2,6	5S
6	Lime species <i>Tilix</i> spp.	Fair	Early-mature	C2	A sub-dominant specimen with trunk multi-stemmed from base with tight unions between stems. This feature is possibly due to grazing damage in the past.	No action necessary	42278	8	350	1,4,4,4	1W
7	Sycamore <i>Acer pseudoplatanus</i>	Fair	Early-mature	C2	Crown restricted to west due to competition from neighbouring tree. Very heavy ivy growth obscuring view for assessment. No visible defects.	No action necessary	10-15	8	250	4,4,4,4	2N
8	Horse chestnut <i>Aesculus hippocastanum</i>	Poor	Mature	U	Extensive decay in base of tree to 3m up trunk. Infection by bleeding canker present.	Fell	0	16	1080	7,7,7,7	2.5N
