Environmental Impact Assessment Report

Appendix 19.2

Refurbishment & Demolition Asbestos Survey

Site Address	Dublin 3FM Masterplan Kilsaran Concrete Southbank Road Dublin Port	
Site Location		
Client	Name: Dublin Port Company Port Centre, Alexandra Road, Dublin Port, Dublin 1 Contact: Sean Reilly, Programme Management Office Tel: 01 8876043 Mob: 086 1035756	
Survey Dates	26/01/23	
Issue Date	30/01/23	
Surveyor(s)	John Kelleher, About Safety Ltd.

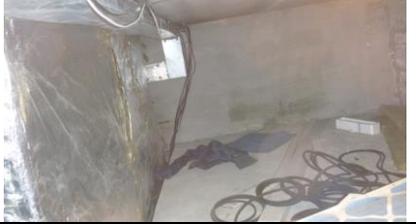
16	P&O Admin Building	Roof Plant		Pipework flange gaskets		Presumed asbestos						Investigation by a competent contractor prior to works likely to cause disturbance.

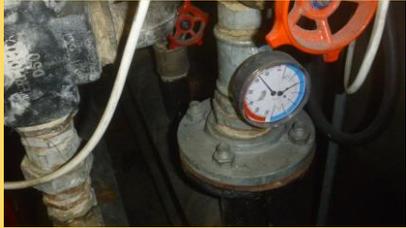
22	P&O Admin Building	Boiler room Calorifer		Immersion flange gaskets		Presumed to contain asbestos						Investigation by a competent contractor prior to works likely to cause disturbance.

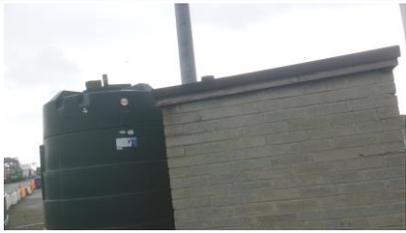
38	Freight Drivers Terminal	Roof		Substrate roofing felt		Presumed asbestos until proven otherwise						Sampling and investigation prior to demolition.

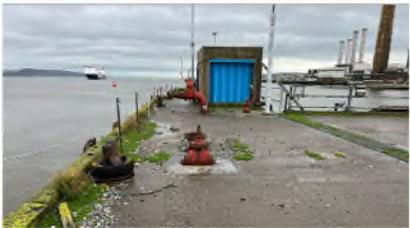
2.	Sludge Jetty	Jetty Head building	2302501	Textured paint to ceiling	Circa 5 SM	Chrysotile	1	2	2	1	6	Removal and disposal as asbestos waste by a specialist asbestos contractor under fully controlled conditions. Statutory notification of 14 days to H.S.A.

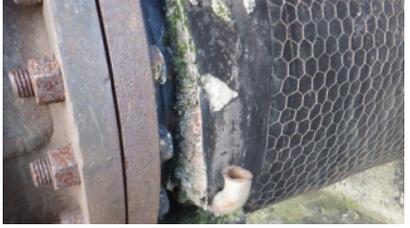
18.	ESB Jetty	Jetty Head Loading Platform	2302502	Old pipework flange gaskets		Chrysotile	1	0	0	1	2	Removal and disposal as asbestos waste by a competent asbestos contractor prior to work likely to cause disturbance.

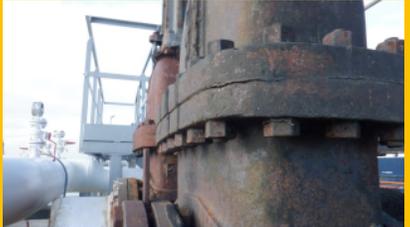
19.	ESB Jetty	Jetty Head Loading Platform		Flange gaskets to all old pipework		Strongly presumed asbestos. Trade standard at the time of installation.						Investigation by a competent contractor prior to work likely to cause disturbance.

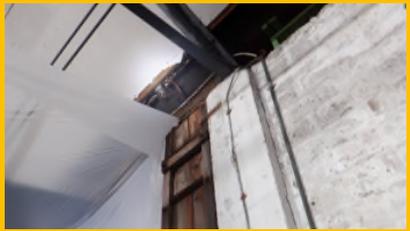
6.	South Port 3FM Project	Old ESB Laboratory Bottom stores building		Integral areas of old electrical panels behind store materials		Presumed asbestos materials	2	2	2	2	8	Investigation and sampling of suspect materials prior to any work undertaken.

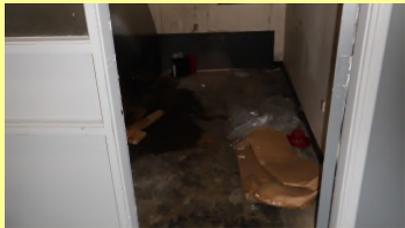
30.	South Port 3FM Project	Old ESB Laboratory And Offices Individual offices		Old common VFT and/or adhesive.		Presumed under carpet.	1	0	0	1	2	Investigation and sampling of suspect materials prior to any work undertaken.

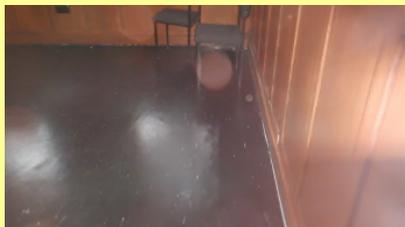
32.	South Port 3FM Project	Old ESB Laboratory And Offices Film crew canteen		Common VFT and adhesive. Intact		Chrysotile	1	0	0	1	2	Removal and disposal as asbestos waste by a competent person prior to work likely to cause disturbance.

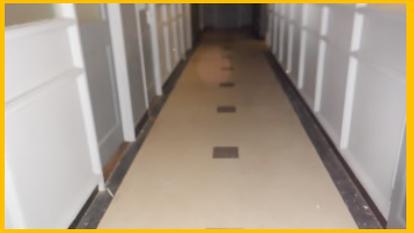
34.	South Port 3FM Project	Old ESB Laboratory And Offices Corridor		Old common VFT and/or adhesive.		Presumed under lino.	1	0	0	1	2	Investigation and sampling of suspect materials prior to any work undertaken.
