An Arboricultural Assessment of the Tree Vegetation on the Grounds of the former 'Central Mental Hospital', Dundrum, Dublin 14.

Prepared for: Dun Laoghaire Rathdown County Council Applicant, and Land
Development Agency as Agent

Prepared by: Felim Sheridan F. Arbor. A, RFS Dip, Nat. Dip & NCH in
Arboriculture

Date: 28th August 2024

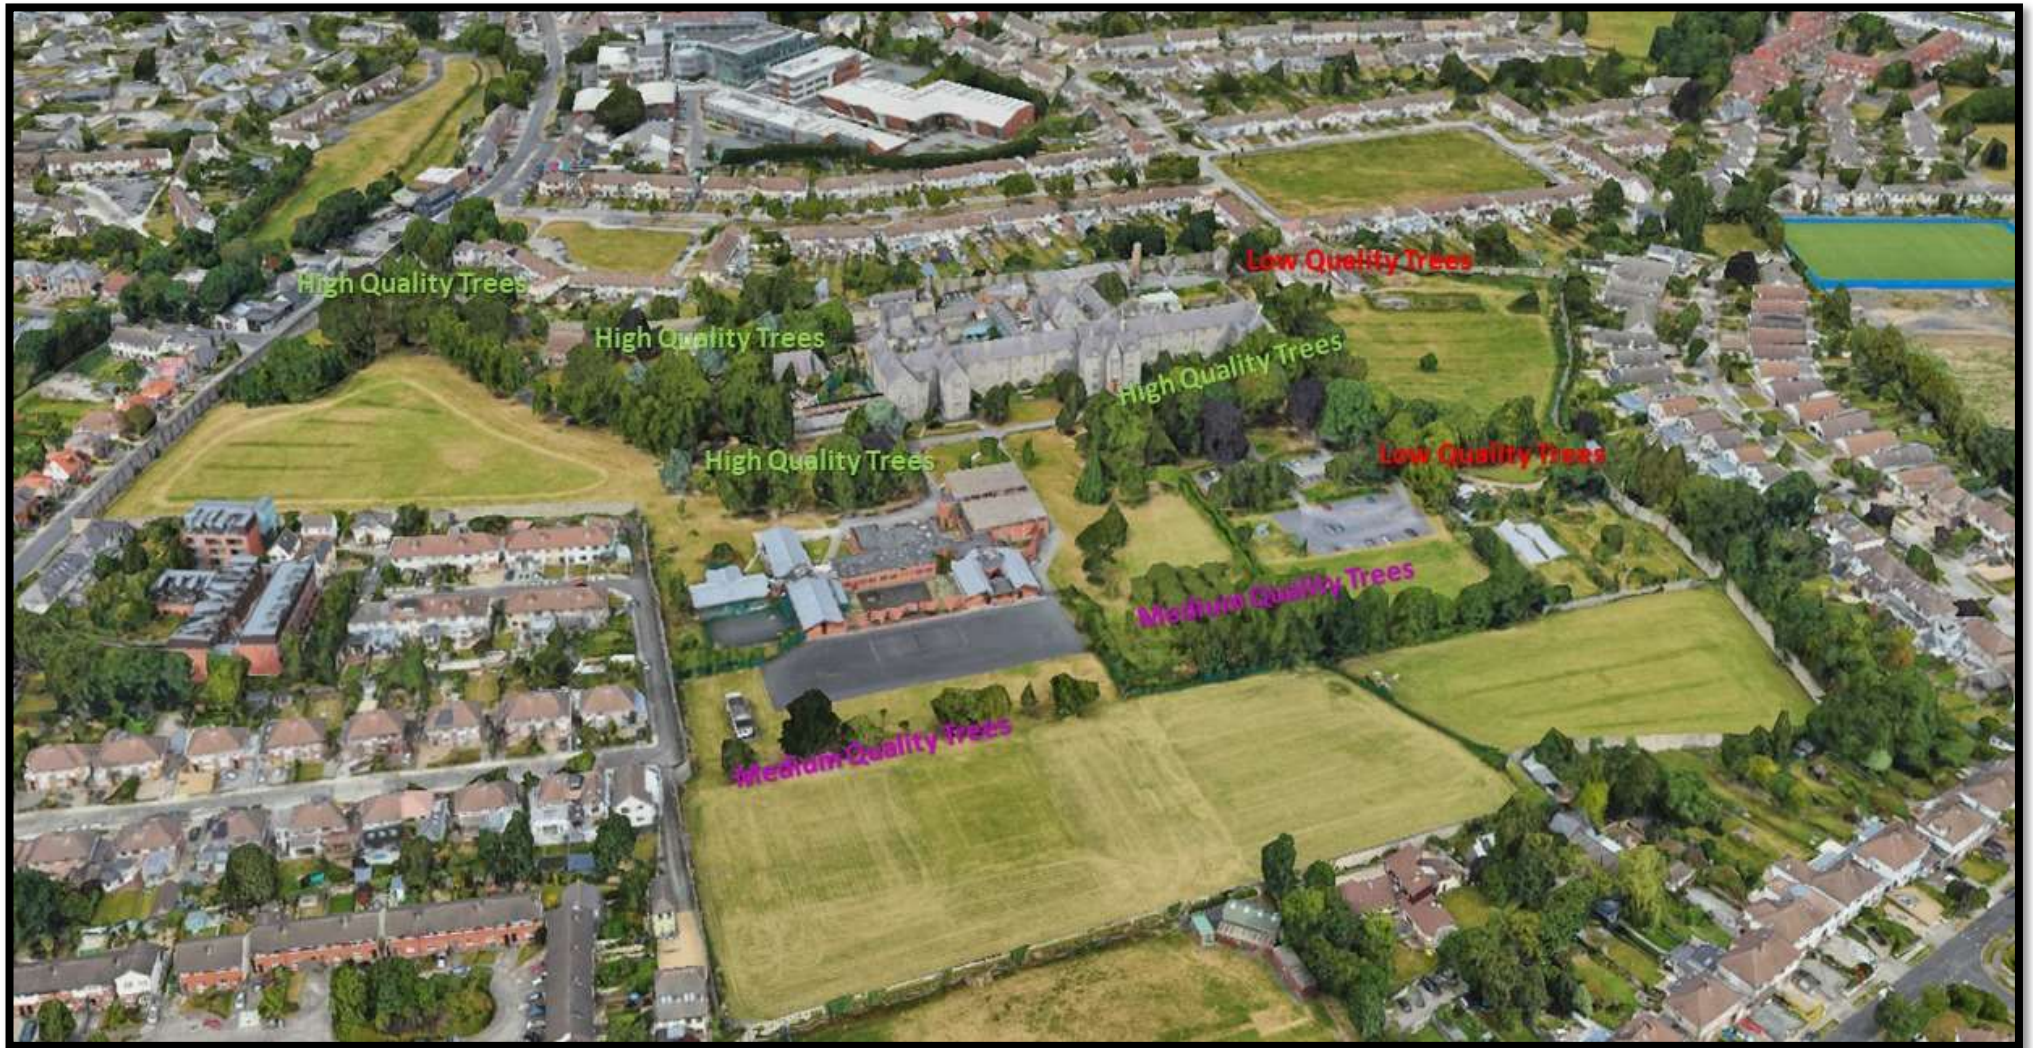
Figure 2: An aerial image of the site at the 'Central Mental hospital'. Areas with High, Medium, and Low-quality trees have been identified. *For illustrative purposes only.*

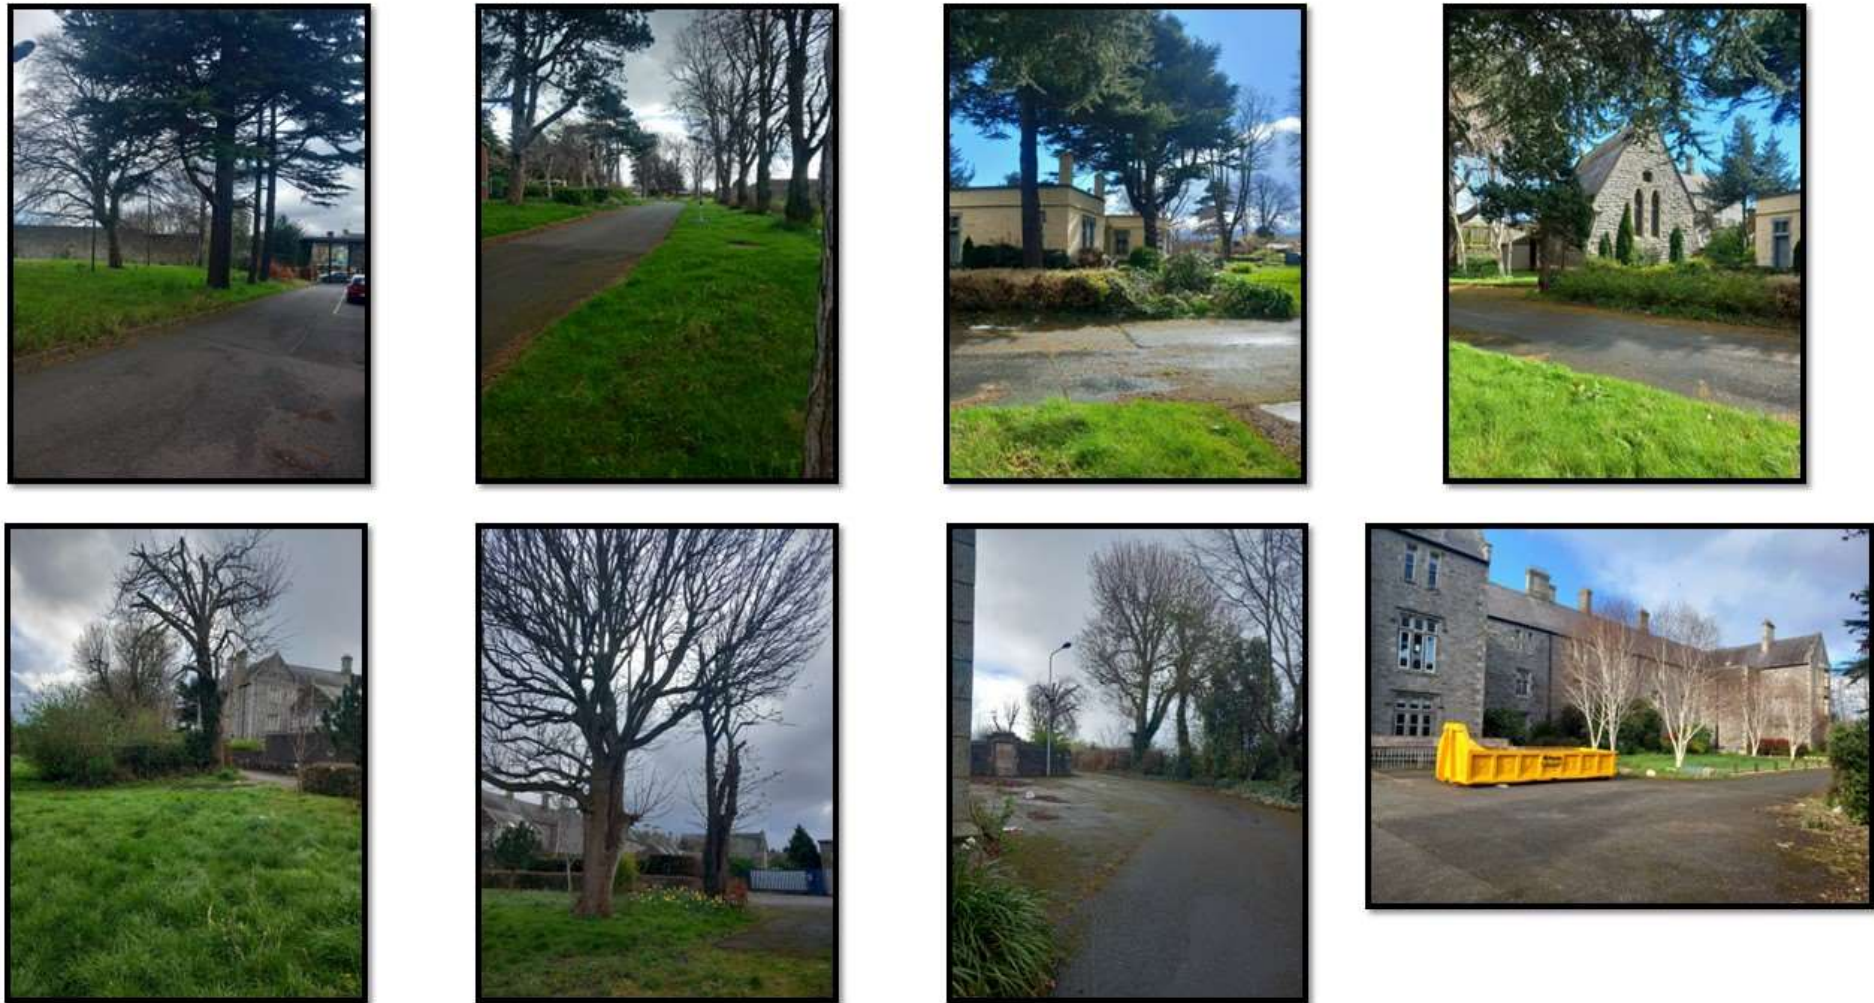
Figure 3: Photo assortment from around the site following the flow of the survey in ‘Appendix 1’.

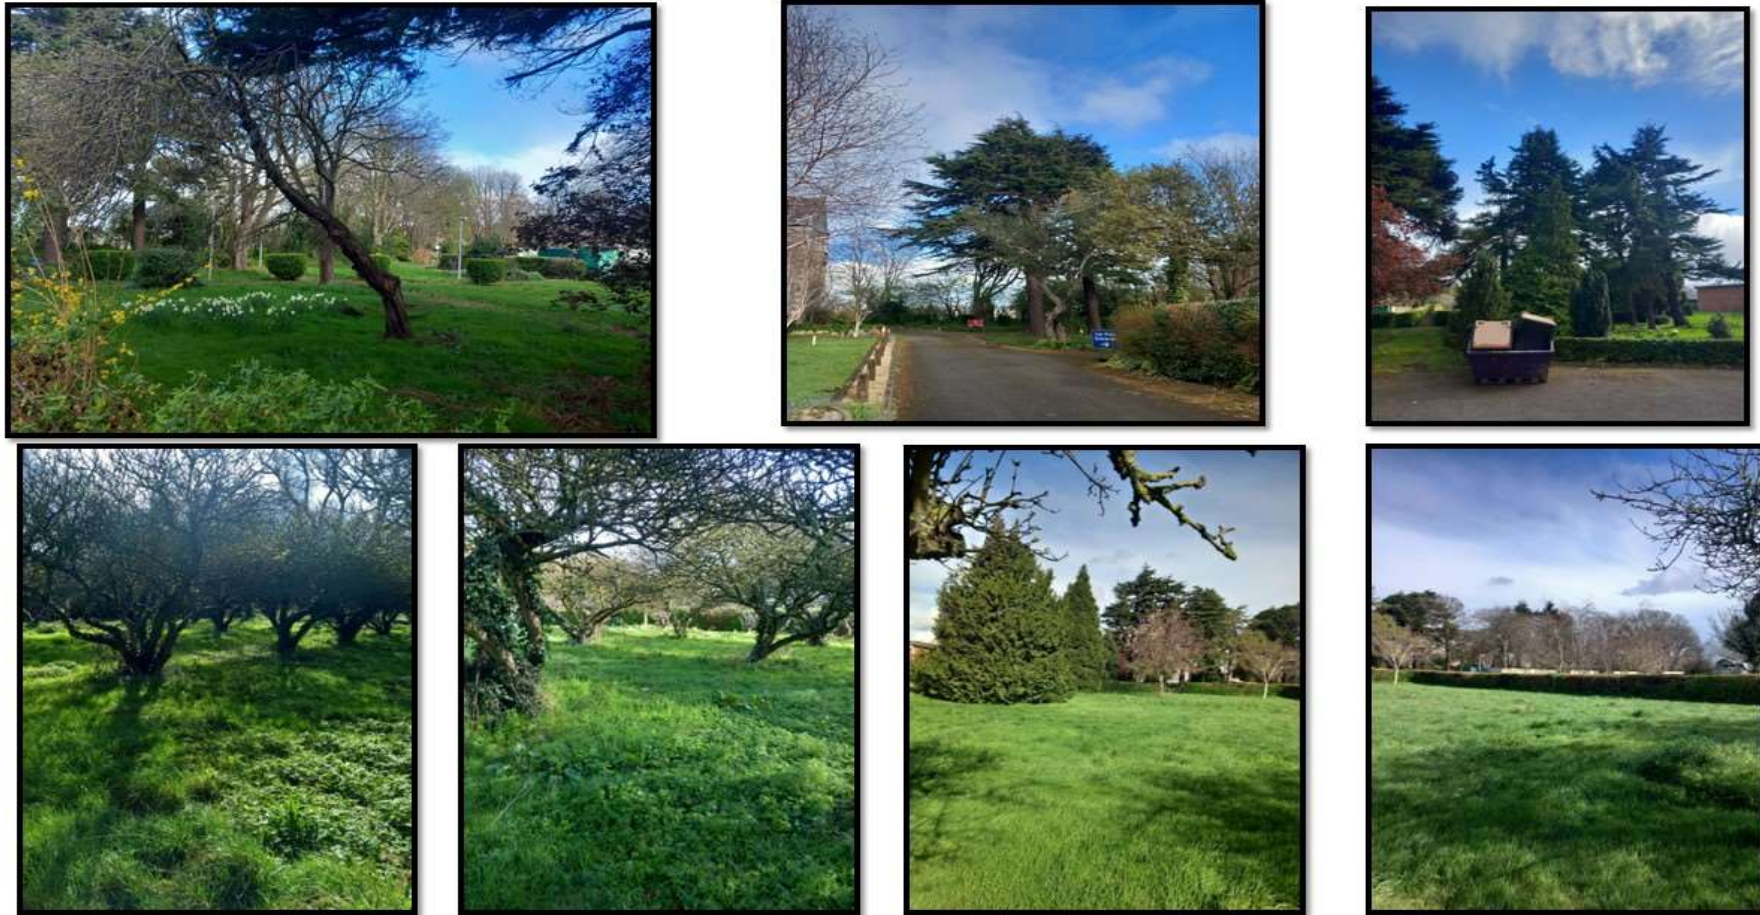
Figure 4: Photo assortment from around the site following the flow of the survey in ‘Appendix 1’.
