## Primary Route Assessment - CMBG Wind Farm, County Kerry

343154

Wednesday, 20 October 2021

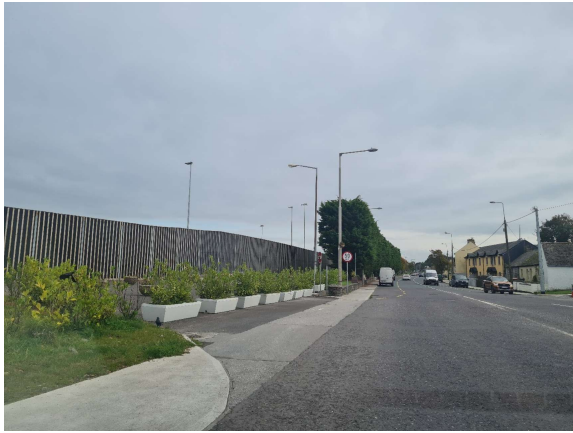
### **Location 1 - Exit From Ringaskiddy Port**

Visual inspection indicates that the fencing and flower pits are to be removed to allow access from the port.

Manual steering required to assist navigation.

Swept Path Analysis recommended to ensure no further modifications are required.

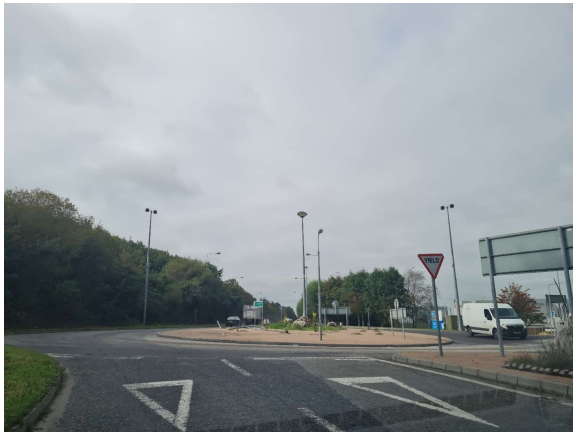
### **Location 2 - N28 Roundabout**

Visual inspection indicates that the loaded blade vehicle is to run on hardstanding central island of the roundabout and the exit Splitter Island.

Street furniture in these locations to be removed.

Swept Path Analysis recommended to confirm medications.

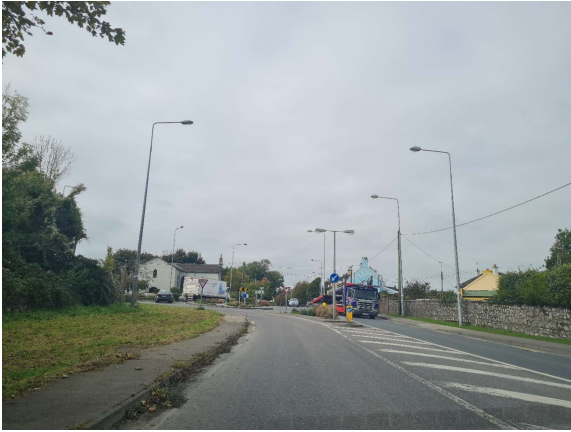
#### **Location 5 - N28 Roundabout**

Visual inspection indicates that a contraflow manoeuvre is required at this roundabout.

Loaded vehicle is required to run on hardstanding area in front of the shop on the offside of the roundabout.

Street furniture in this area to be removed.

Manual steering required to assist navigation.

Swept Path Analysis recommended to confirm modifications.

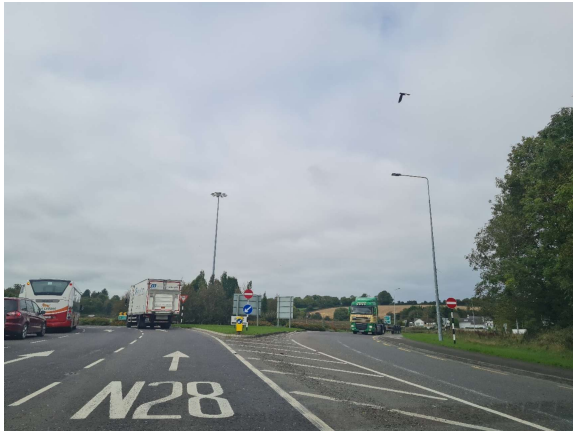
### **Location 13 - N28/R611 Roundabout**

Visual inspection indicates that a contraflow manoeuvre is required to navigate this roundabout.

Street furniture on the entry Splitter Island to be removed due to rear projection of the blade components.

Manual steering required to assist navigation.

Swept Path Analysis recommended to confirm modifications.

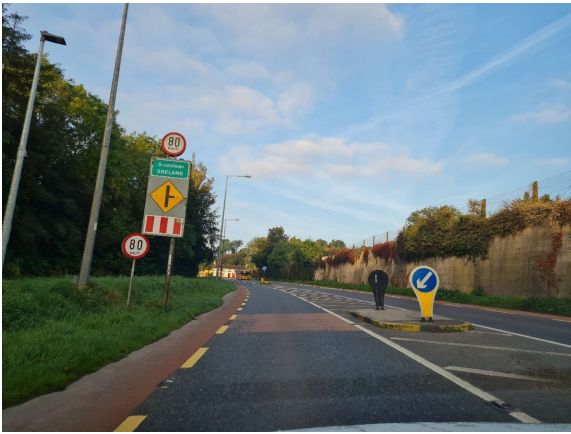
### **Location 17 - Splitter Island On N22**

Visual inspection indicates that flexi bollards to be flattened to allow loaded vehicle to navigate.

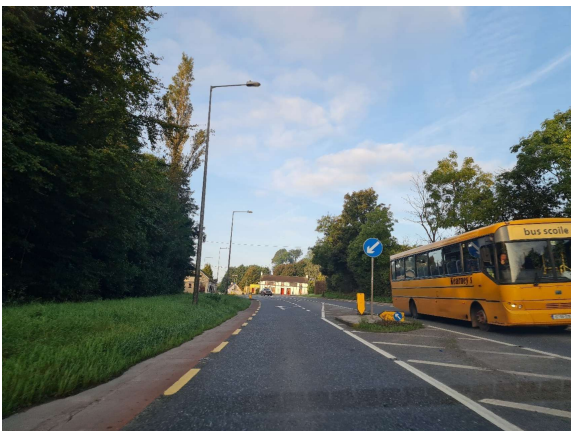
### **Location 18 - Splitter Island On N22**

Visual inspection indicates that flexi bollards on the nearside to be flattened to allow loaded vehicle to navigate and avoid Splitter Island.

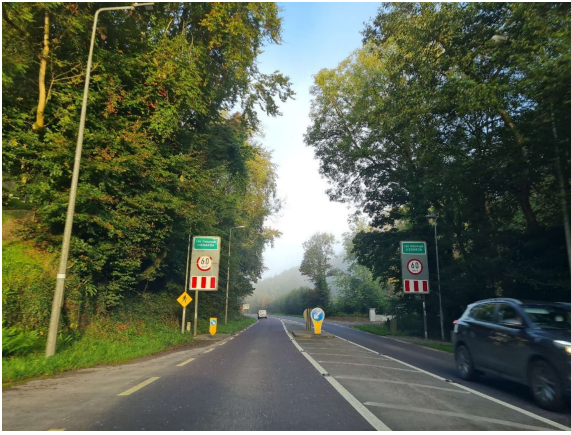
### **Location 28 - Splitter Island On N22**

Visual inspection indicates that the flexi bollards to be flattened to allow loaded vehicle to navigate.

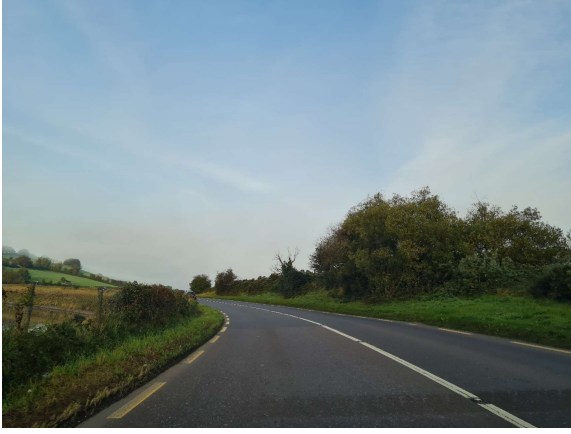
### **Location 34 - Left Bend On N22**

Visual inspection indicates that the loaded vehicle will navigate this location utilising manual steering.

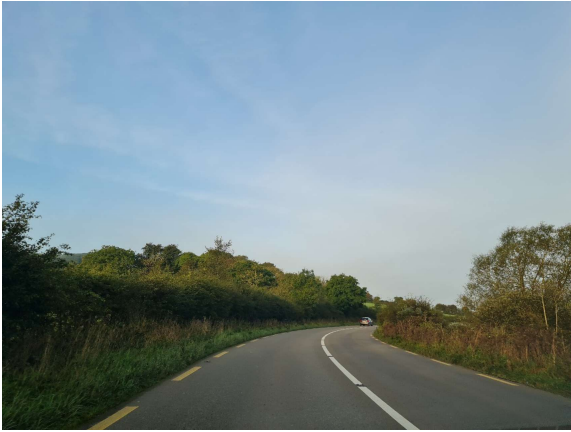
### **Location 35 - Right Bend On N22**

Visual inspection indicates that the loaded vehicle will navigate this location utilising manual steering.

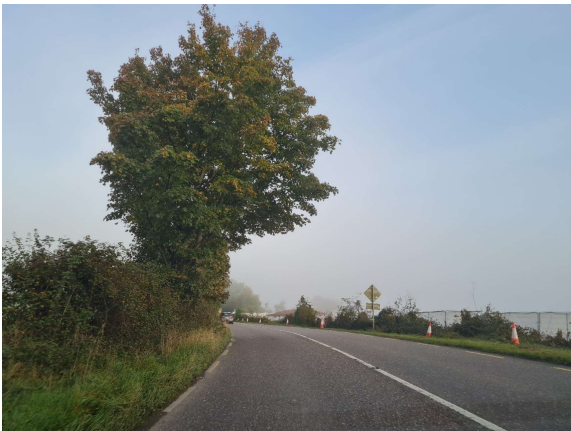
### **Location 36 - Macroom Bypass Interchange**

Loaded vehicles are to use the new Bypass, to navigate to Ballyvourney, which is currently under construction to avoid the town of Macroom.

Once constructed the Bypass is to be assessed to ensure route suitability.

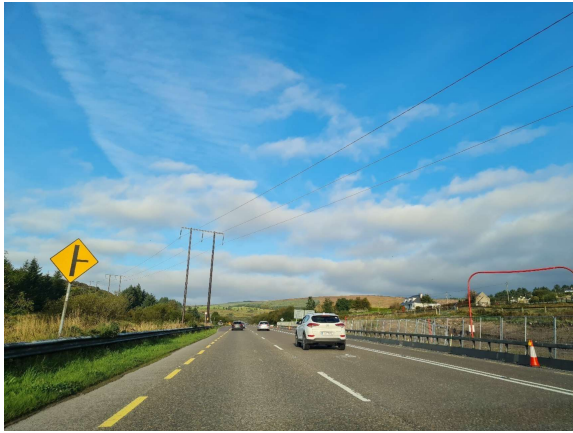
### **Location 37 - N22 / Macroom Bypass Interchange At Ballyvourney**

Loaded vehicles are to use the new Bypass, to navigate to Ballyvourney, which is currently under construction to avoid the town of Macroom.

Once constructed the Bypass is to be assessed to ensure route suitability.

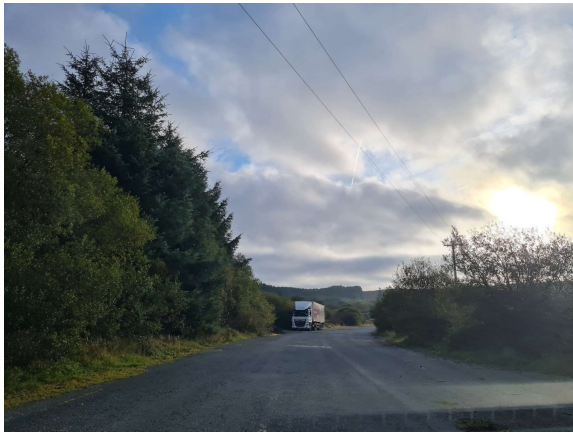
### **Location 38 - N22 Lay By And Proposed Site Entranced**

Visual inspection indicates that the access to the lay by is to be opened up as it is current blocked with an soil banking.

New site entrance to be constructed in accordance with the turbine manufacturers specification. The entrance will require third party land.
