Lackareagh Wind Farm, Co. Clare

Stage 1 Road Safety Audit

EDF Renewables Ireland Ltd.

August 2024

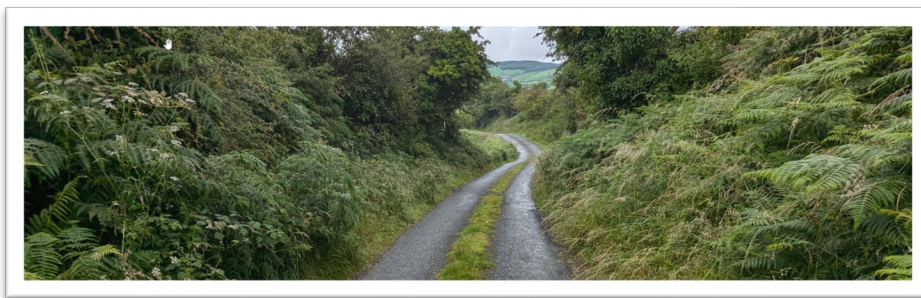
Figure 2.1 – Narrow Bendy Section of L-7080 which Coincides with Walking Route

Location: Turbine Delivery Route Along Local Road L7080

The turbine delivery route follows the (narrow) L7080 which coincides with a posted walking trail. This could increase the risk of walkers (and other local traffic) coming into conflict with construction vehicles.

Appropriate (rigorous) temporary traffic management measures should be set in place to minimise risk of conflicts between construction vehicles and other local traffic (especially walkers) along the turbine delivery route.

2.1	Yes	Yes	It is confirmed that a comprehensive set of traffic management measures, including signage and the presence of "Flagmen" will be put in place on the L-7080 during the construction of the Proposed Wind Farm.	Designer comment noted and accepted.

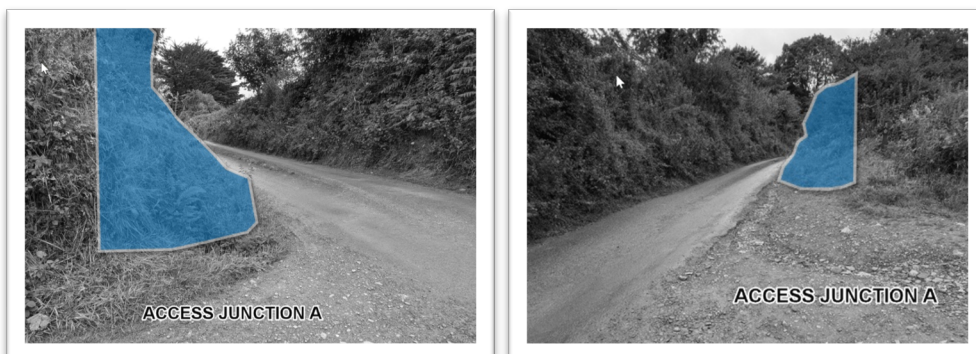
Figure 2.2 – Field Boundaries Impacting Upon the Right-Hand Sightline

Location: Access Junction A | Field Boundaries Along Local Road L7080

Junction sightlines appear to be partially obscured by the existing field boundaries, which includes ditch foliage and some trees. This could lead to side impact type collisions within the access junction's conflict zone.

The field boundaries should be modified to ensure that appropriate sightlines are provided at the access junction.

2.2	Yes	Yes	As shown in Figure 15-8 of Chapter 15 of the EIAR, the L-7080 and the existing junction will be improved with visibility splays appropriate for traffic speeds during construction and the operational phase provided. It is noted traffic management measures, including signage and a "flagman" will be in place at all times during the construction phase.	Designer comment noted and accepted.

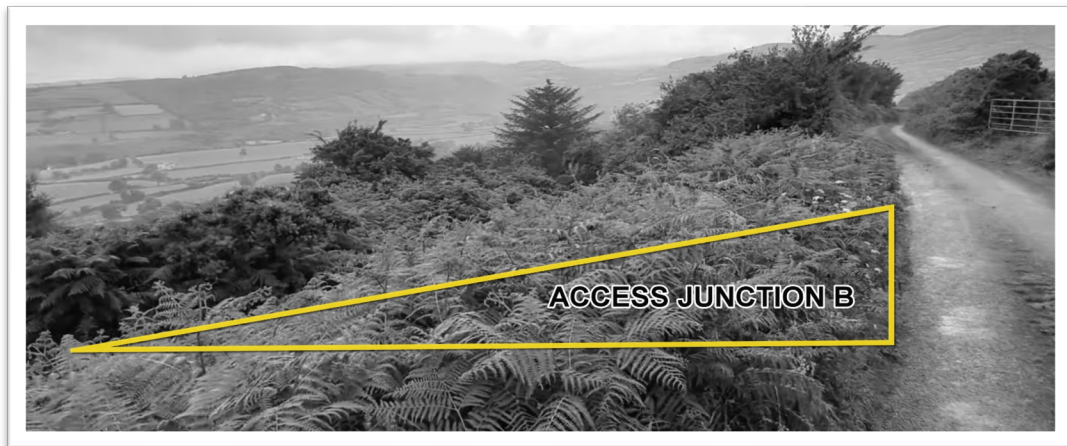
Figure 2.3 – Steep Gradient & Restrictive Horizontal Curvature Could Lead to Vehicle Overturning

Location: Access Junction B | Connection Point to Local Road L7080

The combination of steep approach gradient and unusual horizontal curvature could lead to delivery vehicles getting stuck or overturning at the access junction.

The horizontal and vertical alignment of the access road should be carefully designed to mitigate the risks described (the inclusion of a suitable dwell area is likely to help in this regard).

2.3	Yes	Yes	<p>The proposed junction design shown in Figure 15.9 of Chapter 15 of the EIAR is designed in accordance with Section 5.6.3 of TII Junction Design Guidelines (TII DN-GEO-03060) for junctions with respect to gradients. Junction radii of 9m are proposed to provide for standard small to medium sized HGV turning movements during the operational phase. The junction layout for the delivery of the abnormally sized loads takes account of an autotrack assessment undertaken for these vehicles. The proposed construction of the new access roads and connections with the existing L-7080 is detailed in Section 4.4.2.1 of the EIAR and will comprise of;</p> <p><i>A layer of geogrid or geotextile material will be laid at the formation level to separate the road building material from the subsoil.</i></p>	Designer comment noted and accepted.

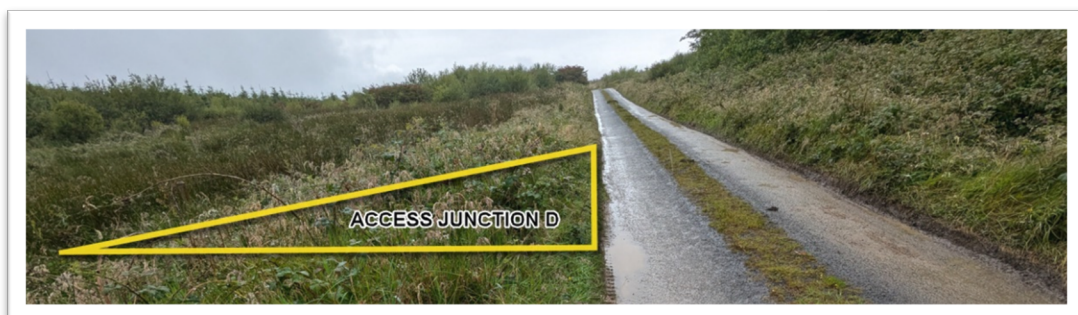
Figure 2.4 – Approach Gradient & Soft Verge Could Lead to Errant Delivery Vehicles Getting Stuck

Location: Access Junction D | Soft Verge with Level Difference at Access Junction

The combination of approach gradient, horizontal curvature and the (unforgiving) boggy soft verge could lead to delivery vehicles getting stuck or overturning.

The horizontal and vertical alignment of the access road should be carefully designed to mitigate the risks described (the inclusion of a suitable dwell area is likely to help in this regard).

2.4	Yes	Yes	<p>The proposed junction design shown in Figure 15.13 of Chapter 15 of this EIAR is designed in accordance with Section 5.6.3 of TII Junction Design Guidelines (TII DN-GEO-03060) for junctions with respect to gradients. In addition junction radii of 9m are proposed to provide for standard small to medium sized HGV turning movements during the operational phase at the eastern junction. A swept path analysis for the abnormally sized loads was undertaken to inform the design for these deliveries. Access road construction details will be as for 2.3 above</p>	<p>Designer comment noted and accepted.</p>
