**PRINCIPLE INSPECTION
REPORT**

Blackwater Bridge (CL-R463-002.00) Principal Inspection Report

13th May 2024

Clare County Council

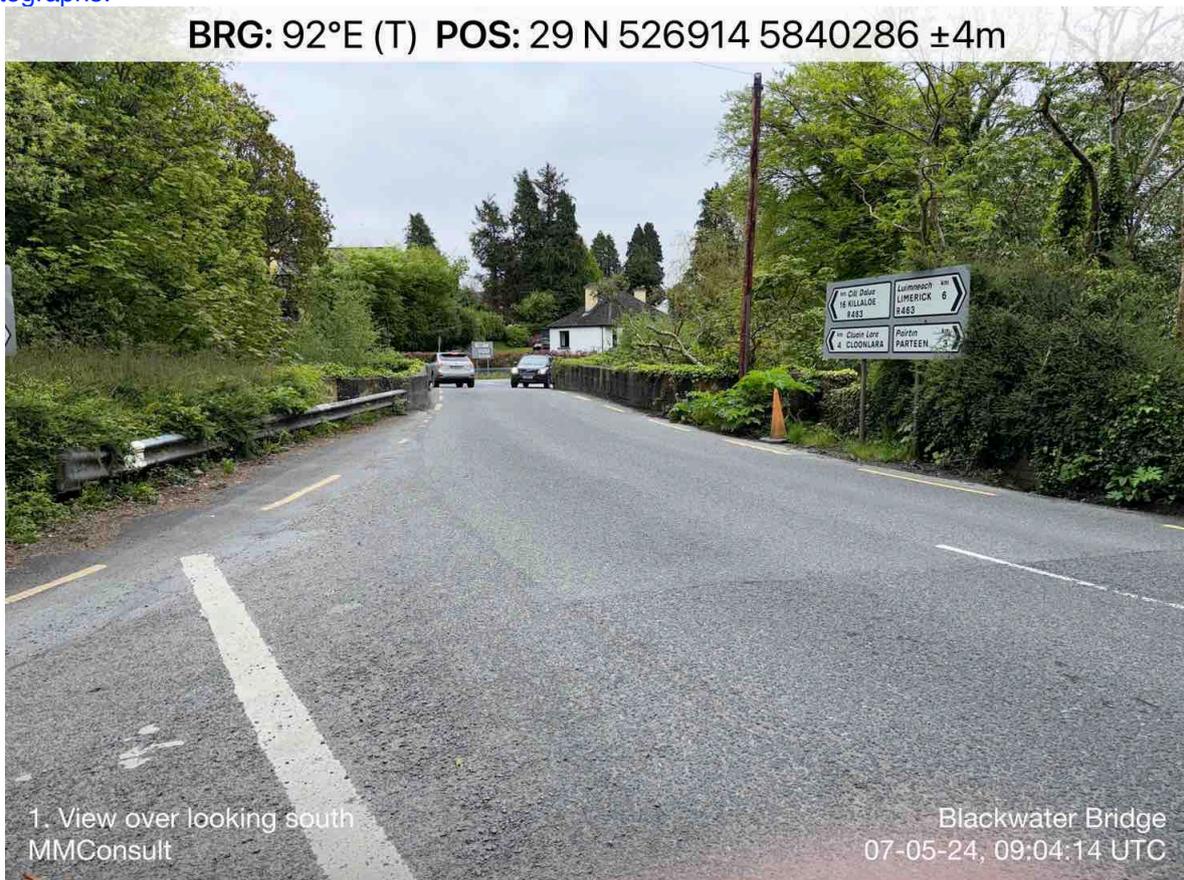
The carriageway of the local road over the structure is in reasonable condition, it is somewhat worn. Vehicle tracking was noted. Potholes are beginning to form at the northeast corner. Traffic yields to ongoing traffic over this narrow bridge. The edges of the carriageway at the parapets are not sealed. Some minor debris and vegetation at the edges.

Cause of Damage: Wear and abrasion.

Photo P1: Bridge surfacing - general view looking east

- ▶ Resurface the bridge when convenient, including sealing of the edges;
 - Quantity of repair = 85m²
 - Estimated Cost of Repair = €15,000
 - Year of Repair = 2028

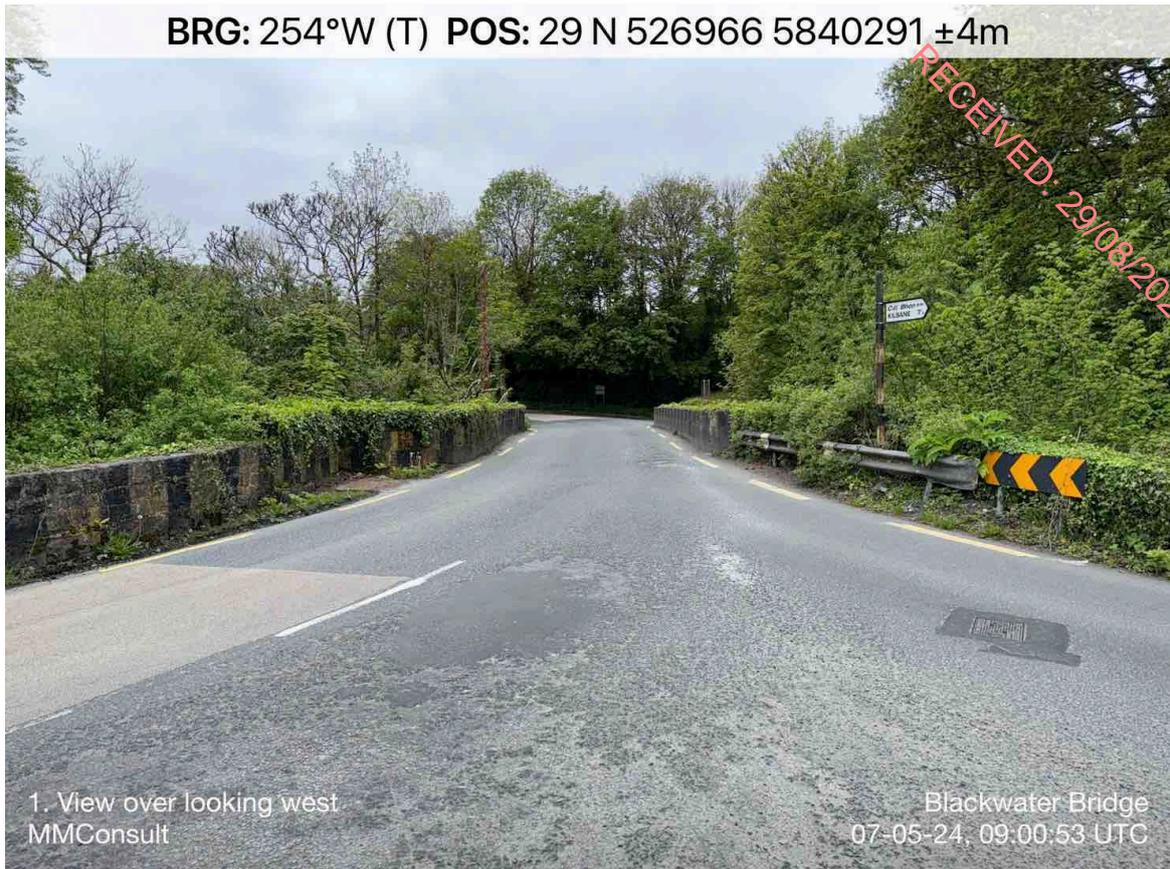
Photo P2: Bridge surfacing - general view looking west

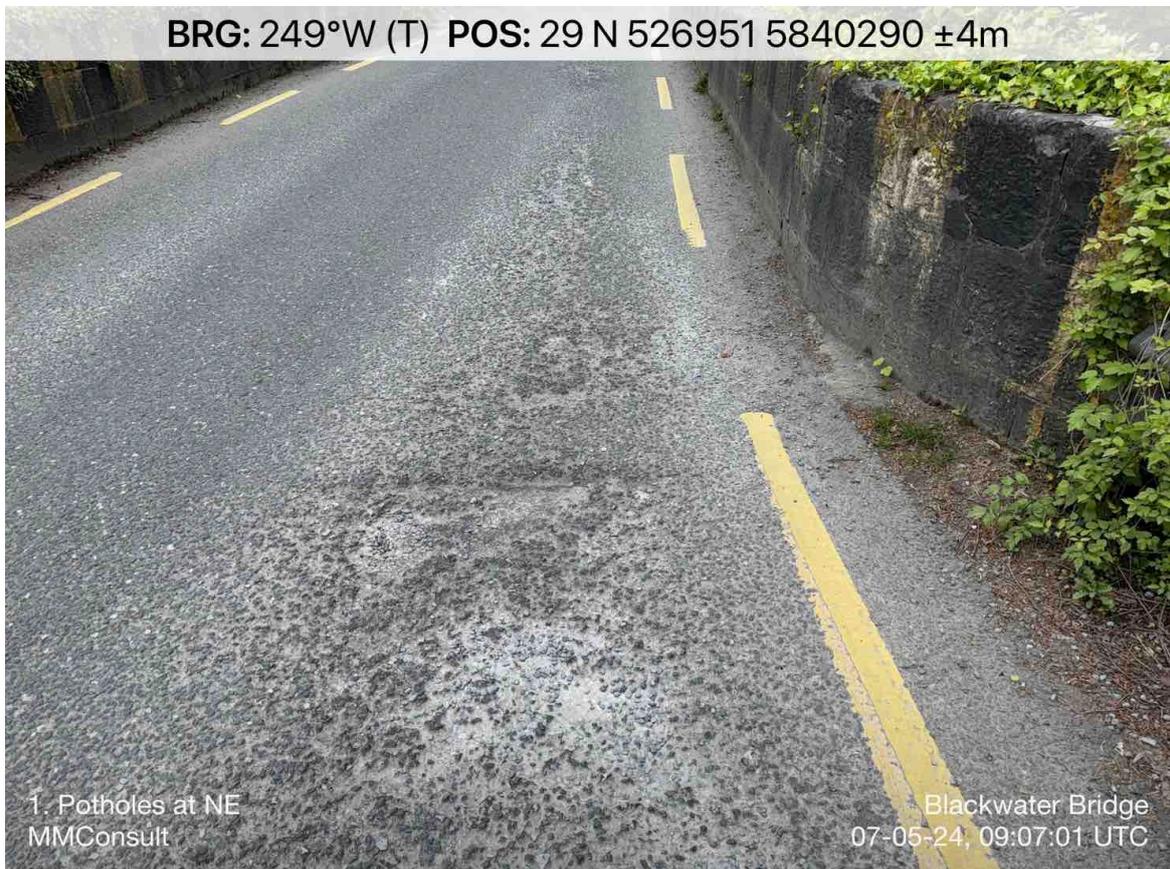
Photo P3: Bridge surfacing - potholes forming at northeast corner

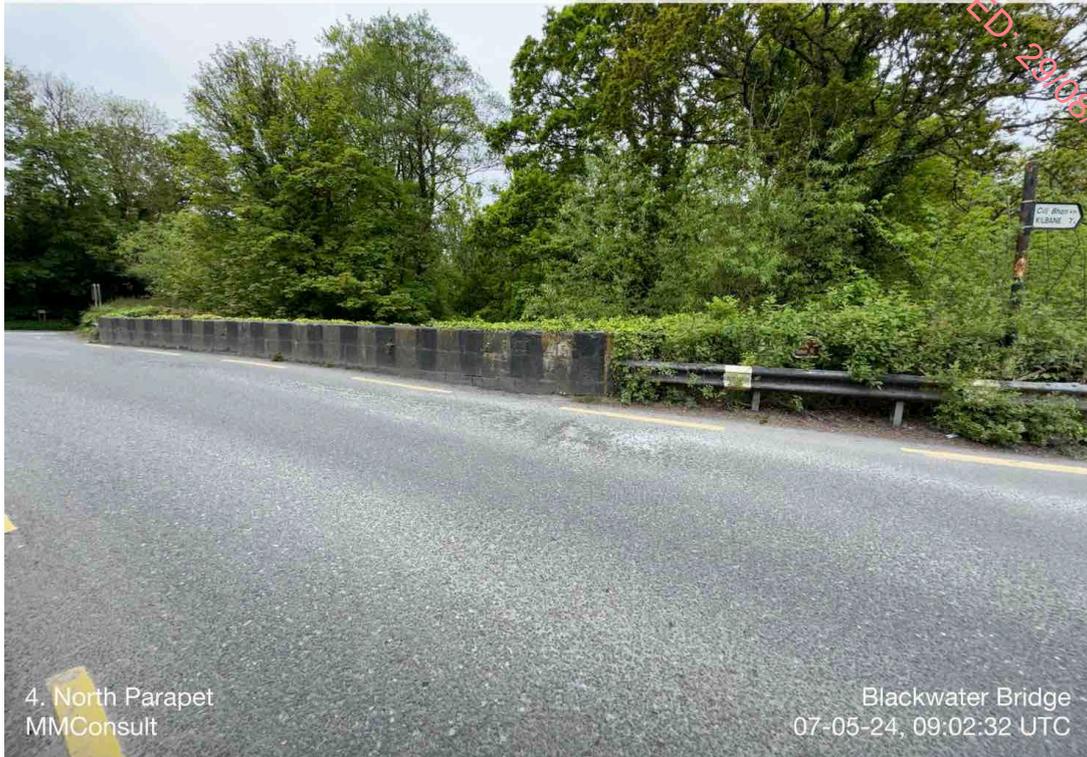
4. North Parapet
MMConsult

Both stone masonry parapets are heavily overgrown on the riverside faces but are largely in good solid condition. Cracked stonework was noted above the crown of the south parapet. There are isolated areas of stone and mortar loss evident.

Photo P4: General view of north parapet

▶ Routine maintenance to remove/cut back all vegetation growth.

▶ Masonry repointing:

- Quantity of repair = 12m²
- Estimated Cost of Repair = €1,500
- Year of Repair = 2026

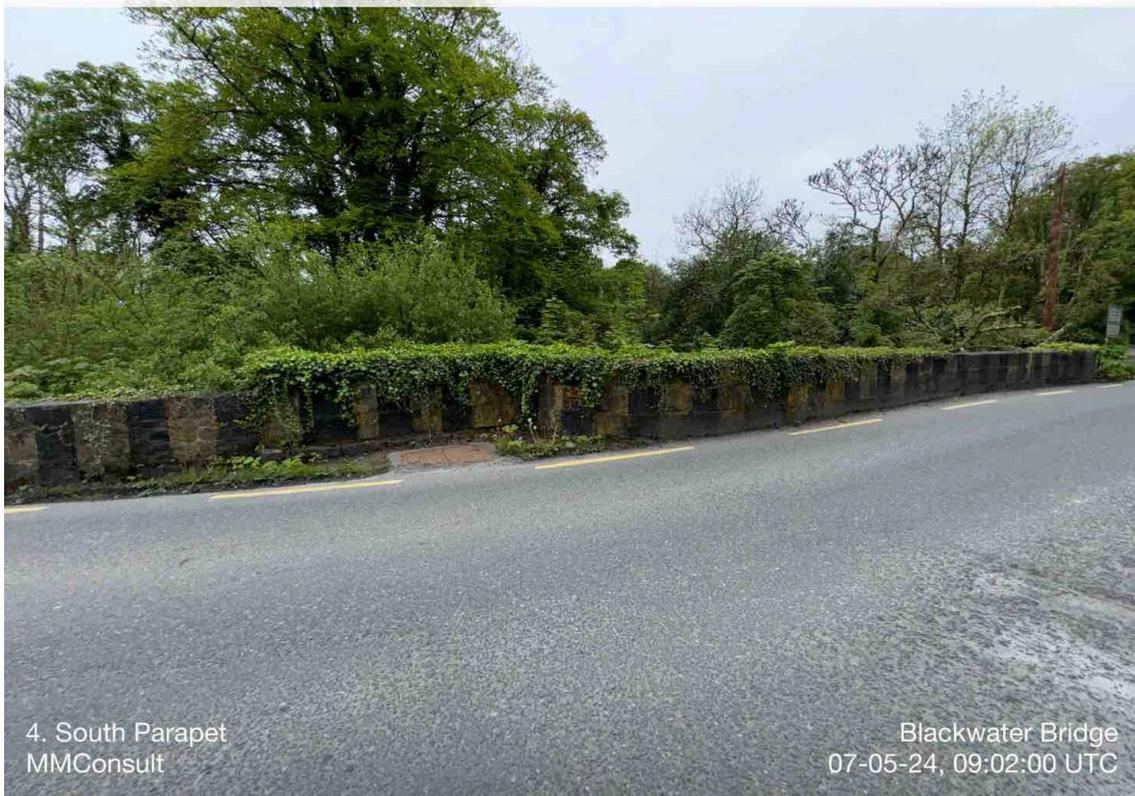
4. South Parapet
MMConsult

Photo P5: General view of south parapet

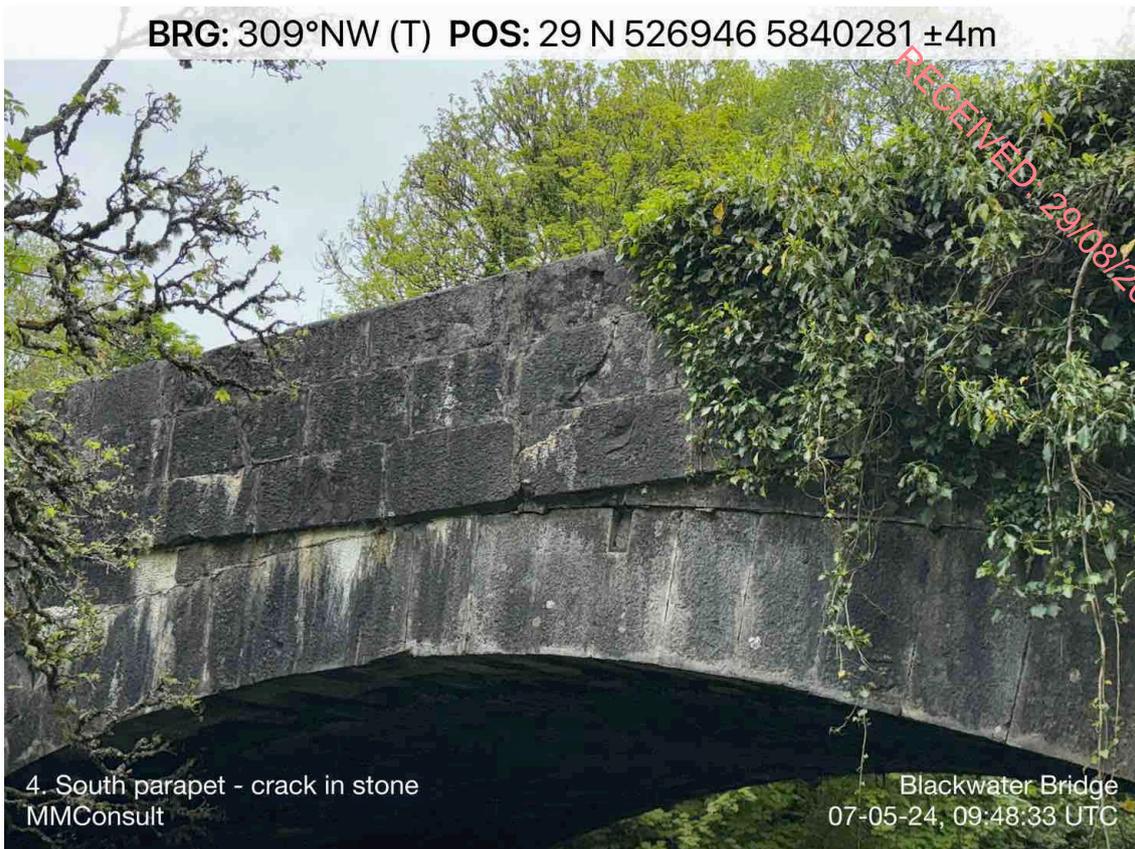
Cause of Damage: Vehicle impact damage, vegetation growth and mortar deterioration.

Photo P6: South parapet - some cracked stones above the crown

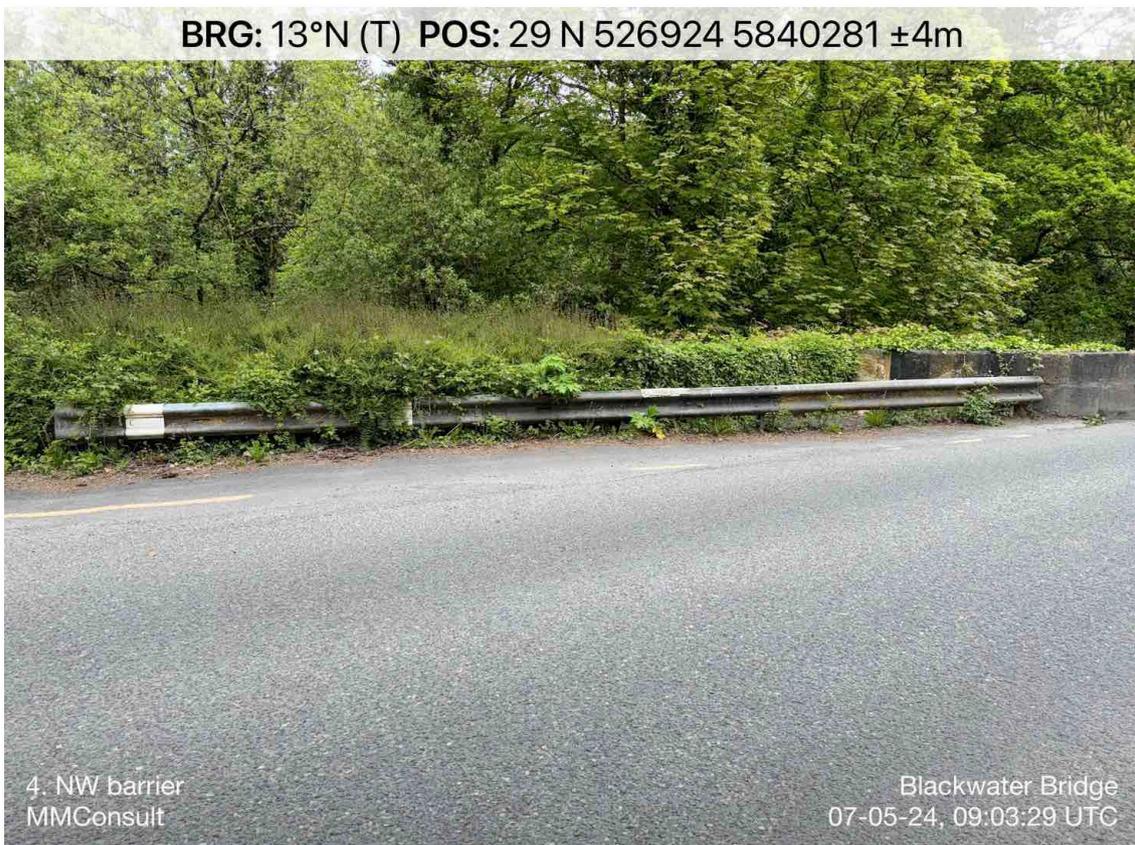
There are steel road safety barriers at the northeast and northwest corners of the bridge. The north east barrier is loose and there is a non-vertical post to the northwest barrier.

Photo P7: Northwest safety barrier, which is partly loose

▶ Repair steel road safety barriers:

- Quantity of repair = 8m
- Estimated Cost of Repair = €2,000
- Year of Repair = 2025

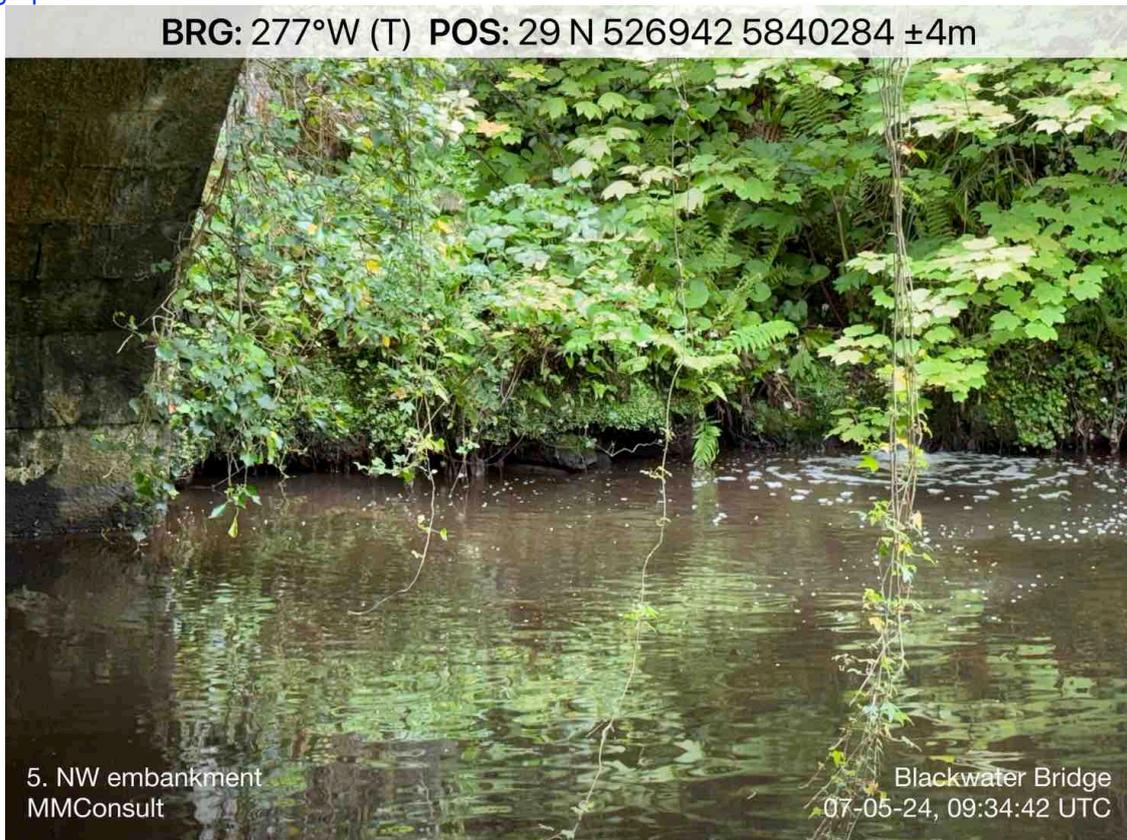
The embankments are heavily overgrown but in solid condition.

Cause of Damage: Vegetation growth

Photo P8: View of northwest embankment

- Routine Maintenance to cut back excessive vegetation

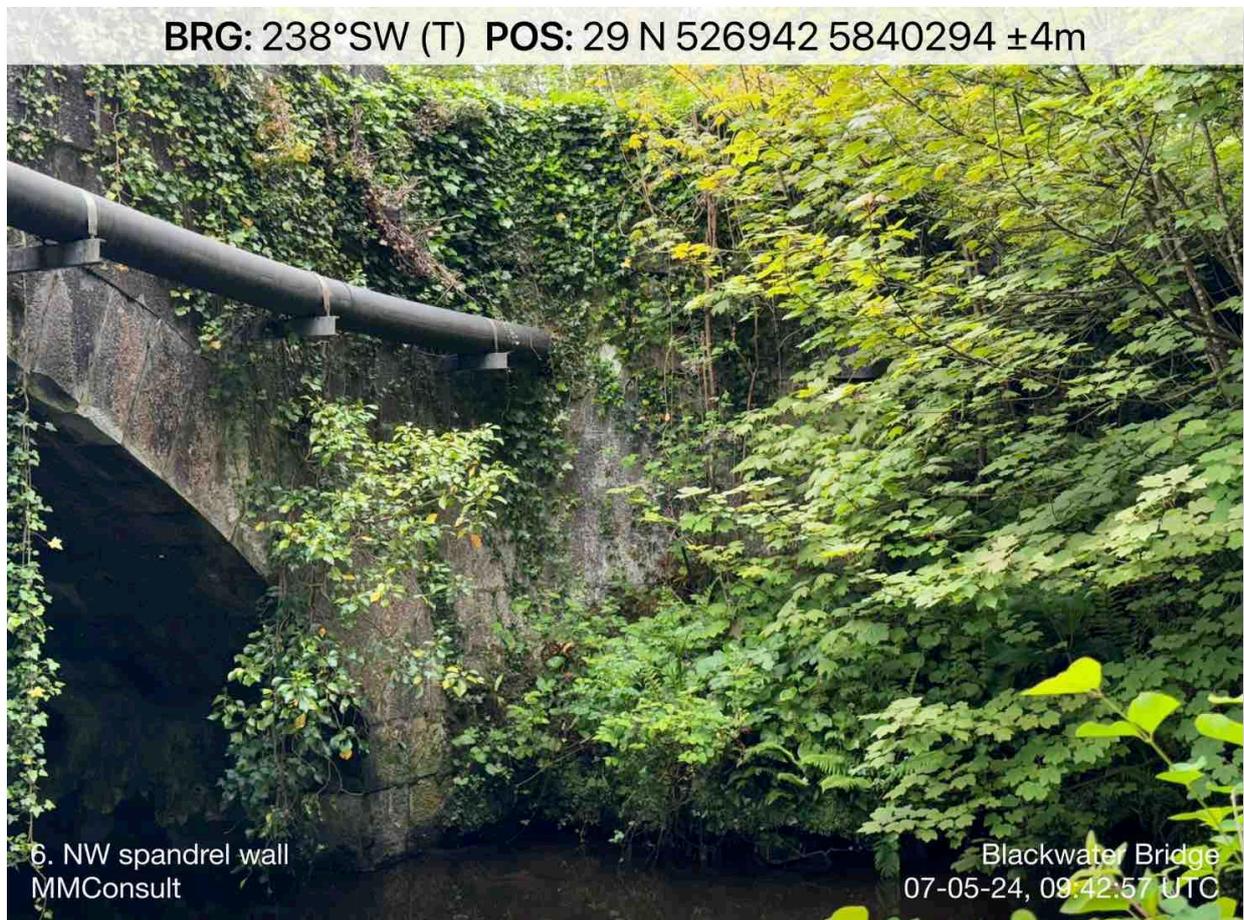
The cut-stone spandrel walls are heavily overgrown, the visible sections appear to be largely in good solid condition. We would recommend that all vegetation be removed and a comprehensive inspection of the large retaining/spandrel walls be undertaken.

Cause of Damage: Vegetation growth

Photo P9: View of northwest spandrel wall extensively overgrown

- ▶ Routine maintenance to remove/cut back all vegetation growth. Reinspect walls.

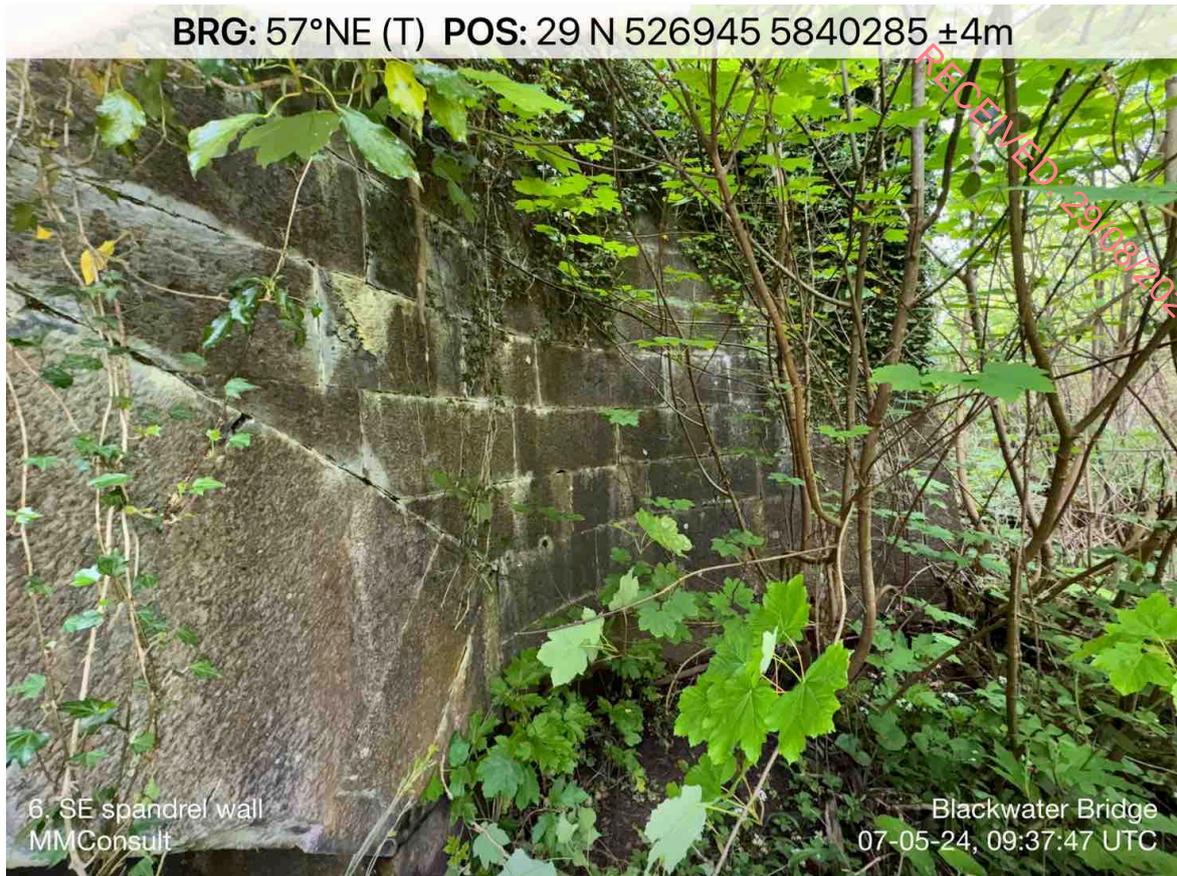
Photo P10: View of southeast spandrel wall noting vegetation

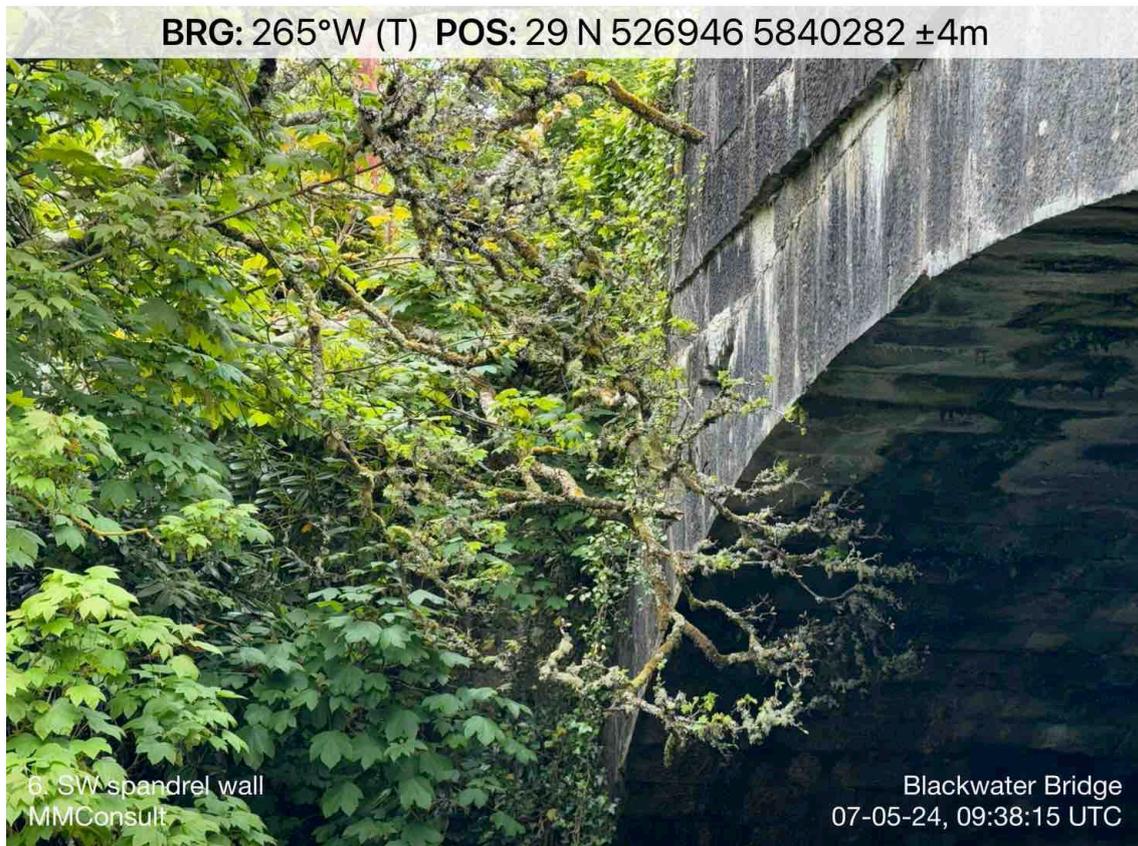
Photo P11: View of southwest spandrel wall

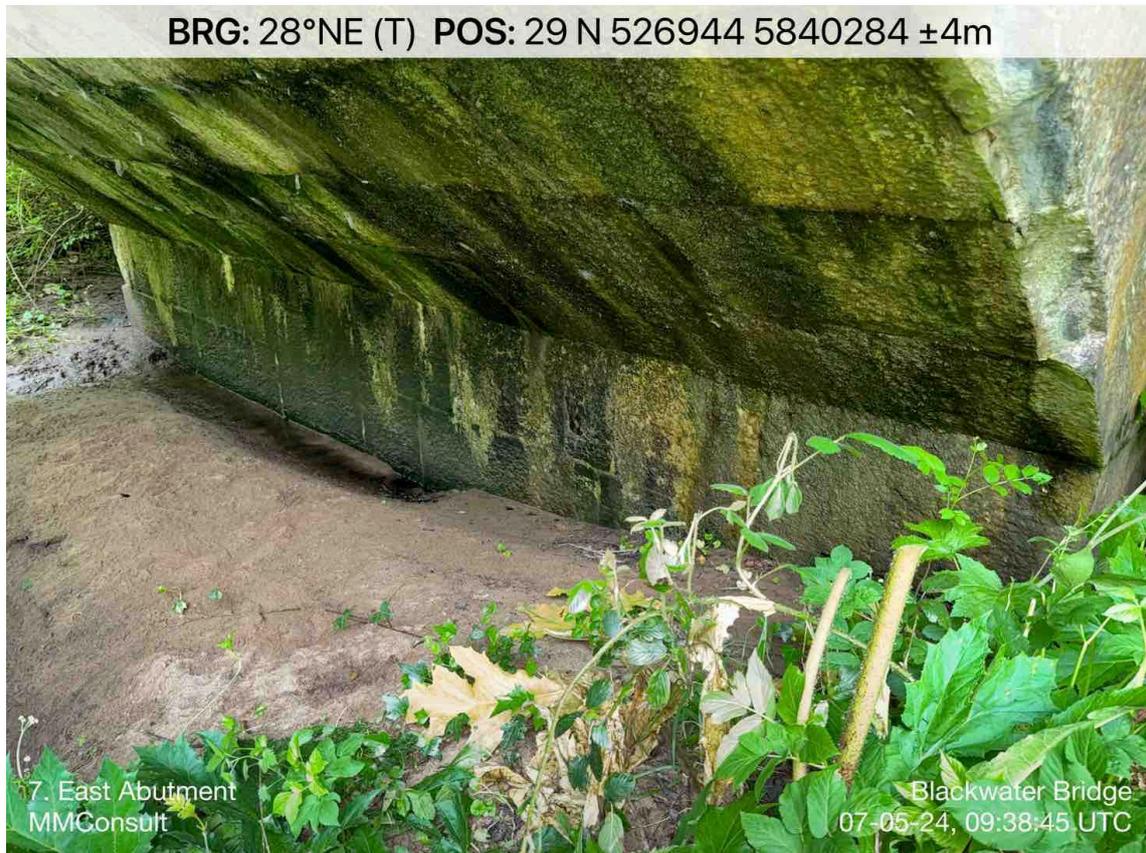
Both cut-stone abutments are in good solid condition, although heavily stained. There are minor areas of missing stonework and mortar.

Cause of Damage: Water penetration

Photo P12: General view of the east abutment

- None required at present

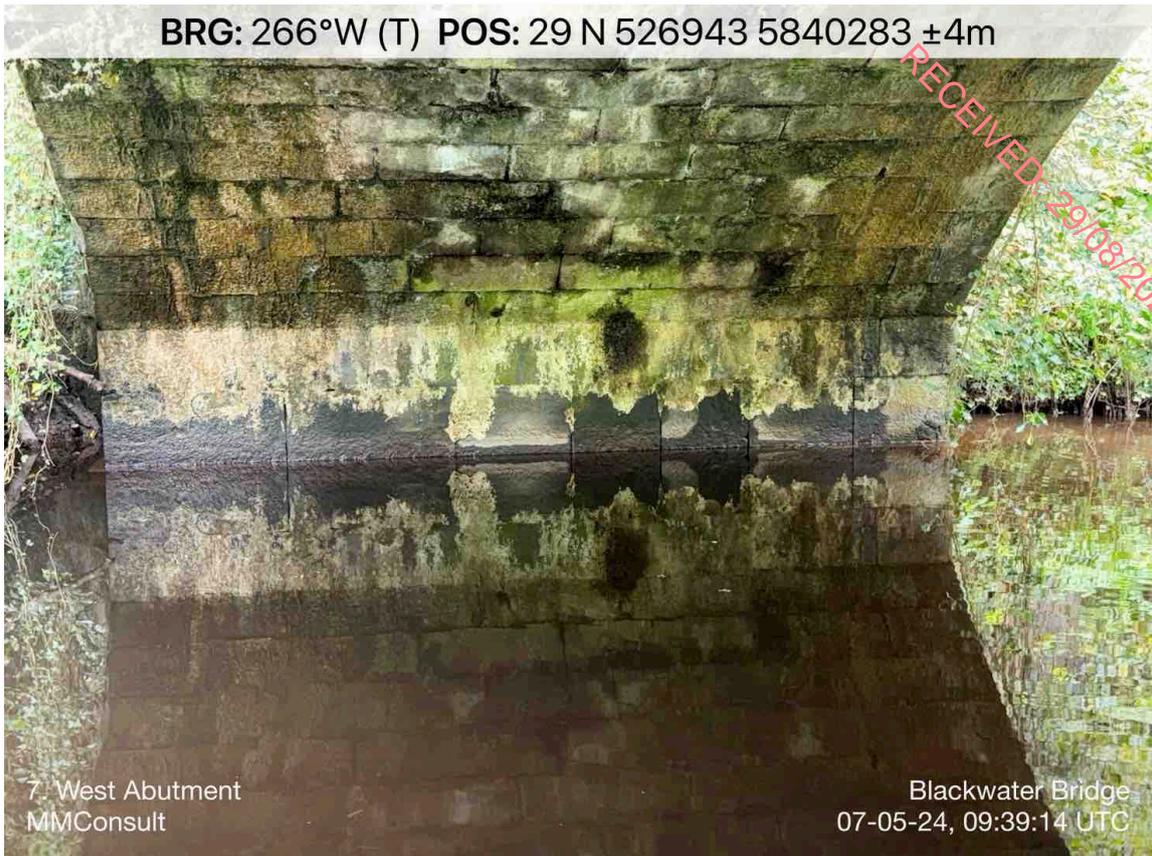
Photo P13: General view of the west abutment

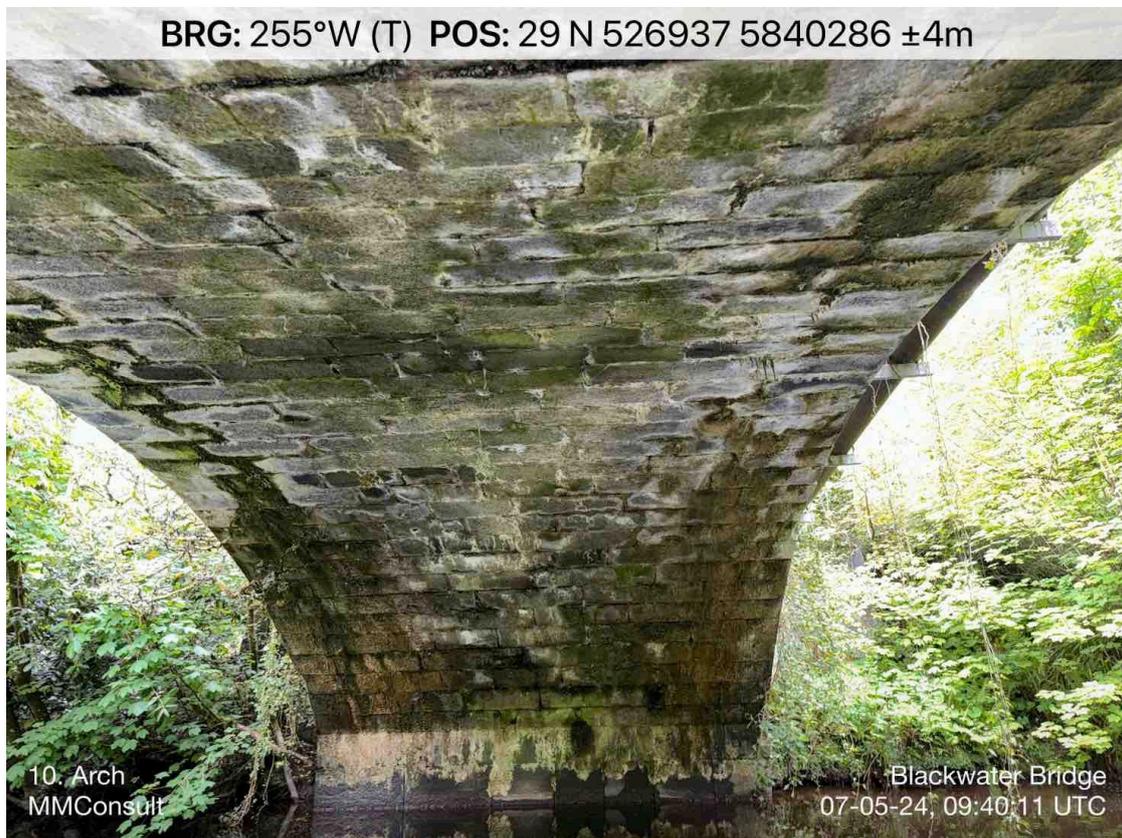
The arch is largely in good condition. There is evidence of extensive water penetration in the form of calcite staining and stalactites. Some crushing of the stonework of the arch barrel was noted at the south end near the crown of the arch.

Photo P14: General view of arch barrel from east side

- None at this stage

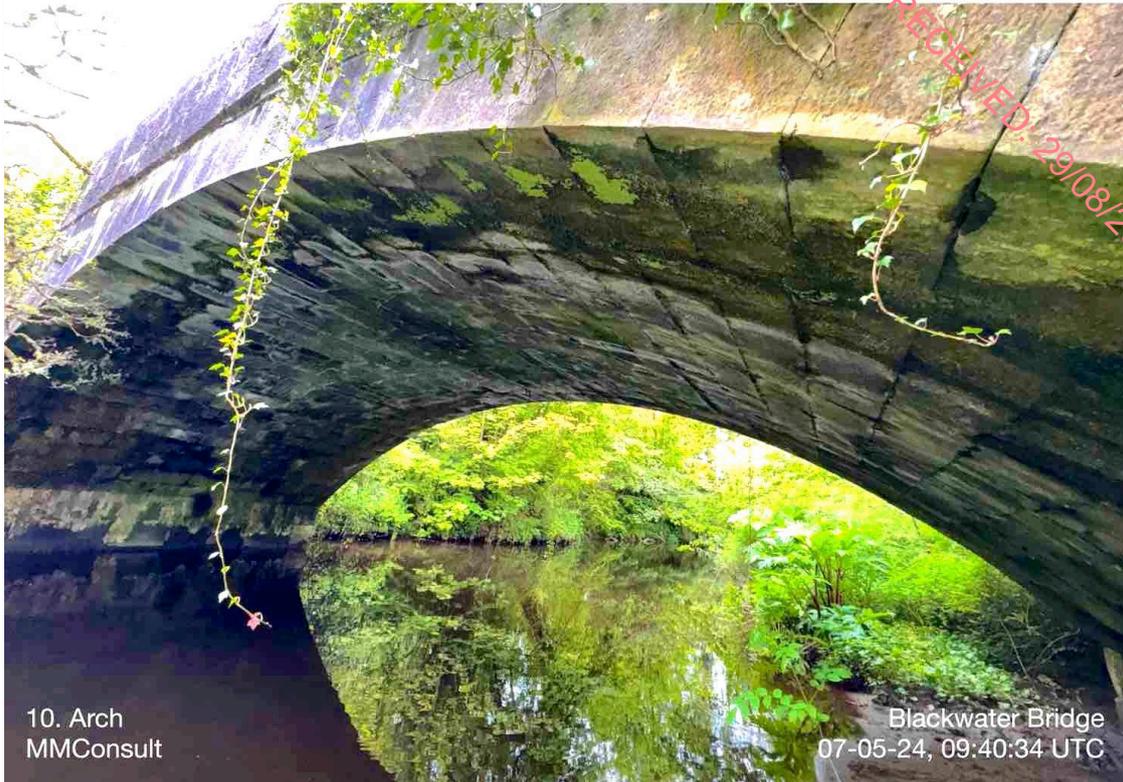
10. Arch
MMConsult

Photo P15: General view of arch barrel from southeast corner

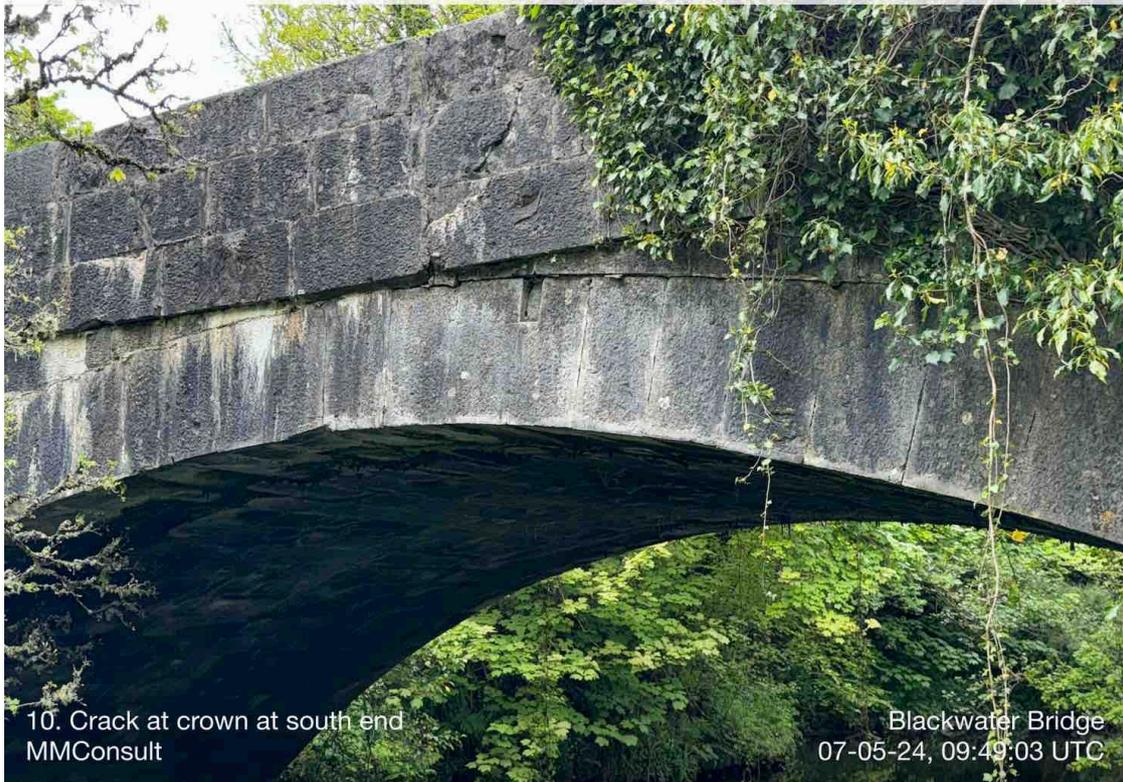
10. Crack at crown at south end
MMConsult

Cause of Damage: Localised excessive loading

Photo P16: View of arch barrel separation from the spandrel wall at the crown at the south end

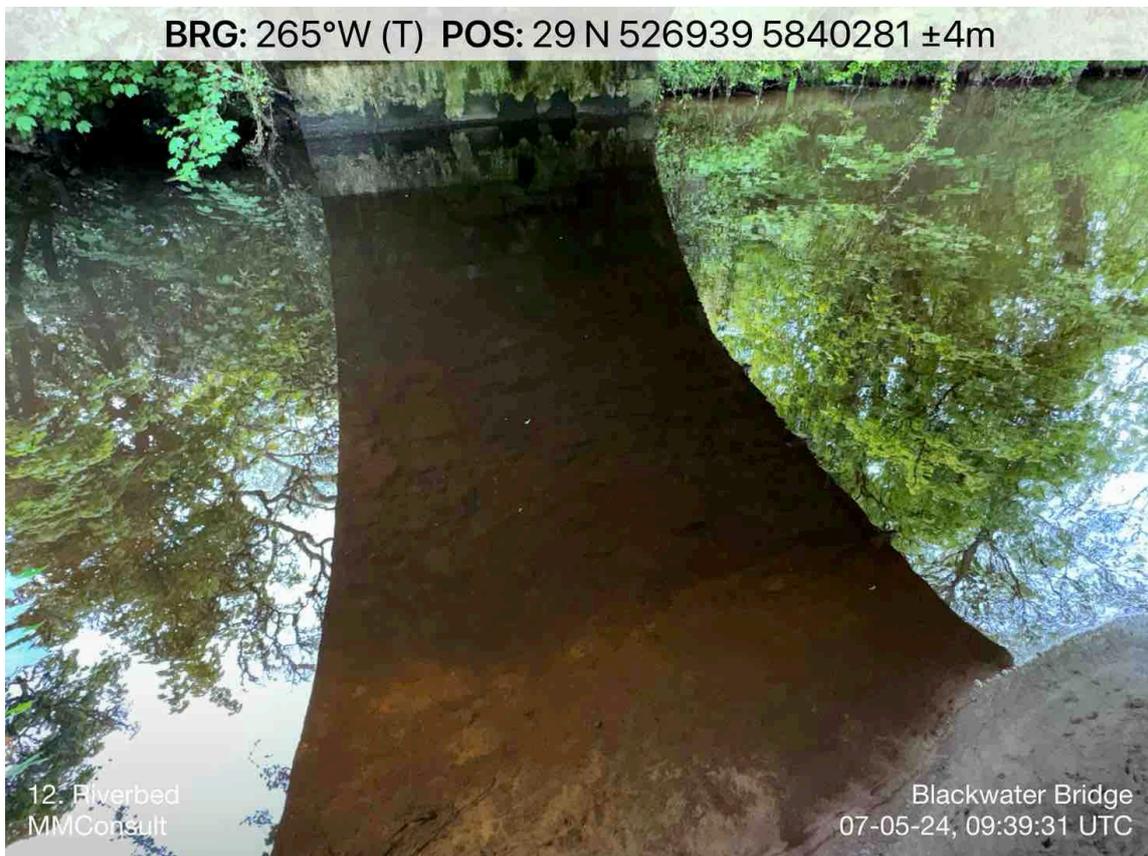
The riverbed is in good condition.

Photo P17: View of scour hole in riverbed below the bridge

- None

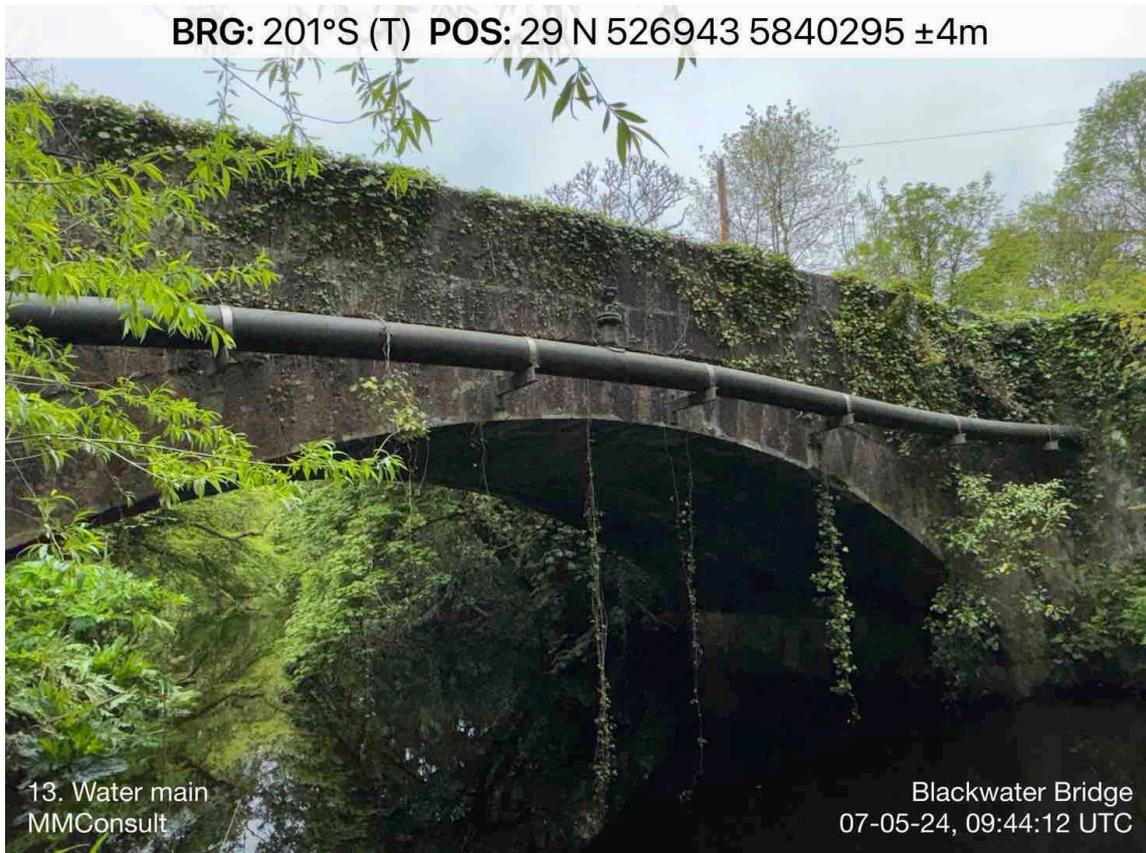
There is a watermain strapped to the north spandrel wall and arch barrel. The bracket supports are in good condition

Photo P18: View of scour hole in riverbed below the bridge

- None

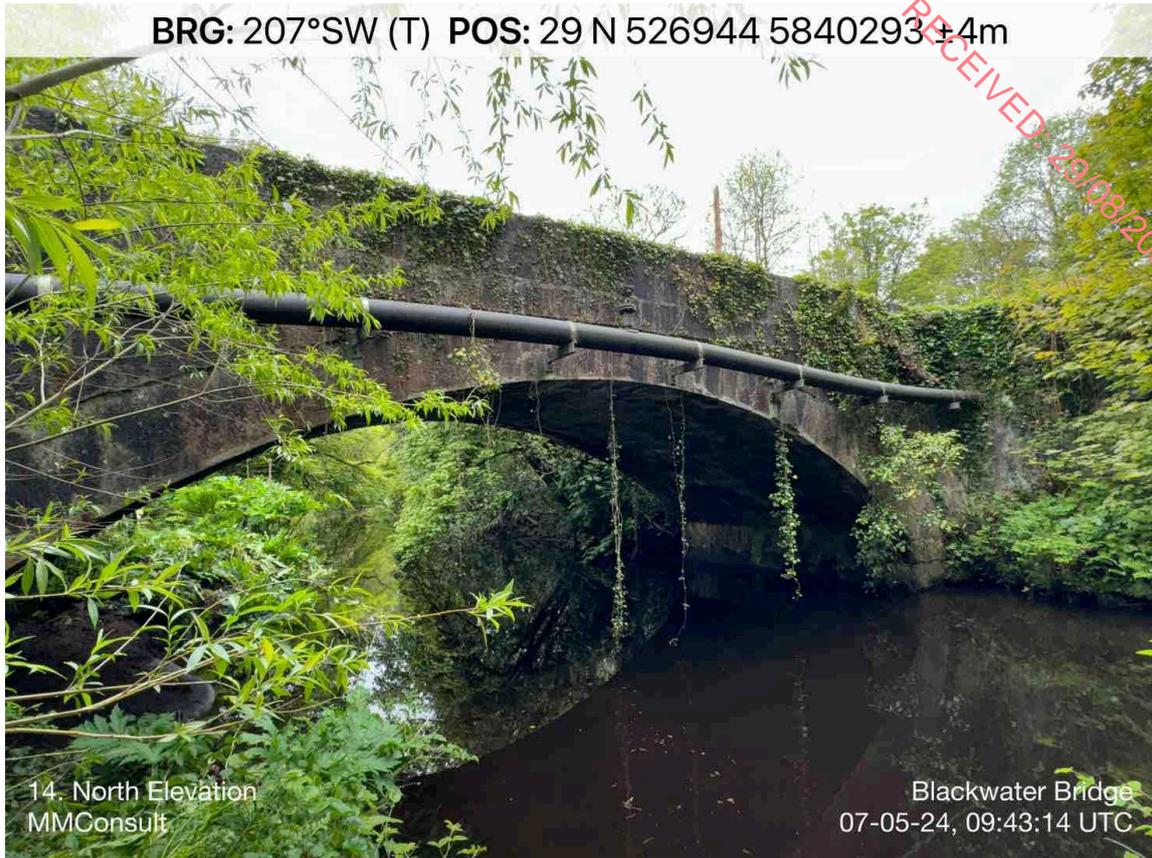
The cut-stone bridge is largely in good solid condition. Extensive vegetation removal is required and some repair work to the surfacing, parapets and safety barrier is required.

Photo P19: General view of the structure - north elevation.

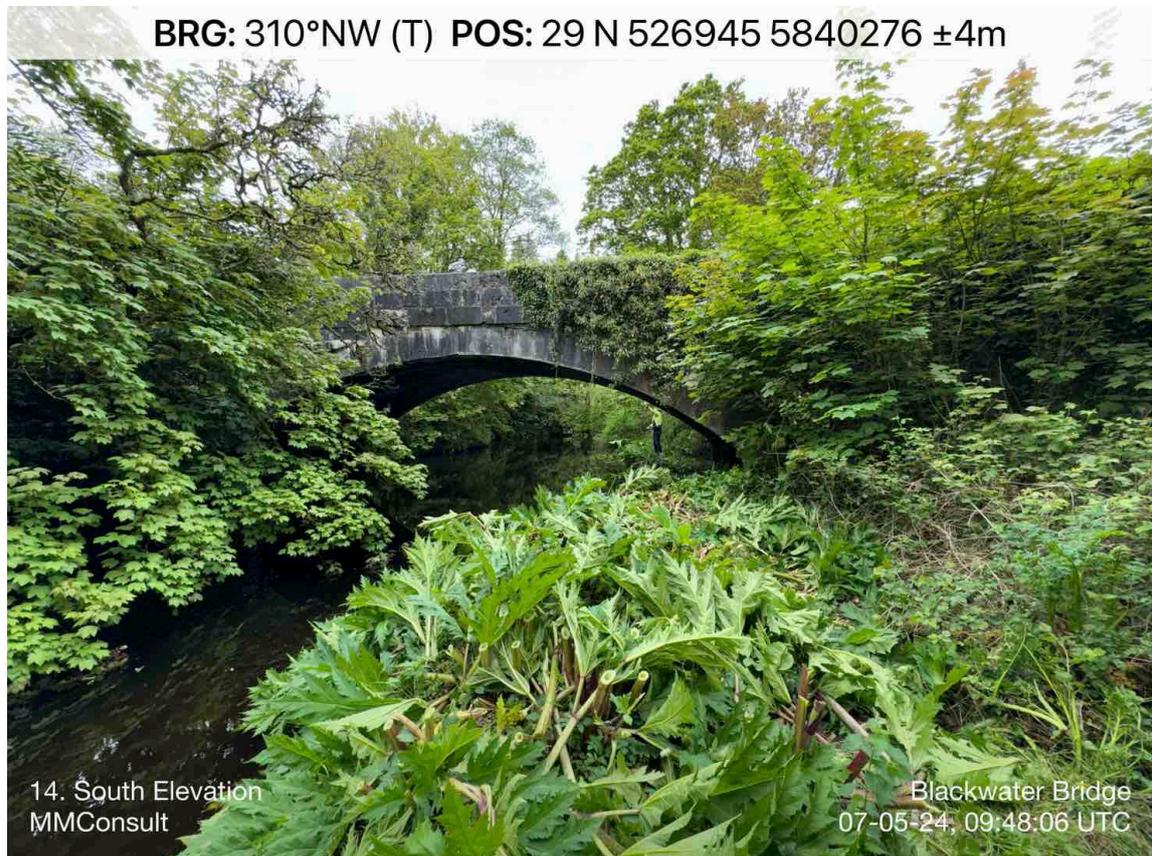
Photo P20: General view of the structure - south elevation.
