Stage 1 Road Safety Audit

Castleconnell Flood Relief Scheme

On behalf of OPW / Limerick City & County Council

July 2024

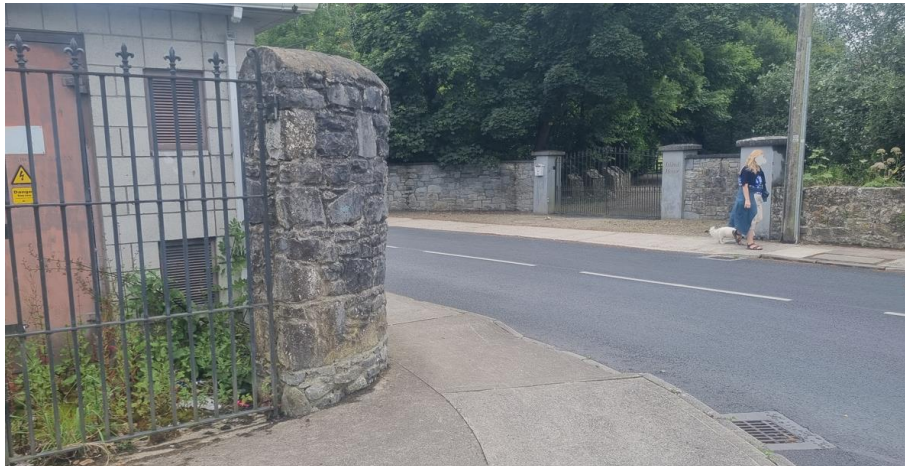
Problem: Visibility at the existing road junctions is already restricted by roadside boundary features. The proposed works result in a reduced carriageway width. This is likely to result in Mall Road traffic travelling closer to the eastern kerb and junctions off the road to the east than present.

Hazard: Users attempting to exit the side roads may protrude into the main line and be struck by passing traffic.

Recommendation: The Design Team should improve side road junction visibility as part of the works.

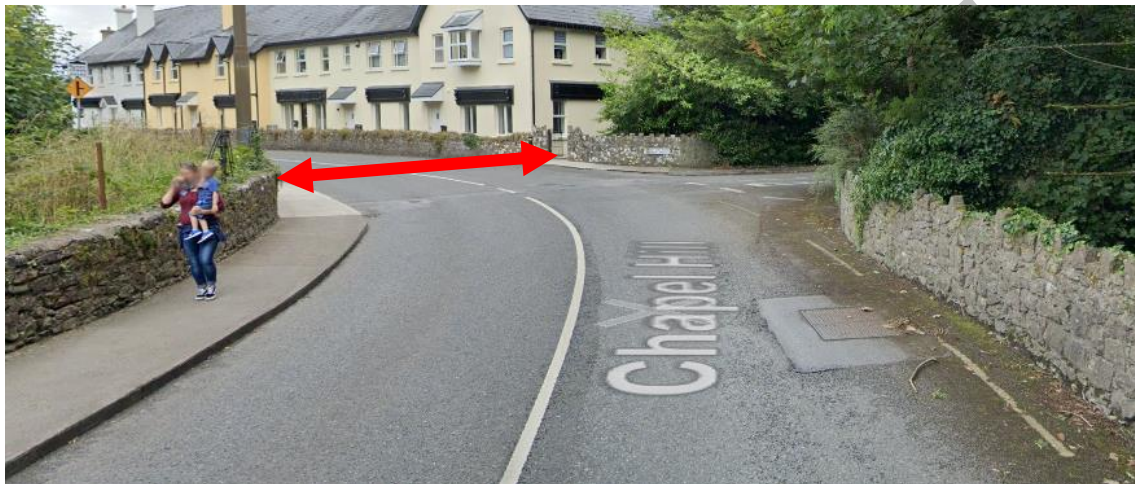
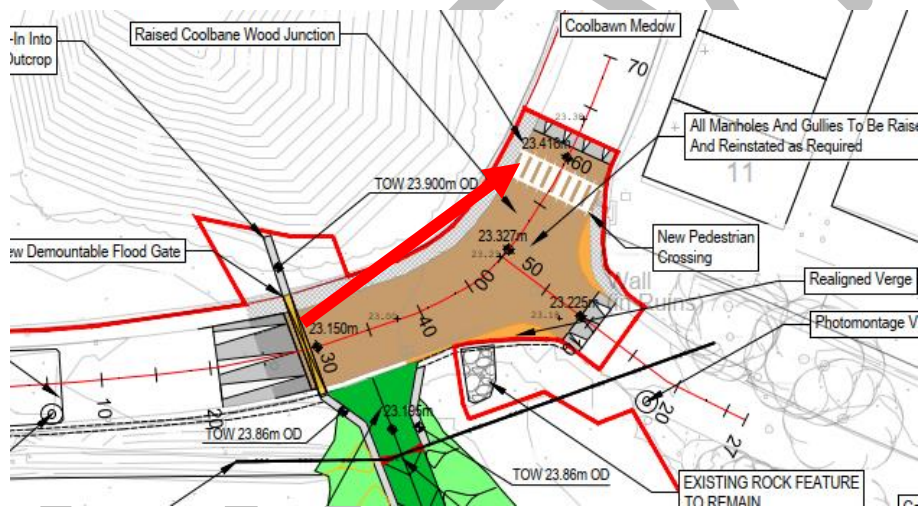
Problem: The proposed zebra crossing is located where driver visibility to the crossing may be restricted by the roadside boundary wall.

Hazard: Motorists may impact with crossing pedestrians.

Recommendation: The Design Team should locate the crossing where suitable inter-visibility is achieved.

Note: This may require the provision of additional footpath to the eastern side of Coolbawn Meadows.

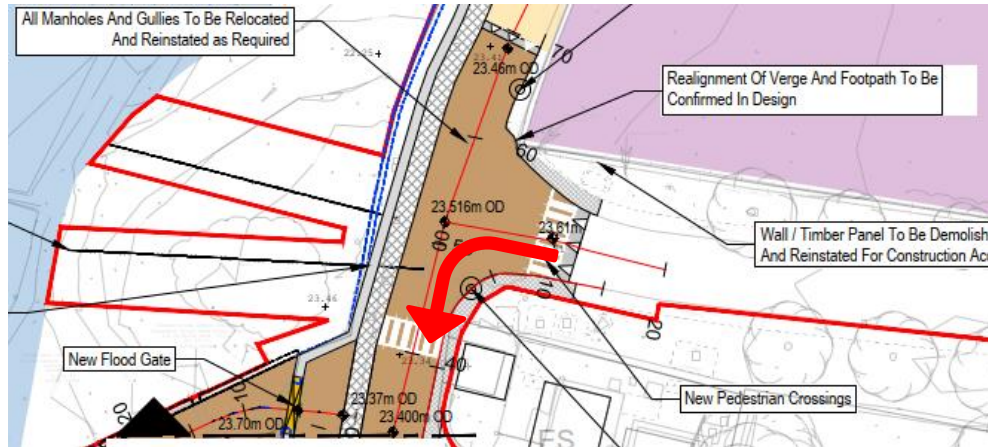
Problem: The proposed zebra crossing is in very close proximity to Scanlon Park. Motorists exiting Scanlon Park and turning left are likely to be concentrating on traffic approaching from their right.

Hazard: On observing no approaching traffic they may proceed out of the side road and impact with pedestrians on the crossing.

Recommendation: The Design Team should relocate the zebra crossing further to the south.

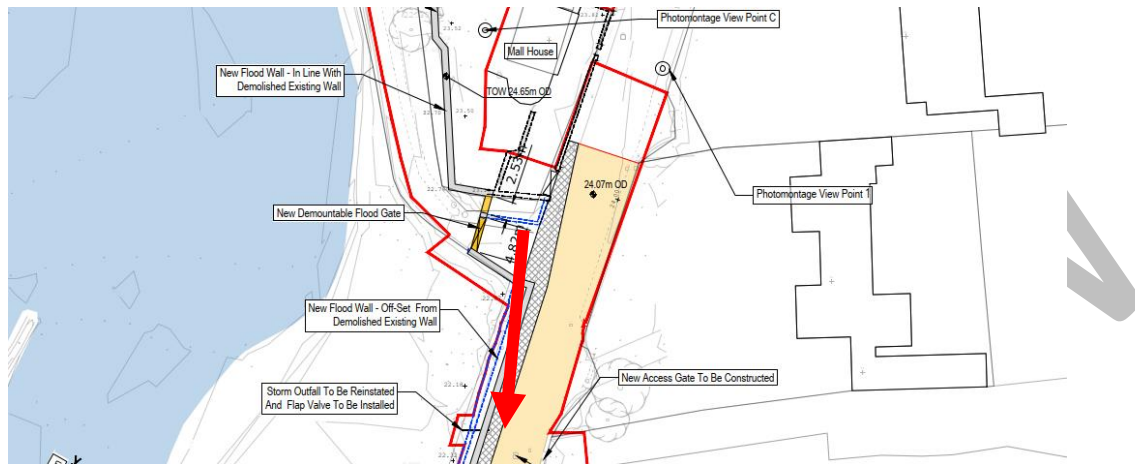
Problem: The proposed flood defence wall is generally higher than the standard vehicle driver's eye height. The new wall proposed to the south of the Dunkineely driveway may restrict visibility for the exiting motorist.

Hazard: Driveway traffic may pull into Mall Road into the path of oncoming pedestrians or motorists.

Recommendation: The Design Team should ensure suitable driveway visibility is provided for users exiting Dunkineely House.
