Appendix 10. Land, Soils and Geology

**10.1 Wuxi Biologics WwPTP Site
Investigation Report' (Murphy Group, 2023)**

CLIENT	Wuxi Biologics
CONTRACT TITLE	Wuxi Biologics Wastewater Pre-Treatment Plant
CONTRACT NUMBER	1011-000121
OPERATING UNIT	M6

Wuxi Biologics WwPTP Site Investigation Report

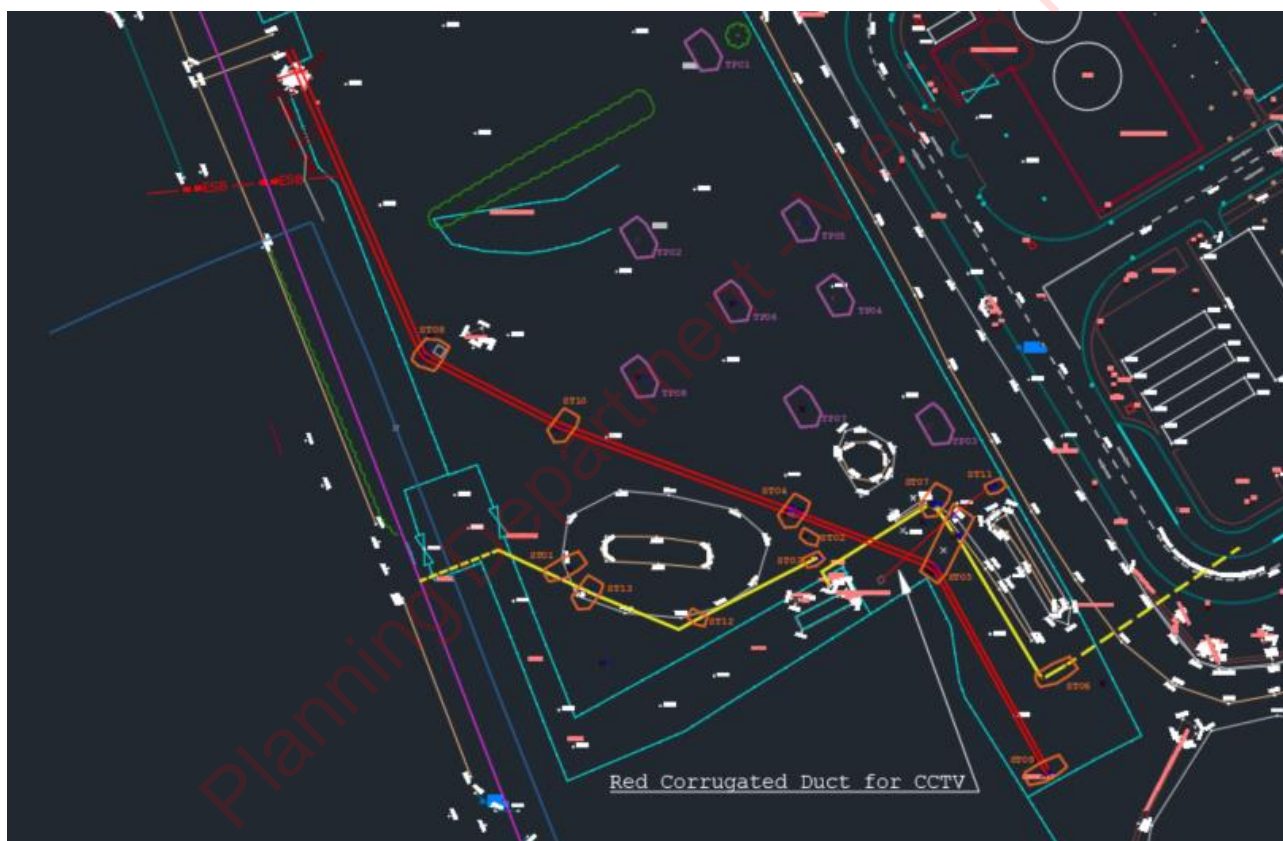
Fig 1: Site :Layout showing Cofirmed Service Locations and Site Investigation Excavations

The drawing below shows all the confirmed locations of the services, measured and surveyed with a GPS unit. Individual trial hole sheets have been prepared for all the trial holes and slit trenches, and are attached in the Appendices.

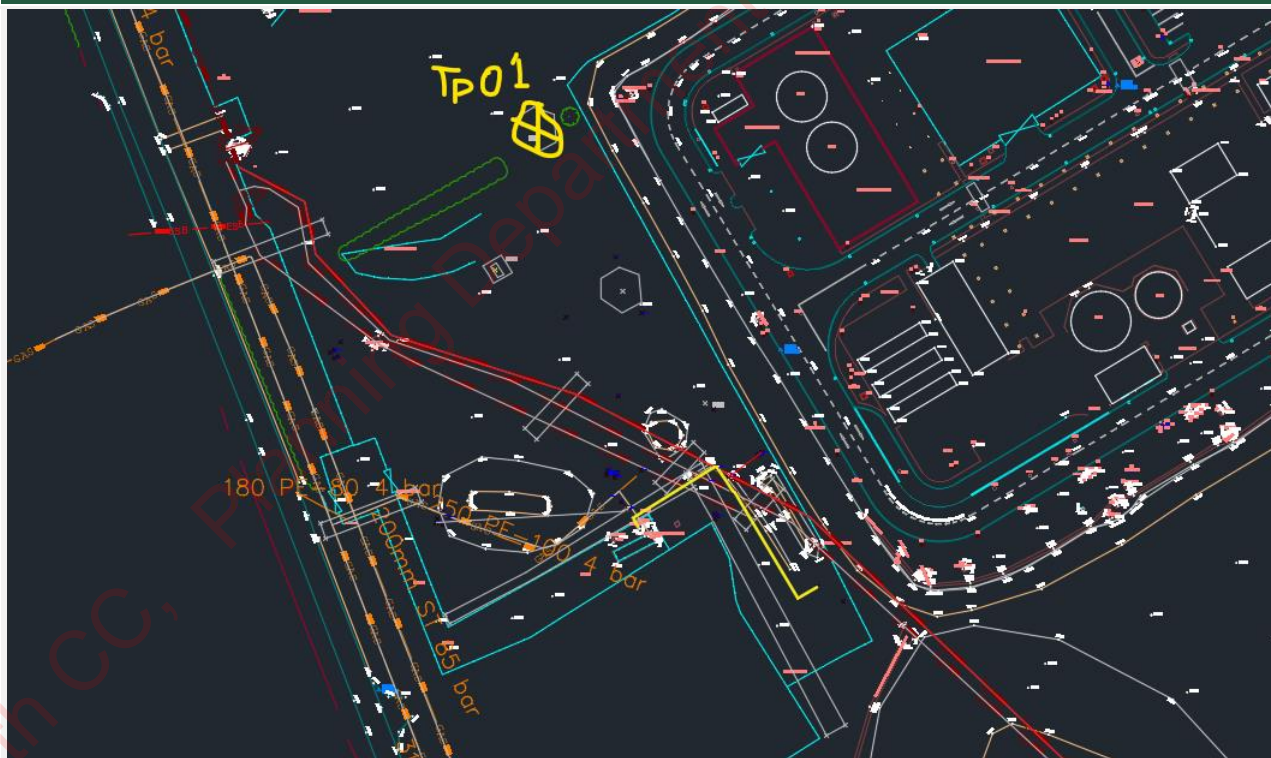
3. Regarding TP01, we reached a depth of 3.7m before we encountered a large boulder. The WuXi archaeologist directed that we couldn't widen the excavation to go deeper, due to its proximity to an area of archaeological value. TP01 had already been repositioned by the archaeologist to an adjacent location after we had taken the first scrape, It was the most sensitive location from an archaeological view.

GL 23.056 mOD Brown Clay soil with blue shale angular small to medium boulders.

2.8 mBGL large boulder encountered, could move it slightly with the bucket and blue flakes of shale were broken off with the bucket.

3.7m depth beside the boulder, no bedrock encountered. Could dig no deeper without widening excavation.

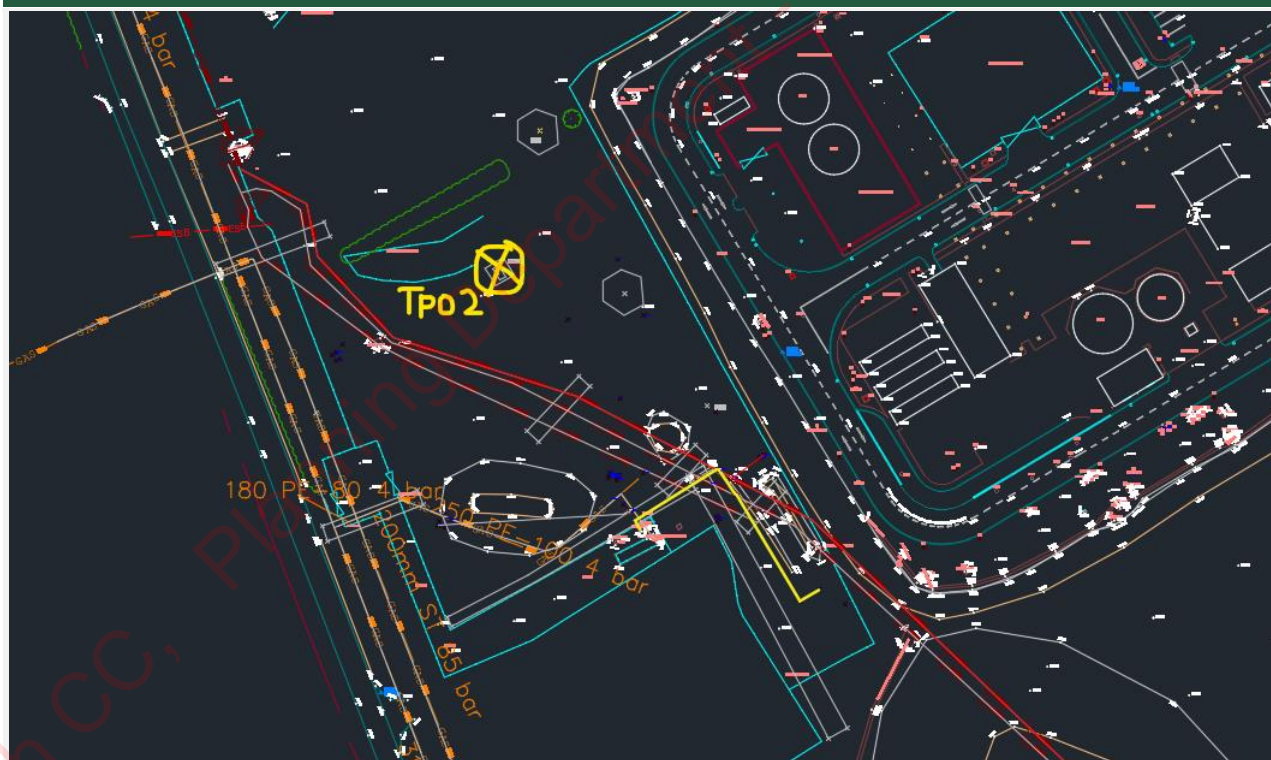
Large Shale boulders encountered at 2.8m BGL so approx. 21.000 mOD. Angular rock that smokes and breaks easily when pulled with the machine bucket. Flakes of blue shale

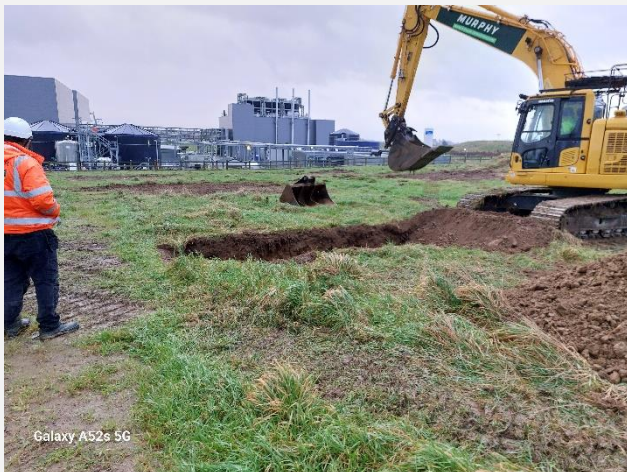
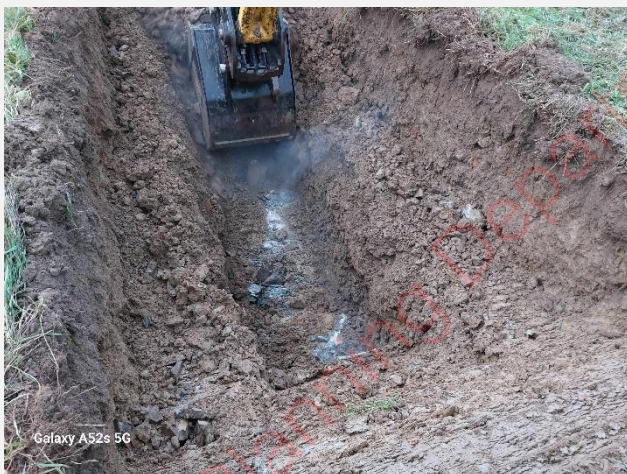
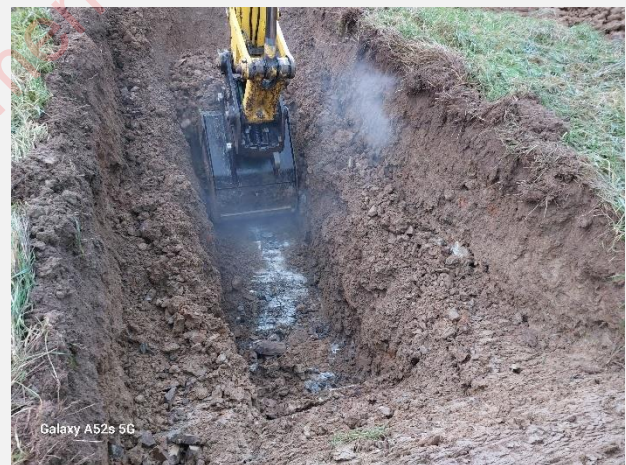
Bedrock encountered at 2.3 mBGL , approx. 21.000 mOD. Blue grey Shale

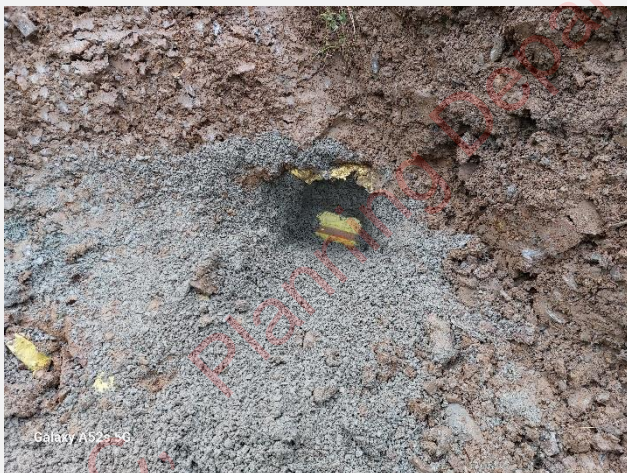
All excavations on gas mains observed by Wuxi Archaeologist and GNI inspector. 315mm Dia PE Gas distribution mains encountered at 1.3 mBGL, approx. 24.068 mOD. Pipe surround is grey grit and yellow Gas main warning tape in place. Location is approx. 2.2m southwest of drawing supplied by GNI

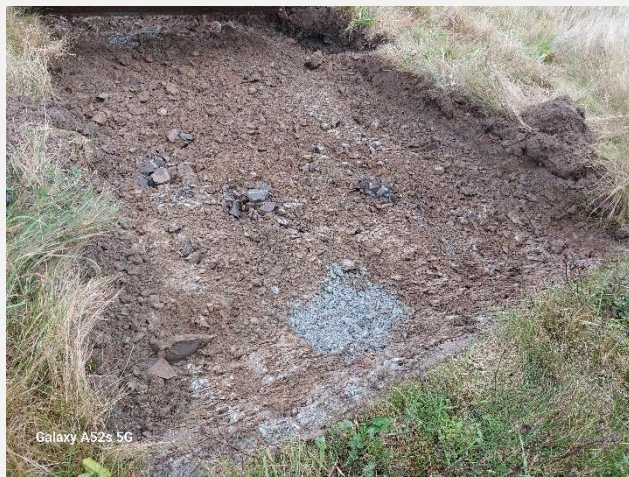
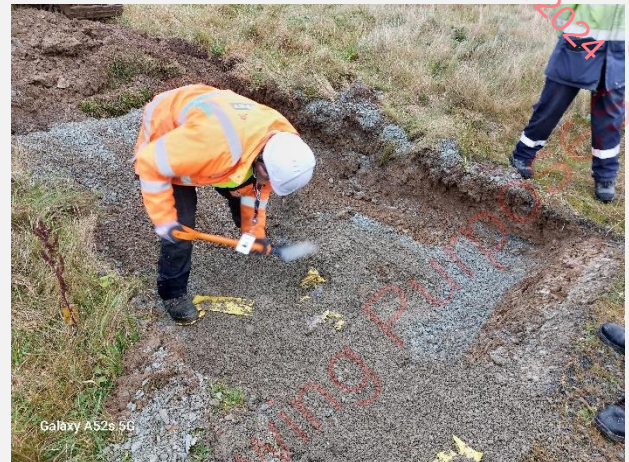
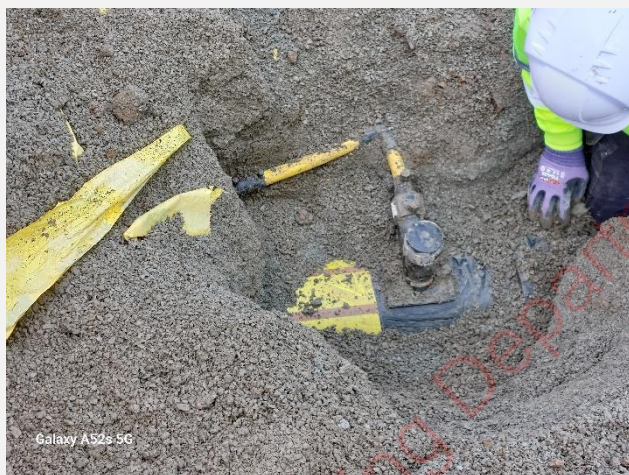
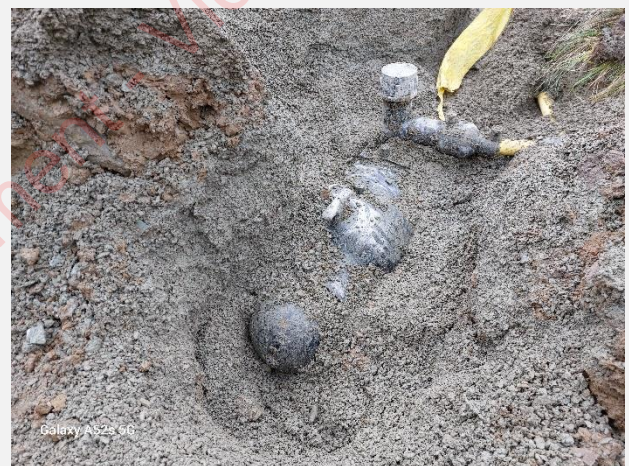
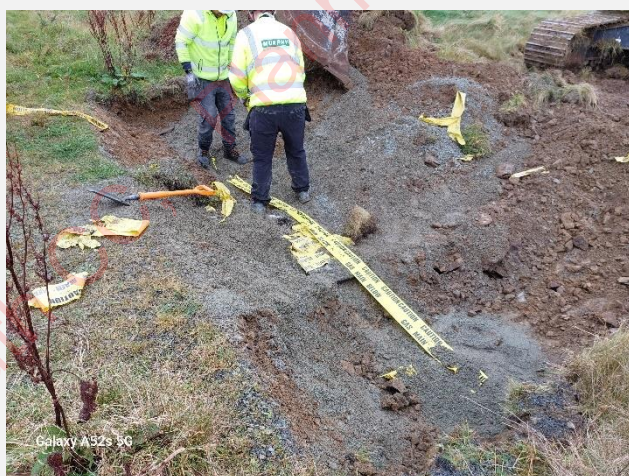
All excavations on gas mains observed by Wuxi Archaeologist and GNI inspector. 315mm Dia PE Gas distribution mains encountered at 0.9 mBGL, approx. 23.4 mOD. Pipe surround is grey grit and yellow Gas main warning tape in place. Location is approx. 3m closer to AGI (south of drawing supplied by GNI)

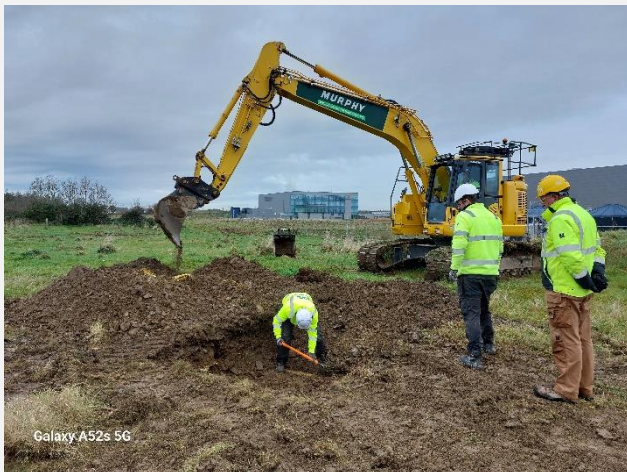
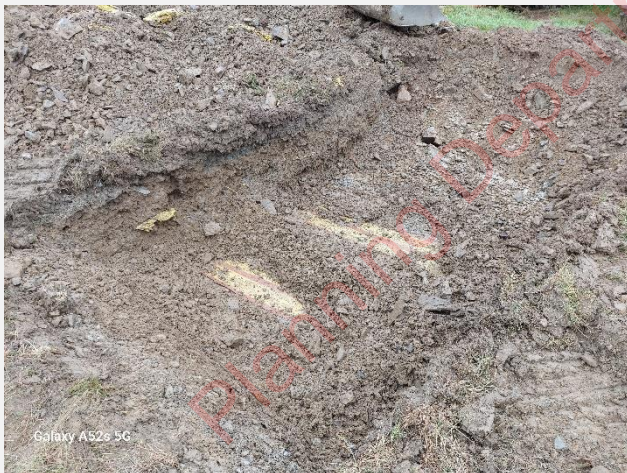
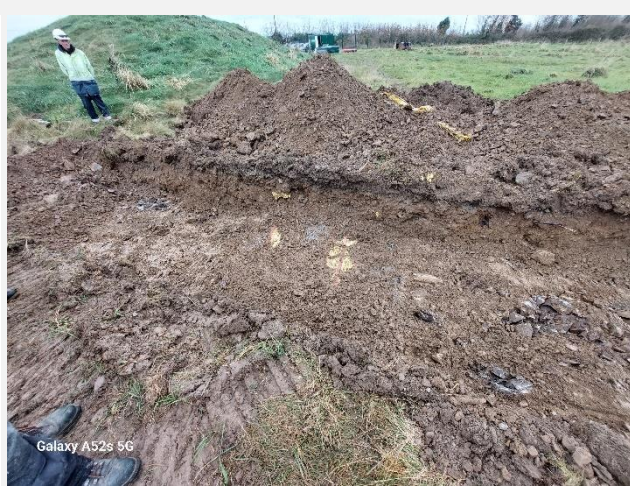
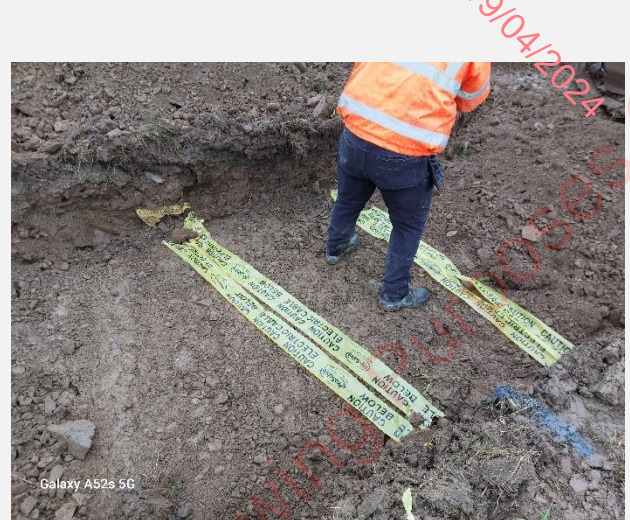
All excavations on ESB Cables observed by Wuxi Archaeologist. Atkins/Wuxi directed that we contact ESB networks before we commence excavating near cables to log onto their system and give a contact no.. This is done again at the end of the shift to log off. ESB cables traced with CAT on power mode with audible tone and shrill alarm and when near and directly above the cables.

We traced 2 separate signals and found 2 distinct lines of ESB warning tile board running NW to SE in ST04. Note that these are approx. 11m further west than indicated on the ESB service drawings and we only found evidence of 2 cables, not 3.

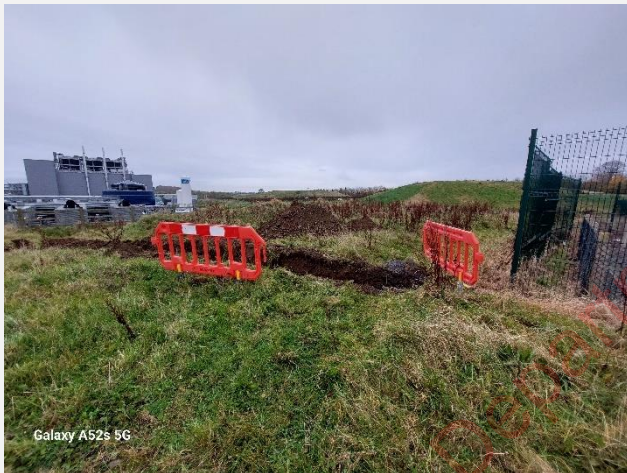
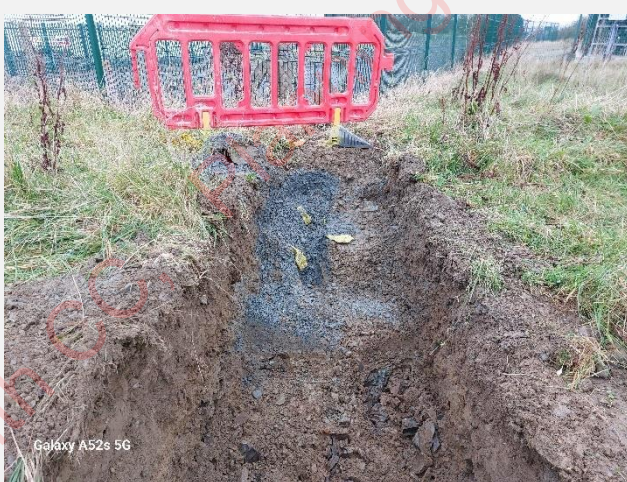
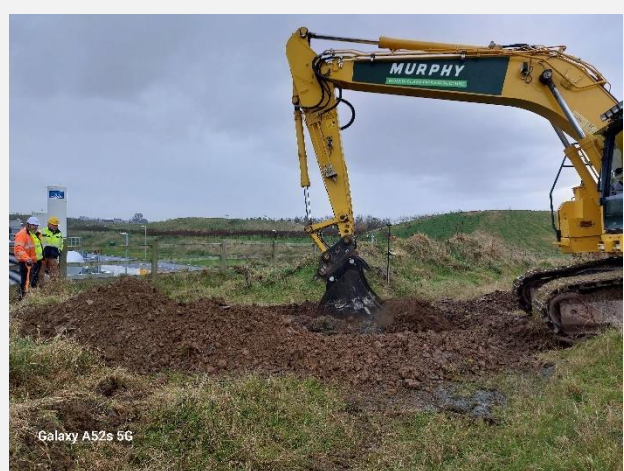
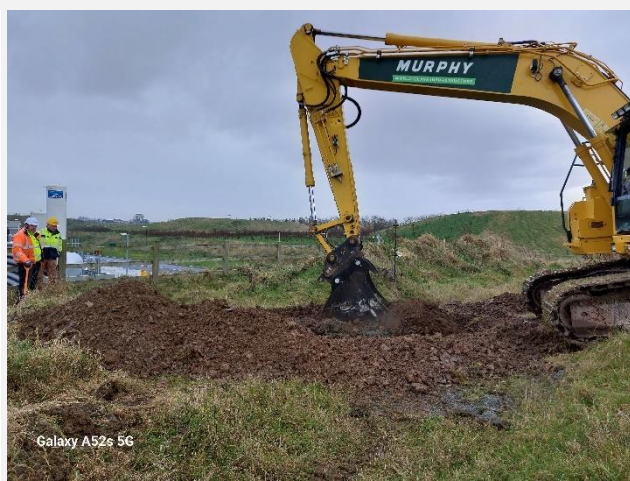
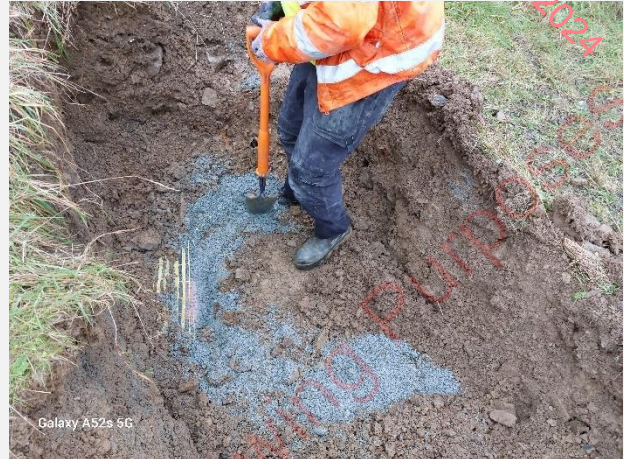
ST05 All excavations on ESB Cables observed by Wuxi Archaeologist. Atkins/Wuxi directed that we contact ESB networks before we commence excavating near cables to log onto their system and give a contact no.. This is done again at the end of the shift to log off. ESB cables traced with CAT on power mode with audible tone and shrill alarm and when near and directly above the cables.

We traced 2 separate signals and found ESB warning tile board near the corner of the palisade fence of Haynestown AGI. Note that these are approx. 9 m further west than indicated on the ESB service drawings and we only found evidence of 2 cables, not 3. We didn't uncover the tile board of the second ESB service as it is running quite close to the fence and excavating nearer to the fence may have undermined the concrete post foundations. The CAT gave a very strong signal to confirm the location of the cable.

Leanmix concrete found under the warning tile board. Good practise would have the tile board located 300mm above the ducts, and this was confirmed by the CAT. We can therefore assume the ESB ducts are approximately **23.350 mOD**

We also found additional mesh barrier tape and a red 4" corrugated duct which is the CCTV feed from the plant to the AGI. This terminates in a chamber near the pedestrian gate of the AGI skid. **22.490mOD** approx. 850mm below ground level.

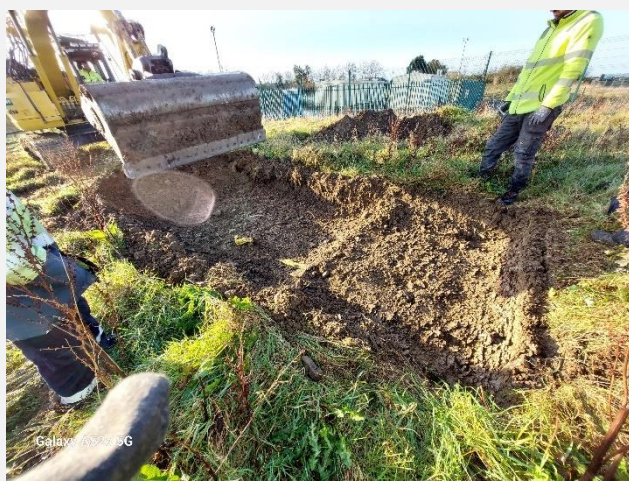
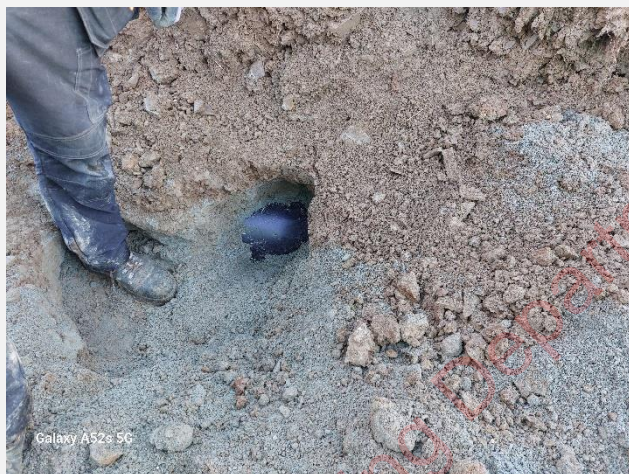
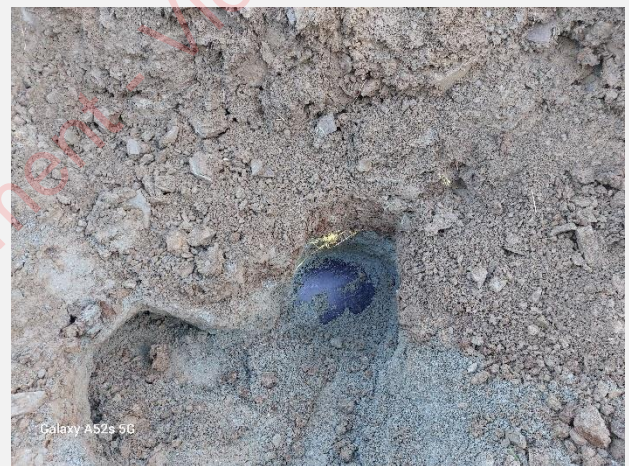
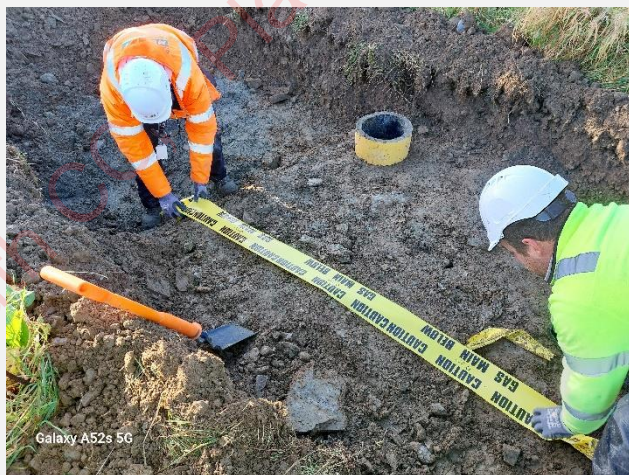
ST06 All excavations on ESB Cables observed by Wuxi Archaeologist and GNI inspector

The gas supply main was found in 2 spots in this trench, approx. 1.2m BGL. We found the yellow straight part and the black 90° fusion collar

Grey grit and warning tape were found and new warning tape installed during backfill.

New cable warning tape placed over the tile board approx. 0.5m below surface when backfilling the trench

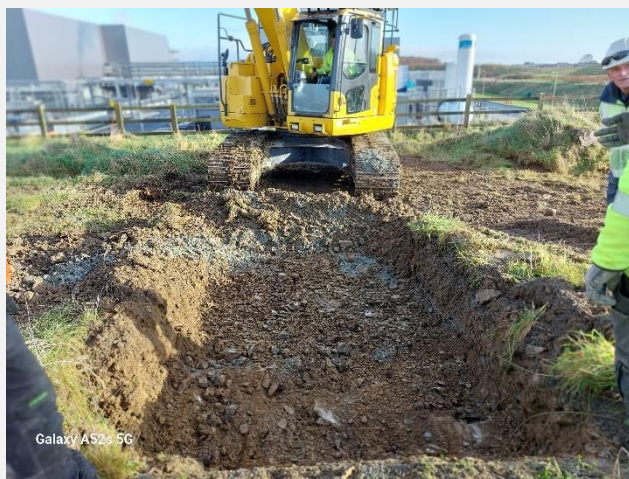
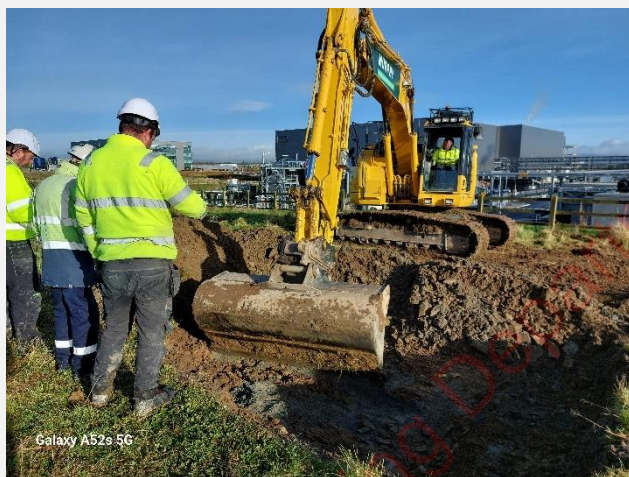
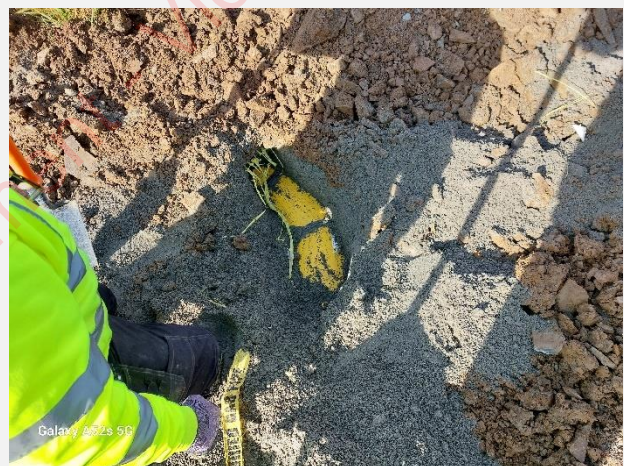
All excavations on gas mains observed by Wuxi Archaeologist and GNI inspector

The gas supply main was found in 2 spots in this trench, approx. 0.75 BGL. We found the yellow straight part and the yellow 90° swept fusion bend at 23.211 mOD

We can now be confident of the route and level of the PE gas main that feeds the Wuxi plant from the AGI skid

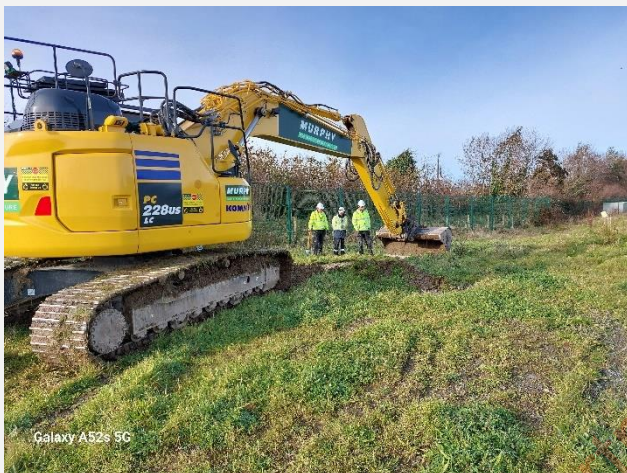
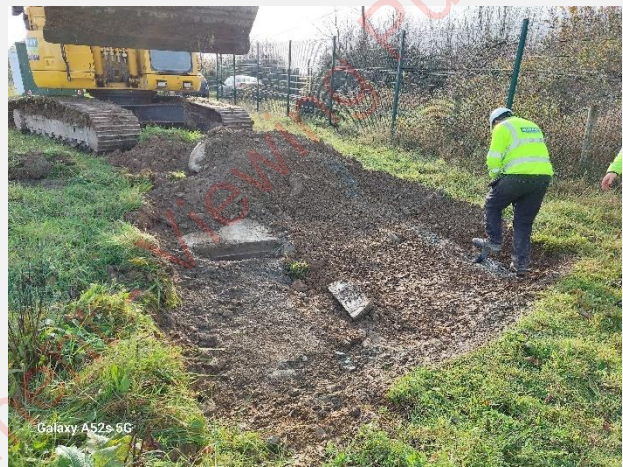
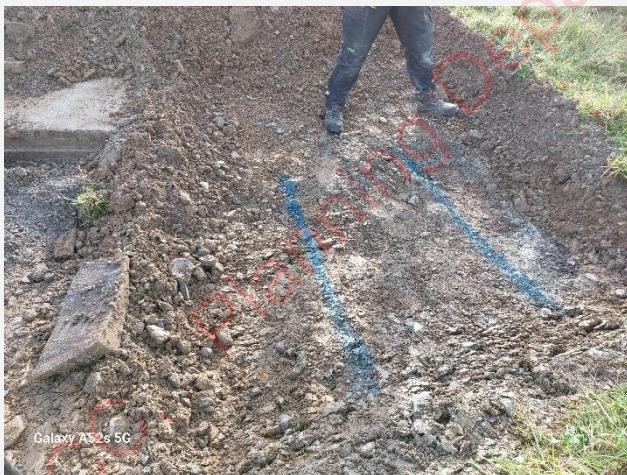
All excavations on ESB lines registered with ESB Prox work centre.

Assume if ESB ducts are 300mm below leanmix (good practice), they are approx. 24.700m OD

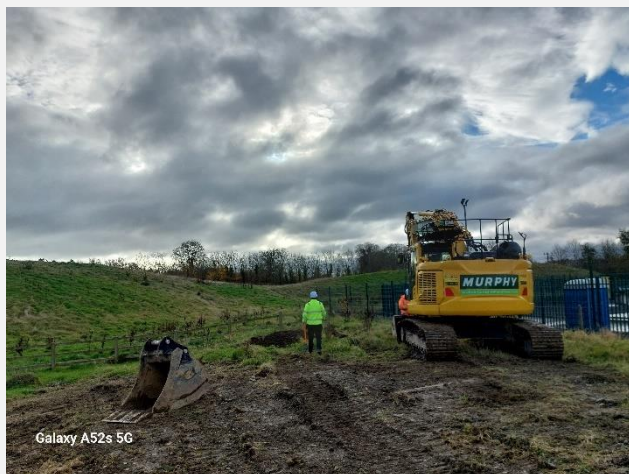
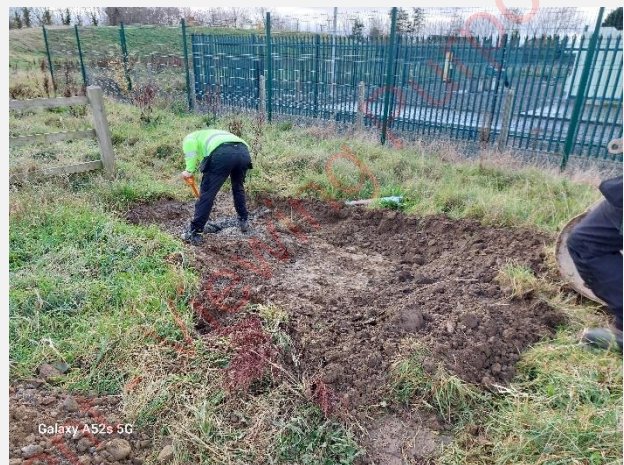
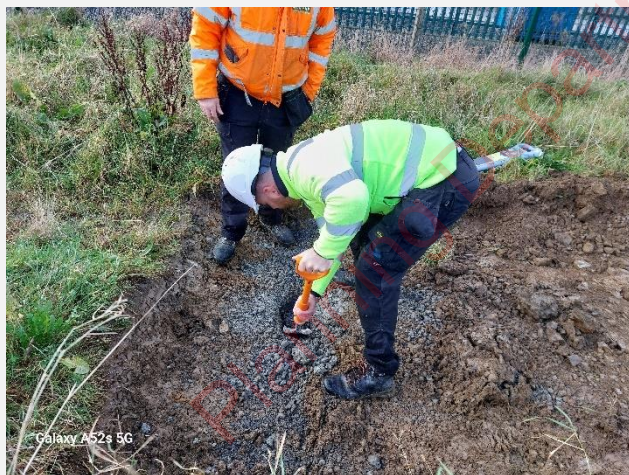
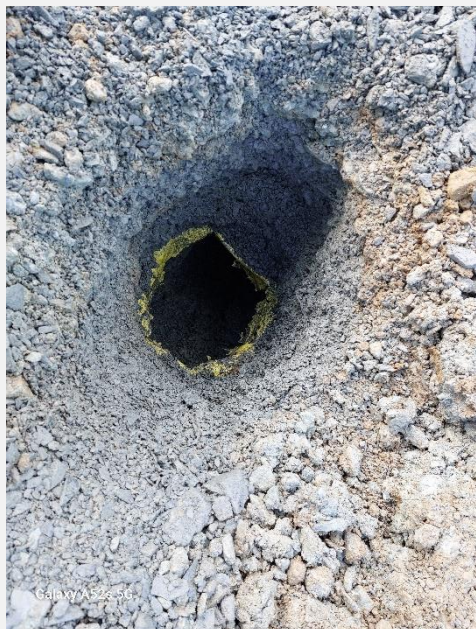
All excavations on ESB lines registered with ESB Prox work centre.

Assume if ESB ducts are 300mm below leanmix (good practice), they are approx. 24.700m OD

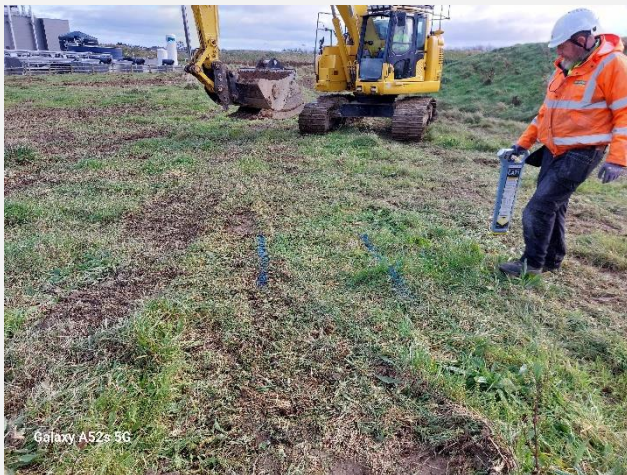
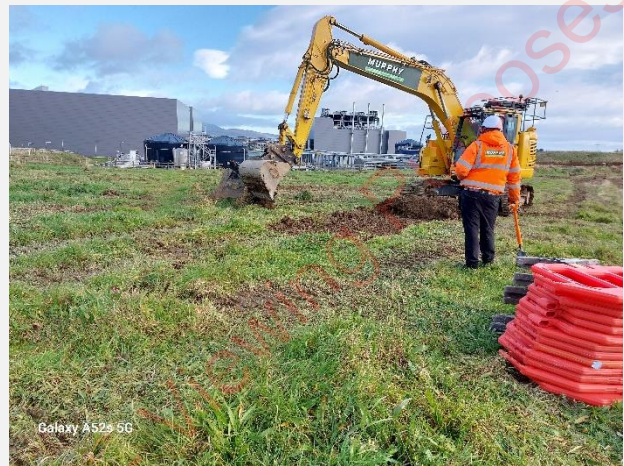
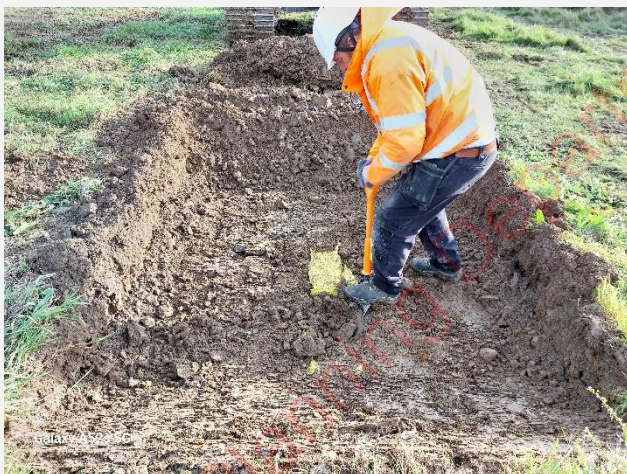
Assume if ESB ducts are 300mm below leanmix (good practice), they are approx. 24.200m OD

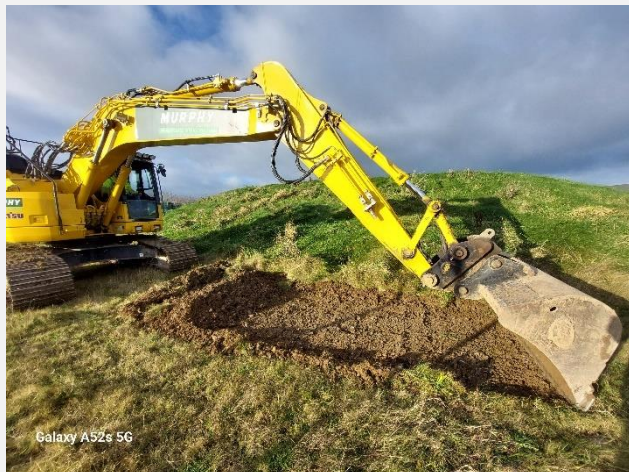
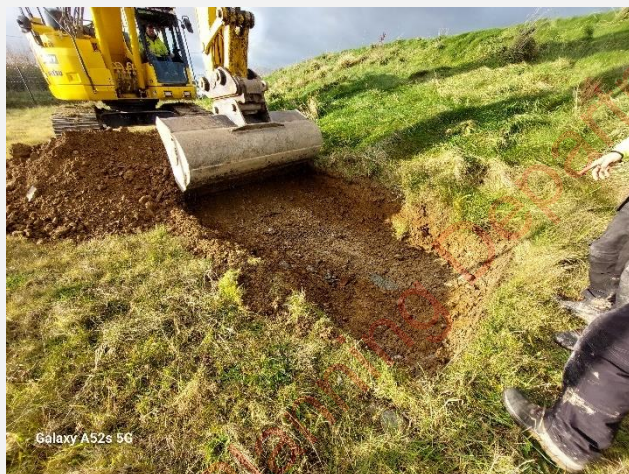
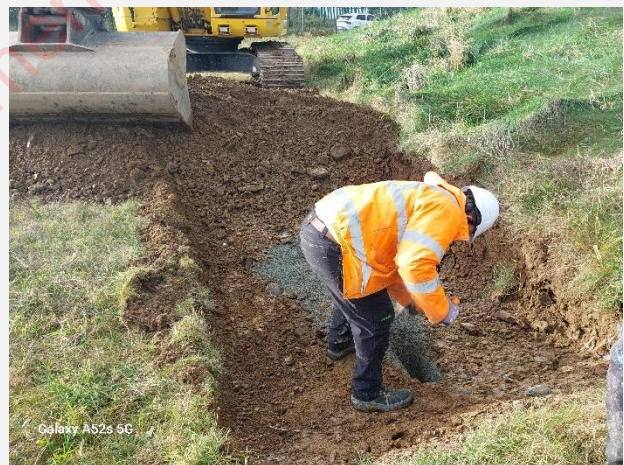
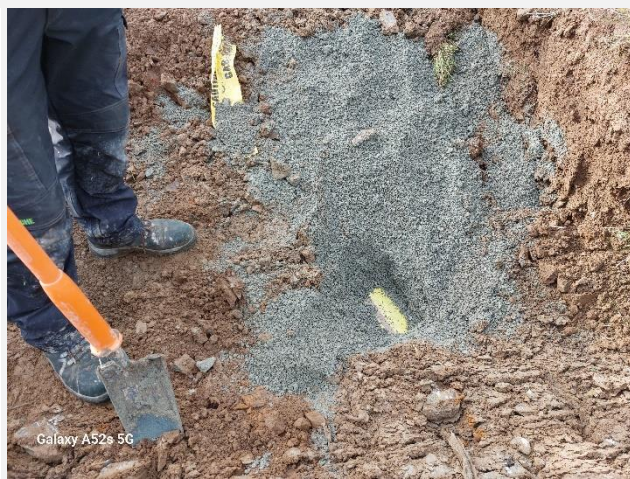
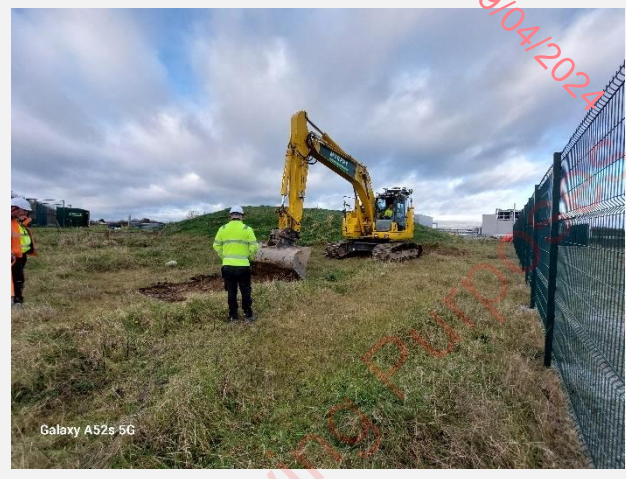
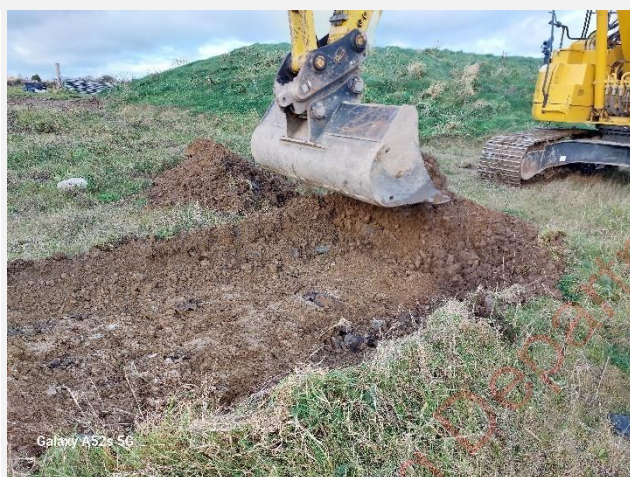
Second location further west excavated to find the bend, but large boulders near the surface confirmed not in this location.

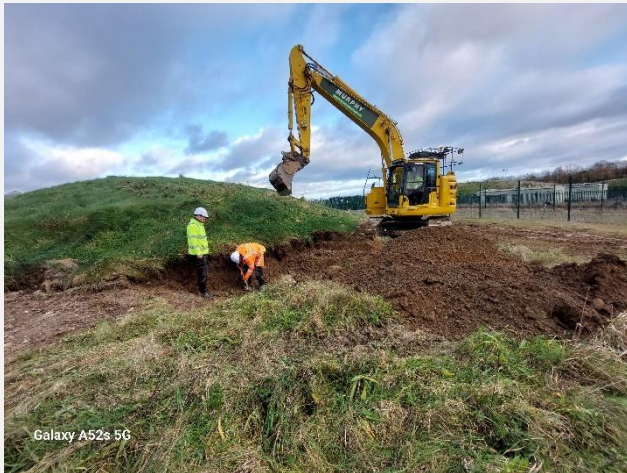
Pipe very shallow in this location. But ground rises in a small hill just above it.
