# Arboricultural Assessment Impact & Tree Protection Report

The Rectory & Quayside  
Mountshannon  
Co. Clare

Project No.	Project name	Date	Revision
TINI003	The Rectory & Quayside	05/12/24	C

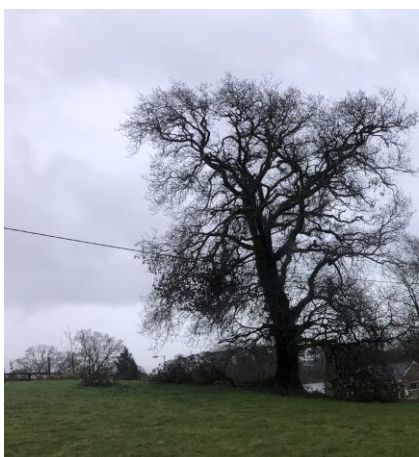
Planting appears to have been undertaken over time and to accomplish both ornamental and practical aims. A number of large Douglas fir (*Pseudotsuga menziesii*) are located on the southern boundary and may have been planting as a windbreak (image 2). These trees are generally in good condition though some exhibit leans and wind blasted crowns due to the exposed nature of the site. A very large oak (*Quercus robur*) is located to the south-eastern corner of the site (image 3) and is probably the oldest tree on the site. It has suffered a degree of storm damage in recent times but has not been overly impacted upon by this and with appropriate management can be a specimen tree on the site.

**Image 3.** Mature oak #1120 toward south-eastern boundary

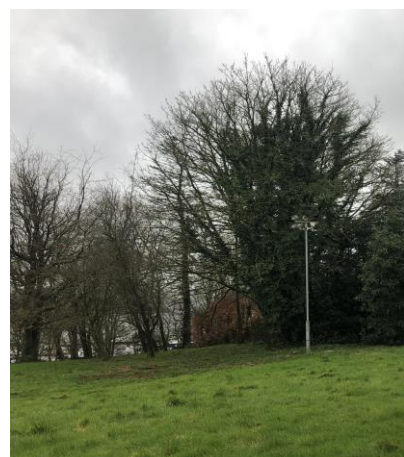
**Image 4.** Sycamore #1153 and rhododendron # 1154 on western boundary

1153	Sycamore <i>Acer pseudoplatanus</i>	Mature	Good	A cluster of stems forming a wide spreading combined canopy. Possibly originating from a stump. Decay present in a stem to east at 1.5m. Remaining stems appear sound.	Remove stem with decay. remove holly and ivy to expose stem structure	A2	40	380	20	5,8,7,6

Tag No.	Species	Age Category	Vigour	Comments	Preliminary Recommendations	Landscape and Arboricultural Category	Useful Life Expectancy	Dbh	Height	Spread
1154	Rhododendron cultivar	Mature	Good	Well-developed multi-stemmed specimen	Raise canopy to expose stem structure	B2	30-40	350	10	4,4,2,3
1155	Beech Fagus sylvatica	Mature	Good	Well developed. excavations at base to north and west. A number of roots severed. Appears to be some time ago. Tree well developed.	Monitor root zone	B2	30-40	660	15	9,9,5,8
1156	Ash Fraxinus excelsior	Mature	Good	A relatively well-developed specimen on boundary. Crown with minor deadwood to west. Very heavy ivy growth up trunk. Trunk co dominant from 2.5m with a tight union between stems. Unlikely to be significant at present.	No action necessary	B2	30-40	350	13	5,7,5,4
1157	Norway spruce Picea abies	Young	Good	Well developed with no visible defects	No action necessary	B2	40	170	7	2,1,1,1

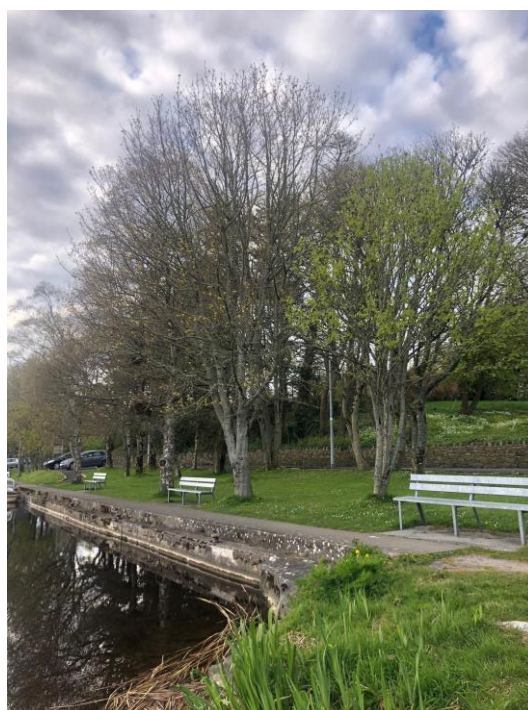
The trees surveyed along the quayside (image 1 blue line) appear to have been planted at the same time though the range of species and the differential in growth patterns make the planting appear somewhat varied in age. The main species present are Sycamore (*Acer pseudoplatanus*), birch (*Betula pendula*) with more occasional Norway maple (*Acer platanoides*) and ash (*Fraxinus excelsior*) (image 5). These trees are, in the main, growing relatively well in this exposed location though a number have been categorised as being of low value and / or in need of removal (table 2).

**Image 5.** Quayside trees from carpark area
