23196-01-001

SCARTMOUNTAIN WIND FARM TURBINE DELIVERY ROUTE

Road Safety Audit Stage 1

February 2024

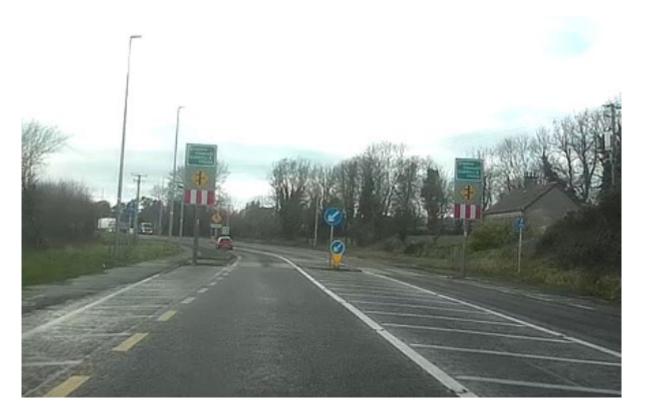
Road signs, within the swept path, may have to be removed while the turbine delivery vehicle is operating on the route. In the absence of these signs, drivers of vehicles on the route may not be aware of the layout of the road ahead leading to possible collisions owing to sudden braking or incorrect manoeuvres.

Provide adequate temporary signage and traffic management to inform road users at all locations where existing signs have been temporarily removed.

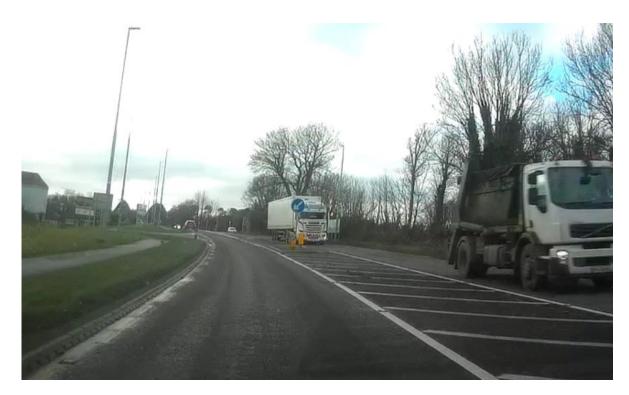
The westbound truck and boogie tyre path appears to occupy the eastbound lane through the traffic calming layout in Lemybrien. This may lead to head-on collisions if appropriate temporary traffic management is not in place.

Provide appropriate traffic management, to stop eastbound traffic while the truck and boogie occupy the eastbound lane while travelling in a westerly direction. The traffic management should encompass the exit from the Applegreen Service Station. Westbound traffic should be prevented from undertaking the truck and boogie.

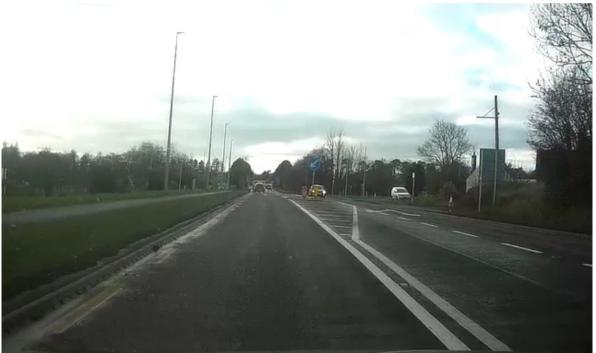
The westbound truck and boogie tyre path appears to occupy the eastbound lane at the entry to the N72 from the N25. This may lead to head-on collisions if appropriate temporary traffic management is not in place.

Install appropriate traffic management while truck and boogie occupy the eastbound lane while travelling in a westerly direction.

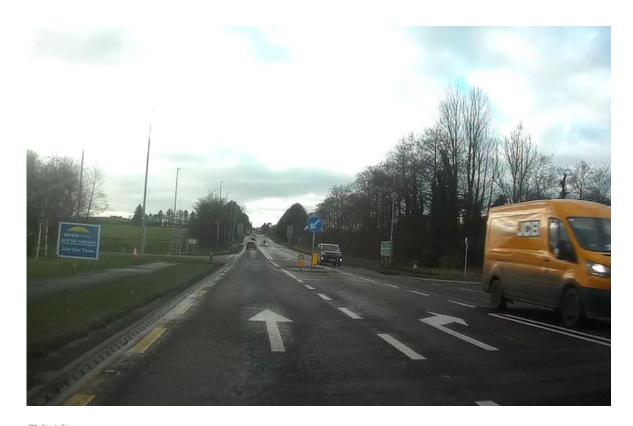
The westbound truck and boogie tyre path appears to occupy the eastbound lane on the approach to the N72 junction with the R672 and as the truck travels west through the Master McGrath traffic calming. This may lead to head-on collisions if appropriate temporary traffic management is not in place.

Install appropriate traffic management while truck and boogie occupy the eastbound lane while travelling in a westerly direction. The traffic management should encompass the exit from the R672. Westbound traffic should be prevented from undertaking the truck and boogie.

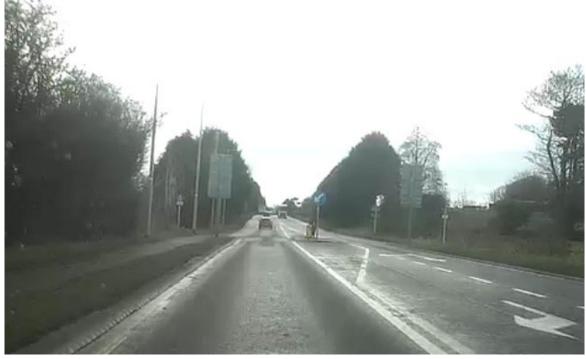
Traffic Calming, which has recently been installed at Carroll's Cross on the N25, does not appear to have been assessed in the drawings provided. This may have some impact on the swept path of the delivery truck and boogie.
