6.1 Arboricultural Impact Assessment Report

Summary table		
Site Name:	Galway BusConnects: Dublin Road	
Project Reference:	5402	
Site Address:	Dublin Road (R338), East of Moneenageisha to Doughiska Junction	
Nearest Postcode:	H91 YTR6	
Location:	Start of Route - Google maps link End of Route - Google maps link	
Local Authority:	Galway City Council	
Statutory Controls:	Tree Preservation Order	Conservation Area
	None advised - To be further checked	N/a
Soil Type: (Source: Geological Survey Ireland - © 2023)	Superficial/Drift	Bedrock
	None recorded	Burren Formation - Limestone. The formation is typified by pale-grey packstones and wackestones
Proposed Developmentdrawing:	Proposed General Arrangement Plan: <i>BCGDR-BTL-GEO_GA-XX-DR-CR-00001_00011_General_Arrangement</i>	
Notes:	N/a	
Report Author:	Richard Hyett <i>MSc, BSc (Hons), MICFor, MArborA</i>	
Date of Issue:	2nd December 2024

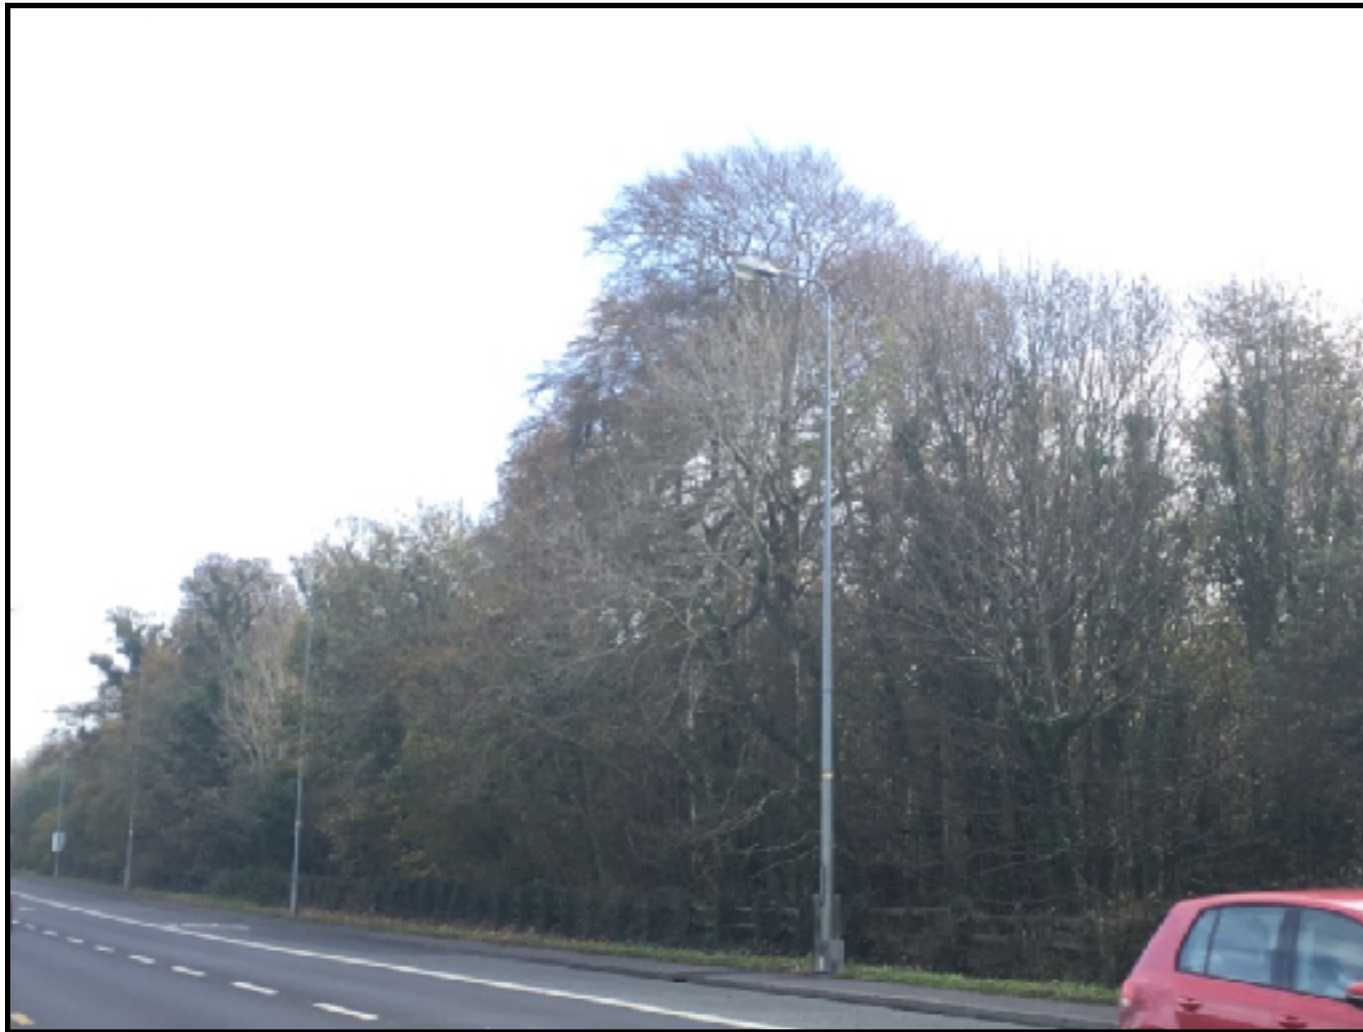
Photoview 2: (2018) Looking west from due south of the old quarry within in Section 1 (to the south of Merlin Hospital and between Doughiska Road and Coast Road). This demonstrates the typical linear groups of alders (with some silver birch and common ash) and their relationship to the Highway. Most of the larger trees have been assigned to Category B with some smaller trees assigned to Category C.

Collectively these trees are very prominent in the streetscene. Recommendations have been made to remove some trees in this area to address the impact of Phytophthora infection. The long-term approach to the management of the alders in light of the presence of this disease should be considered as part of the emerging proposals. It may be appropriate to adopt a longer term 'fell and replace' approach.

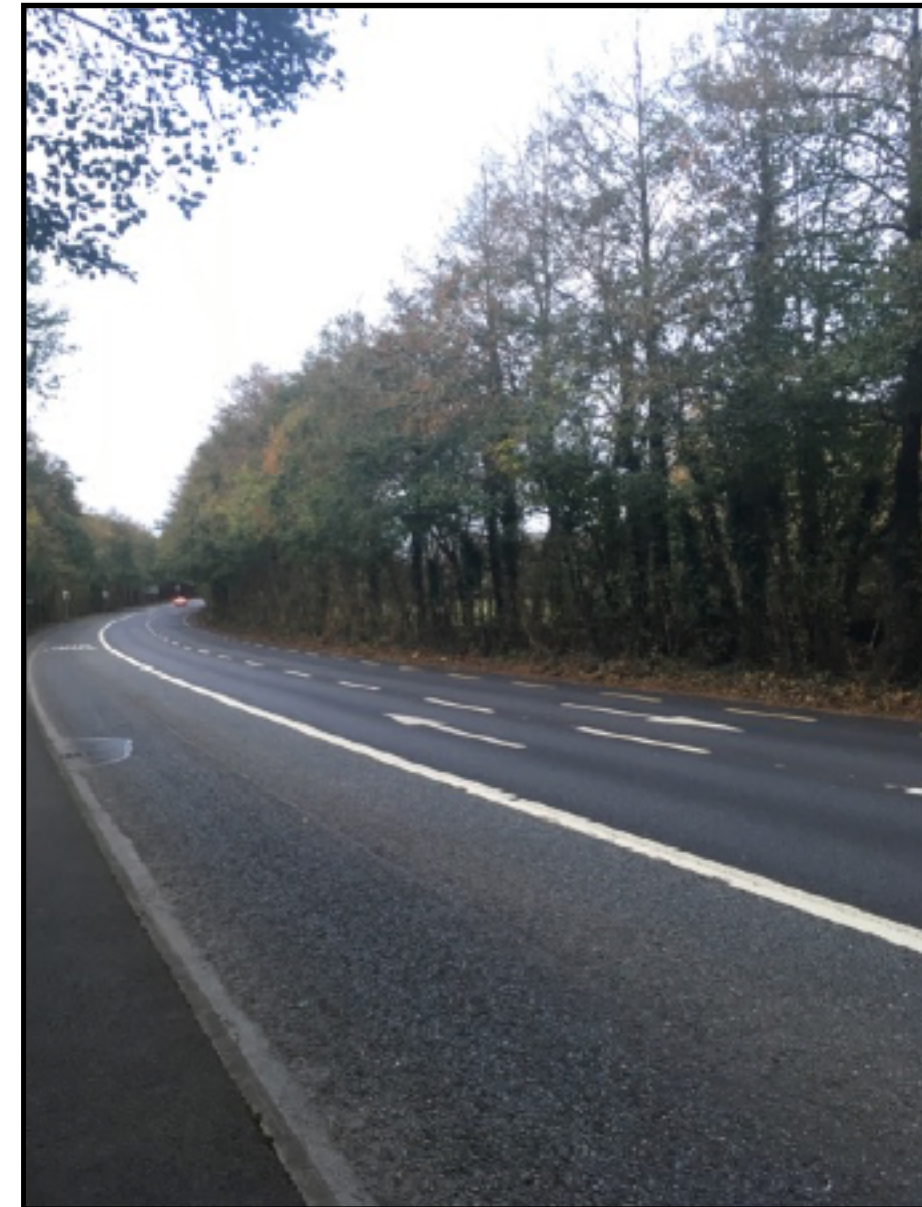
Photoview 3: looking south-east along the north side of Roscam woods where it borders the south side of the R338. The trees and tree groups within the area are overwhelmingly Category B (moderate quality).

Individual trees T1243 and T1241 - Common beech - are the large trees at centre frame. Both trees are Category U (unsuitable for retention) due to established decay caused by infections of Kretzschmaria deusta. A preliminary recommendation has been made to fell these trees on safety grounds.

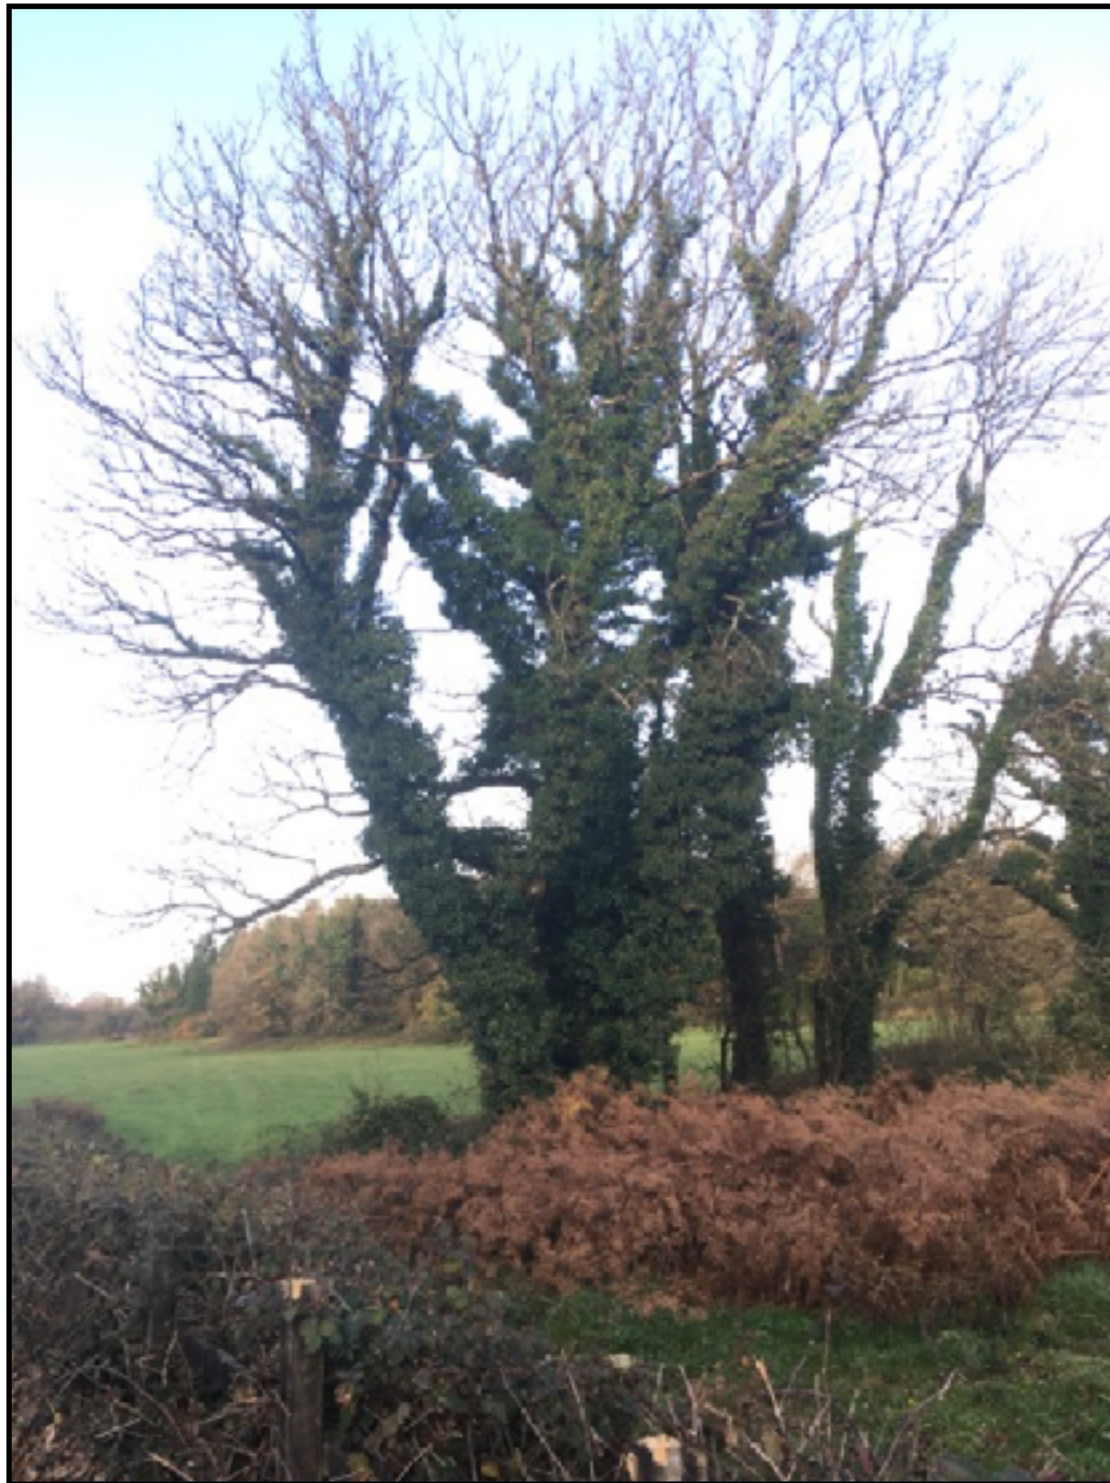
Photoview 4: looking north-west to T1456. T1457, T1458 (All now Category C and U). The edge of the woodland area within Merlin Hospital grounds can be seen in the background. These trees are prominent when viewed by users of the R338, however all trees are in an established state of decline. Given the condition of these trees they should not be seen as a significant constraint to the scheme.

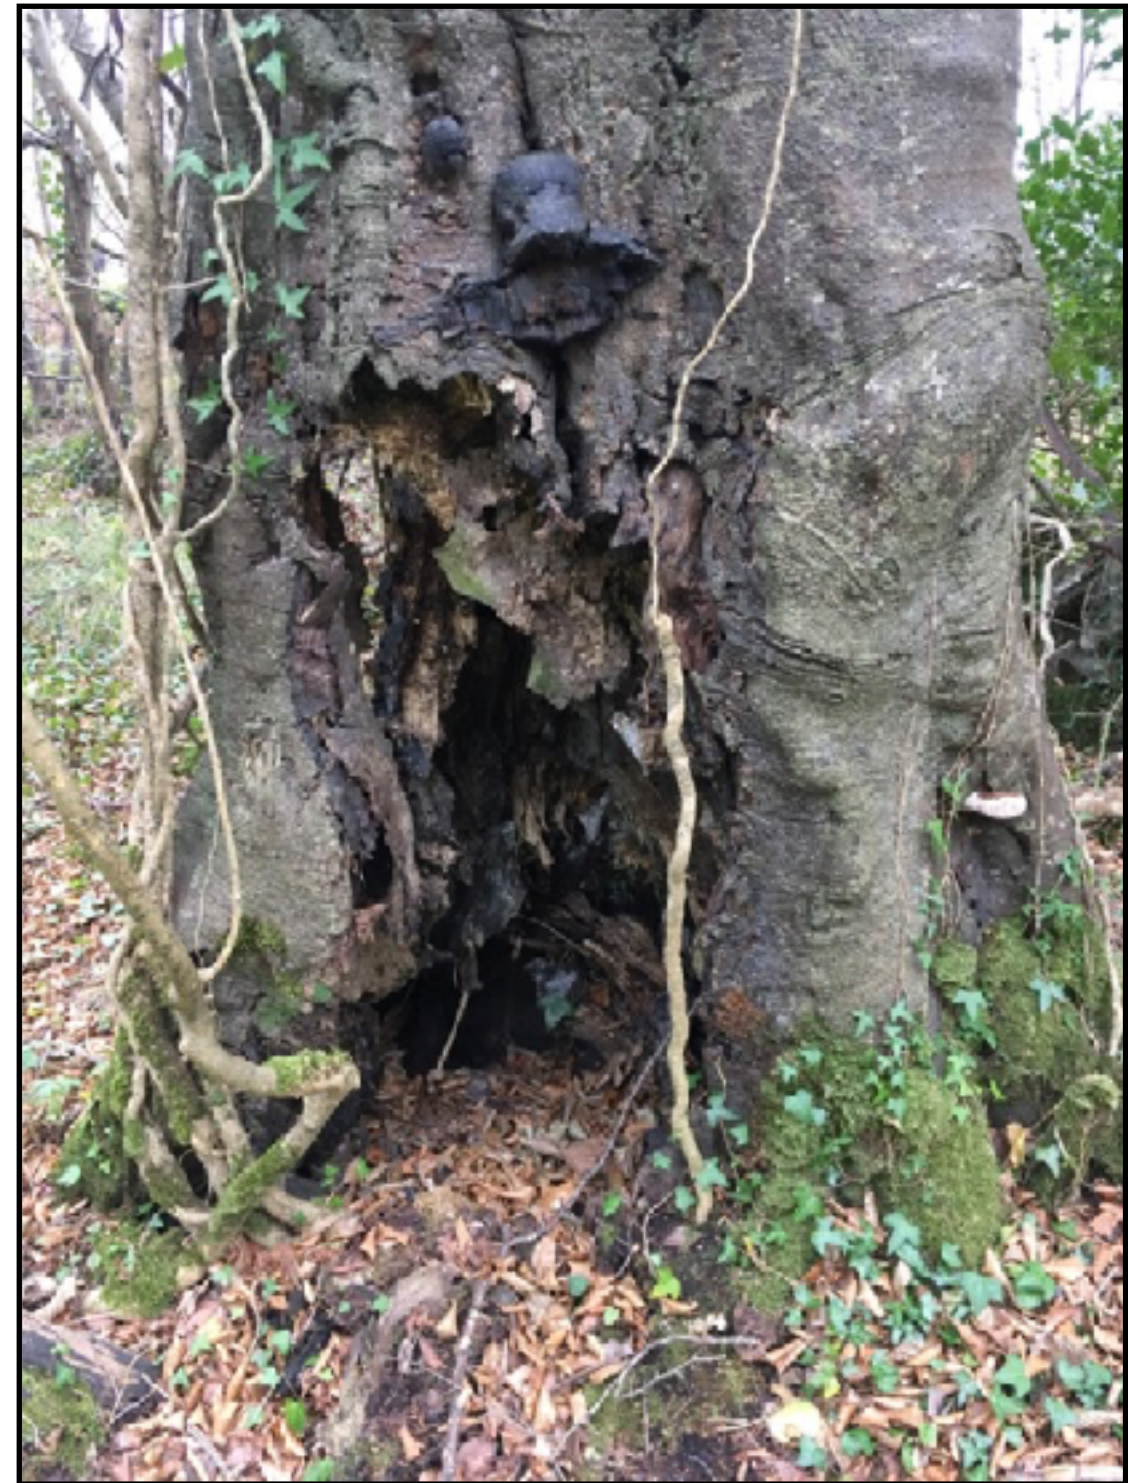
Photoview 5: The significant basal decay of T1669 (Category C) located in the woodland area of the Merlin Hospital grounds to the north-west of Galway Crystal. The tree is remote from the current Highway alignment and despite being a large tree of potential ecological value it may not pose a constraint to the proposal in terms of tree quality or RPA. However, the potential for this tree to pose an unacceptable risk to the highway improvements (e.g. new cycle lanes or footways) needs to be considered.

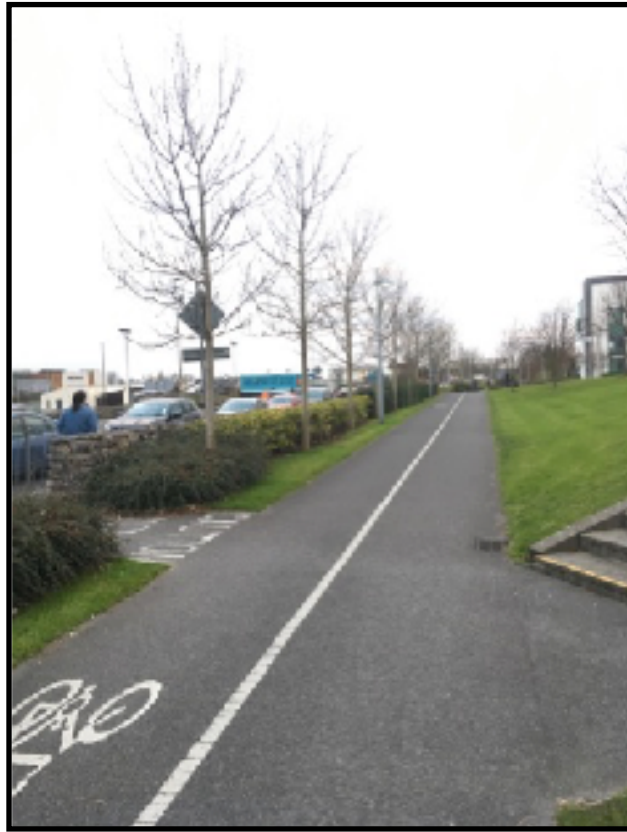
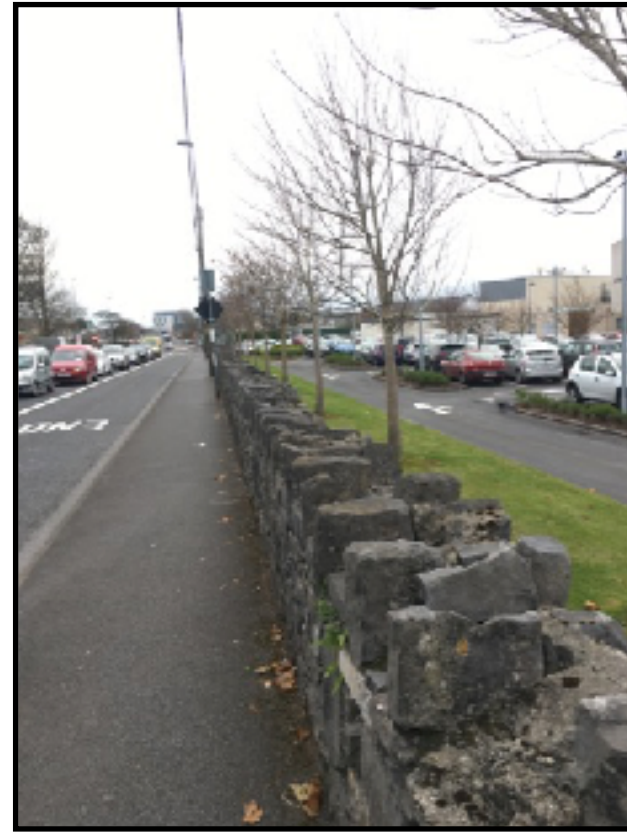
Photoview 6 and 7: looking west along the ATU boundary with the R338 and existing cycleway and west along the Bon Secours boundary. Both images show the relatively recent institutional planting. Most of the trees on the ATU Frontage are in an acceptable condition but others are succumbing to Ash Die Back disease (ADB). Over time it is likely that all of these ash trees (T1710 to T1742) will succumb to ADB. .

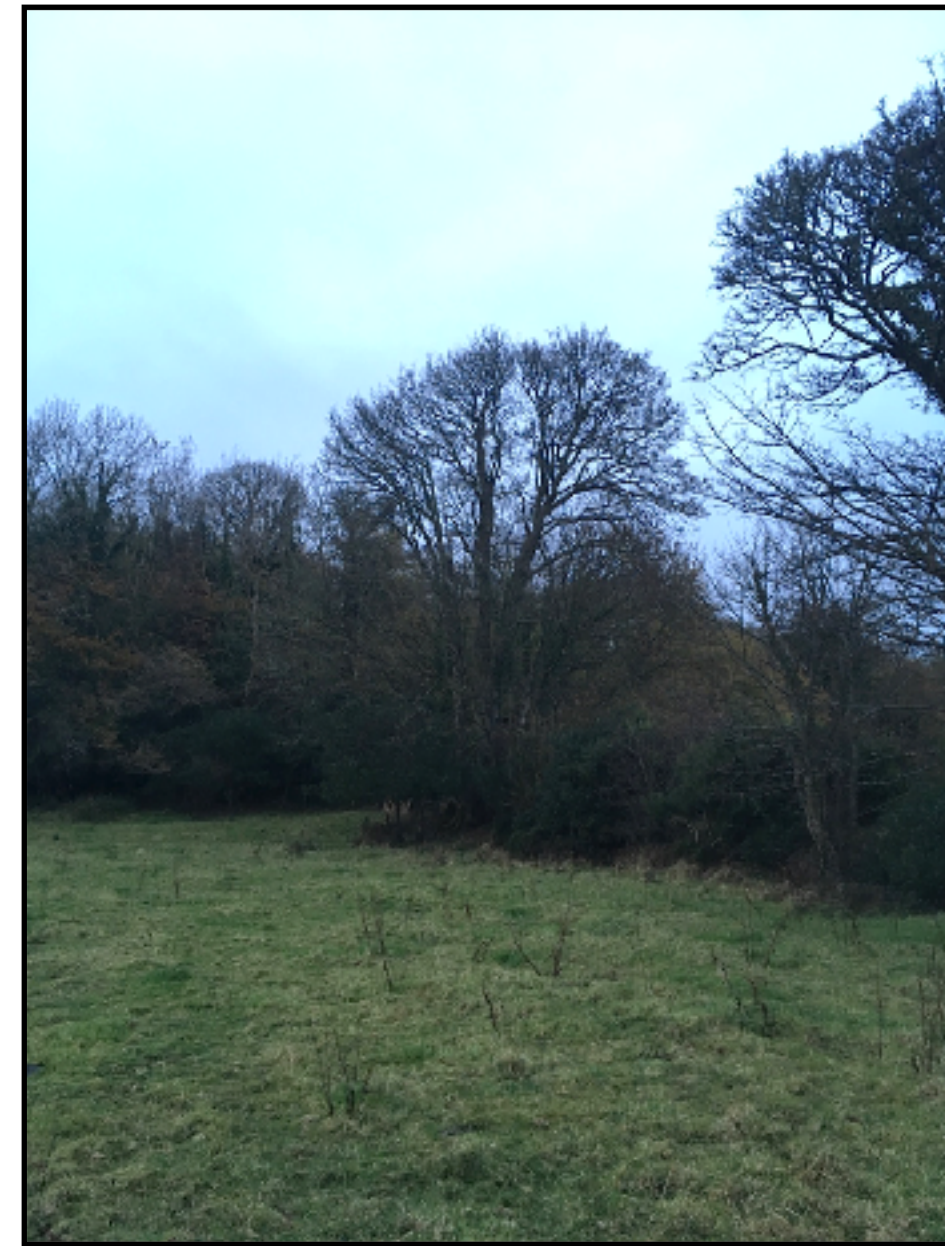
Photoview 8: Looking north towards T2050 (Category A). The tree is located close to the woodland edge in Merlin Hospital grounds and is good specimen tree. Whilst its presence requires appropriate consideration in the Proposed Development it is likely to be remote from the proposed works.
