**Stage 1  
Road Safety Audit**

**Neo Environmental Limited**

**Drybridge Solar Farm  
and BESS**

**SUBMISSION ISSUE**

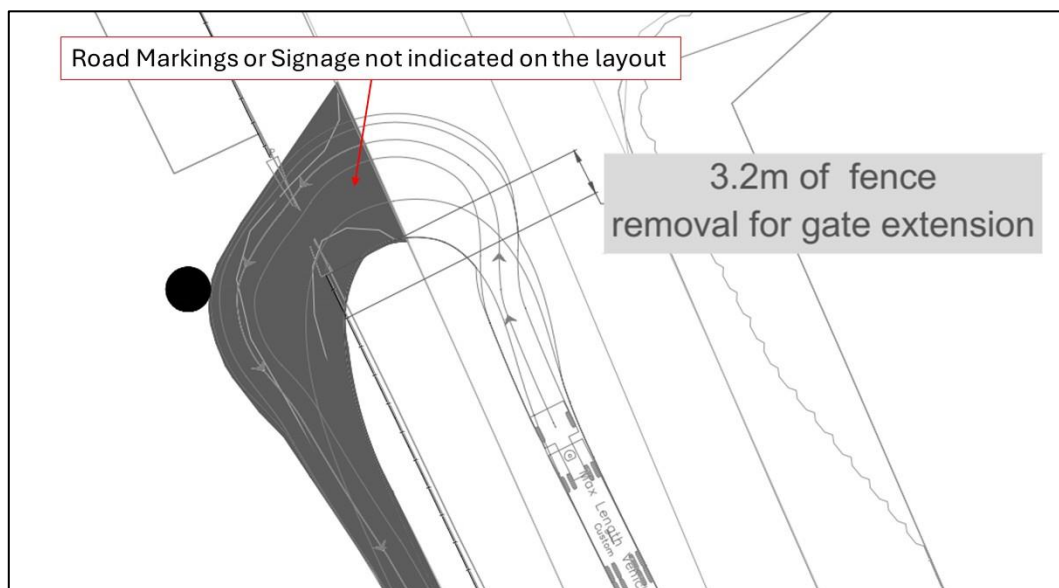
#### 3.1 Lack of Permanent Access Arrangements

The proposed junction layouts for the permanent access arrangements, at both Site Access 1 and Site Access 2 have not been submitted. The drawing provided does not include the full access design details typically associated with a standard Roads Layout drawing, including road markings, signage, and other permanent traffic control measures.

In the absence of appropriate road signage and markings, there is potential for driver uncertainty in relation to permitted access and egress manoeuvres, which could result in vehicle conflict and collision.

**No Road Markings or Signage Provided**  
(Drawing No. NEO01191\_054I\_A Figure 5.2)

Detailed permanent access junction layouts (at both Site Access 1 and Site Access 2) should be provided for the operational stage of the development, when maintenance personnel will require regular access to the site.

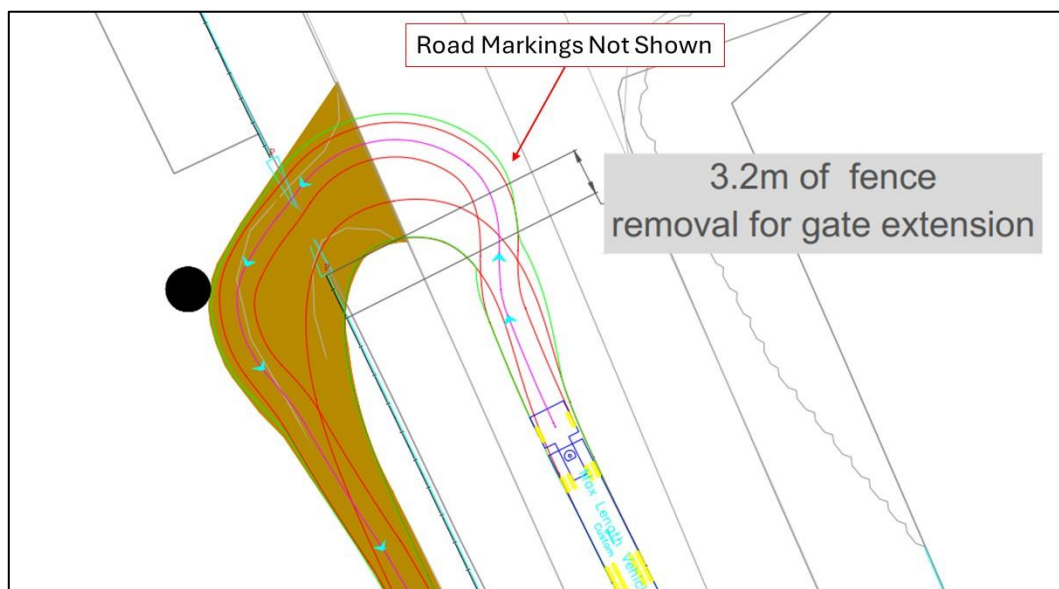
### 3.3 Autotracking at Site Access 1

It is proposed that HGVs will enter Site Access 1 via a left-turn manoeuvre. To facilitate this movement, approximately 3.2m of existing boundary fencing will be removed.

However, HGVs are subsequently required to undertake a 180-degree turning manoeuvre within the site using the internal road layout. Autotrack analysis indicates that, in order to complete this manoeuvre, an HGV may need to overrun lane markings, encroach onto the hatched area, or potentially track into the opposing southbound traffic lane. This interaction could give rise to a risk of vehicle conflict and potential collision.

***Autotracking of Site 1 (Drawing No. NEO01191\_054I\_A Figure 5.2)***

The access should be designed to ensure that all HGV movements can be accommodated without overrunning lane markings or encroaching into opposing traffic lanes.

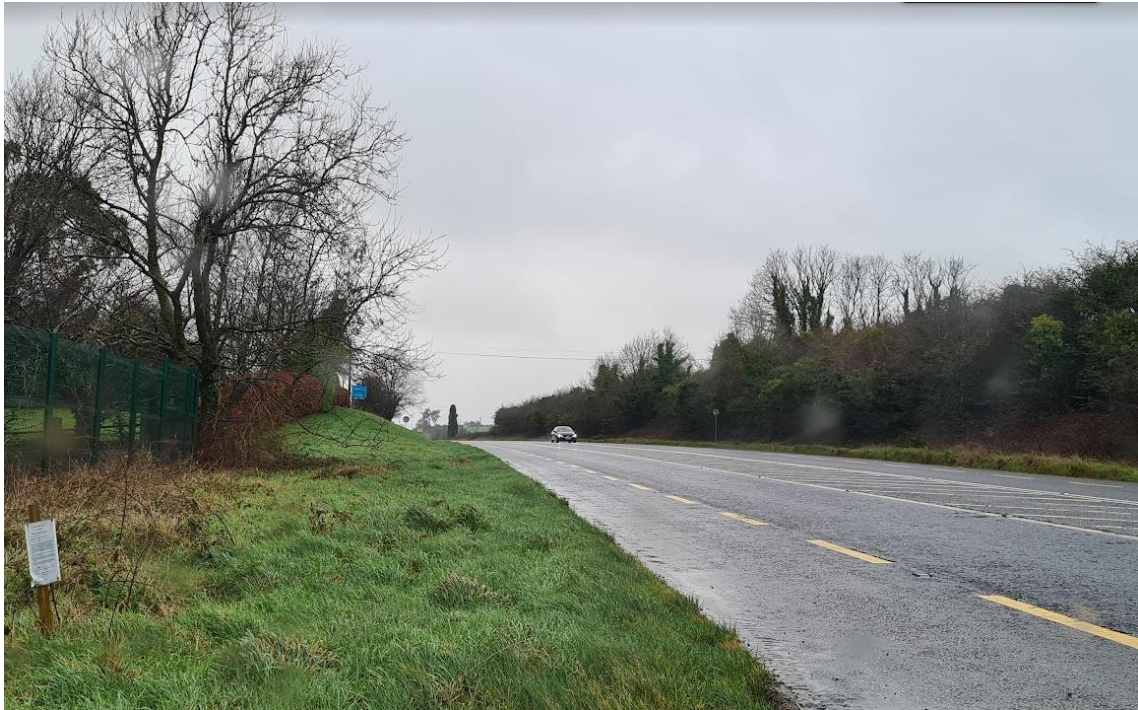
### 3.4 Exit Visibility at Site Access 1

Exit visibility to the left may be obscured by the existing earth bund. Although it is noted in the CTMP that *“on exit from Site Access 1, vehicles will turn left and travel in a northern direction onto the M1 at Junction 11”*, exit visibility to the left should be provided, particularly given that service and maintenance vehicles will use this access during the operational phase. A reduced exit visibility could result in a vehicle turning from a side road, onto the major road carriageway when it is unsafe to do so, resulting in a collision.

***Exit Visibility to the Left at Site Access 1***

Exit visibility to the left should be reviewed and verified to ensure that adequate sightlines are achieved in accordance with the relevant design standards for a 100km/hr design speed.

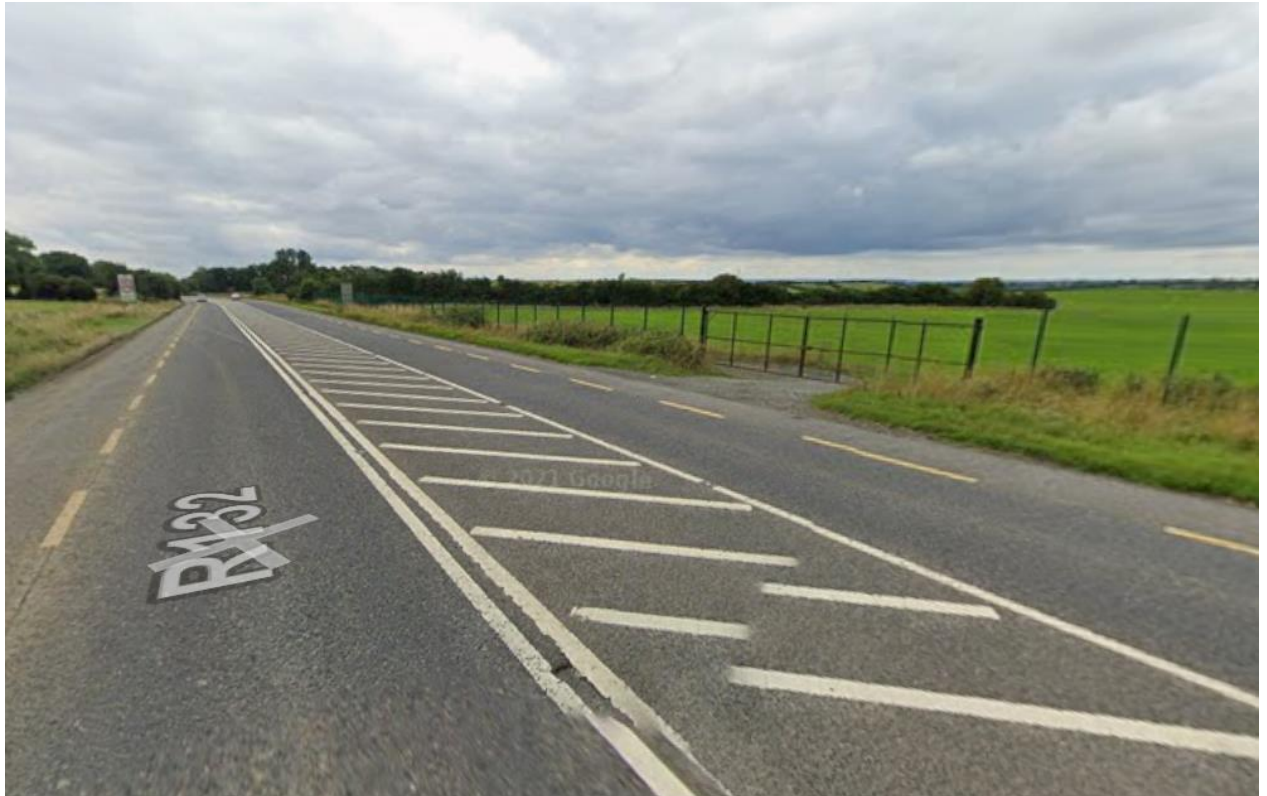
### 3.5 Banning Right Turn Movements at Site Access 1

It is proposed that HGVs will egress from Site Access 1 via a left-turn manoeuvre only. However, no details have been provided to demonstrate how the prohibition of right-turn movements will be effectively enforced. Given the presence of an extensive solid hatched median along much of the R132, motorists would not reasonably anticipate right-turning movements emerging from a side road, with the risk of a collision.

***Existing R132 Road Carriageway including a Solid Hatched Median (Google Image)***

Measures to prohibit HGVs from undertaking right-turn movements upon exit from the site should be clearly set out and detailed.

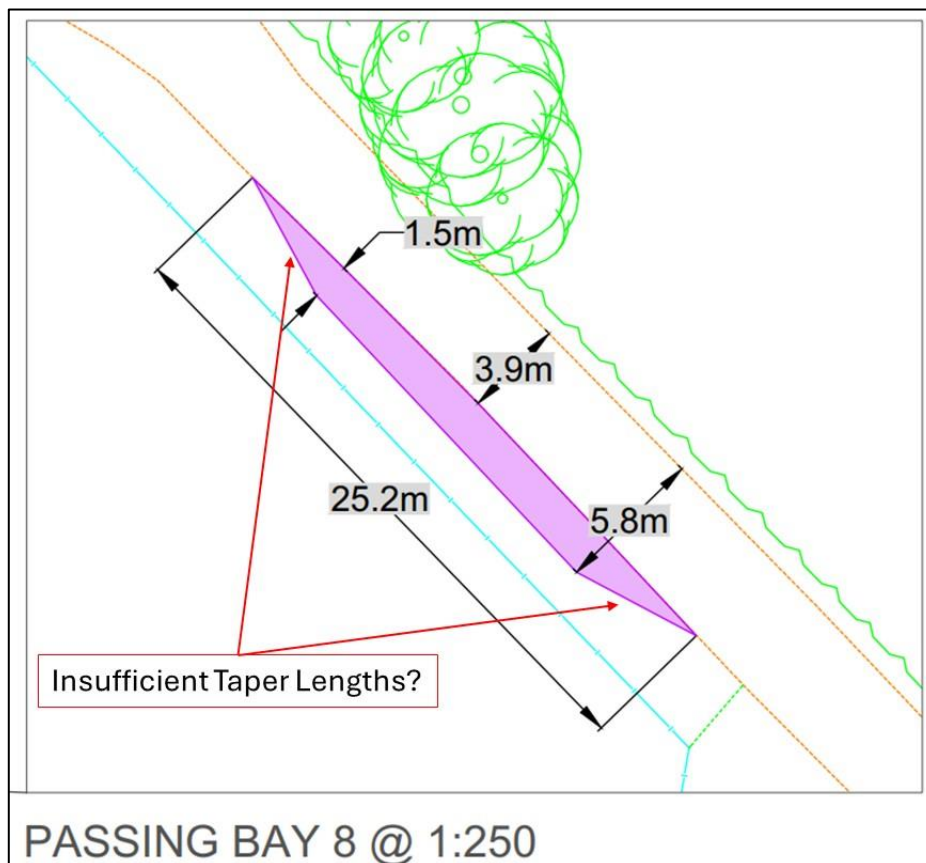
### 3.6 Passing Bays

The proposed entry and exit transitional taper lengths to the passing bay appear to be insufficient. Inadequate taper provision may result in abrupt lateral vehicle movements when entering and exiting the passing bay, leading to sharp weaving manoeuvres. This could increase the likelihood of vehicles encroaching into the opposing carriageway, particularly on exit from the passing bay, thereby resulting in a side-swipe or head-on collision.

**Passing Bay Taper Lengths (Drawing No. NEO01191\_071I\_B Figure 5.6)**

Appropriate Taper Lengths should be provided at the Passing Bays.

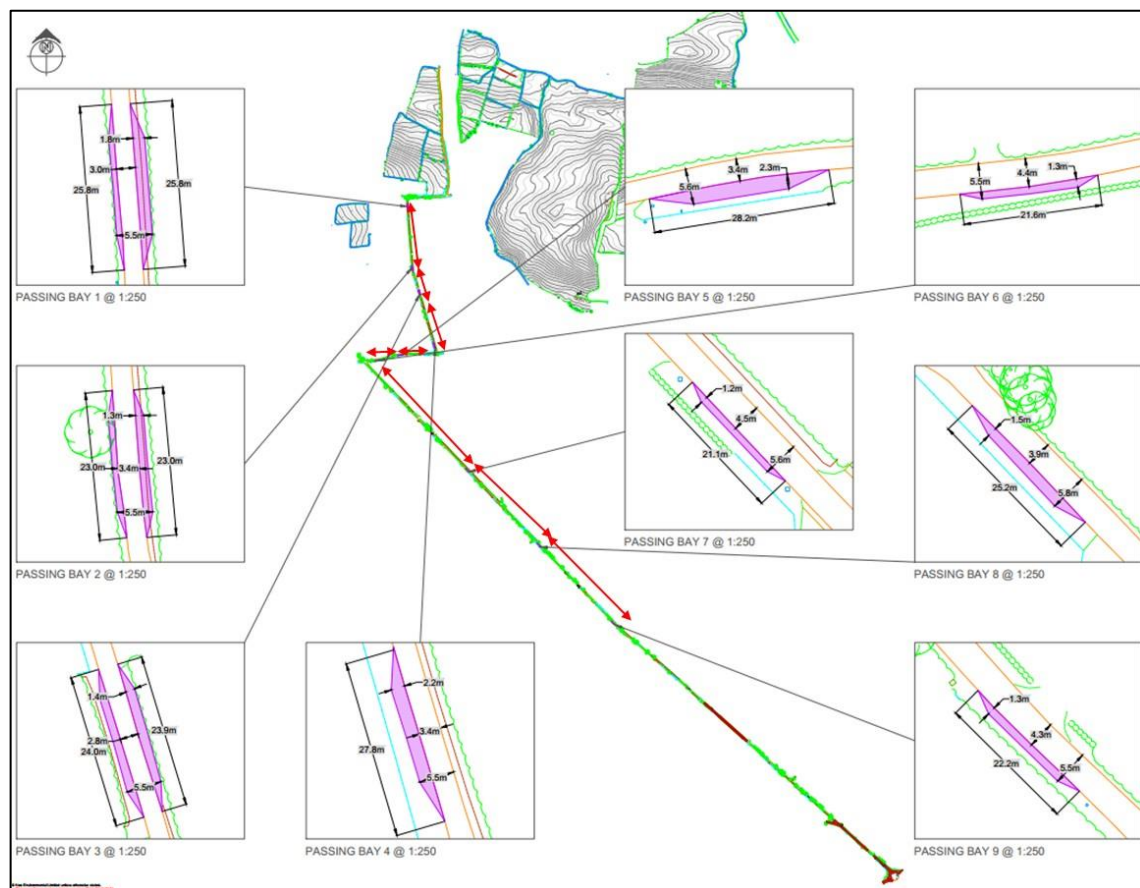
### 3.7 Passing Bay Locations

The location of passing bays should be arranged so that at least one passing bay is visible from any point along the road, and that adjacent passing bays are inter-visible. Where passing bays are not appropriately located to achieve this level of visibility, there is a risk during the construction phase that two large HGVs may meet without adequate manoeuvring space, potentially resulting in collision or vehicles being forced into the adjoining verge or drainage ditch.

Furthermore, appropriately located passing bays are necessary to ensure that, during the construction phase, HGVs do not use private accesses to facilitate passing manoeuvres.

**Passing Bay Locations**

An assessment should be undertaken of the proposed passing bay locations to ensure that, where the carriageway width narrows to less than 5.3 m, at least one passing bay is visible from any point along the route. In addition, areas not intended for passing, such as private accesses and grassed verges, should be clearly delineated with hazard marker posts, subject to agreement with the relevant landowners.

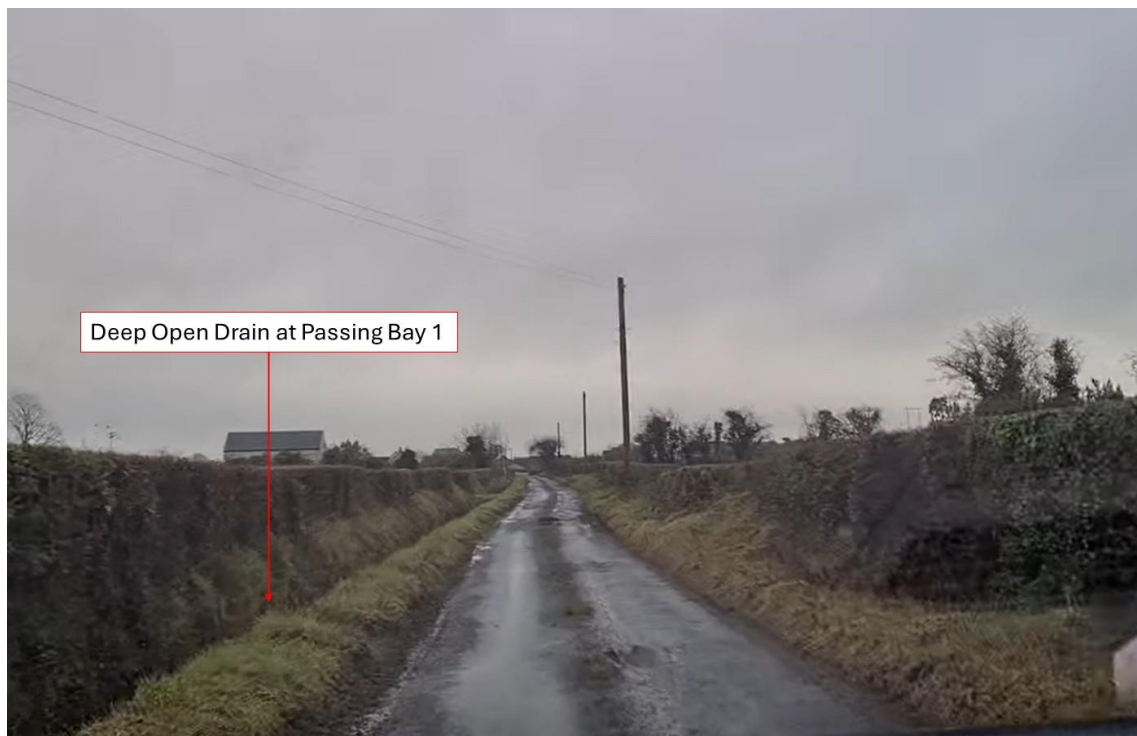
### 3.8 Passing Bays at Open Drains

The CTMP acknowledges that certain passing bays will require the piping of roadside ditches to facilitate their construction, with detailed culvert design to be developed post-consent. However, these works are not illustrated on the submitted scheme drawings. In the absence of defined design details, there is a risk that the proposed culverts may be inadequately sized or insufficiently designed, which could result in edge instability and increase the potential for a vehicle to leave the carriageway and enter the ditch, leading to a single-vehicle collision.

***Existing Open Drain and Ditch at Passing Bay Location 1***

The proposed culvert design should be such that new hazards are not provided for road users.

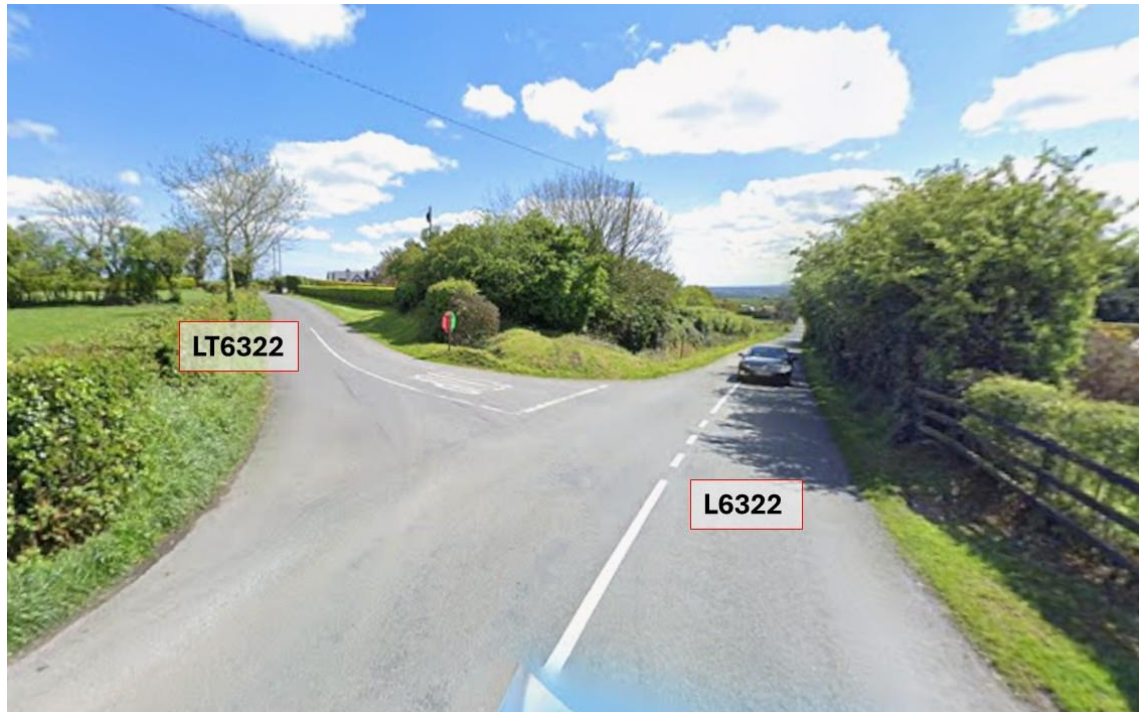
### 3.9 L6322 / LT6322 Priority Junction

There is a very sharp turn at the junction of the L6322 and LT6322, with a slight skew in the angle at which it meets the L6322 mainline. The tracking drawings show a 16.5m articulated vehicle accessing the development. It is not clear if such a vehicle would be able to turn into and from this junction without significantly overrunning the opposing lane or into the verge, which could result in a collision.

***L6322 / LT6322 Priority Junction (Google Image)***

Swept path analysis should be undertaken for this junction to demonstrate that the proposed 16.5m articulated vehicles can safely negotiate the turn without encroachment into verges.

Should the analysis identify that the manoeuvre cannot be accommodated safely within the existing geometry, smaller delivery vehicles or implementing appropriate traffic management measures during delivery times may be required.

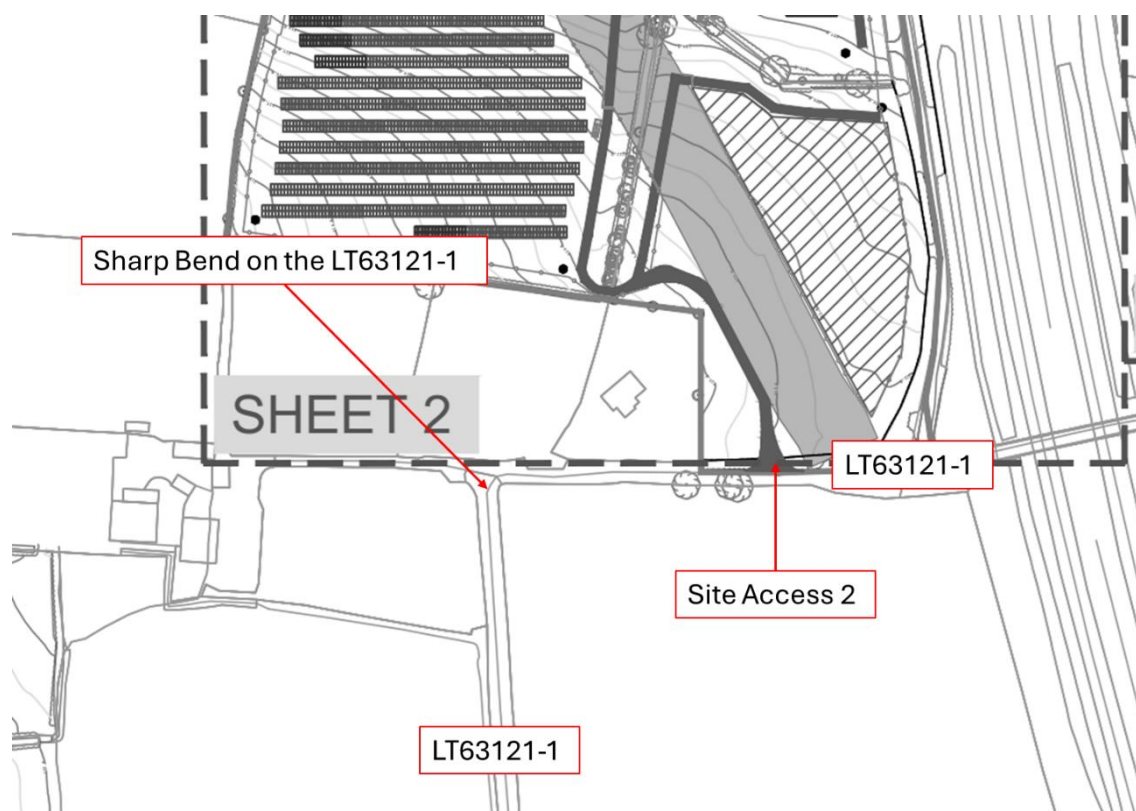
### 3.10 LT63121-1 Road Alignment

There is a very sharp turn on the LT63121-1 Road Alignment, close to Site Access. The tracking drawings show a 16.5m articulated vehicle accessing the development. It is not clear if such a vehicle would be able to turn through this tight turn without significantly overrunning the opposing lane or into the verge, which could result in a collision.

***Sharp turn on the LT63121-1 Road Alignment  
(Drawing No: NEO01191\_071I\_B Figure 5.6)***

Swept path analysis should be undertaken at this location to demonstrate that the proposed 16.5m articulated vehicle can safely negotiate the turn without encroachment into the verges.

Should the analysis identify that the manoeuvre cannot be accommodated safely within the existing geometry, smaller delivery vehicles or implementing appropriate traffic management measures during delivery times may be required.

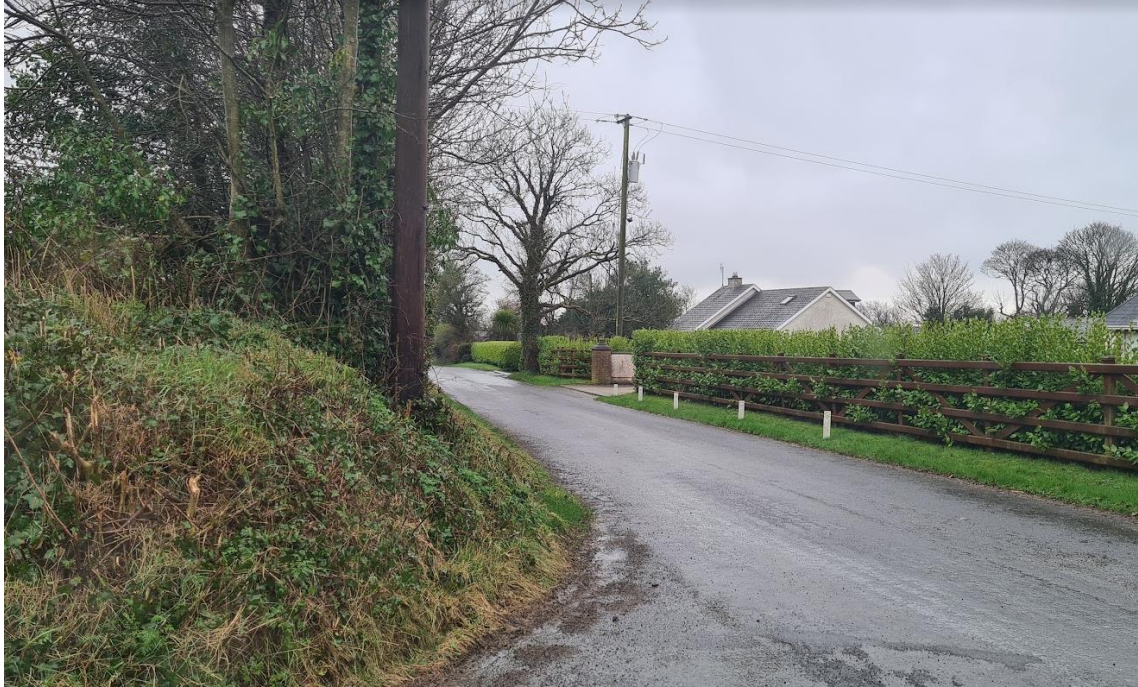
### 3.11 LT6322 / LT63121-1 Priority Junction

Exit visibility to the left may be obscured by the existing hedge. A reduced exit visibility could result in a vehicle turning from a side road, onto the major road carriageway when it is unsafe to do so, resulting in a collision.

***Exit Visibility to the Left at LT6322 / LT63121-1 Priority Junction***

Exit visibility to the left should be reviewed and verified to ensure that adequate sightlines are achieved in accordance with the relevant design standards.

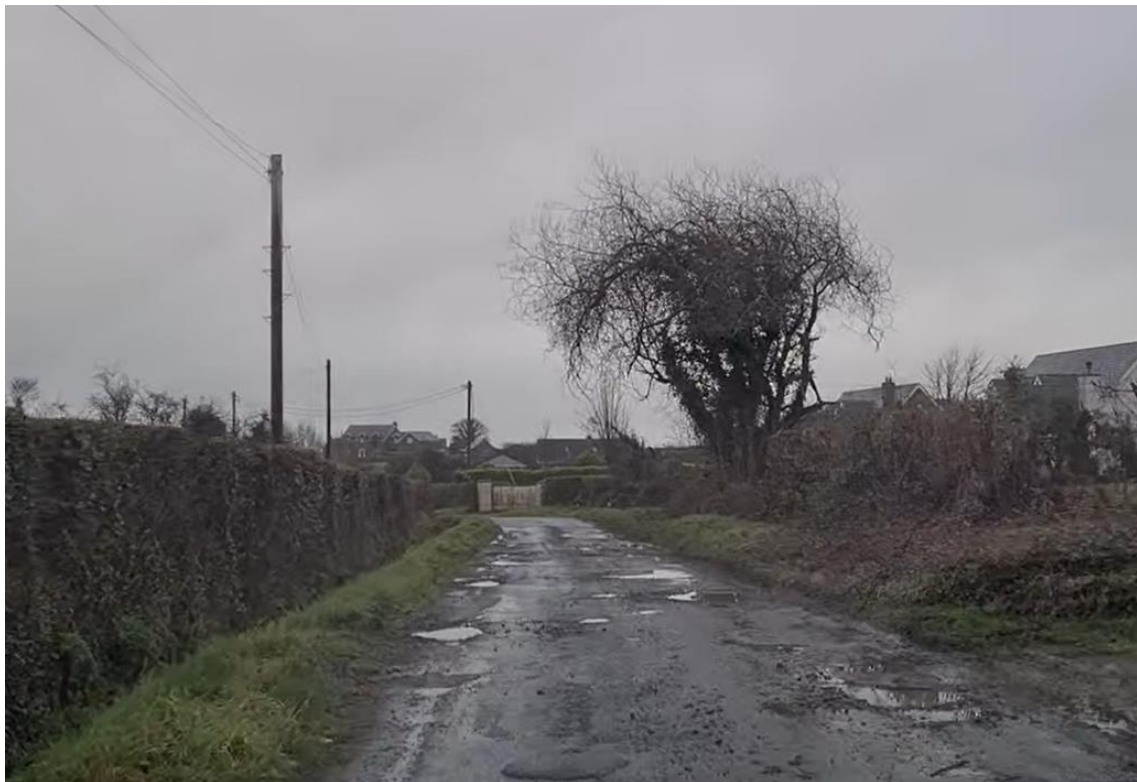
### 3.12 Condition of the LT63121-1 Road Surface

It is acknowledged in the CTMP that the Applicant will undertake pre- and post-construction condition surveys of the R132 and LT63121-1. However, the existing surface condition of the LT63121-1 is poor, with a number of significant potholes present. The passage of large HGVs during the construction phase is likely to exacerbate this existing deterioration. Accordingly, any reinstatement works should address not only construction-related damage but also ensure that the existing carriageway defects are appropriately repaired.

***Existing LT63121-1 Road Surface***
