Proposed Residential  
Development at Dyke Road,  
Co. Galway

Stage 1 Road Safety Audit

Document Ref:	P24-092-PMCE-XX-XX-RP-SA-3_0001
---------------	---------------------------------

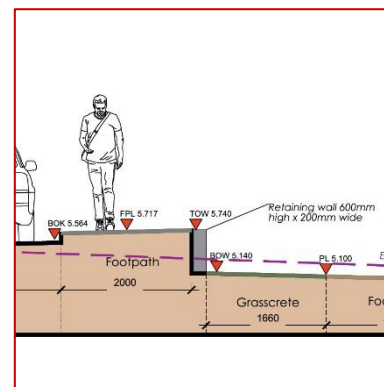
### 3.1 Lack of Edge Protection

*Summary:* No edge protection has been indicated along the retaining wall where there is a drop in height to its rear.

A low retaining wall has been indicated to the rear of the footpath on the eastern side of Dyke Road for a short distance extending southwards from the proposed development's northern access. The top of the retaining wall is indicated as being level with the adjacent footpath, however a vertical drop of 600mm has been indicated between the footpath and the Grasscrete material within the development (see Section A-AA on Drawing No. 1911\_PL\_S\_01 (Rev. 0)), and no edge protection has been indicated at this location.

This may lead to pedestrians, particularly the visually-impaired, inadvertently straying from the footpath and falling to the rear of the wall resulting in a risk of personal injuries.

Edge protection should be provided along the top of the retaining wall at this location throughout the extent of the exposed level difference.

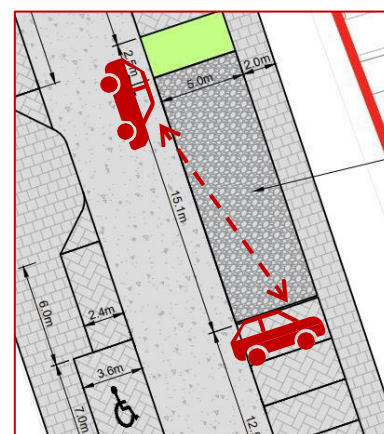
### 3.2 Visibility for Reversing Drivers

*Summary:* The proposed WWPS may be located such that it could obstruct the visibility of a driver exiting the adjacent parking space.

A WWPS has been indicated on the southern side of the development's southern access road, located within the row of perpendicular parking spaces on this side of the access road. The layout of the WWPS is unclear however it is assumed that a building, or fenced, area would be provided at this location.

The location of the WWPS may be such that it may obstruct visibility for a driver exiting the adjacent parking space, at its western boundary, particularly when reversing. This may lead to drivers entering the access road ahead of oncoming vehicles, resulting in potential low-speed side-on collisions.

An assessment should be undertaken to confirm that a driver exiting the adjacent parking space, particularly when reversing, would have sufficient visibility towards a driver approaching from the east.

Where sufficient visibility cannot be achieved measures should be provided, such as providing a grassed buffer area on the western side of the WWPS, similar to that provided on its eastern side, to maximise visibility.

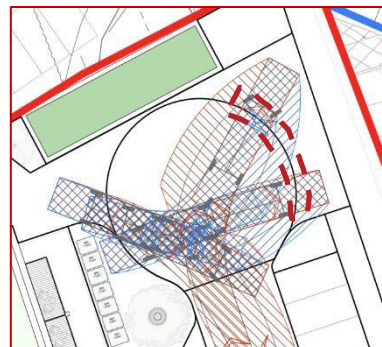
### 3.3 Swept Path of Large Vehicles

**Summary:** The swept paths of various large vehicles are indicated as colliding with a row of bollards at the turning circle.

The swept path of large vehicles, including a fire tender, medium refuse vehicle, large refuse vehicle and removal van, performing a U-turn manoeuvre at the turning circle at the eastern end of the proposed development's southern access road have been provided to the Audit Team. The swept paths of these vehicles undertaking this manoeuvre indicate that they would overrun the edge of the turning circle carriageway and collide with the row of bollards indicated on its southern side which may result in material damage collisions.

The row of bollards should be removed, and alternative measures provided to restrict unauthorised parking at this location.

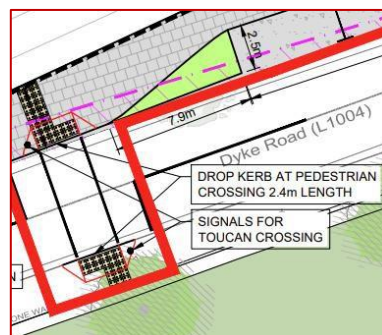
### 3.4 Width of Toucan Crossing

**Summary:** The width of the proposed Toucan crossing may be insufficient to cater for the volume of pedestrians and cyclists that may utilise it.

A new Toucan crossing has been indicated on Dyke Road immediately south of the proposed development's northern access. The crossing is indicated as being 2.4m wide which may not be sufficient to cater for the volume of pedestrians and cyclists that may utilise the crossing simultaneously. Should the crossing provided not be of a sufficient width to accommodate both pedestrians and cyclists, there is an increased risk of pedestrian-cyclist collisions when waiting at, and using, the crossing.

The width of the Toucan crossing should be a minimum of 4m in accordance with Section 4.3.2 of DMURS.

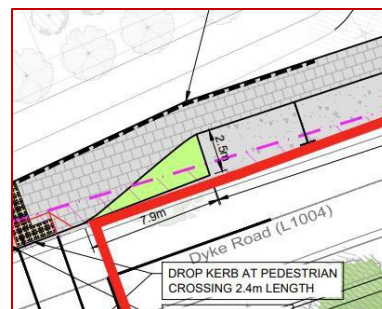
### 3.5 Lack of Taper at Parallel Parking Space

**Summary:** Drivers may experience difficulties entering/exiting the parallel parking spaces on Dyke Road due to the absence of a taper.

A row of parallel parking spaces has been indicated on the eastern side of Dyke Road. No taper in the adjacent kerb line has been indicated at the northern and southernmost parking spaces and this may lead to drivers experiencing difficulties entering these parking spaces, resulting in a risk of kerb strikes and material damage collisions.

The kerb line adjacent to these parking spaces should be amended to provide appropriate entry and exit tapers.

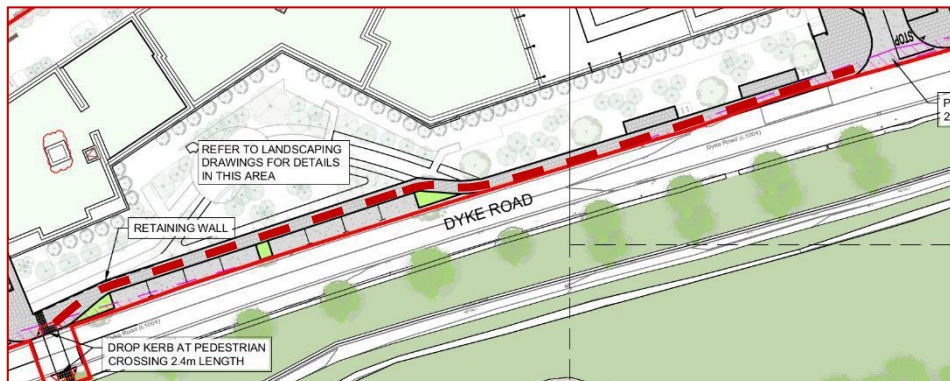
### 3.6 Width of Shared Path

**Summary:** The proposed footpath may not be of a sufficient width to accommodate both pedestrians and cyclists.

There are a number of visitor/short-stay bicycle stands indicated within the footpath on the eastern side of Dyke Road adjacent to the southern access to the proposed development. It is, therefore, likely that the footpath between the proposed Toucan crossing, further north, and the proposed southern development access would be utilised by both pedestrians and cyclists traveling to/from these bicycle stands.

The footpath at this location, however, is indicated as 2m wide, which would not be wide enough to accommodate both pedestrians and cyclists. This may result in an increased risk of conflicts between pedestrians and cyclists within this section of footpath.

The footpath between the Toucan crossing and the proposed southern development access should be sufficiently widened to accommodate both pedestrians and cyclists.

In addition, hazard tactile paving should be provided across the width of the footpath where it would transition to a shared surface, used by cyclists also.

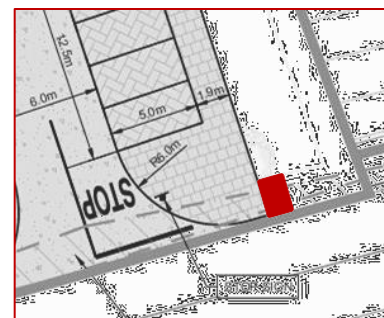
### 3.7 Absence of Hazard Warning Tactile Paving

**Summary:** The absence of hazard warning tactile paving where the footpath would transition to a shared surface may lead to visually-impaired pedestrians being insufficiently aware that they are entering a space shared with both motorised vehicles and cyclists.

The access roads within the proposed development have been indicated as shared areas which would be shared by motorised vehicles, cyclists and pedestrians. No warning tactile paving, however, has been indicated where the existing footpath on the eastern side of Dyke Road, to the south of the development's southern access, would meet the shared surface. This may lead to visually-impaired pedestrians, approaching from the south, being insufficiently aware that they are entering an area shared with both motorised vehicles and cyclists where they would be at an increased risk of being struck by either of these road users.

Hazard warning tactile paving should be provided across the width of the footpath where the shared surface transitions to the footpath on the eastern side of Dyke Road.

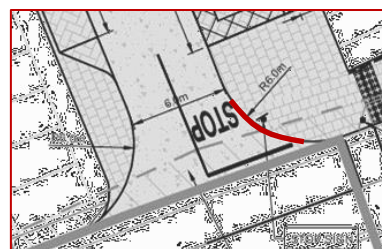
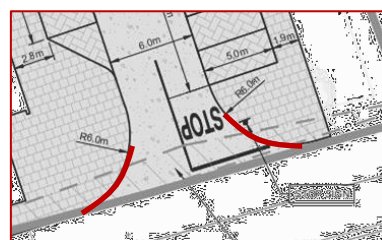
### 3.8 Absence of Pedestrian Crossings

**Summary:** The absence of pedestrian crossings across the proposed development's accesses may result in visually and mobility-impaired pedestrians experiencing difficulties.

A footpath has been indicated on Dyke Road along the western boundary of the proposed development. This would create a desire line along the eastern side of Dyke Road extending southwards from the development's northern access. A pedestrian crossing of either of the development's accesses, including dropped kerbs and tactile paving, has, however, not been indicated.

This may lead to difficulties for the visually and mobility-impaired, particularly wheelchair users, in independently navigating the access when travelling northbound or southbound on the footpath, as they would be required to ascend/descend full height kerbs when crossing the accesses.

A pedestrian crossing, including dropped kerbs and tactile paving, should be provided across the northern and southern accesses to the proposed development.

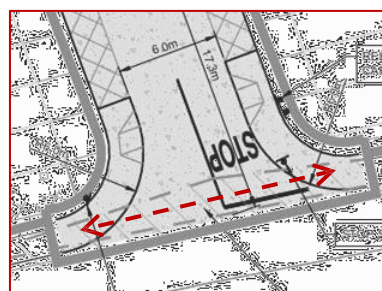
### 3.9 Pedestrian Crossing Outside of Desire Line

**Summary:** The provision of a pedestrian crossing outside of the pedestrian desire line may lead to pedestrians crossing the road where drivers may not anticipate them to do so, and where they may be required to ascend/descend full height kerbs.

An uncontrolled pedestrian crossing appears to be indicated at the proposed new entrance to the Dyke Road Car Park, however this is indicated inset into the access and, therefore, away from the likely pedestrian desire line. Pedestrians, including the mobility-impaired, may choose to cross the access closer to the Dyke Road carriageway, along the likely desire line, where drivers may not anticipate them to do so resulting in a risk of vehicle/pedestrian collisions.

In addition, should pedestrians cross the access on the likely pedestrian desire line, they would be required to ascend/descend full height kerbs resulting in a risk of trips and falls and personal injuries.

The pedestrian crossing at the access to the Dyke Road Car Park should be relocated closer to the pedestrian desire line.

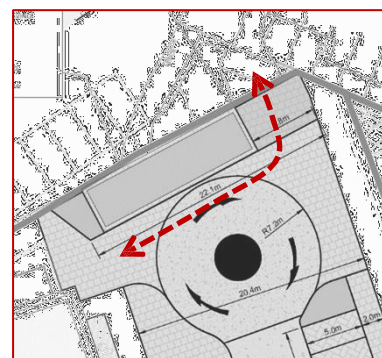
### 3.11 Route for Visually-Impaired Pedestrians

**Summary:** *Visually-impaired pedestrians may experience difficulties travelling across the turning circle at the development's southern access road, resulting in them inadvertently entering the area shared with motorised vehicles.*

Shared surfaces for all road users are indicated as being provided within the access roads at both the northern and southern accesses to the proposed development. It is, therefore, assumed that the carriageway and adjacent footpaths within the shared surface at the development's access roads would be at the same level.

In order to travel between the future link at the southeastern corner of the proposed development and the apartment blocks within the development, pedestrians would be required to travel through the carriageway of the turning head at the development's southern access road. Measures have not been indicated, however, to advise visually-impaired pedestrians that they would be entering an area shared with motorised vehicles when taking this route. This may lead to them unknowingly entering the area shared with motorised vehicles where they are at risk of being struck by a vehicle.

The footpath area within the shared surface between the turning head carriageway and the adjacent ESB substations should be widened and measures, such as warning tactile paving, provided to delineate the different surfaces and guide visually-impaired pedestrians along this route

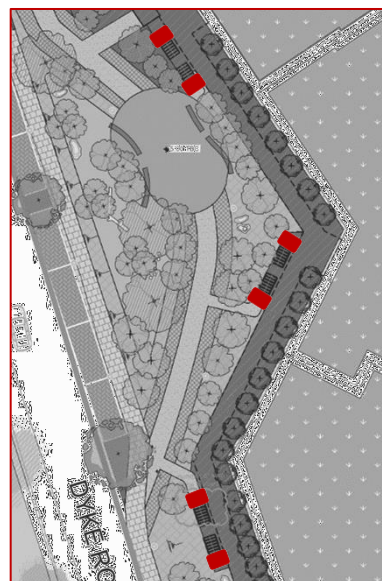
### 3.12 Absence of Hazard Warning Tactile Paving

**Summary:** *The absence of hazard warning tactile paving at the top and bottom of steps within the proposed development may result in personal injuries.*

A number of steps have been indicated within the proposed development. However, hazard warning tactile paving has not been indicated at the top and bottom of the steps adjacent to the Building Core Entrances within the development. This could lead to visually-impaired pedestrians being insufficiently aware of the vertical hazard when approaching the steps, resulting in possible trips and falls.

Hazard warning tactile paving (corduroy) of a sufficient depth should be provided at the top and bottom of all steps within the proposed development.

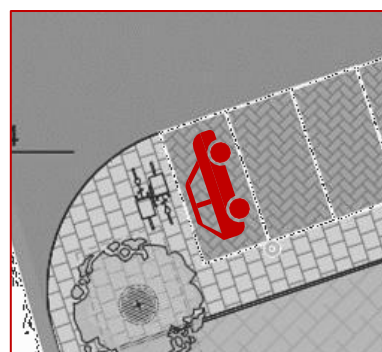
### 3.13 Location of Cargo Bicycle Parking Stand

**Summary:** *There is a risk of material damage collisions where a cargo bicycle parking stand has been located in close proximity to an adjacent car parking space.*

A cargo bicycle parking stand has been indicated on the southern side of the proposed development's southern access road. The stand appears to be located in close proximity to the adjacent parking space such that vehicle occupants may experience difficulties entering/exiting a vehicle parked at this location, resulting in a risk of material damage collisions.

The cargo bicycle parking stand should be relocated such that there is a sufficient buffer area between the stand and the adjacent parking space.

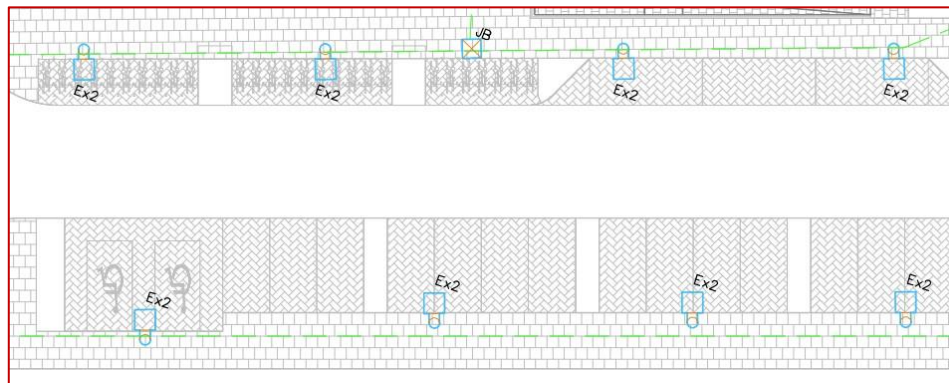
### 3.15 Location of Public Lighting Columns

**Summary:** *It is unclear if public lighting columns would be sufficiently setback from the edge of the carriageway on Dyke Road and from the rear of parking spaces within the proposed development.*

Public lighting columns have been indicated throughout the proposed development, including along the eastern side of Dyke Road and to the rear of parking spaces at the development's two accesses. Should lighting columns be positioned such that they would be insufficiently setback from the edge of the carriageway and parking spaces, this may lead to an increased risk of drivers striking lighting columns, particularly when entering parking spaces, resulting in material damage.

All public lighting columns should be positioned a minimum of 450mm from the edge of the carriageway and to the rear of the parking spaces throughout the proposed development.

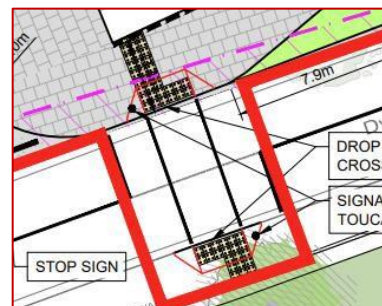
- 4.1 A new Toucan crossing has been indicated on Dyke Road immediately south of the proposed development's northern access. The tactile paving indicated on both sides of the crossing appears to be buff in colour. This may lead to confusion for visually-impaired, or partially sighted, pedestrians and could result in them misinterpreting the crossing as an uncontrolled crossing. Blister tactile paving that is red in colour should be provided at the Toucan crossing.

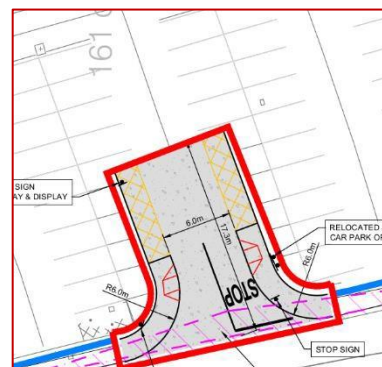
- 4.2 It is proposed to provide a new access to the Dyke Road Car Park to the south of the proposed development's southern access. The layout of this access, however, does not appear to tie-in with the layout of the existing carpark which is to be retained. The layout of the existing carpark should be amended such that it would tie-in with the proposed access junction.
