ARCHITECTURAL CONSERVATION REPORT

DOCUMENT TITLE	DATE OF ISSUE	REVISION NUMBER
Ballina Flood Relief Scheme, Preliminary Conservation Report	08/01/2024	А
As above	01/02/2024	В
As above	25/03/2024	С
Ballina Flood Relief Scheme, Architectural Conservation Report	16/04/2024	D
As above	30/04/2024	E

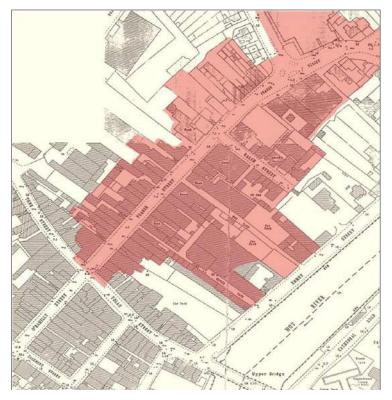
Fig.02 Lower Bridge

- Existing condition It has been confirmed that neither Upper nor Lower Bridge, including their wing walls, are to be repaired, altered or impacted by the flood relief scheme. It should, however, be noted that both bridges appear to require some reasonably urgent repair.
- Demarcation with river boundary walls There is no physical demarcation between the north-east wing wall of Upper Bridge and north-west wing wall of Lower Bridge and the ashlar limestone walling of River Boundaries 14 and 26.

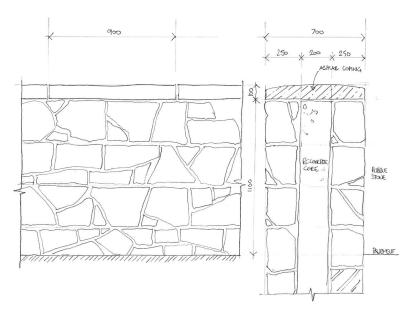
Fig.04 Indicative sketch detail

- Potential solution The sketch detail (Fig.04) illustrates one possible appropriate solution for new flood walls to replace existing river boundary walls. The construction envisages a reinforced concrete core faced on both sides with coursed rubble limestone and capped with tooled ashlar stone hog-back copings. Stonework joints should be pointed with NHL3.5 lime batched with suitably graded aggregate, finished flush with stonework arrises with a bag-rubbed finish. The detail will require refinement following structural design.
- A sample panel of the proposed walling design should be constructed for review and approval by all stakeholders.
 It was agreed at the site walkaround on 06 February 2024 that a suitable location for this would be at Batchelors Walk.
