CLONASLEE FLOOD RELIEF SCHEME

Appendix 16.8: Conservation Report

CONSERVATION REPORT

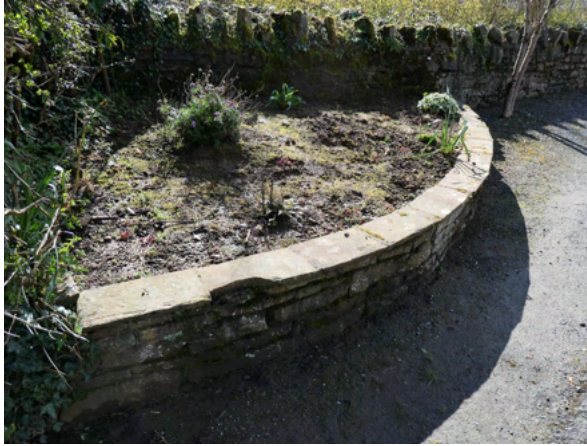
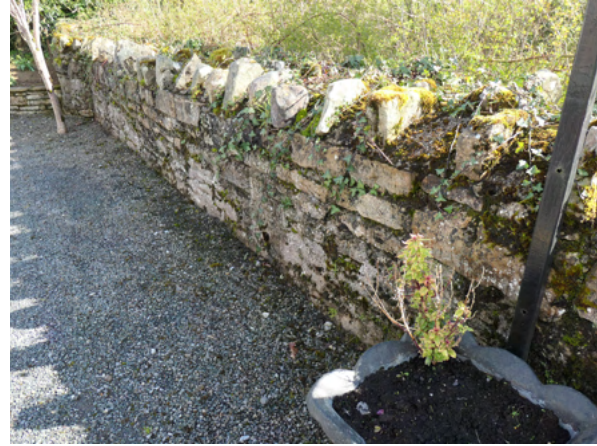
- Section 01 – Height of wall increased as described above. Wall bulges outwards towards north end. Extensive moss growth on west face. Extensive vegetation to top and east face. Low flower bed to north end in rough quadrant plan constructed in rubble stone with flat stone coping. 1no. tree. 1no. painted steel square section post behind planter to south end. Crushed aggregate surface between wall and yellow line.

Fig.09 Section 01, flower bed

Fig.10 Section 01, wall

- The river facing sides of all existing rubble stone walls should be fully repointed after removal of vegetation in order to prevent erosion of the masonry.

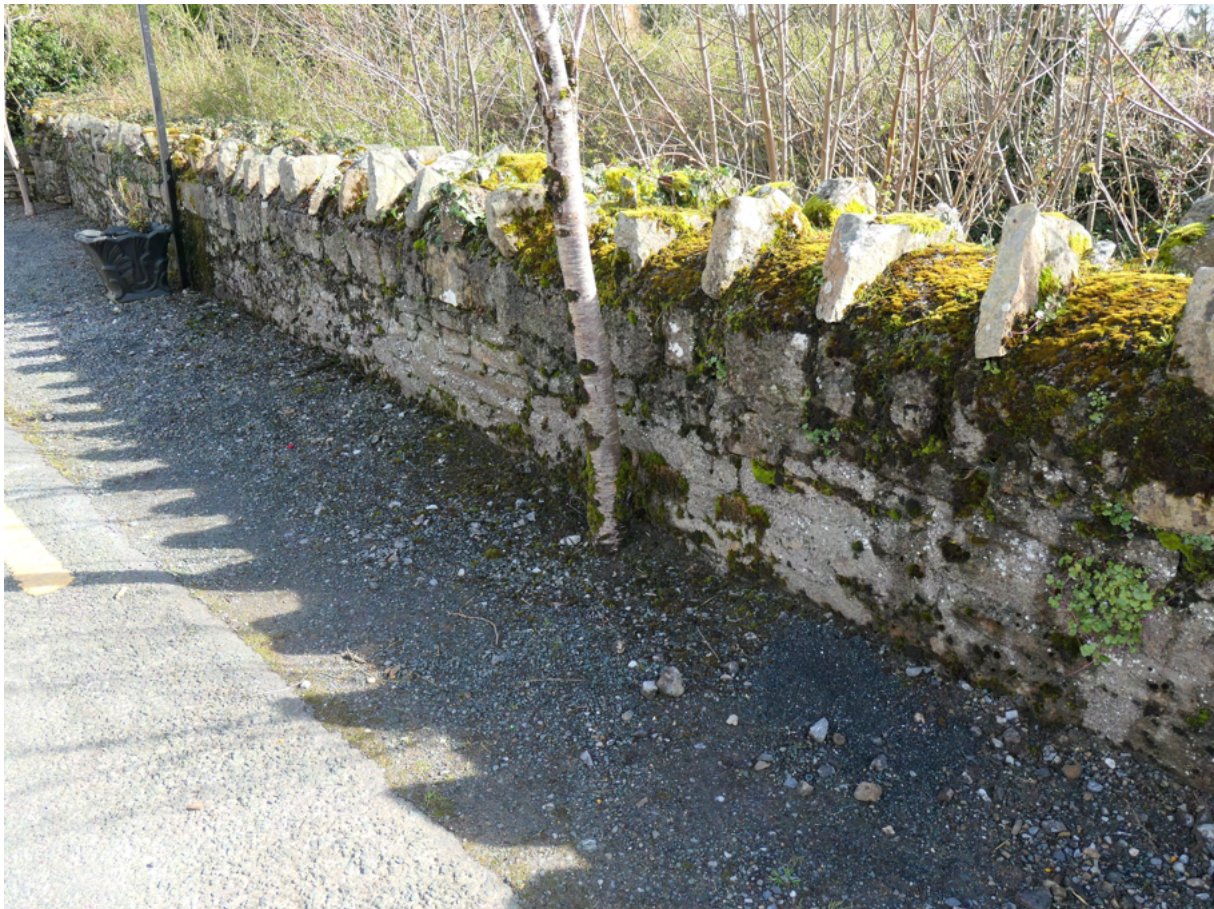
- Section 02 – Height of wall increased as described above. Extensive moss growth to top of wall. Extensive vegetation to east face. 1no. tree. 1no. recently installed octagonal galvanized steel electricity pole. 1no. painted steel square section post beside planter to south end. Crushed aggregate surface between wall and yellow line.

Fig.11 Section 02, wall

- Existing road signs should be removed and relocated.
- Recently-installed electricity poles should be relocated to permit construction of new flood relief wall.

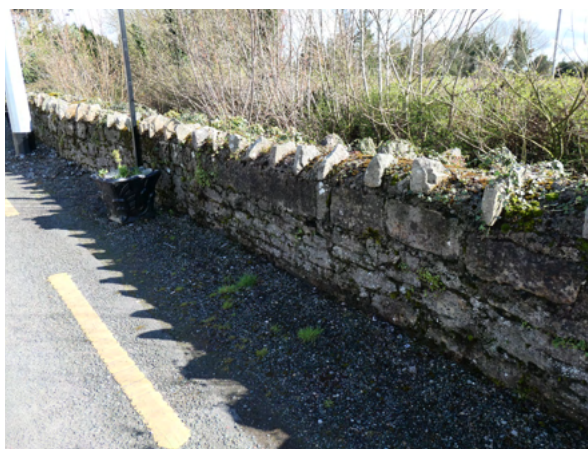
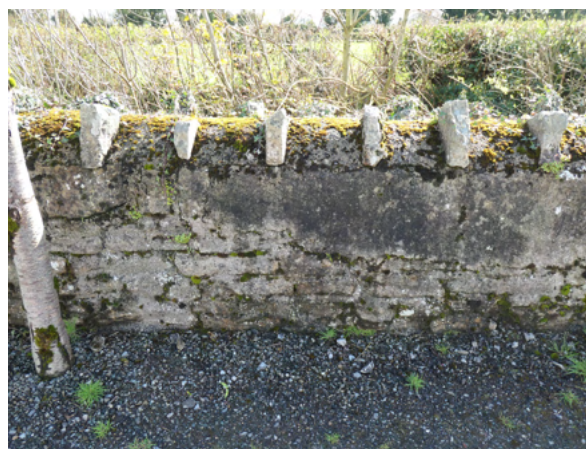
- Section 03 – Height of wall increased as described above. Some moss growth and vegetation to top and west face. Extensive vegetation to east face. Extensive mass concrete repairs. 1no. tree. 1no. painted steel square section post behind planter to south end. Crushed aggregate surface between wall and yellow line.

Fig.12 Section 03, wall

Fig.13 Section 03, mass concrete repair

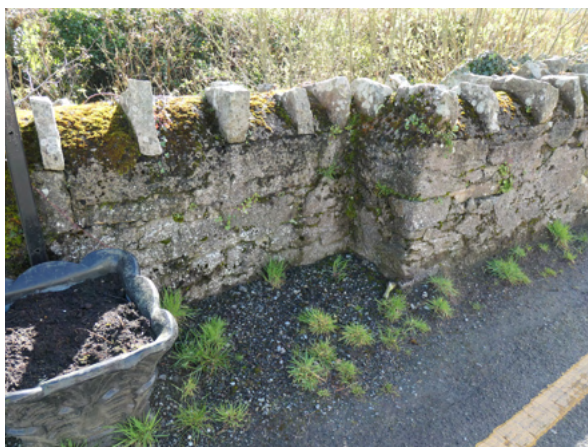
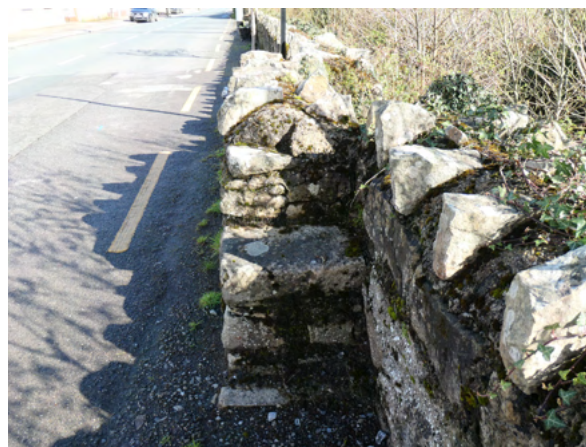
- Section 04 – Height of wall increased as described above. Some moss growth to top. Extensive vegetation to top and east face. Wall steps out for approximately two metres at north of section, step at south end of projection possibly intended to provide access steps to river side of wall. Isolated mass concrete repairs. 1no. tree. 1no. circular metal traffic sign post. 1no. painted steel square section post behind planter to south end. Crushed aggregate surface between wall and yellow line.

Fig.14 Section 04, step in wall

Fig.15 Section 04, possible access steps

- Wall offsets (Sections 04 and 08) contribute to the character of the existing wall and should be replicated in the Flood Relief Scheme.
- Proposal - New flood walls should comprise a reinforced concrete core formed against the west side of the existing walls and faced with new uncoursed rubble stone and capped with vertically placed merlon stones set in a hog back mortar bed.

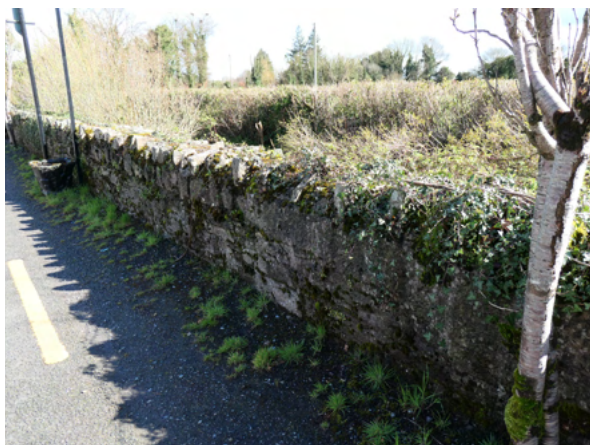
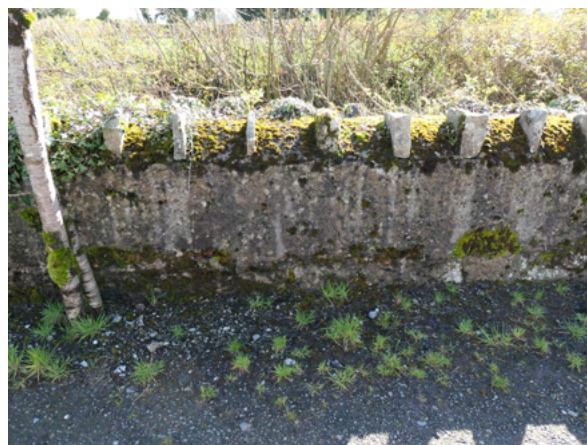
- Section 05 – Height of wall increased as described above. Extensive moss growth to top. Extensive vegetation to top and east face. Extensive mass concrete repairs. 1no. tree. 1no. circular metal traffic sign post. 1no. painted steel square section post. 1no. recently installed octagonal galvanized steel electricity pole. Planter to south end. Crushed aggregate surface between wall and yellow line.

Fig.14 Section 05, wall

Fig.15 Section 05, mass concrete repair

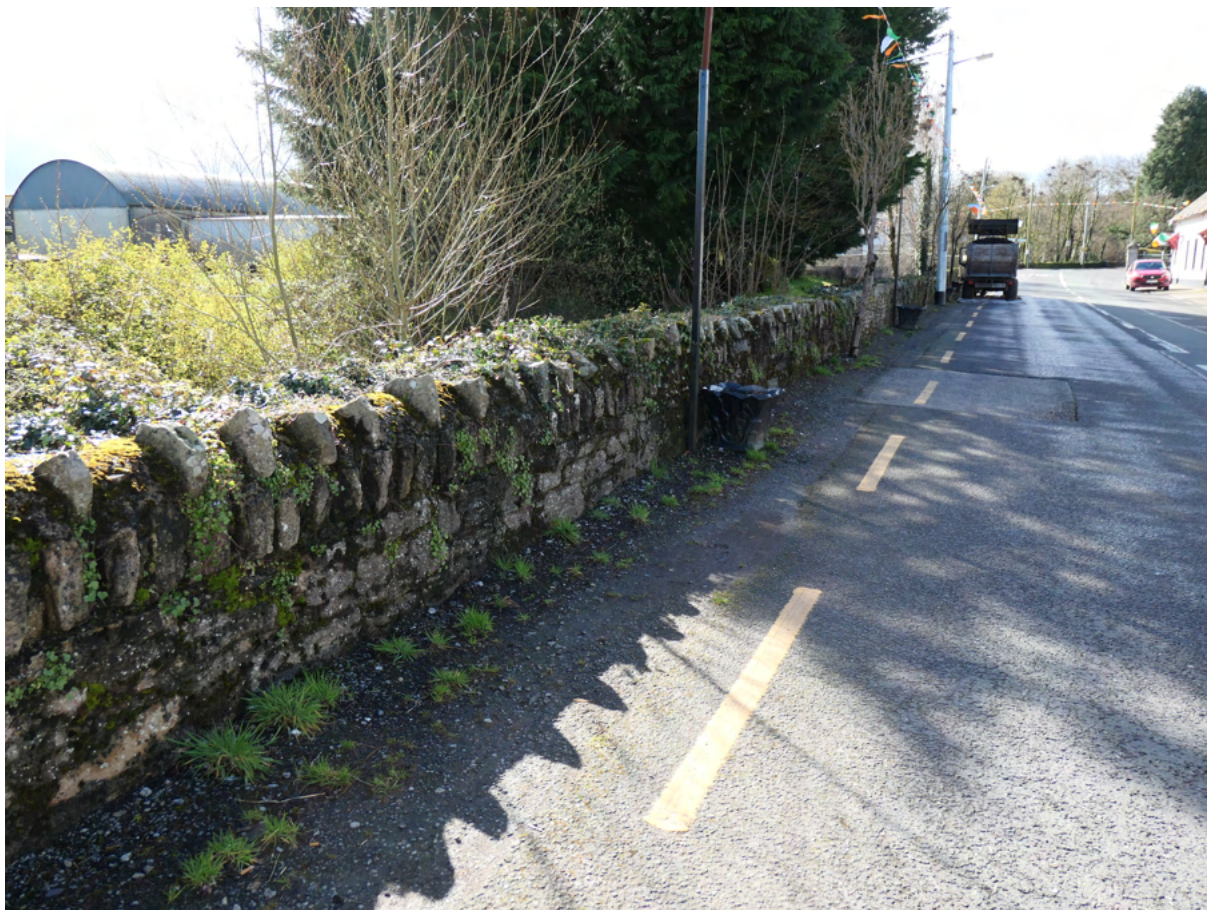
- Section 06 – Height of wall increased as described above. Extensive moss growth on west face. Extensive vegetation to top and east face. Extensive mass concrete repairs. 1no. tree. 1no. circular metal traffic sign post. 1no. painted steel square section post adjacent to planter to south end. Crushed aggregate surface between wall and yellow line.

Fig.16 Section 06, wall

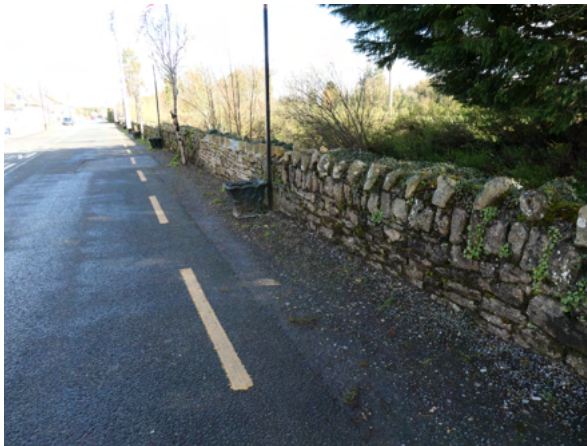
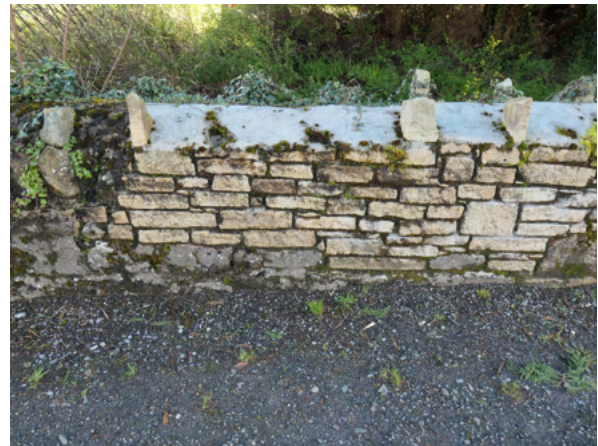
- Section 07 – Height of original wall increased as described above. Part of wall towards south end rebuilt in roughly squared rubble sandstone. Extensive moss growth on west face of original wall. Extensive vegetation to top and east face. Isolated mass concrete repair to original walling. 1no. tree. 1no. painted steel square section post behind planter to south end. Crushed aggregate surface between wall and yellow line.

Fig.17 Section 07, wall

Fig.18 Section 07, rebuilt wall

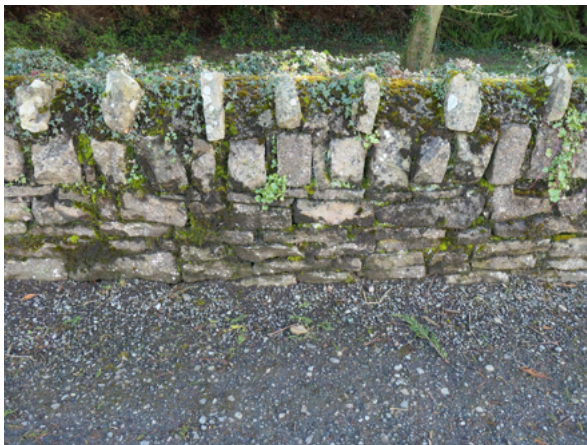
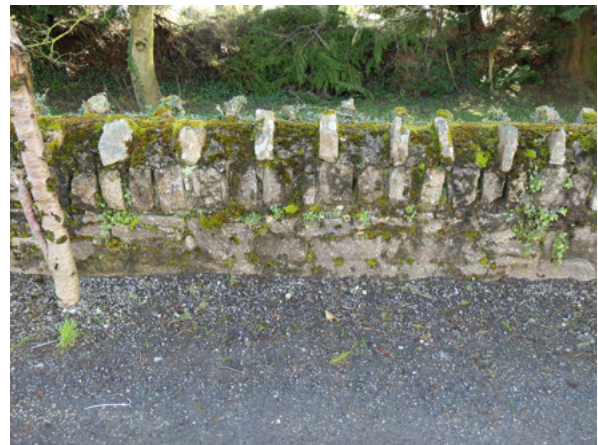
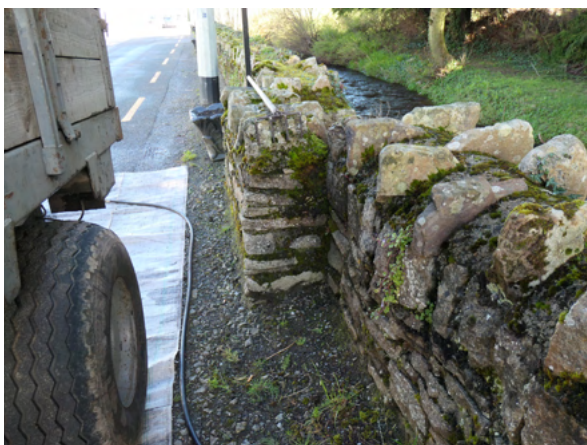
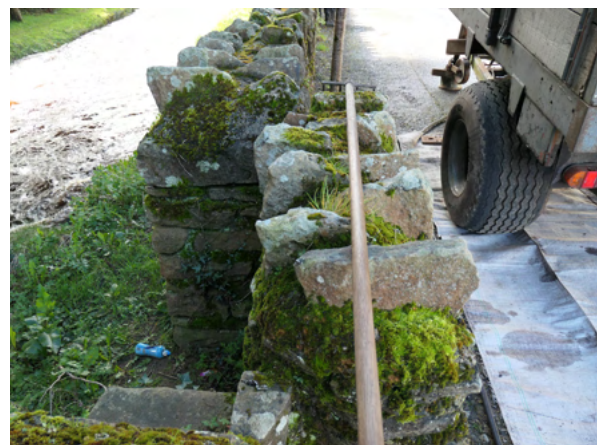
- Section 08 – Height of wall increased as described above. Some moss growth on top of wall. Extensive vegetation to east face. Wall steps out for approximately two metres, to access steps on river side of wall. Isolated mass concrete repairs. 2no. trees. 1no. painted steel square section post behind planter to south end. 1no. recently installed octagonal galvanized steel electricity pole. Crushed aggregate surface between wall and yellow line.

Fig.19 Section 08, wall

Fig.20 Section 08, wall

Fig.21 Section 08, step in wall

Fig.22 Section 08, riverside access steps

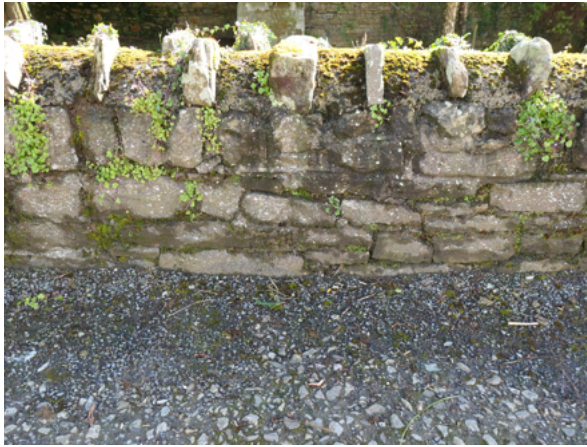
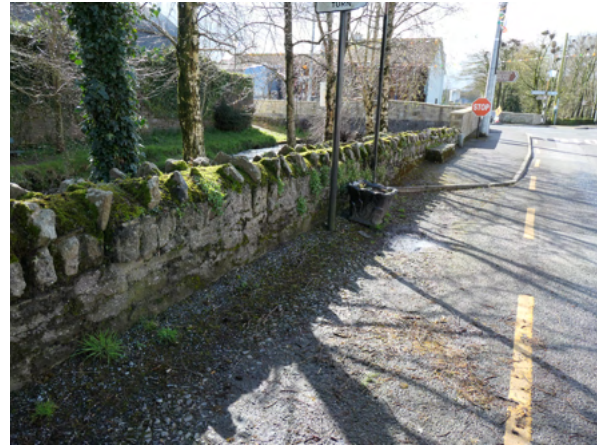
- Section 09 – Height of wall increased as described above. Some moss growth on top of wall. Extensive vegetation to east face. Isolated mass concrete repairs. 1no. tree. 1no. circular metal traffic sign post. 1no. planter to south end. Crushed aggregate surface between wall and yellow line.

Fig.23 Section 09, wall

Fig.24 Section 09, wall

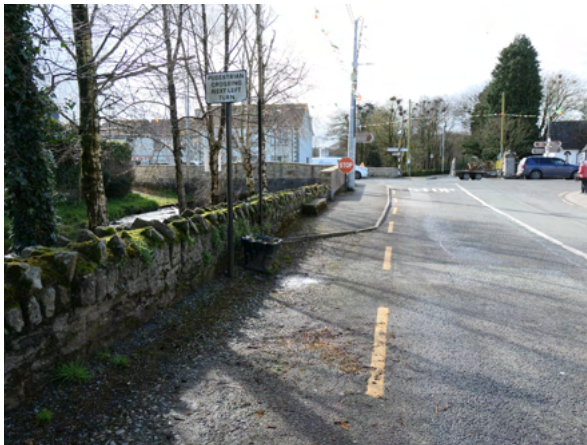
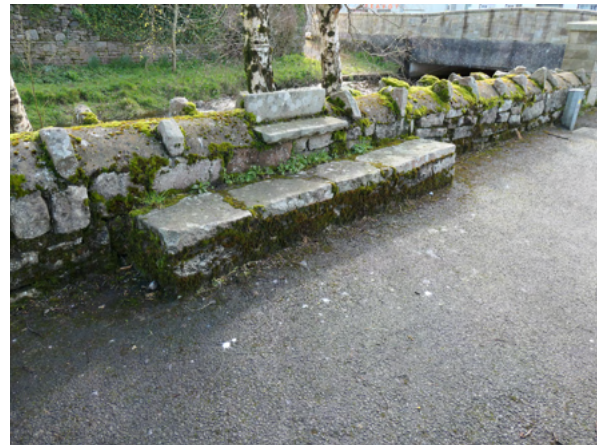
- Section 10 – Height of wall increased as described above. Some moss growth on top of wall. Outward projection having 4no. stone cappings and small stone 'seat' built into top of wall. 1no. painted steel square section post to north end. Bitmac pavement with concrete kerbs extending to bridge.

Fig.25 Section 10, wall

Fig.26 Section 10, projection and seating

- Capped projection Section 10) is a significant historic feature and should be replicated in the Flood Relief Scheme.
- Existing square metal posts should be removed.

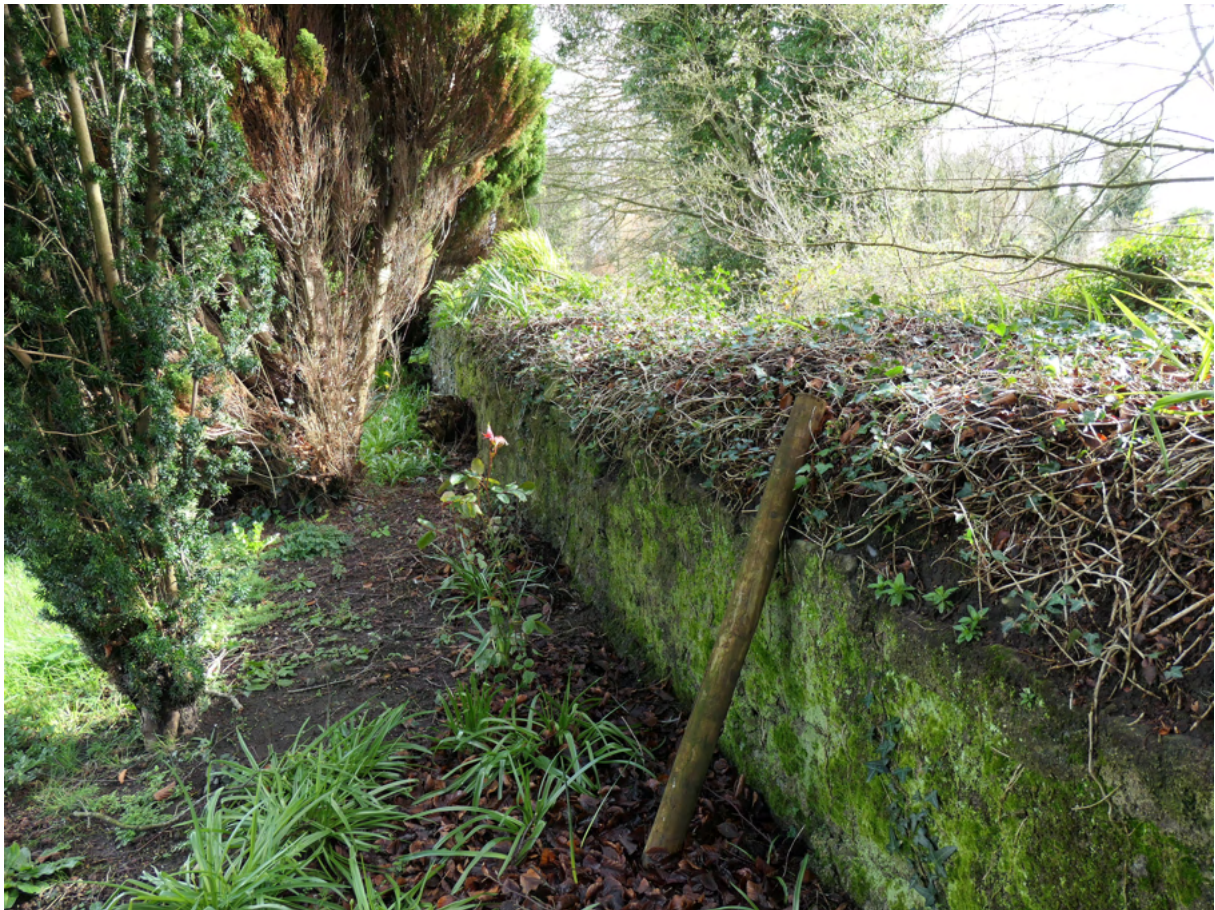
The first section of wall at the southern end of McGrail's garden was difficult to access because of the presence of a number of small trees and shrubs planted in the lawn close to the wall. It is approximately 600mm high on the garden side but considerably higher on the river side. The vertical face of the wall is largely concealed by mosses, lichens and ivy and the top surface is entirely obscured by dense vegetation including ivy and perennial plants. As a result, it was not possible to make a meaningful assessment of the structural condition. It appears that the wall is constructed from uncoursed, as-found, rubble stones with lime mortar jointing and perhaps a thin surface coat of lime-based harling.

Fig.27 Southern boundary wall

- Existing shrubs and trees should be removed from the southern boundary.
- River facing sides of all existing rubble stone walls should be fully repointed after removal of vegetation in order to prevent erosion of the masonry.
- If engineering solutions can be reached which allows reinforcement of existing walls, these should be implemented. If not, a completely new wall should be constructed, parallel to and offset by approximately 1.5 metres from the existing walls and having a reinforced concrete core and faced and capped with new quarried rubble stone. A new gravel path should be formed between the existing and new walls. A floodgate would be required to provide access to the pathway. The owners consent would be required.

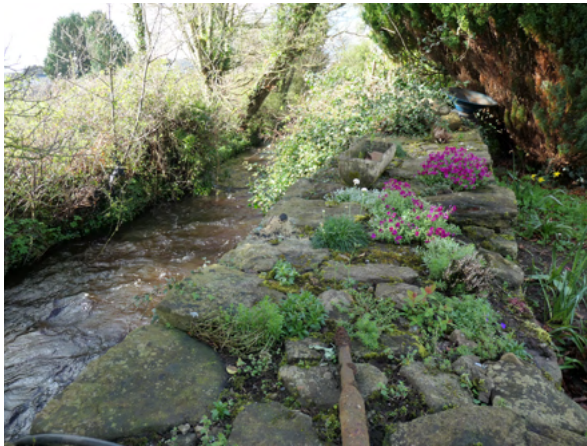
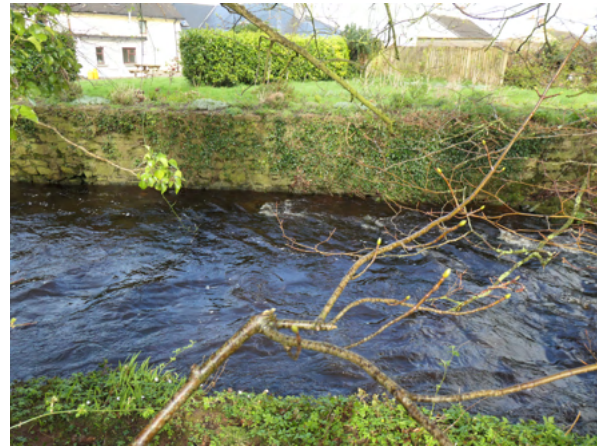
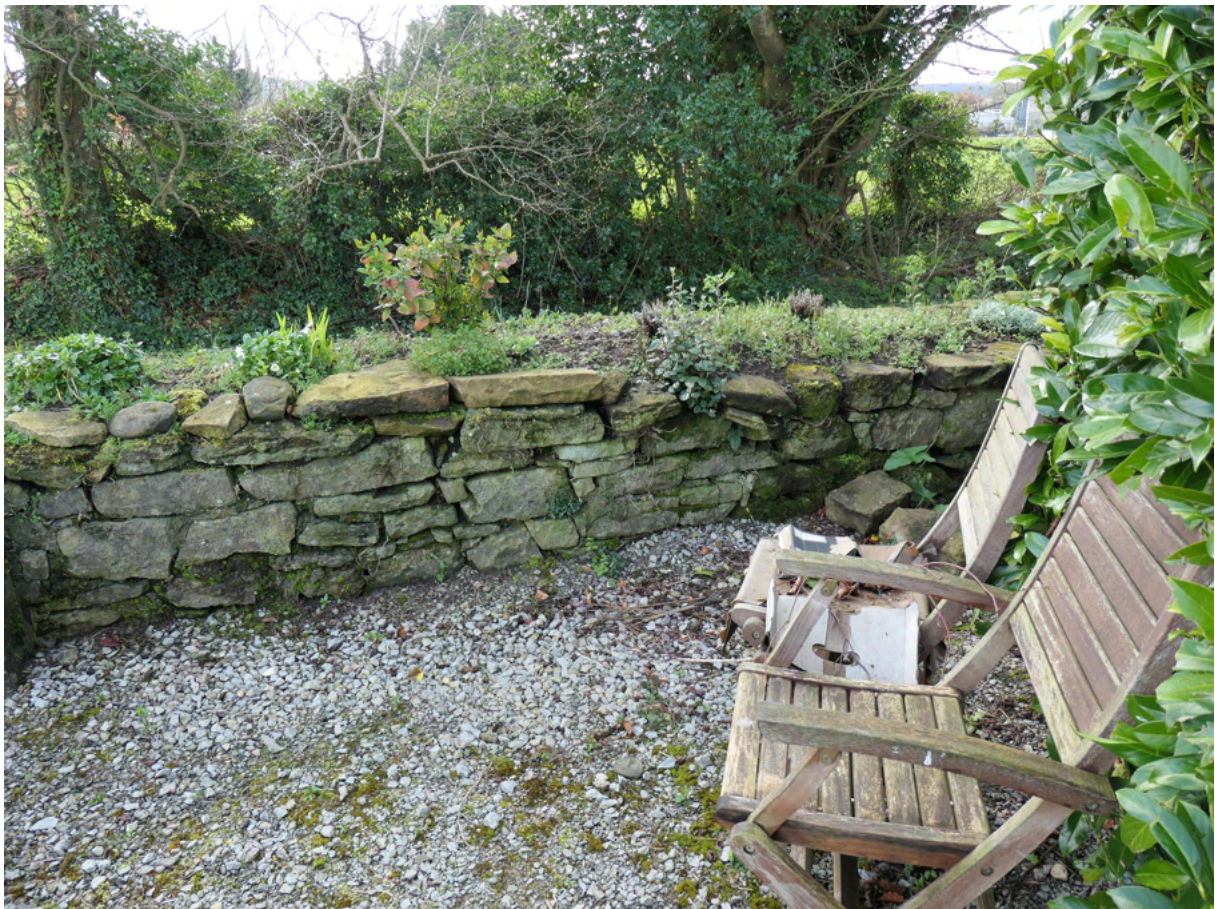
The central section of wall is approximately 600mm high on the garden side but considerably higher on the river side. It is more readily accessible than the first section and is also constructed from as-found stones but apparently substantially without mortar bedding and jointing. The wall is capped by loose stones creating a roughly flat surface which supports deliberate planting. Extensive ivy cascades down the river side of the wall which appears to be pointed.

Fig.28 Central boundary wall, capping

Fig.29 Central boundary wall, riverside

Fig.30 Central boundary wall

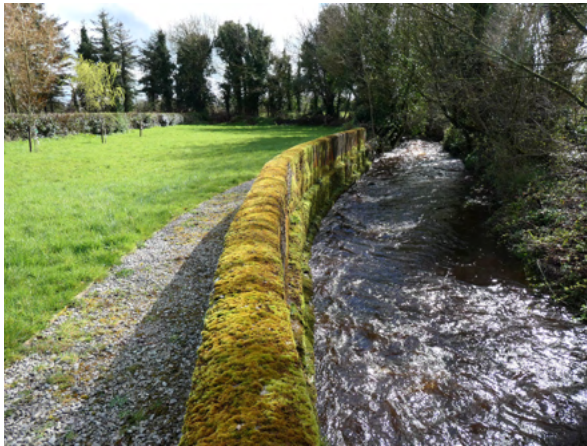
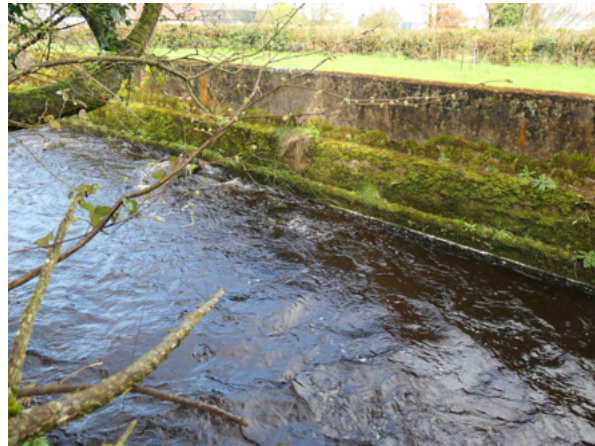
The third and final, northernmost, section of wall is constructed from insitu concrete. It is approximately 800mm high on the garden side but considerably higher on the river side. The upper section is finished with an integral curved top and is approximately 300mm wide. On the river side the wall thickens at the base. The top and inner face of the wall supports extensive moss growth. A gravel path, approximately one metre wide, flanks the garden side of the wall.

Fig.31 Northern boundary wall

Fig.32 Northern boundary wall, riverside
