ASSESSEMENT OF ON-SITE WASTEWATER TREATMENT SYSTEM

January 7,
2025

Existing Development at Isertkelly North,
Kilchreest, Co. Galway

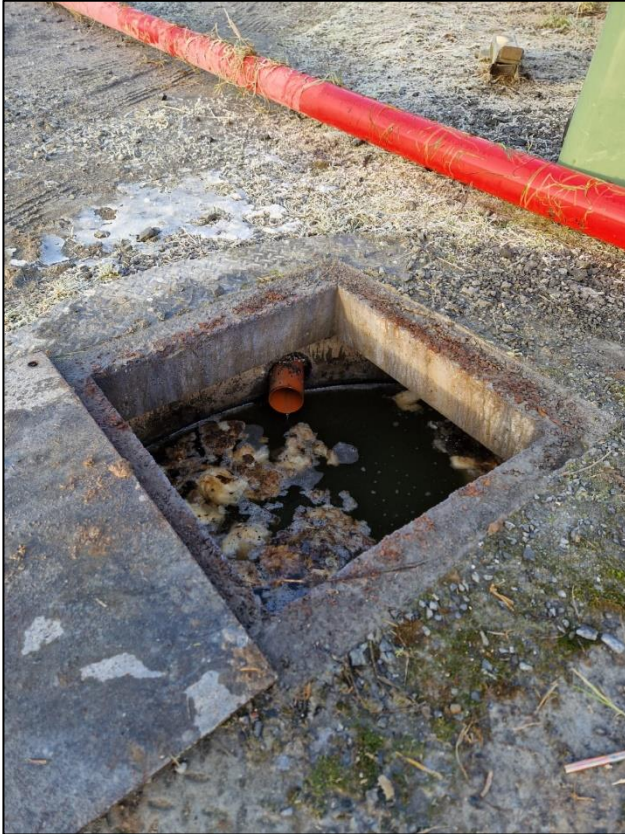
PHOTO 1. SEPTIC TANK INLET

The visual inspection noted that the septic tank appeared to be in a good state of repair, although T-pieces were missing on the inlet (Photo 1) and the outlet (Photo 2) pipes. A baffle wall (Photo 3) is in situ between the two chambers of the tank. Although no vents were observed on the tank, the manhole cover provides a sufficient void over the top of the access shaft as to allow for the movement of air and the venting of gases.

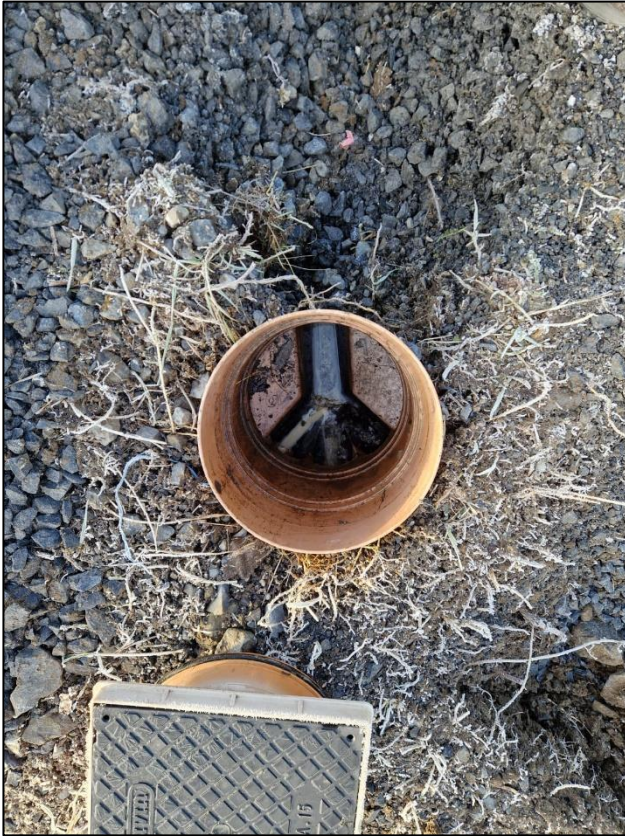
PHOTO 4. DISTRIBUTION ACCESS JUNCTION

The visual inspection of the system confirmed the presence of a distribution chamber (Photo 4), with one inlet and three outlet pipes. The percolation area consists of three 10m runs of distribution pipes, totalling 30m, with visible vent stacks to delineate the ends of the pipes (Photo 5). The pipes are 110mm smooth-wall slotted wavin pipes. Although the condition and performance of the percolation cannot be commented on and is omitted from this report, no odours or nuisance was noted in the vicinity of the percolation area.

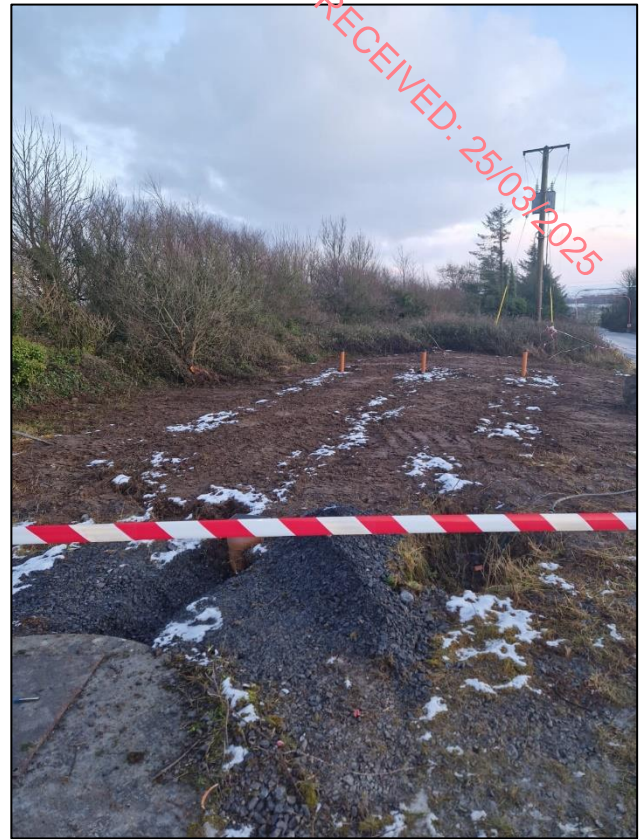
PHOTO 5. PERCOLATION AREA, WITH VENTS VISIBLE AT THE ENDS
