Pre and Post Structural Photos

Martello Tower,

Re:	Post Works Structural Report.
Name of client:	Dept of Agriculture, Food and the Marine,
Address of client	Reen Point, Blennerville, Tralee, Co.Kerry.
Date of inspection	25th Oct 2024 .
Address of structure	Ros an Mhil, Chontae na Gaillimhe

Re: **Pre commencement Structural Report on
Martello Tower,.**

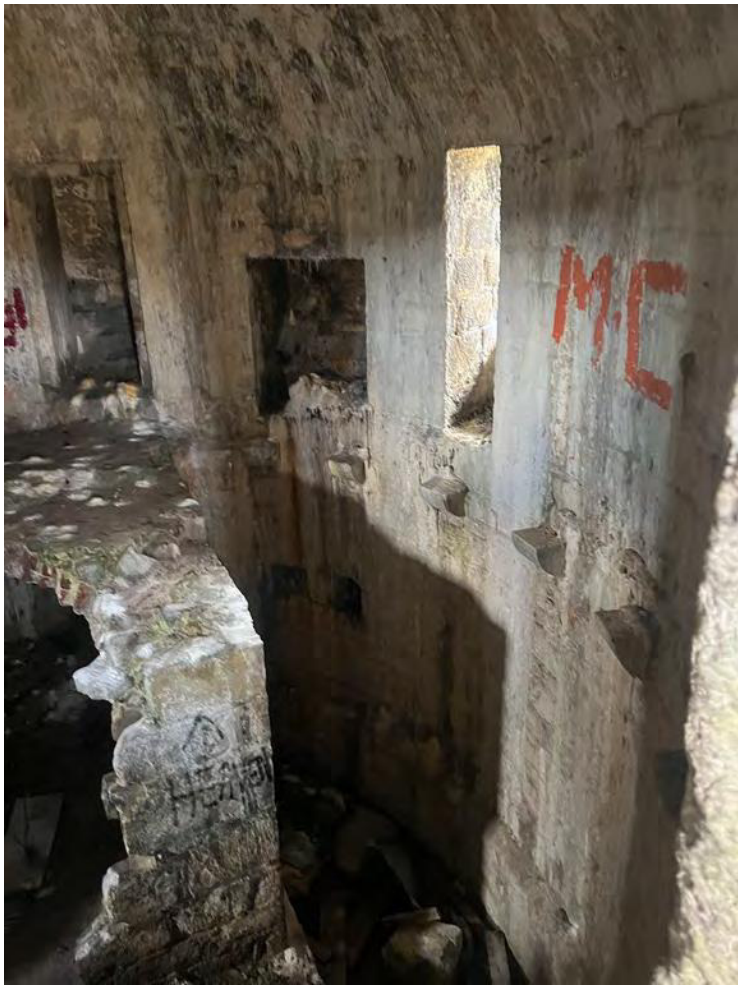
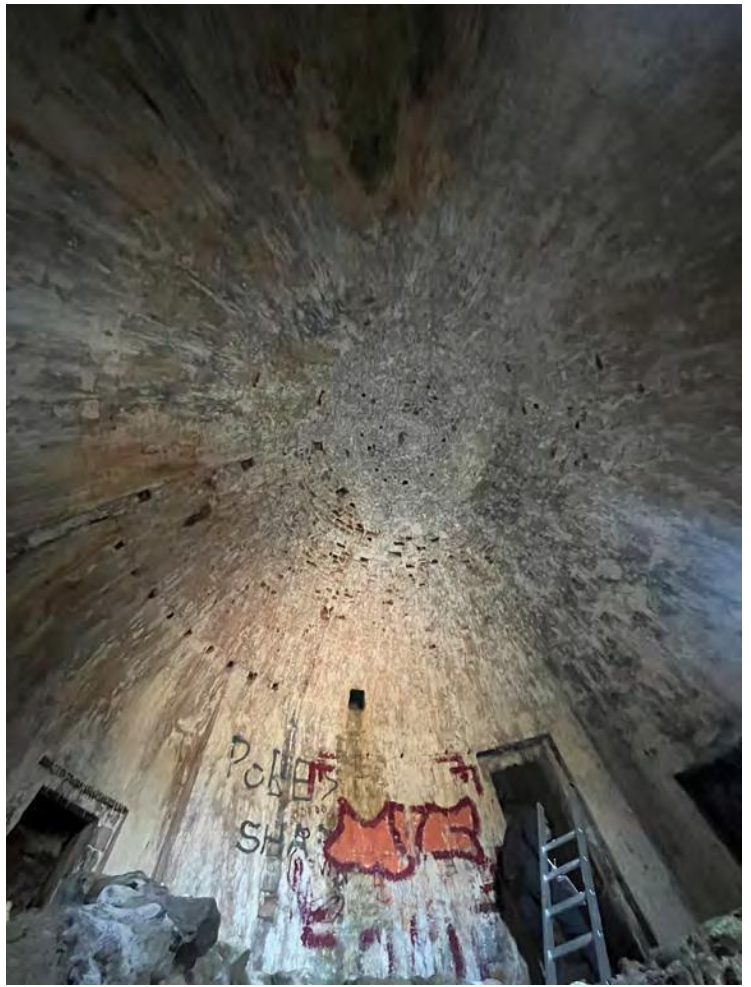
Images of Martello Tower

Generally, the external walls and roof structure are in very good condition, apart from sections of the parapet above roof level which appear to have been intentionally damaged by removal of some stones. Also, parts of the roof and walls of an internal structure, which was most likely the powder room, are damaged. Some large carved limestone blocks are present on the ground directly beneath the damaged areas of the parapet. This is surprising as it would require considerable effort to dislodge these larger stones from the parapet.

The very robust nature of the Martello Tower combined with the dry ashlar facing and its position remote from the proposed construction works make it unlikely that any damage should occur to its structure during the course of construction of the works. Nevertheless, it is recommended that during the course of construction which will involve blasting works, vibration monitoring of the Martello Tower should take place on a continuous basis over the period of construction works.
