### Tree Survey Report

Project <b>Tree Survey for the Douglas and Togher Flood Relief Scheme.</b>				
Client <b>ARUP</b>				
Project no	No pages	Client reference	©DixonBrosnan 2016	
1653	-	-	v010111	
<p>DixonBrosnan 7 The Cedars Bridewood Ovens Co Cork          Tel 086 8511437   carl@dixonbrosnan.com   www.dixonbrosnan.com</p>				
Report no	Date	Edit	Prepared by	
1666	18/04/17	0 – Issue to client	Mark Donnelly	
			Carl Dixon	
<p style="font-size: small;">This report and its contents are copyright of DixonBrosnan. It may not be reproduced without permission. The report is to be used only for its intended purpose. The report is confidential to the client, and is personal and non-assignable. No liability is admitted to third parties.</p> <p style="text-align: right; font-weight: bold; font-size: small;">Do you <i>really</i> need a printed copy of this report?</p>

## DOUGLAS- Flood Relief Scheme

04/04/2017

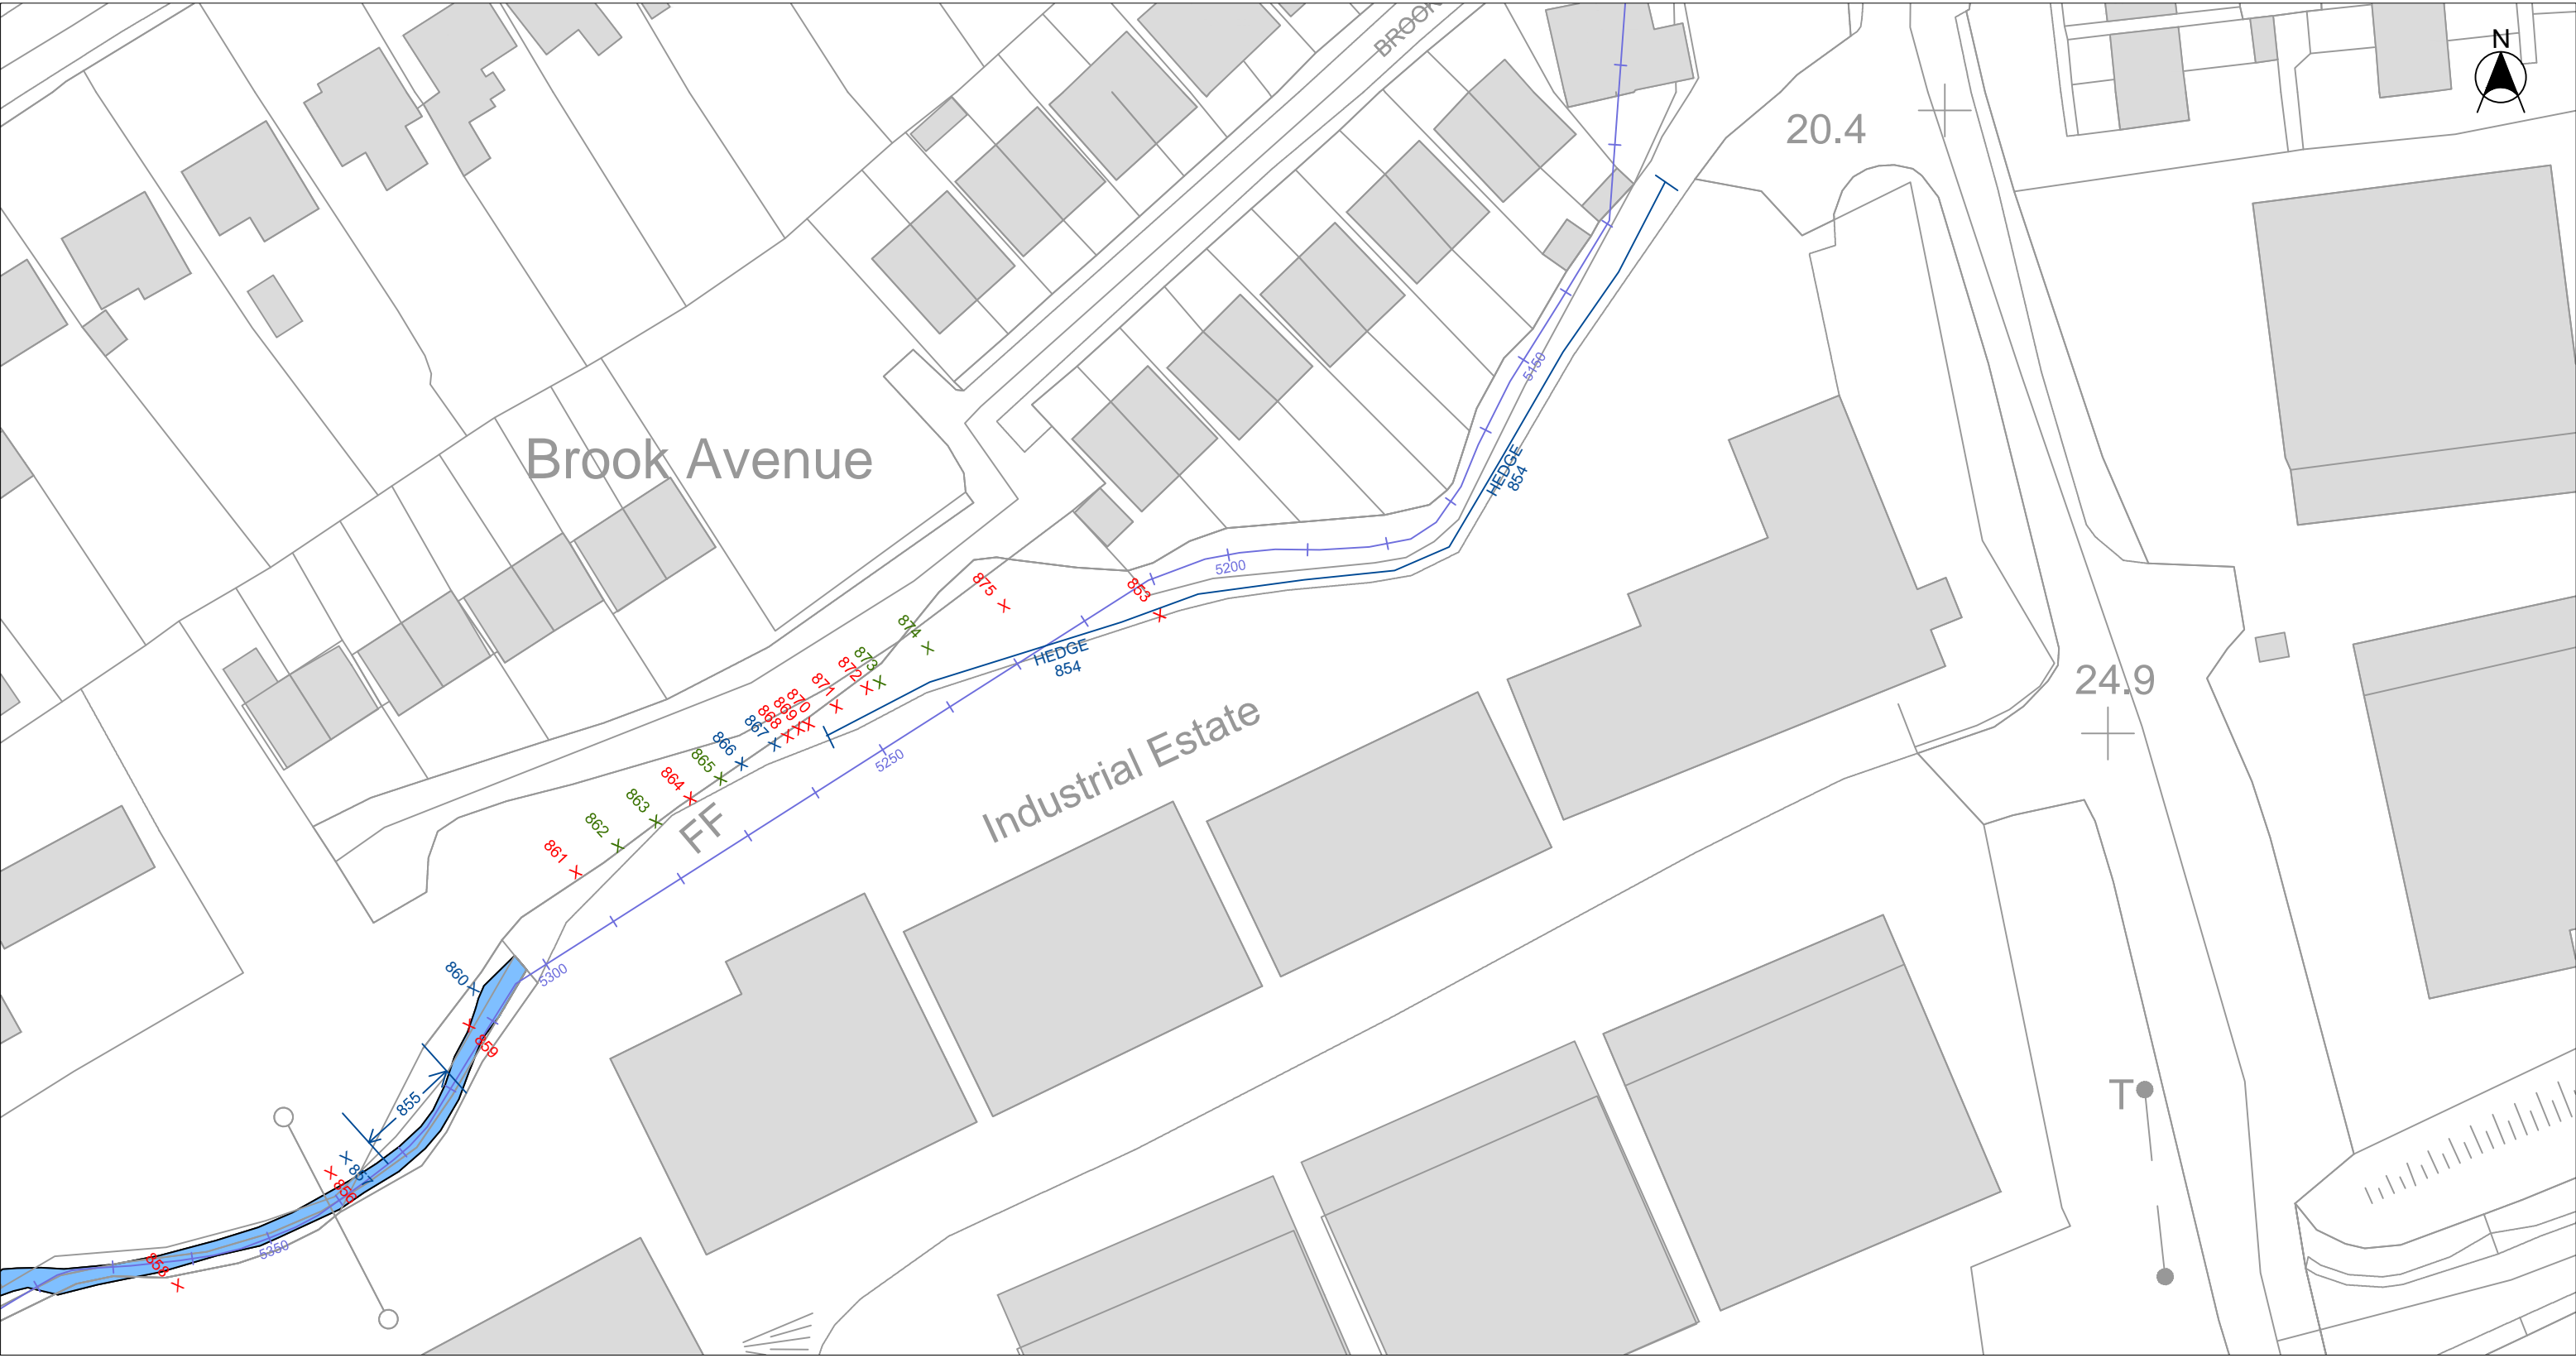
Drawing No.: C-000-007-TS (04/04/2017)-Tree Survey (Not to Scale)

No.	Species	Age Class	Girth (mm)	Height (m)	Spread (m)				Condition	Risk Code	Comments	Rec	RPA (m)
					N	E	S	W					
853	Sycamore	M	400	12		10			Fair	B	4 stems	3	-
854	Western Red Cedar	SM	200	4					Good	C	Hedge (and <i>Cypressus macrocarpa</i> )	2	2.4
855	Alder	SM	250	12		5			Good	C	GROUP of 20 trees	2	3.0
856	Elm	M	500	15		10			Poor	A	Dead 2 trees	3	-
857	Willow	M	250	9		8			Good	C	GROUP of 5 trees	2	3.0
858	Elm	M	350	10	5				Poor	A		3	-
859	Elm	M	380	20		10			Poor	A	GROUP of 4 trees	3	-
860	Sycamore	SM	300	18		10			Fair	B	5 stems	2	3.6
861	Elm	M	500	20		9			Poor	C	2 dead Elm	3	-
862	Sycamore	SM	300	15		9			Good	C	2 trees (1 ash)	1	3.6
863	Sycamore	M	900	20		20			Good	C	2 stems	1	10.8
864	Ash	M	350						Poor	B	Poor tree. 2 stems	3	-
865	Sycamore	M	380	18		10			Good	C		1	4.2
866	Alder	M	280	14		8			Good	C	1 tree	2	3.3
867	Alder	M	200	15		8			Fair	C	3 trees	2	2.4
868	Alder	M	300	18		8			Fair	B		3	-
869	Beech	SM	350	18		8			Poor	A	Rot at base	3	-

870	Alder	M	300	18		8			Poor	A	Rot at base	3	-
871	Elm	M	350	15		6			Poor	A	Dead	3	-
872	Elm	SM	300	12		6			Poor	A	Dead	3	-
873	Ash	M	1000	18		15			Poor	B	Veteran tree. Dead top. Rot at base. POLLARD	1	12.0
874	Evergreen Oak	M	450	13		10			Good	C	Specimen tree - RETAIN	1	5.4
875	Elm	M	450	13		10			Poor	A	2 trees dead	3	-

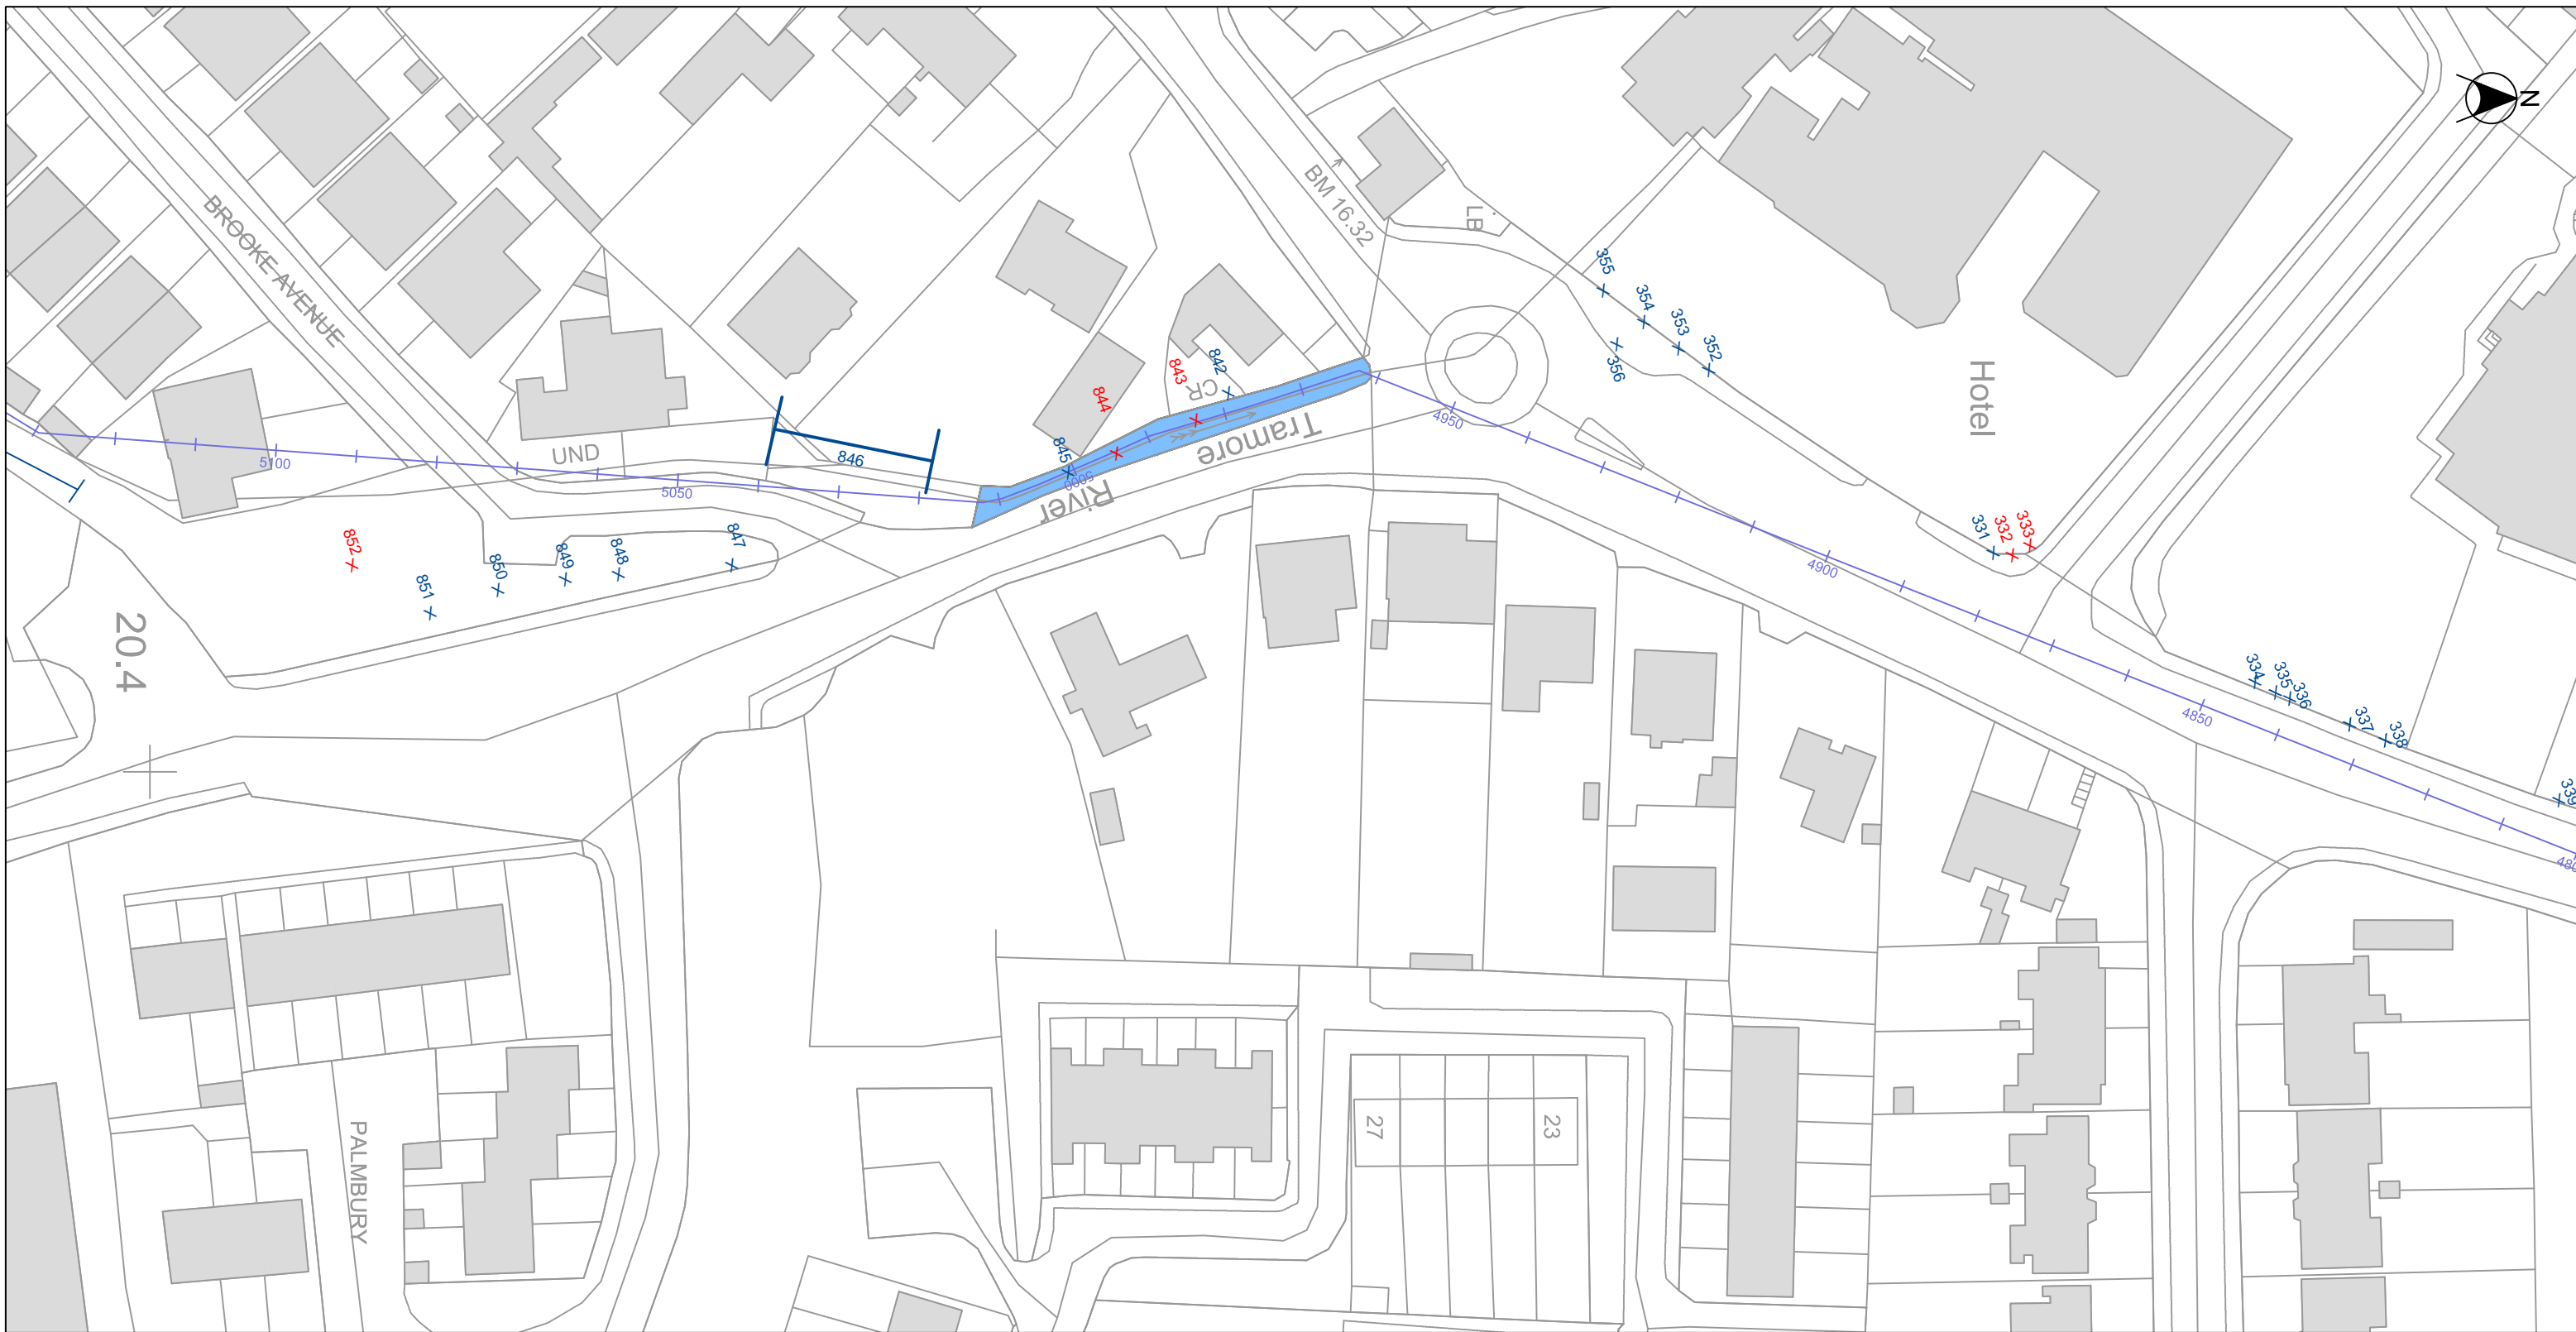
Drawing No.: C-000-008-TS (04/04/2017)-Tree Survey (Not to Scale)

No.	Species	Age Class	Girth (mm)	Height (m)	Spread (m)				Condition	Risk Code	Comments	Rec	RPA (m)
					N	E	S	W					
842	Horse Chestnut	M	450	23		18			Fair	B	Poor form. 3 stems. 30 % crown reduction if compromised by excavations	2	5.4
843	Ash	M	450	18	10				Fair	B		3	-
844	Elm	M	450	8		5			Fair	B		3	-
845	Lime	M	300	13		10			Fair	B	4 stems - Will need leaning stem removed	2	3.6
846	Ash & Elm	M	450	18		9			Good	B	GROUP of 10 trees	2	5.4
847	Ash	SM	400	9		8			Good	C		2	4.8
848	Ash	SM	500	9		8			Good	C	Over culvert	2	6.0
849	Ash	SM	500	9		8			Poor	A	Poor form	2	6.0
850	Ash	SM	300	9		8			Poor	A	Cankered	2	6.0
851	Ash	SM	400	9		8			Fair	B	Forked	2	4.8
852	Ash	SM	580	12		10			Fair	B	Poor health	3	-
338	Norway Maple	IM	200	8		4			Good	C	Retain if possible	2	2.4
337	Norway Maple	IM	200	8		4			Good	C	Retain if possible	2	2.4
336	Birch	IM	150	5		4			Good	C	Retain if possible	2	1.8
335	Birch	IM	150	5		4			Good	C	Retain if possible	2	1.8

334	Birch	IM	150	5		4			Good	C	Retain if possible	2	1.8
333	Norway Maple	IM	250	9		4			Poor	A	Damaged	3	-
332	Norway Maple	IM	230	9		5			Poor	A	Damaged	3	-
331	Norway Maple	SM	300	10		6			Good	C	Retain if possible	2	3.6
352	Lime	IM	200	8		5			Good	C	Retain if possible	2	2.4
353	Lime	IM	200	8		5			Good	C	Retain if possible	2	2.4
354	Lime	IM	250	8		5			Good	C	Retain if possible	2	3.0
355	Lime	IM	300	8		5			Good	C	Retain if possible	2	3.6
356	Callery Pear	IM	200	8		4			Good	C	Retain if possible	2	2.4

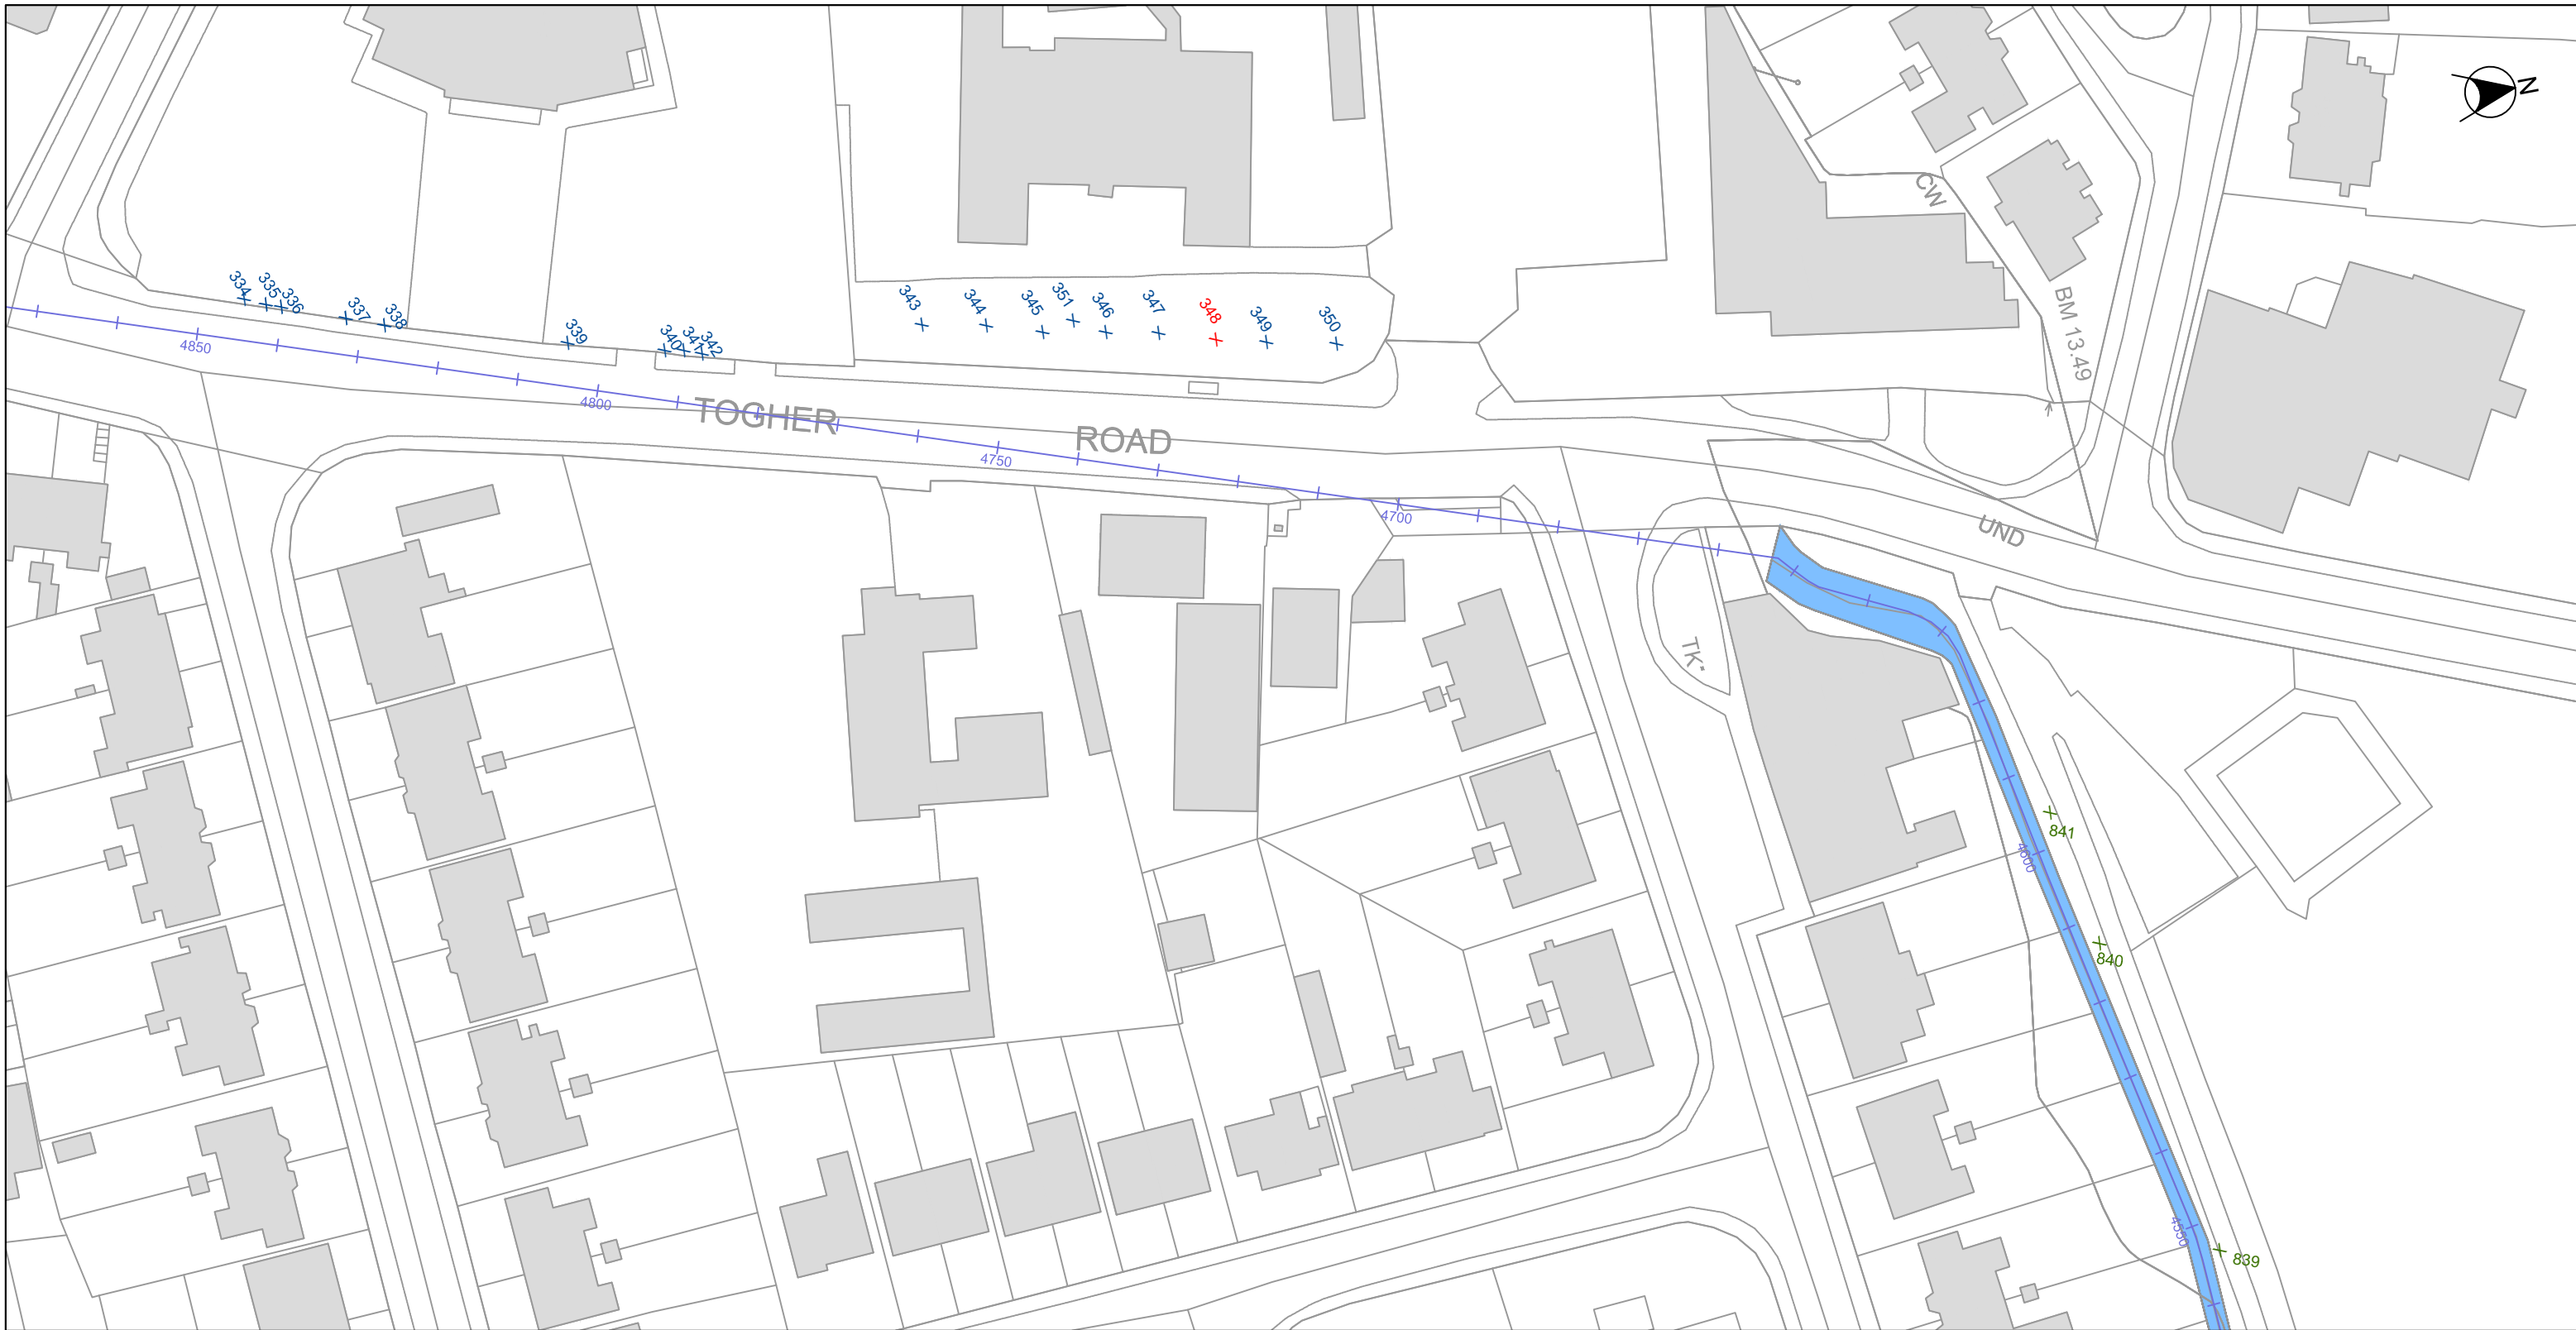
Drawing No.: C-000-009-TS (04/04/2017)-Tree Survey (Not to Scale)

No.	Species	Age Class	Girth (mm)	Height (m)	Spread (m)				Condition	Risk Code	Comments	Rec	RPA (m)
					N	E	S	W					
839	Lime	SM	300	8		5			Good	C		1	3.6
840	Lime	SM	200	8		5			Fair	C	Suppressed and damaged at base	1	2.4
841	Beech	SM	360	10		10			Good	C		1	4.2
350	Silver Birch	IM	150	5		3			Good	C	Commemorative Tree (Priority Tree)	2	1.8
349	Cherry	SM	350	8		6			Good	C		2	4.2
348	Ash	IM	200	5		4			Poor	B	Poor Health - Cankered	3	-
347	Cherry	SM	300	6		4			Good	C		2	3.6
346	Rowan	M	350	9		4			Good	C		2	4.2
351	Silver Birch	SM	250	9		5			Good	C		2	3.0
345	Cherry	SM	300	8		5			Good	C		2	3.6
344	Ash	SM	350	9		8			Good	B		2	4.2
343	Oak	SM	250	9		6			Fair	C	Poor Form	2	3.0
342	Birch	SM	200	8		4			Good	C	Good form - Retain if at all possible	2	2.4
341	Birch	SM	200	8		4			Good	C	Retain if possible	2	2.4
340	Birch	SM	200	8		4			Good	C	Retain if possible	2	2.4
339	Norway Maple	IM	150	5		2			Good	C	Retain if possible	2	1.8

338	Norway Maple	IM	200	8		4			Good	C	Retain if possible	2	2.4
337	Norway Maple	IM	200	8		4			Good	C	Retain if possible	2	2.4
336	Birch	IM	150	5		4			Good	C	Retain if possible	2	1.8
335	Birch	IM	150	5		4			Good	C	Retain if possible	2	1.8
334	Birch	IM	150	5		4			Good	C	Retain if possible	2	1.8

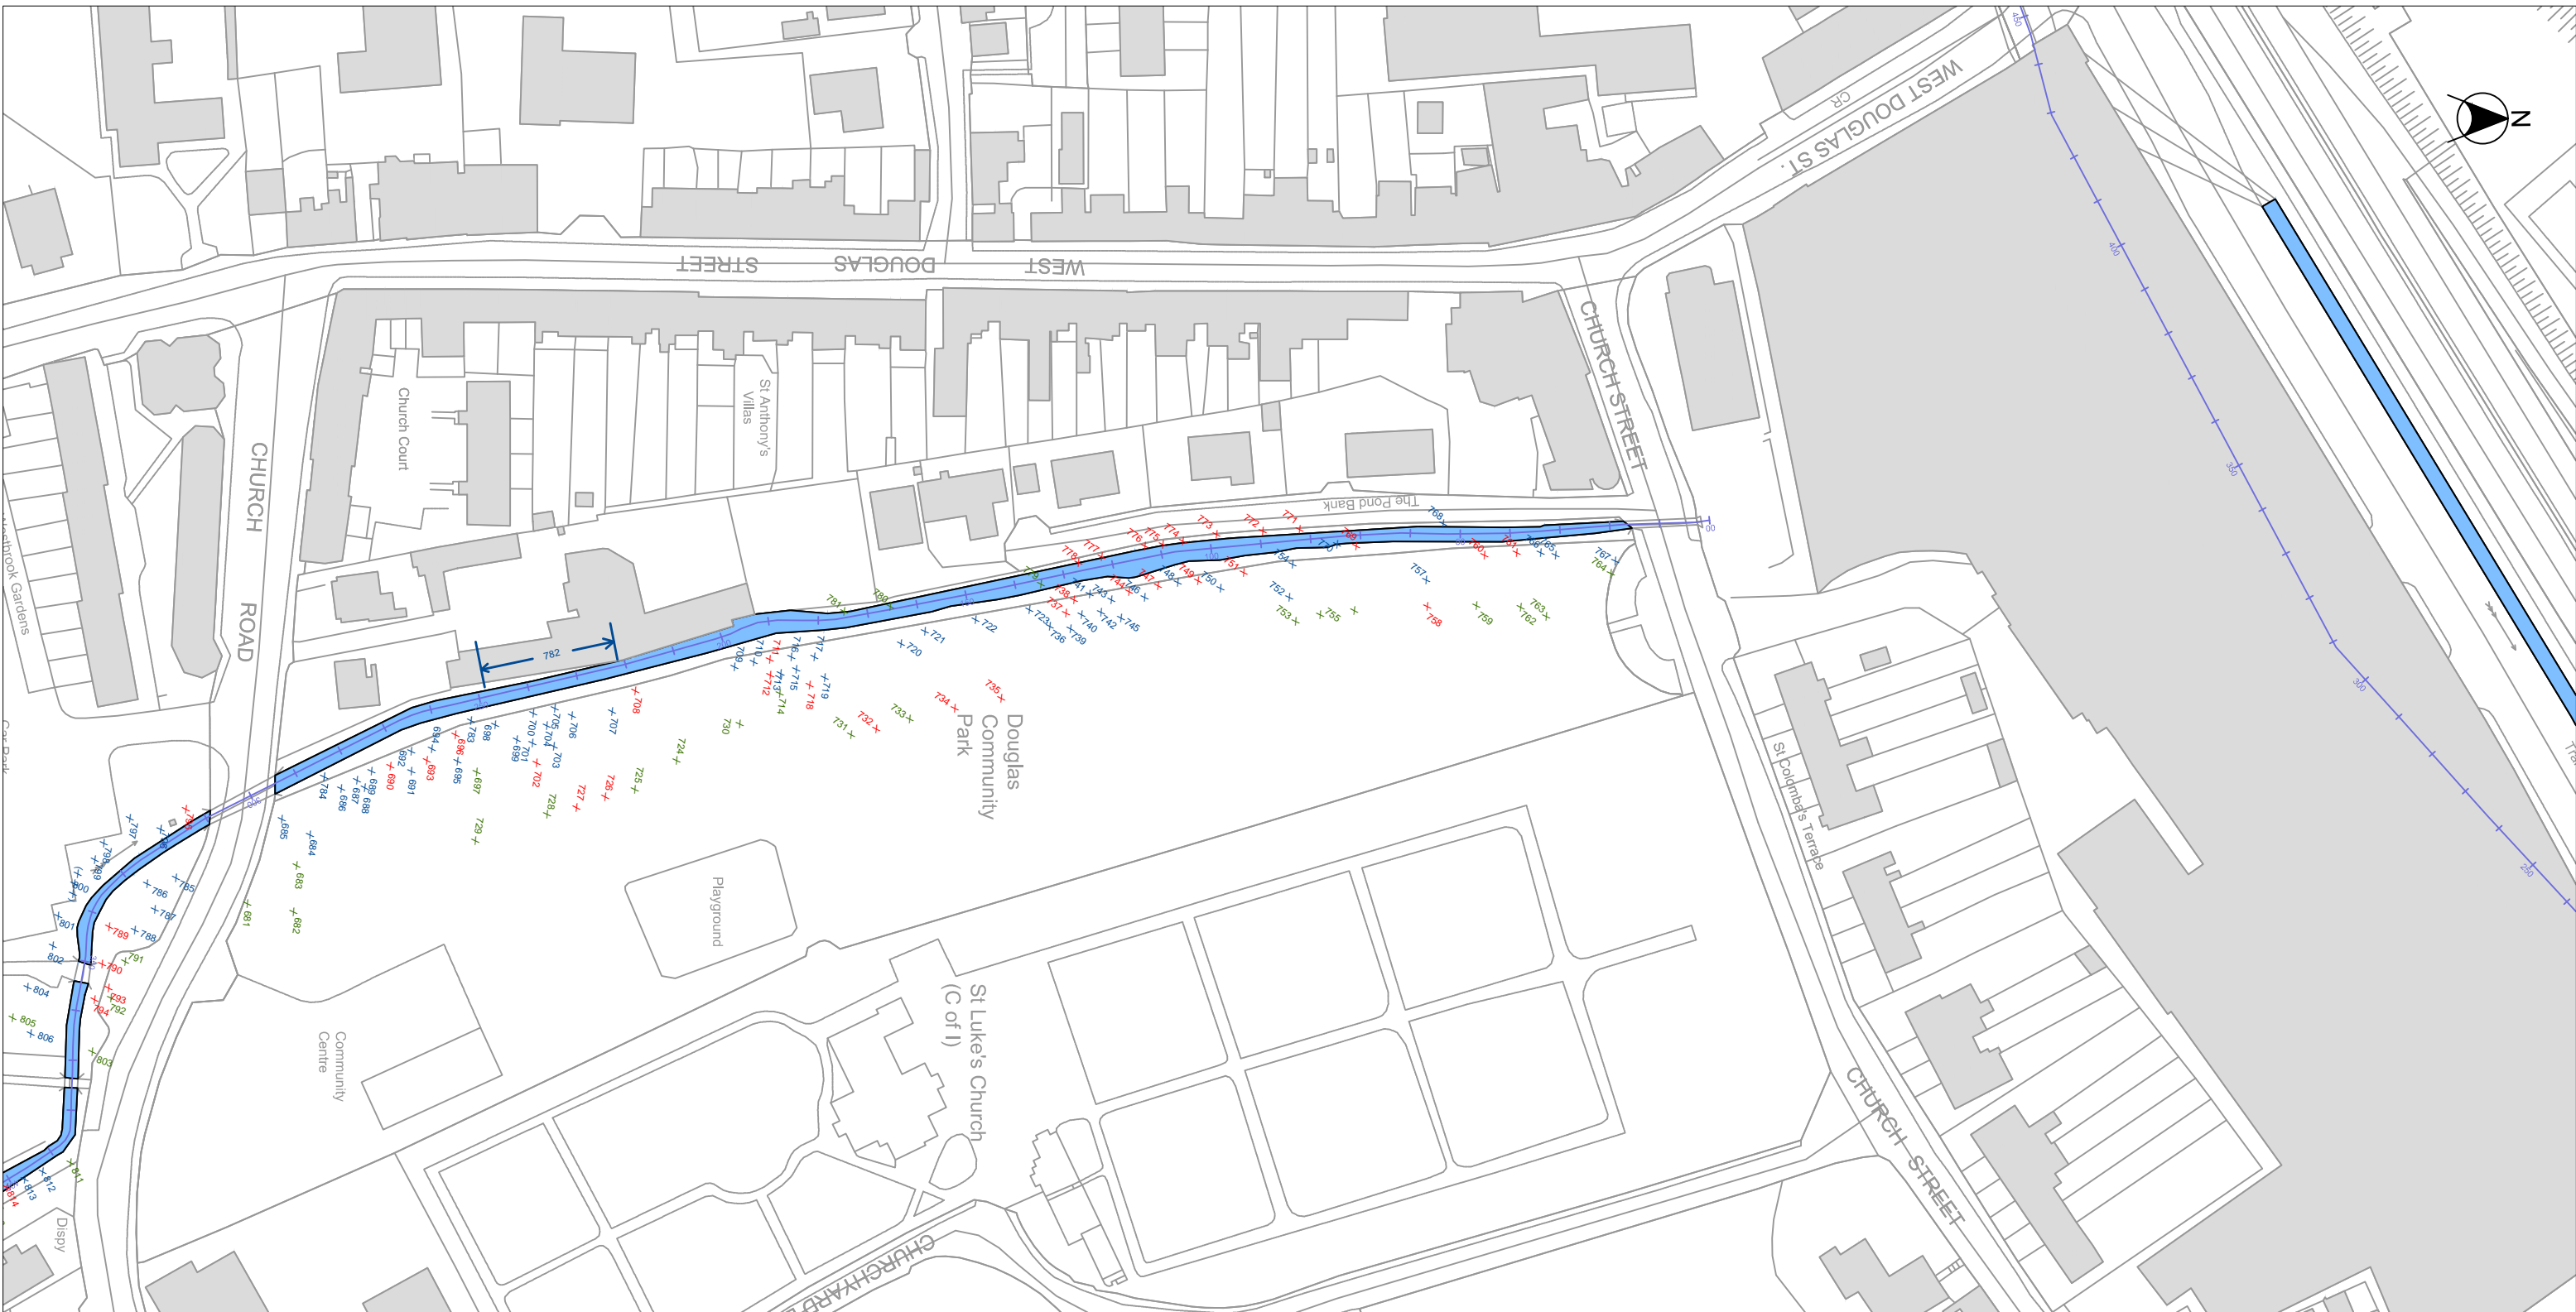
Drawing No.: C-000-011 TS (04/04/2017)-Tree Survey (Not to Scale)

No.	Species	Age Class	Girth (mm)	Height (m)	Spread (m)				Condition	Risk Code	Comments	Rec	RPA (m)
					N	E	S	W					
681	Sycamore	SM	300	8		7			Good	C		1	3.6
682	Ash	SM	400	9		8			Good	C		1	4.8
683	Norway Maple	SM	350	8		8			Good	C		1	4.2
684	Norway Maple	SM	260	7		7			Good	C		2	4.2
685	Ash	SM	300	7		7			Good	C		2	3.6
686	Norway Maple	SM	300	7		6			Good	C		2	3.6
687	Birch	IM	150	6		3			Good	C		2	1.8
688	Birch	IM	200	6		4			Good	C		2	2.4
689	Birch	IM	190	6		4			Good	C		2	2.4
690	Norway Maple	SM	400	8		9			Poor	B	Poor form	3	-
691	Norway Maple	SM	300	9		8			Good	C		2	3.6
692	Norway Maple	SM	320	8		7			Good	C		2	3.9
693	Norway Maple	SM	300	8		7			Good	C	Could remove or thin	3	3.6
694	Norway Maple	SM	290	9		9			Good	C		2	3.6
695	Norway Maple	SM	400	8		7			Poor	B	Poor form	2	4.8
696	Norway Maple	SM	280	8		7			Poor	B	Poor form/fork	3	-
697	Norway Maple	SM	290	7		6			Good	C		1	3.3
698	Norway Maple	IM	280	7		6			Good	C		2	3.3

699	Field Maple	M	320	8		6			Good	C	Good tree	2	3.9
700	Field Maple	M	300	8		6			Good	C	Good tree	2	3.6
701	Norway Maple	SM	280	7		7			Good	C	Could thin	2	3.3
702	Norway Maple	SM	300	7		7			Poor	B	Poor form	3	-
703	Norway Maple	SM	250	7		7			Good	C		2	3.0
704	Norway Maple	SM	260	8		7			Good	B	Good form. Could thin	2	3.3
705	Norway Maple	SM	250	8		6			Good	C		2	3.0
706	Lime	SM	350	10		8			Good	C		2	4.2
707	Birch	SM	250	8		3			Good	C		2	3.0
708	Lime	SM	350	8		7			Fair	B	Close to bank. Leaning	3	-
709	Lime	SM	320	8		7			Good	C	Good form	2	3.9
710	Lime	SM	320	8		7			Good	C		2	3.9
711	Lime	SM	300	8		7			Fair	C	Forked	3	-

No.	Species	Age Class	Girth (mm)	Height (m)	Spread (m)				Condition	Risk Code	Comments	Rec	RPA (m)
					N	E	S	W					
712	Lime	SM	450	9		7			Poor	A	Rot at base	3	-
713	Lime	SM	150	5		3			Poor	B	Suppressed	2	1.8
714	Aspen	M	400	11		8			Good	C	Good tree	1	4.8
715	Ash	SM	250	6		4				B	Suppressed	2	3.0
716	Lime	SM	280	9		5			Good	C		2	3.3
717	Lime	SM	350	10		6			Good	C		2	4.2
718	Lime	SM	250	7		5			Fair	B	Suppressed	3	-
719	Aspen	IM	440	11		8			Good	C		2	5.4
720	Aspen	M	400	12		8			Good	C		2	4.8
721	Norway Maple	SM	400	10		8			Good	C		2	4.8
722	Lime	M	450	11		9			Good	C		2	5.4
723	Lime	SM	400	10		8			Fair	B	Forked	2	4.8
724	Rowan	M	250	7		6			Good	C		1	3.0
725	Rowan	M	250	7		6			Good	C		1	3.0
726	Maple	SM	350	9		7			Poor	B	Damaged base	3	-
727	Maple	SM	360	9		7			Poor	B	Damaged base	3	-
728	Lime	M	680	12		10			Good	C		1	8.1
729	Norway Maple	SM	360	9		8			Good	C		1	4.2
730	Rowan	M	240	7		6			Good	C		1	2.7
731	Norway Maple	SM	380	11		8			Good	C		1	4.5

732	Norway Maple	SM	400	10		8			Fair	B		3	-
733	Ash	SM	400	11		9			Good	C		1	4.8
734	Norway Maple	SM	380	11		9			Fair	B	Forked. Poor form	3	-
735	Field Maple	SM	420	11		9			Fair	B	Damaged stem	3	-
736	Oak	SM	320	9		5			Fair	B	Poor form	2	3.9
737	Horse Chestnut	SM	280	9		4			Good	B	Thin out	3	-
738	Horse Chestnut	SM	330	9		6			Fair	B	Thin out/Damaged stems	3	-
739	Norway Maple	SM	250	9		6			Good	C		2	3.0
740	Norway Maple	SM	340	10		8			Good	C		2	4.2
741	Field Maple	SM	300	9		5			Good	C		2	3.6
742	Norway Maple	SM	280	8		5			Good	C		2	3.3

No.	Species	Age Class	Girth (mm)	Height (m)	Spread (m)				Condition	Risk Code	Comments	Rec	RPA (m)
					N	E	S	W					
743	Norway Maple	SM	200	9		6			Good	C		2	2.4
744	Norway Maple	M	500	11		10			Poor	B	Poor form	3	-
745	Norway Maple	SM	240	10		5			Good	C		2	3.0
746	Norway Maple	SM	230	10		5			Good	C		2	2.7
747	Horse Chestnut	SM	350	11		8			Poor	B	Poor form	3	-
748	Field Maple	M	320	11		8			Good	C		2	3.9
749	Norway Maple	SM	380	10		8			Poor	B	Poor form	3	-
750	Lime	SM	280	10		9			Good	C		2	3.3
751	Norway Maple	SM	480	12		10			Poor	B	Poor form	3	-
752	Field Maple	M	320	10		7			Good	C		2	3.9
753	Field Maple	M	480	11		8			Good	C		1	5.4
754	Horse Chestnut	SM	360	9		9			Good	C		2	4.2
755	Field Maple	M	440	10		8				C		1	5.4
756	Field Maple	M	400	10		9			Good	C		1	4.8
757	Norway Maple	SM	400	12		10			Good	C		2	4.8
758	Norway Maple	SM	400	12		10			Poor	B		3	-
759	Norway Maple	SM	400	12		10				C		1	4.8
760	Norway Maple	SM	430	11		8			Fair	B	Poor form	3	-

761	Norway Maple	SM	380	10		6			Fair	C	Close to facilities	3	-
762	Norway Maple	SM	380	10		8			Good	C		1	4.5
763	Norway Maple	SM	350	10		6			Good	C		1	4.2
764	Lime	SM	400	9		8			Good	C		1	4.8
765	Norway Maple	SM	360	10		8			Fair	B	Poor form	2	4.2
766	Norway Maple	SM	300	10		6			Fair	B	Close to river	2	3.6
767	Norway Maple	SM	250	10		8			Fair	B	Damaged. NO TAG	2	3.0
768	Alder	M	400	10		10			Good	C	3 stems (1 sycamore). NO TAG	2	4.8
769	Sycamore	SM	280	10		3			Poor	B	Poor form	3	-
770	Ash	M	450	5		3			Fair	C	Pollarded	2	5.4
771	Ash	IM	300	10		4			Good	B	Can't reach potential	3	-
772	Ash	IM	200	9		4			Good	B	Can't reach potential	3	-
773	Ash	IM	350	10		8			Fair	B	Won't reach potential	3	-

No.	Species	Age Class	Girth (mm)	Height (m)	Spread (m)				Condition	Risk Code	Comments	Rec	RPA (m)
					N	E	S	W					
774	Sycamore	IM	350	11		9			Fair	B	Won't reach potential	3	-
775	Sycamore	IM	150	7		3			Fair	B	Won't reach potential	3	-
776	Ash	IM	200	7		5			Fair	B	Won't reach potential	3	-
777	Ash	IM	200	8		5			Fair	B	Won't reach potential	3	-
778	Sycamore	M	400	15		10			Fair	B	4 stems	3	-
779	Alder	M	400	15		10			Fair	C	4 stems	1	4.8
780	Alder	M	800	15		15			Good	C	2 stems	1	9.6
781	Alder	M	500	15		10			Good	C		1	6.0
782	Alder Sycamore Elder	M SM M	300 300 150	15		10			Fair		Could be retained but not if RPA is compromised	2	3.6
783	Sycamore	SM	230	12		10			Fair		4 stems	2	2.7
784	Alder	M	320	10		8			Fair		2 stems	2	3.9
785	Red Oak	SM	320	10		10			Good	C		2	3.9
786	Rowan	M	250	8		6			Fair	B	End of lifespan	2	3.0
787	Lime	SM	350	10		10			Good	C	Poor form	2	4.2
788	Beech	SM	360	10		10			Good	C	Poor form	2	4.5

789	Horse Chestnut	SM	480	10		12			Poor	B	Poor health (Cankered)	3	-
790	Horse Chestnut	SM	300	6		10			Poor	C	Poor form	3	-
791	Western Red Cedar	M	900	20					Fair	B	Reduce crown SURGERY	1	10.8
792	Western Red Cedar	M	840	20		6			Fair	B	Reduce crown SURGERY	1	10.2
793	Ash	SM	280	9		5			Good	C		3	-
794	Elder	M	450	8		5			Good	C		3	-
795	Ash	SM	300	8		6			Poor	B	Cankered. Poor form	3	-
796	Birch	M	300	10		9			Good	C		2	3.6
797	Alder	SM	240	8		7			Good	C	3 stems	2	3.0
798	Alder		320						Fair	B		2	3.9
799	Black Poplar	M	600	25		8			Good	C	SURGERY Reduce crown 30 %	2	7.2
800	Black Poplar	M	500	25		10			Fair	B	GROUP of 3 trees (1 poor tree) SURGERY reduce 30 %	2	6.0
801	Alder	SM	200	8		5			Good	C	3 stems	2	2.4
802	Atlantic Cedar	SM	230	10		5			Fair	C		2	2.7

No.	Species	Age Class	Girth (mm)	Height (m)	Spread (m)				Condition	Risk Code	Comments	Rec	RPA (m)
					N	E	S	W					
803	Beech	M	850	20		15			Good	C	Damage to stem (Reduce crown 30 % - SURGERY)	1	10.2
804	Rowan	M	350	8		5			Good	C		2	4.2
805	Norway Maple	SM	300	10		9			Good	C		1	3.6
806	Horse Chestnut	SM	400	10		9			Good	C		2	4.8
811	Beech	M	700	22		10			Fair	B	Not tagged. On corner. Crown reduction 30 %	1	8.4

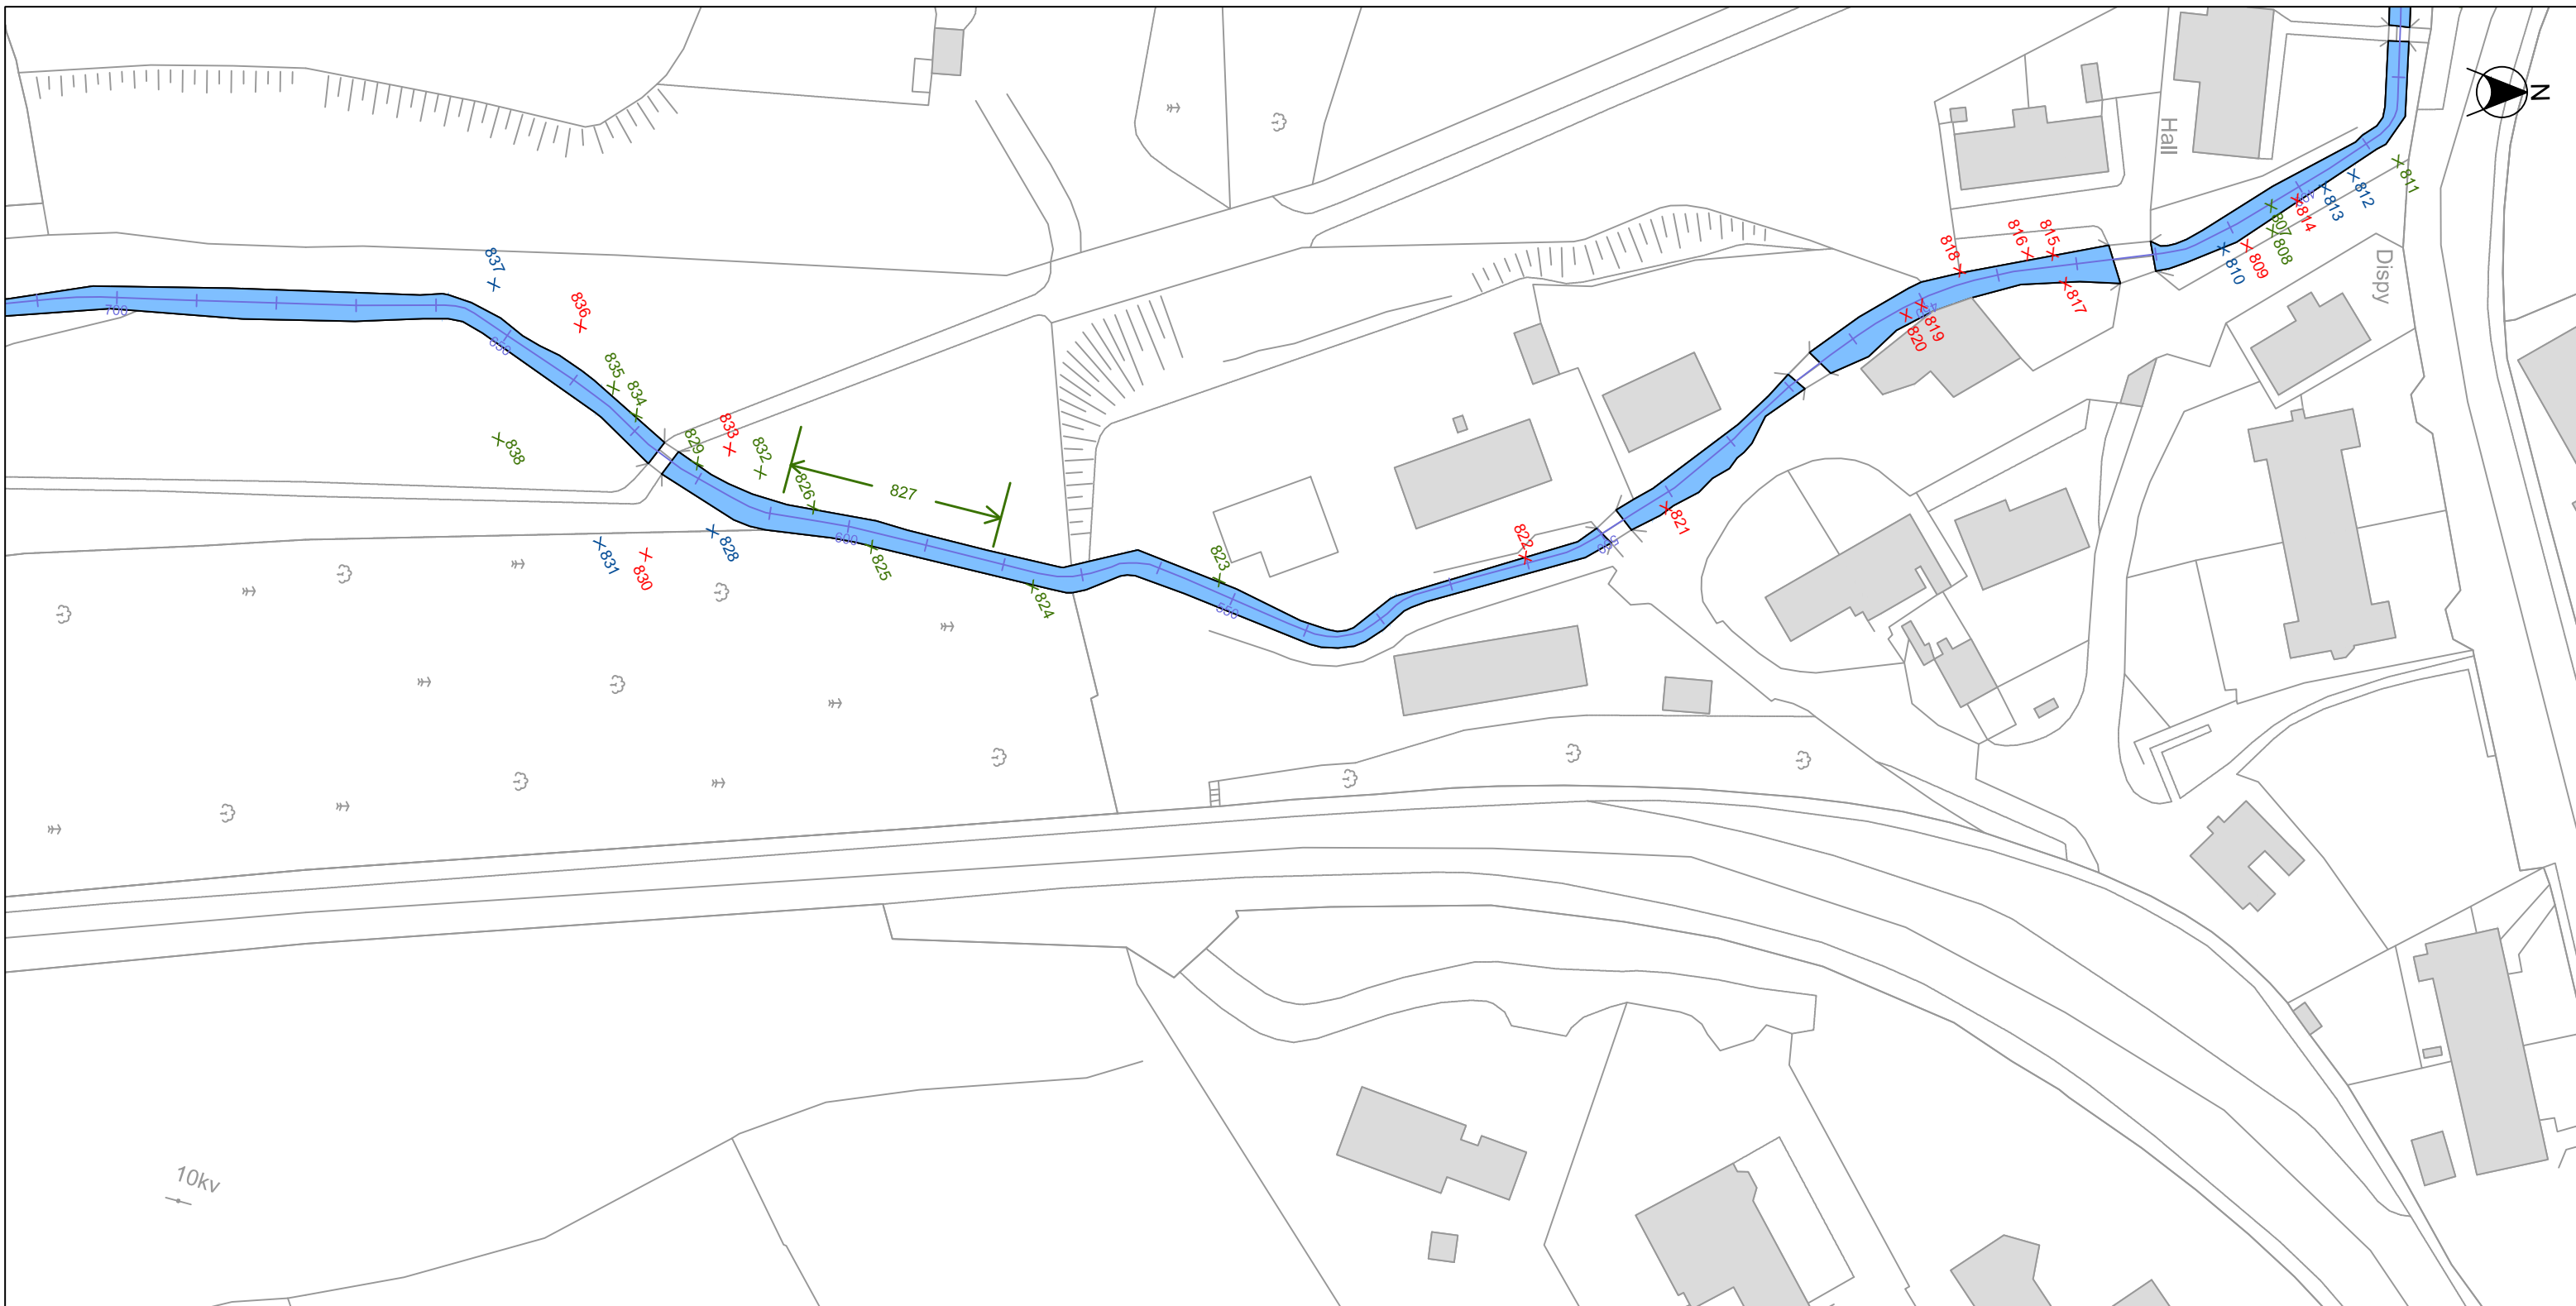
Drawing No.: C-000-012 TS (04/04/2017)-Tree Survey (Not to Scale)

No.	Species	Age Class	Girth (mm)	Height (m)	Spread (m)				Condition	Risk Code	Comments	Rec	RPA (m)
					N	E	S	W					
807	Holly	M	200	8		4			Good	C	2 stems	1	2.4
808	Ash	SM	300	15		10			Fair	B	2 trees - Over stream and road	1	3.6
809	Holly	M	280	10		8			Fair	B	Undermined. 3 stems	3	-
810	Sycamore	IM	200	6		3			Fair	B		2	2.4
811	Beech	M	700	22		10			Fair	B	Not tagged. On corner. Crown reduction 30 %	1	8.4
812	Beech	M	750	22		10			Fair	B	Thin crown or fell.	2	9.0
813	Beech	M	400	18			8		Fair	B	Thin crown or fell	2	4.8
814	Elm	SM	300	15			8		Dead	A	Dead	3	-
815	Alder	M	430	12		8			Good	A	In retaining wall	3	-
816	Sycamore	SM	350	12		8			Fair	A	In retaining wall	3	-
817	Alder	IM	200	5		5			Por	A	Remove	3	-
818	Alder	IM	200	9		5			Fair	A	In retaining wall	3	-
819	Willow	SM	150	7		5			Fair	B		3	-
820	Sycamore	IM	200	7		5			Fair	B		3	-
821	Sycamore	SM	300	12		10			Fair	B	6 stems, In retaining	3	-
822	Alder	IM	150	6		4			Fair	B	4 stools	3

823	Sycamore	M	400	6		4			Fair	B	3 stools (1 sycamore) Pollarded	1	6.6
824	Sycamore	M	550	18				10	Good	C	In bank	1	7.2
825	Beech	M	600	20		12			Good	C		1	4.8
826	Sycamore	M	400	20		12			Good	C		1	3.6
827	Alder	SM	300	15		10			Good	C	GROUP of 25 trees	1	9.0
828	Beech	M	750	25		12			Good	B	Reduce crown by 20% - SURGERY	2	7.2
829	Alder	M	600	20		10			Good	C		1	4.8
830	Oak	M	800	20	15				Poor	A	Leaning over river	3	
831	Sycamore	M	550	18				15	Good	C	2 stems	2	2.7
832	Plane	SM	220	12				8	Good	C		1	2.4
833	Plane	IM	190	10		5			Poor	C	Damaged stem	3	3.0
834	Alder	SM	250	15		10			Good	C	5 stems	1	3.6
835	Alder	M	300	18		10			Good	C	5 stems	1	3.8
836	Laurel	M	480	5			10		Poor	B	Fallen	3	
837	Lime		840	25		15			Fair	B	Remove trunk over river - SURGERY	2	3.6

No.	Species	Age Class	Girth (mm)	Height (m)	Spread (m)				Condition	Risk Code	Comments	Rec	RPA (m)
					N	E	S	W					
838	Alder	M	300	15			12		Good	C	Bat boxes present	1	3.8
											GROUP of Alder and Willow		-
