### Tree Survey Report

Project <b>Tree Survey for the Douglas and Togher Flood Relief Scheme.</b>				
Client <b>ARUP</b>				
Project no	No pages	Client reference	©DixonBrosnan 2016	
1653	-	-	v010111	
<p>DixonBrosnan 7 The Cedars Bridewood Ovens Co Cork          Tel 086 8511437   carl@dixonbrosnan.com   www.dixonbrosnan.com</p>				
Report no	Date	Edit	Prepared by	
1666	18/04/17	0 – Issue to client	Mark Donnelly	
			Carl Dixon	
<p style="font-size: small;">This report and its contents are copyright of DixonBrosnan. It may not be reproduced without permission. The report is to be used only for its intended purpose. The report is confidential to the client, and is personal and non-assignable. No liability is admitted to third parties.</p> <p style="text-align: right; font-weight: bold; font-size: small;">Do you <i>really</i> need a printed copy of this report?</p>

## DOUGLAS- Flood Relief Scheme

04/04/2017

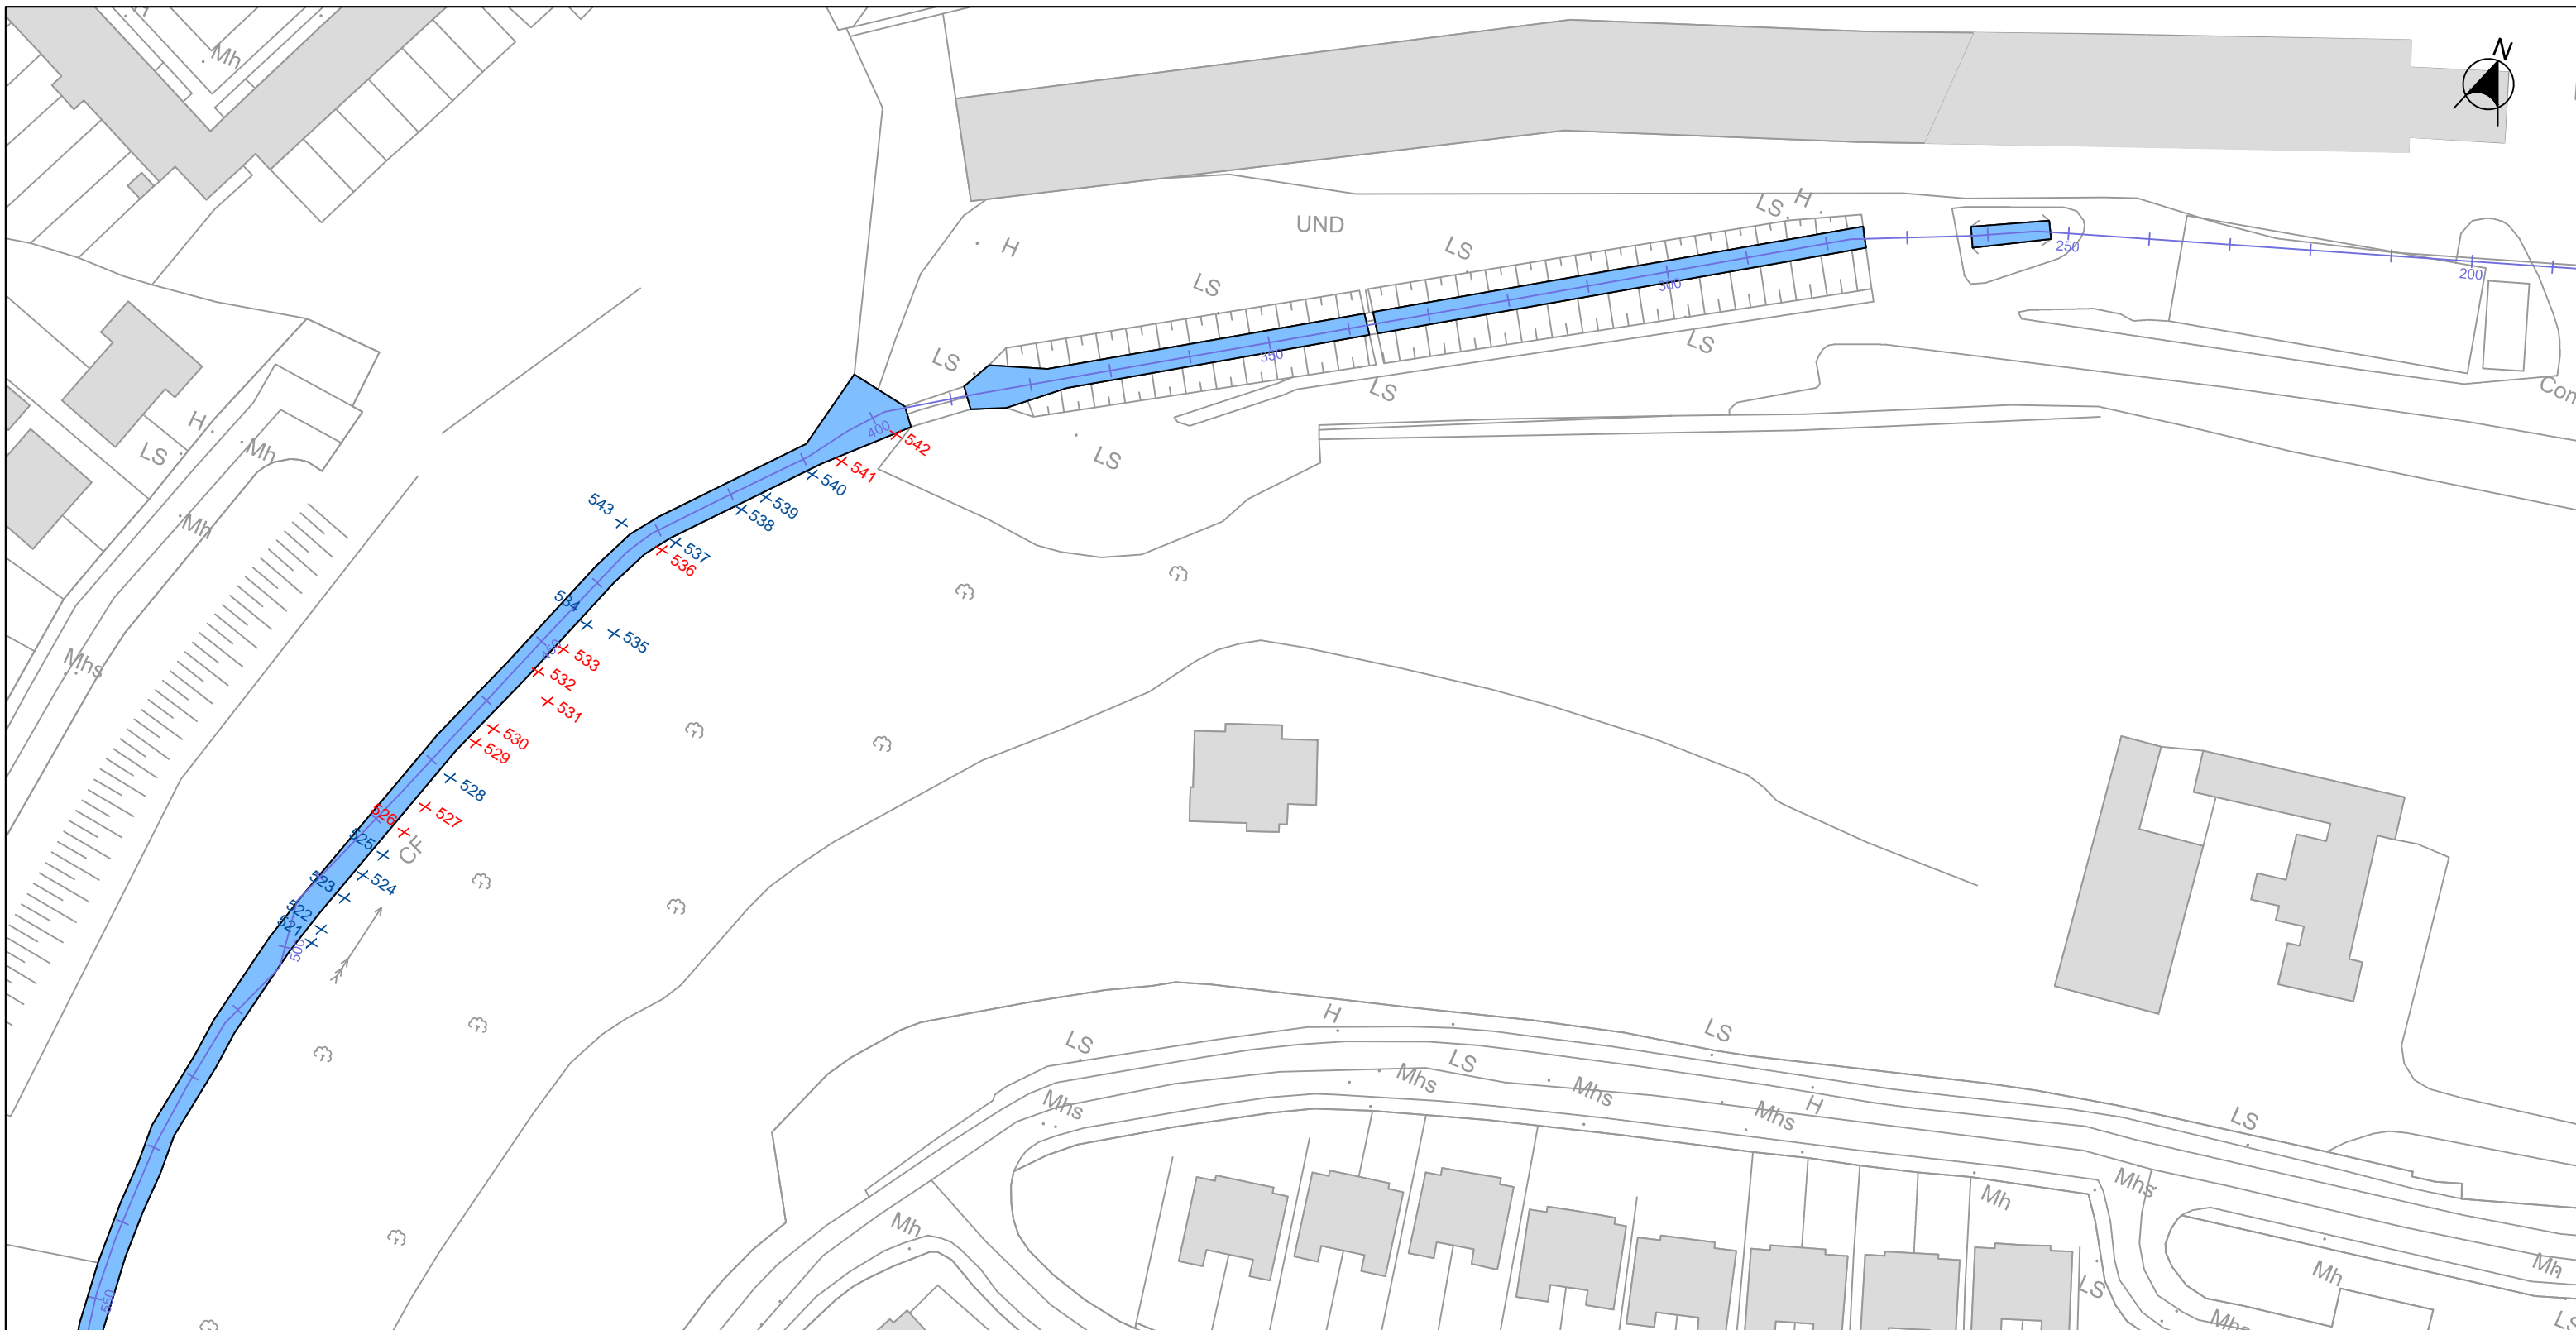
Drawing No.: C-000-0013-TS (04/04/2017)-Tree Survey (Not to Scale)

No.	Species	Age Class	Girth (mm)	Height (m)	Spread (m)				Condition	Risk Code	Comments	Rec	RPA (m)
					N	E	S	W					
521	Lime	M	400	15		8			Good	C	Muti-Stem 3 Minor	2	6.9
522	Alder	M	300	14		6			Good	C	2 Stems	2	5.1
523	Horse Chestnut	M	420	18		10			Good	C	2 Stems	2	5.1
524	Alder	M	300	15	6				Good	C	-	2	3.6
525	Lime	SM	180	16		4			Fair	C	-	2	2.1
526	Alder	M	420	16	8				Fair	B	Over River(1)	3	-
527	Horse Chestnut	SM	300	15		8			Fair	B	Multi-Stemmed- Cavity	3	-
528	Lime	SM	490	20		10			Good	C	Multi stemmed	2	8.5
529	Alder	M	400	19		9			Fair	B	2 stems	3	-
530	Horse Chestnut	M	420	20		10			Good	B	Multi-stemmed (5)	3	-
531	Alder	M	370	18		1			Poor	A	-	3	-
532	Alder	M	430	17	12				Fair	A	Over River	3	-
533	Lime	M	400		8				Good	B	2 Stems	3	-
534	Alder	M	460	16		10			Good	C	3 Stems	2	8.1
535	Alder	M	300	17		10			Good	C	-	2	3.6
536	Holly	M	1470	12	8				Fair	B	Over River	3	-
537	Alder	M	420	18		10			Good	C	-	2	5.1

538	Ash	M	200	17		8			Good	C	-	2	2.4
539	Ash	M	300	18		10			Good	C	2 Stems	2	4.2
540	Ash	M	370	18		12			Good	C	2 Stems	2	3.0
541	Alder	M	330	18		10			Fair	B	-	3	-
542	Alder	M	400	18		10			Poor	A	Multi-stemmed - Isolated	3	-
543	Alder	SM	250	15		5			Good	C	Surrounded by IM Alder	2	3.0
