**Report on Investigations into Planning,  
Environmental Compliance and General Nuisances  
Associated with a Quarry Operated**

**P. McCaffrey & Sons Ltd.  
Ballymagroarty,  
Ballintra,  
Co. Donegal**

**REPORT**

December, 2000

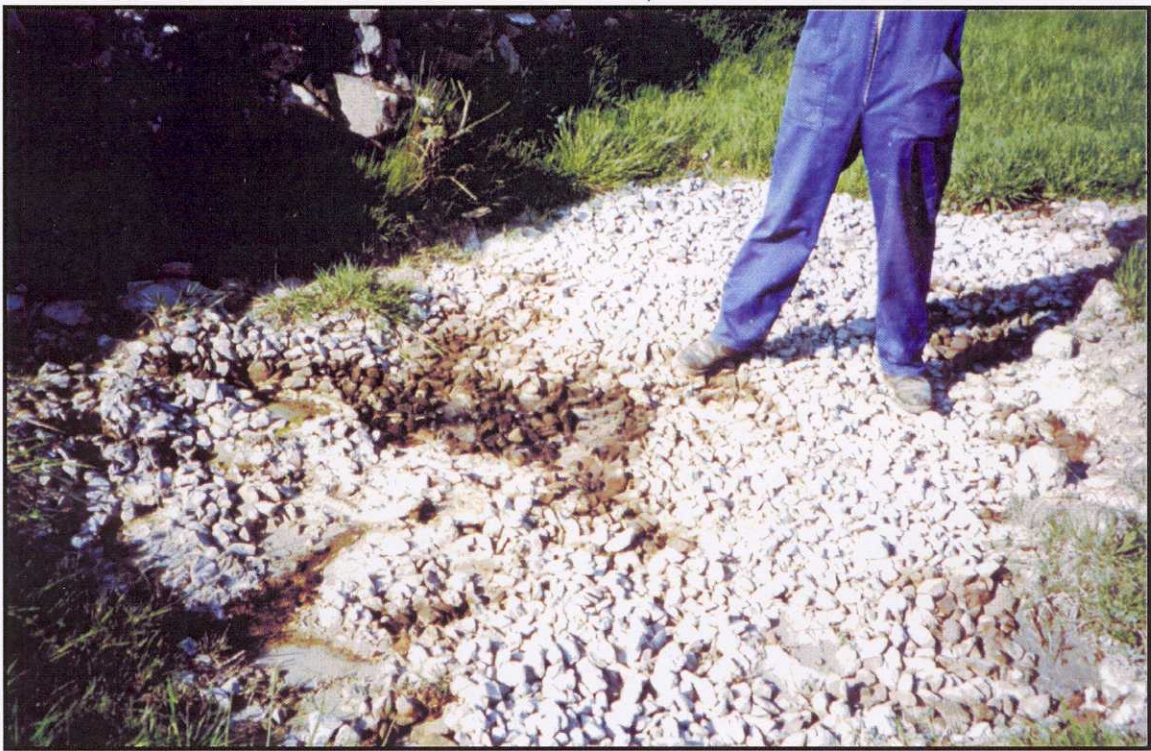
An examination of the site earlier this year showed in addition to the area where surface water is directed towards the soakpit, at another location surface water is flowing through a ditch and contaminating the Gorman's property with tar residues. At this location run-off from the on-site landfill is also migrating into the Gorman's property. Photographs 19 to 22 attached show how the Gorman's property has been impacted with the run off of waste water that contains dust, dirt, oil, grease etc

Stained soakway area from Mc Caffreys surface run-off.

It is therefore recommended that all contaminated soil on the Gorman's property is excavated and properly disposed off. Because of the elevated concentrations of certain parameters this soil under EPA guidelines is classified as hazardous waste. It will therefore most likely have to be shipped out of the country for disposal.

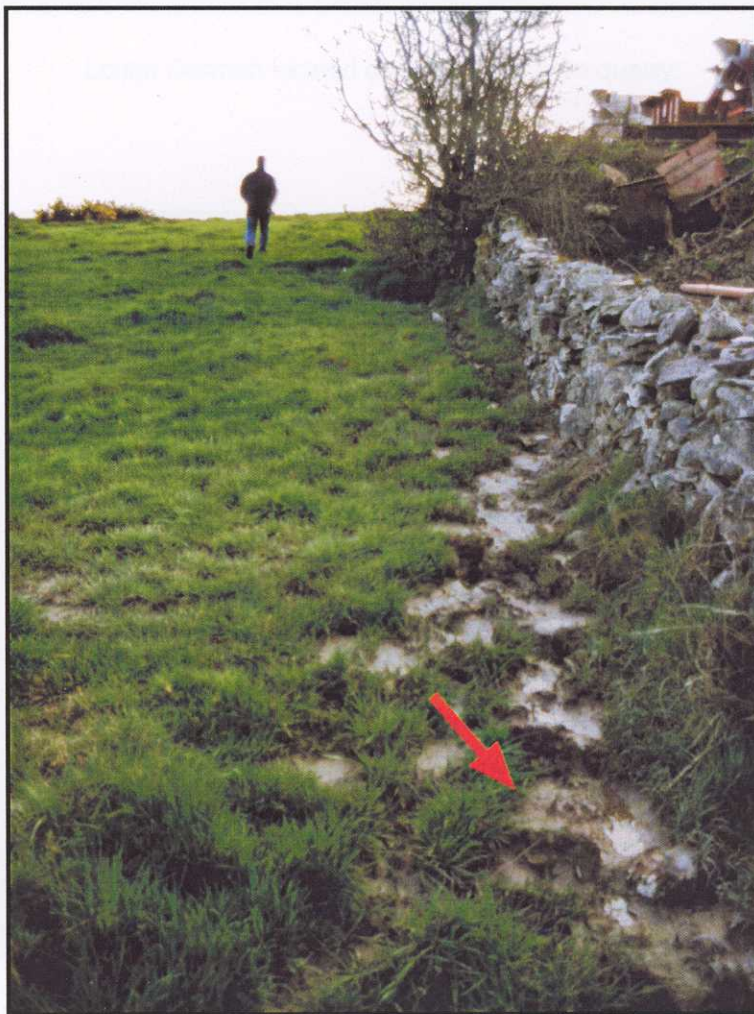
Surface run-off from Mc Caffreys.

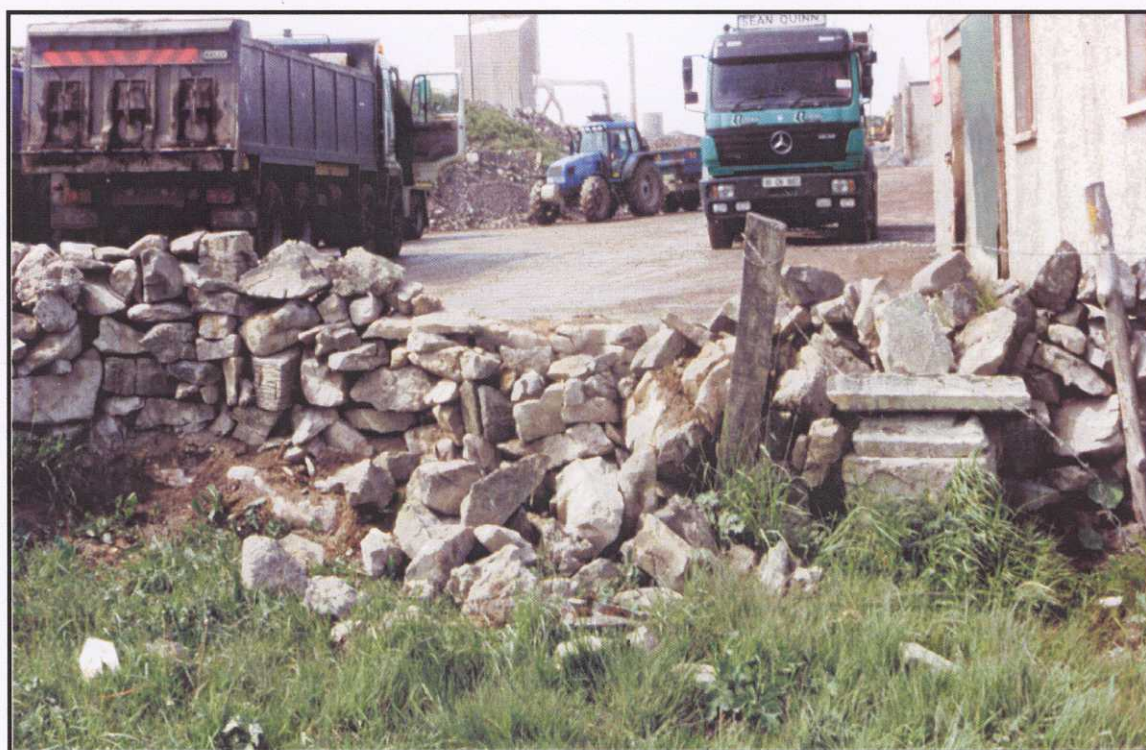
According to the Gormans the McCaffreys management were asked several times to rebuild the ditches, but maintain it is not their responsibility. Obviously the issue of who is responsible for repairs to these ditches needs to be established so that a permanent solution can be found to this problem. Otherwise there exists a risk of public liability claims arising from stock breaching these lands.

Damaged boundary wall between quarry and Gormans land.
