Quarry at Glasbolie, Ballintra, Co. Donegal

SU0128

Review Comments¹ on the Hydrogeological Sections of:

- 1. Environmental Impact Statement Section 37L Application; and
- 2. Revised Remedial Environmental Impact Statement

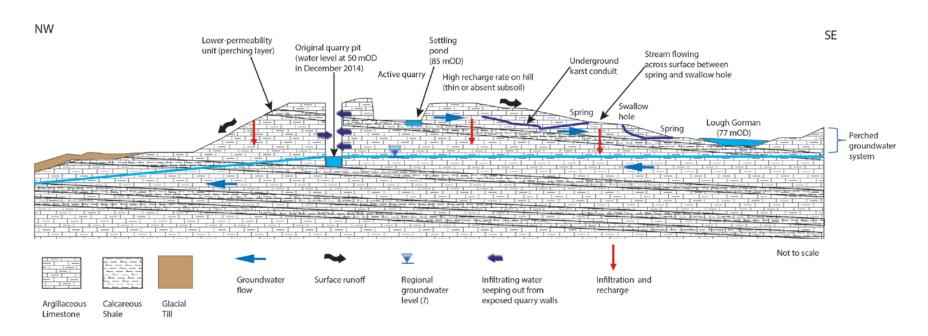
Numerous seeps at several different elevations are also visible high up on the exposed cliff faces of the existing quarries. These support the possible presence of perched water. Some of the seeps occur at discrete cm-scale points rather than along bedding or other horizons. This indicates that rainwater which infiltrates on higher ground may partly be transported laterally in a shallow karst. It can partly also recharge a deeper regional flow system which would be inferred to flow towards Lough Durnesh and the coastline. A conceptual hydrogeological cross-section between Glasbolie Hill and Lough Gorman is shown in **Figure 1**.

Figure 1: Conceptual hydrogeological cross-section between Glasbolie Hill and Lough Gorman

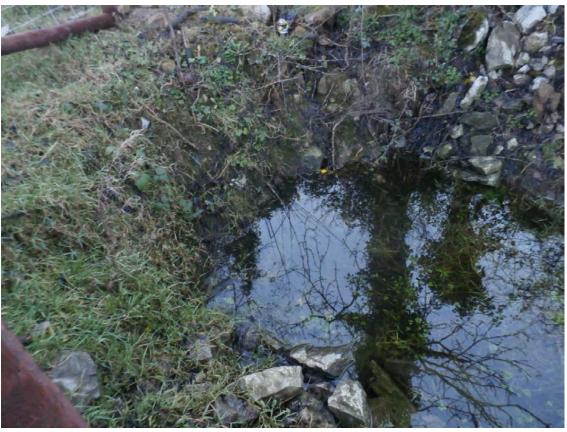
Location L: Active Swallow Hole

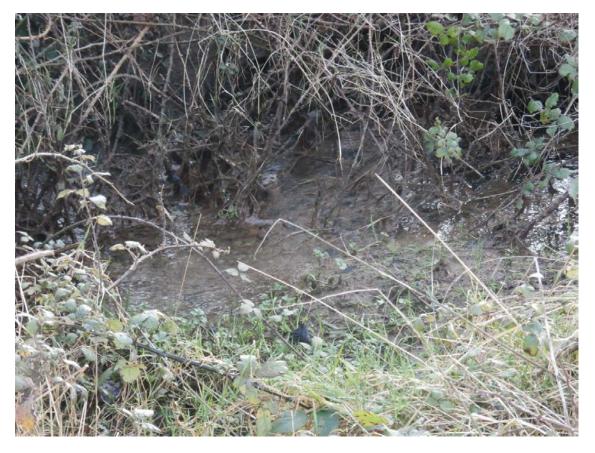
Location K: Spring at Gorman's

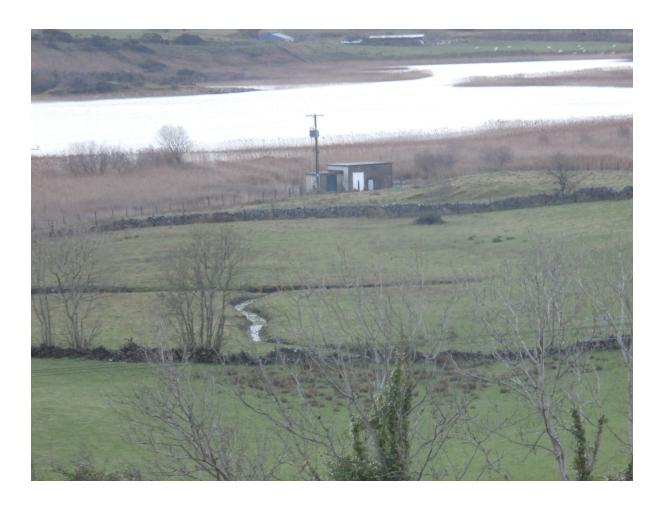
Location F: looking south towards Lough Gorman
In the foreground is the spring at Location E which drains into Lough Gorman. Visible in the background is the pumping station for the Ballymagroarty Water Supply and fen vegetation surrounding Lough

Gorman

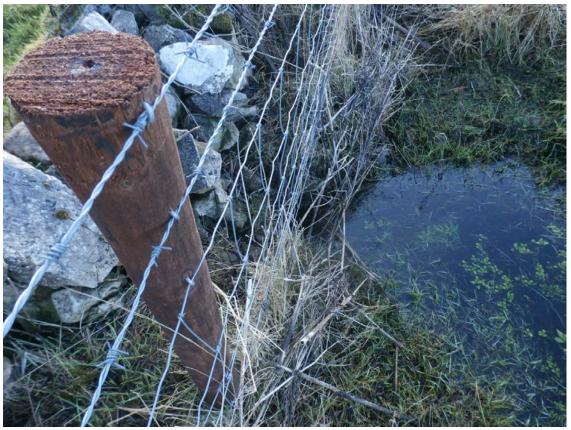
Location G: Active Swallow Hole

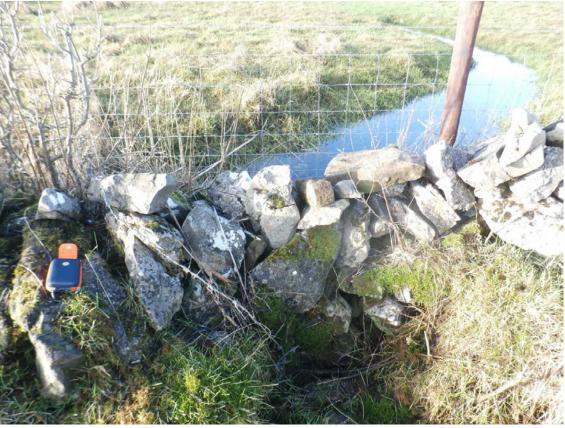
Location G: Active Swallow Hole

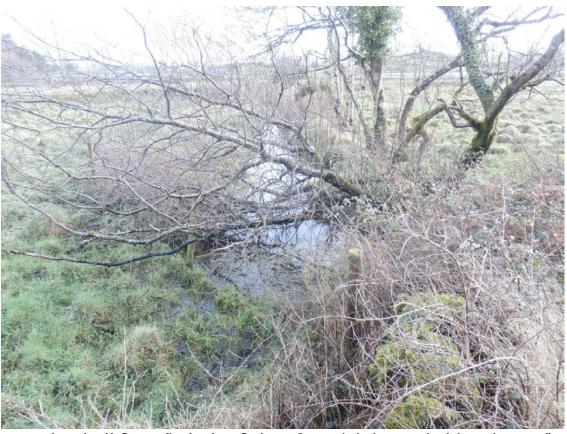
Location K: Stream flowing from Spring at Gorman's (subsequently sinks underground)

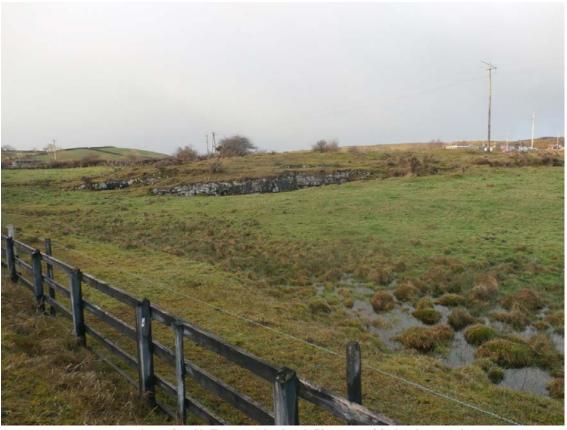
Location N: Exposed bedrock (limestone) in background

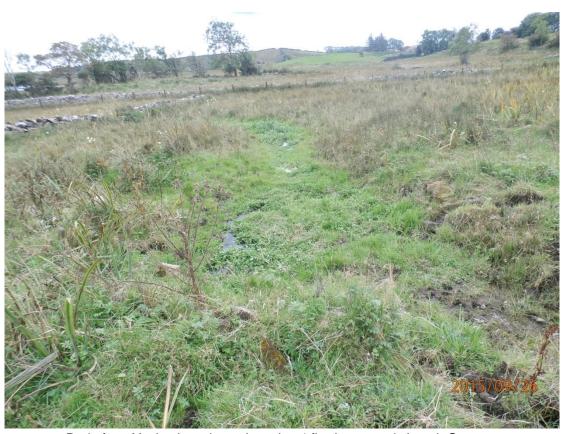
Drain from Yankee's spring at Location 4 flowing towards Lough Gorman

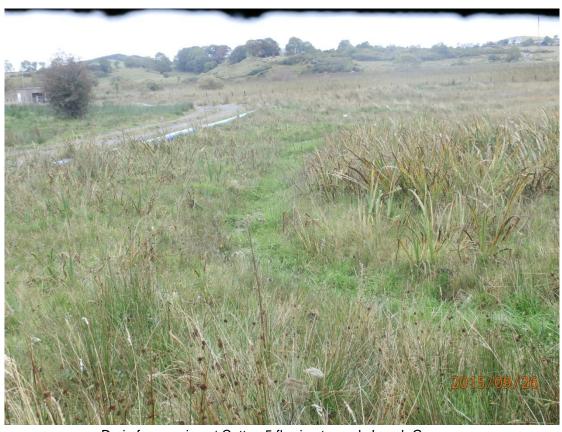
Drain from spring at Cotton 5 flowing towards Lough Gorman
Pumphouse for Ballymagroarty Group Water Supply at Lough Gorman in background
Colour and type of vegetation indicates ground water

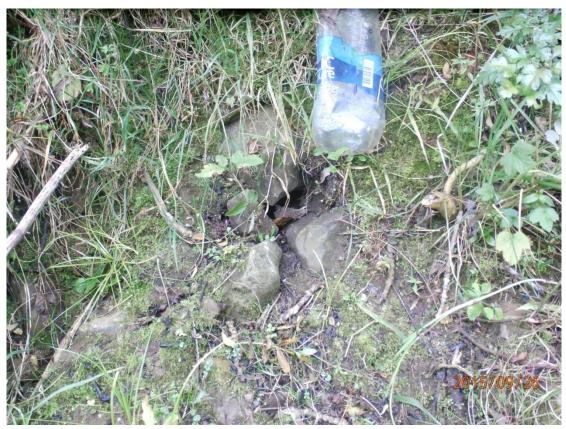
Dry Swallow Hole adjacent to SW No 1 (invert level 83.481mOD)

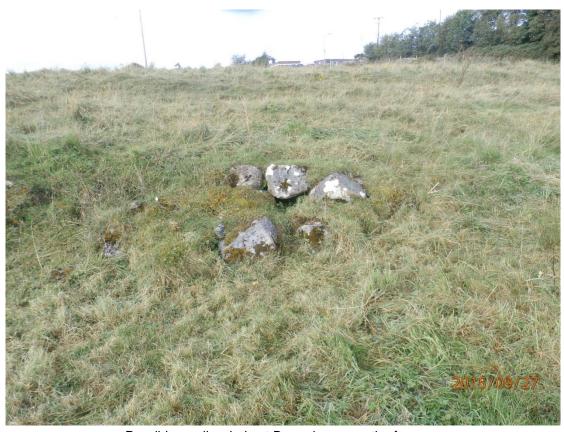
Possible swallow hole at Barnyderg – south of quarry

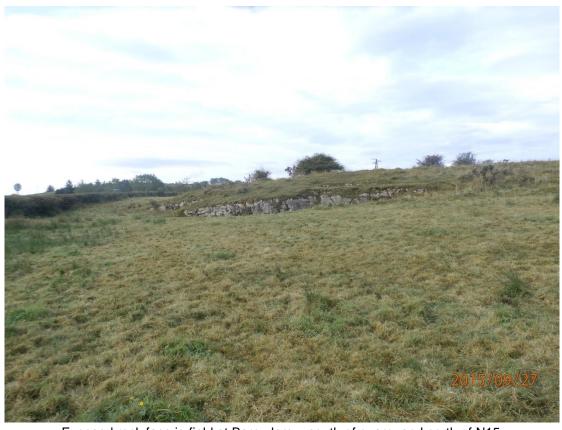
Exposed rock face in field at Barnyderg – south of quarry and north of N15

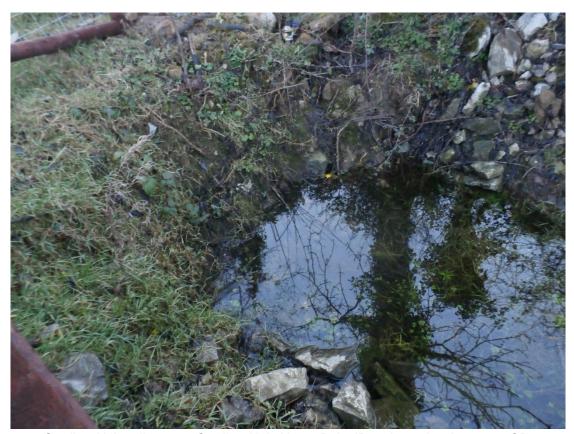
Swallow Hole adjacent to Swallow Hole No 1- Point ID 81 invert level 83.481mOD Swallow Hole working January 2015

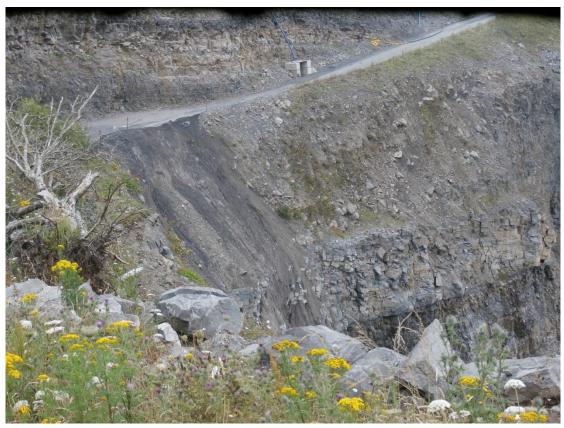
Access road into north quarry with deposition from dumping 07/08/2015

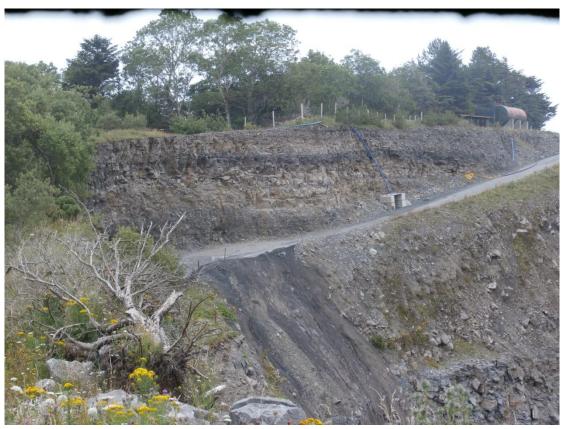
Access road into north quarry with deposition from unauthorised dumping on cliff face 07/08/2015

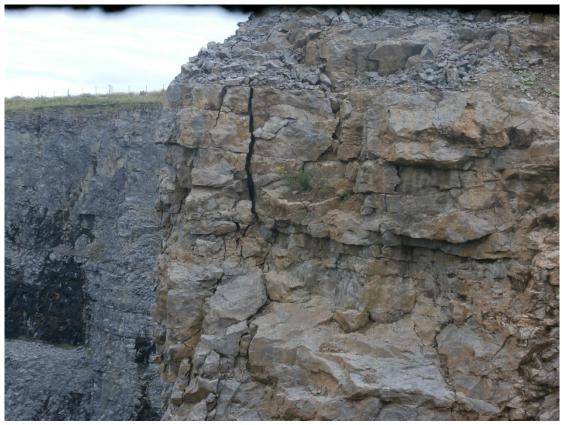
Photograph of west face of north quarry with cracks through rock face 07/08/2015

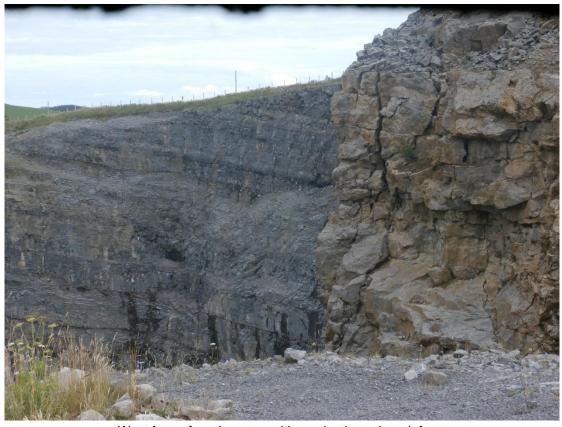
West face of north quarry with cracks through rock face 07/08/2015

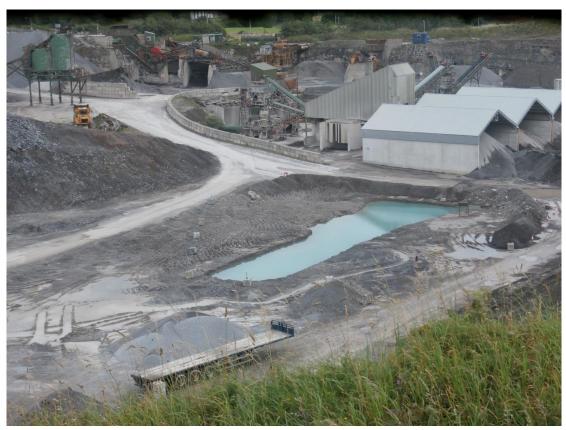
South Quarry – additional pond recently excavated in floor of quarry 07/08/2015
