- **Appendix 6.3 Hedgerow Impact Study**

SEPTEMBER 2011

TOBIN CONSULTING ENGINEERS

Client:	EirGrid Plc
Project:	North South 400kV Interconnection Development
Title:	Benchmark Hedgerow Studies

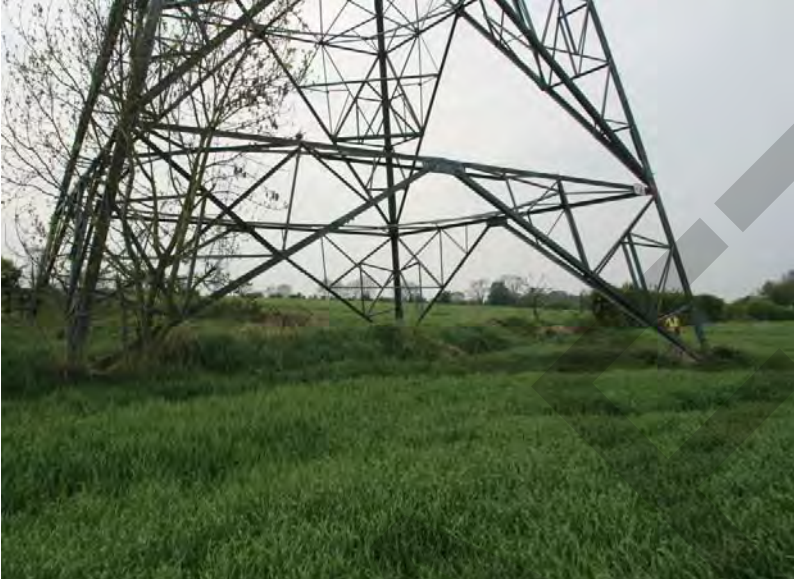
<p>Angle tower with entire hedge removed and no significant recovery. Note existing managed hedgerow in background. This tower is located at the junction of 2 "low value" hedgerows.</p>
2

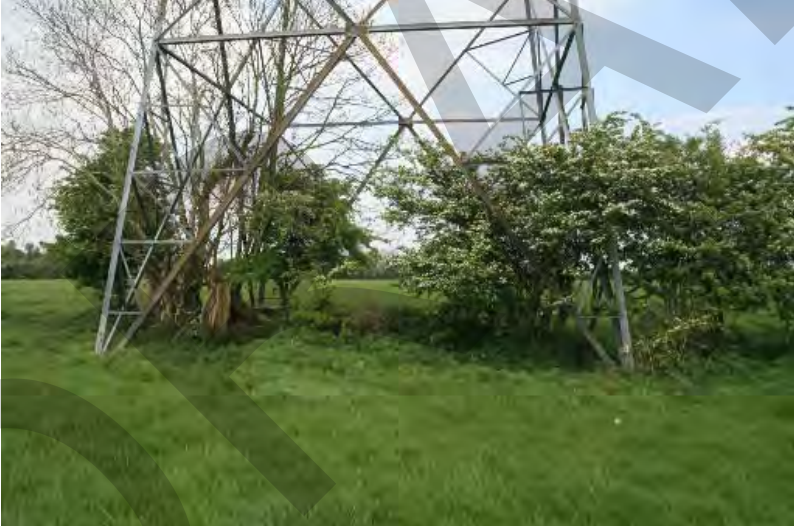
<p>Intermediate tower with limited woody vegetation recovery. Vegetation was pollarded rather than completely removed during construction.</p> <p>Hedgerow either side has low evaluation and is heavily grazed by sheep preventing recovery/ re-establishment.</p>

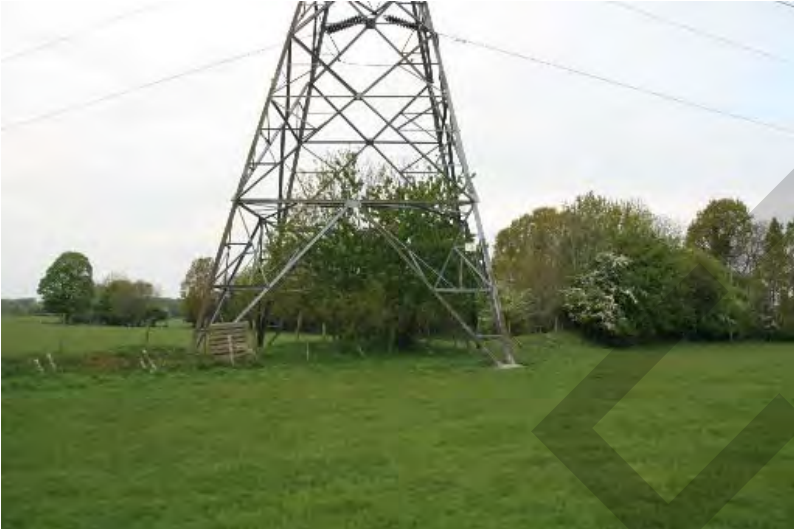
<p>Intermediate tower with limited woody vegetation recovery. Some woody vegetation was pollarded rather than completely removed during construction.</p> <p>Hedgerow either side has low evaluation and is heavily grazed by sheep preventing recovery/ re-establishment.</p>
11

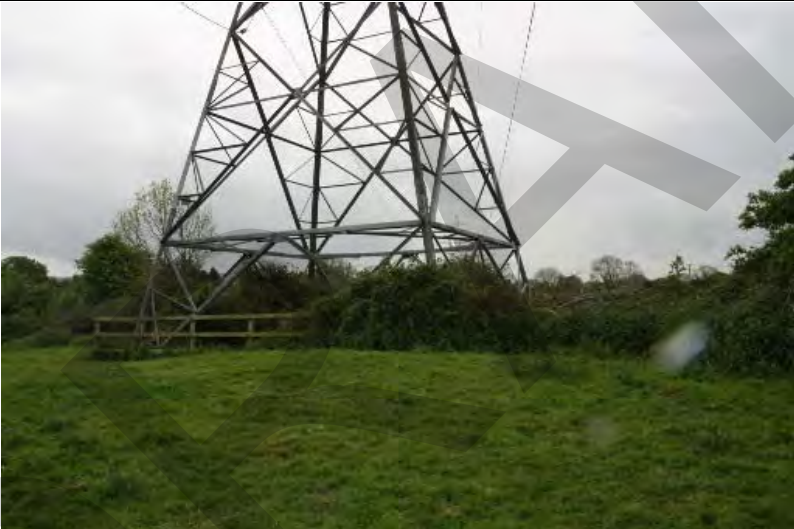
11	Angle	Livestock	Tower base surrounded by wood fence. Hedgerow (30m) replaced by bramble thicket.	Species poor hawthorn and elder unmanaged hedgerow. Damaged cattle. Some woodland ground flora. Livestock	Rabbits, passerines	Moderate	Loss of woody hedgerow species at tower location. Dense brambles maintain connectivity
12	Intermediate	Livestock	Hedgerow completely removed at 7m wide gap.	Species poor (rose, ivy, bramble, ash hawthorn) some woodland flora (e.g. viola, primula). Long term managed. Damaged by cattle.	Rabbits, passerines. No bat activity noted in this area during survey.	Moderate	Loss of woody hedgerow species at tower location.

<p>Moderate value hedgerow. Tower base surrounded by wood fence. Hedgerow (30m) replaced by bramble thicket. Note fencing, to keep livestock out, allows some woody vegetation to re-establish</p>

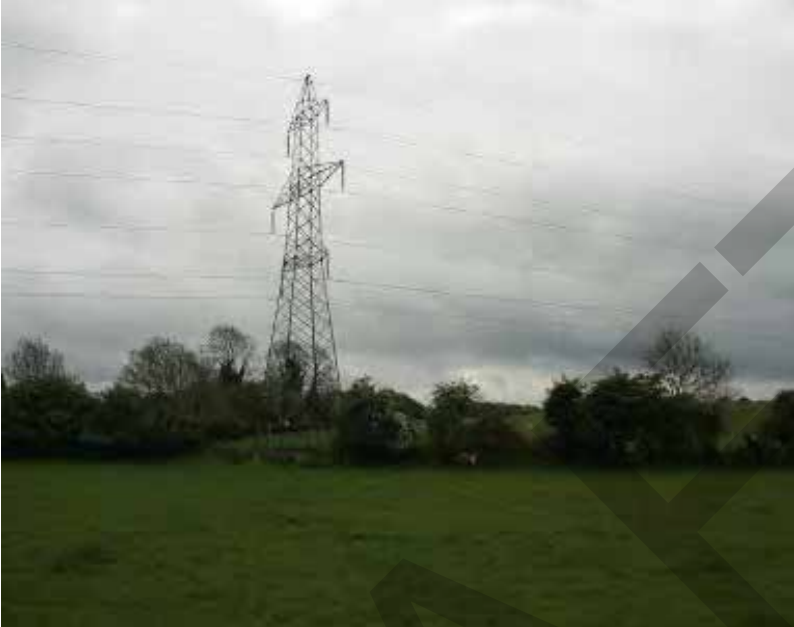
<p>Moderate value Hedgerow with section completely removed at 7m wide gap where tower located</p>
13

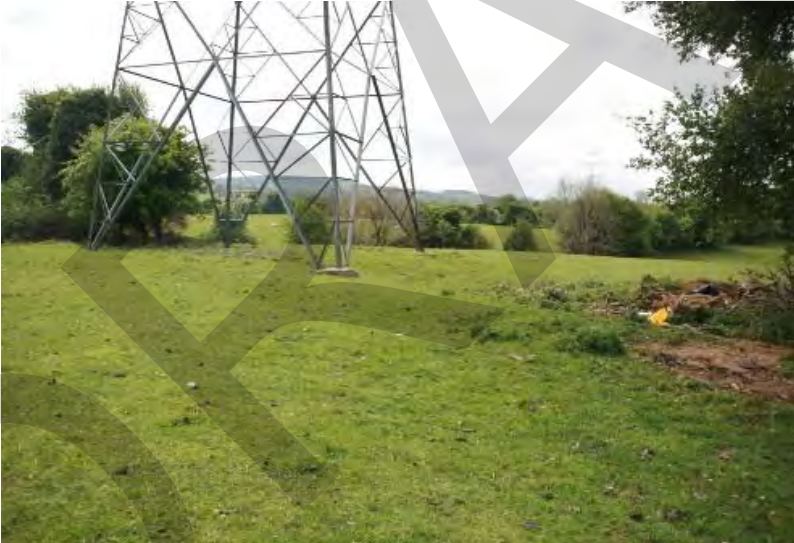
<p>Hedgerow completely removed at 25m wide gap where intermediate tower located. No reinstatement</p>

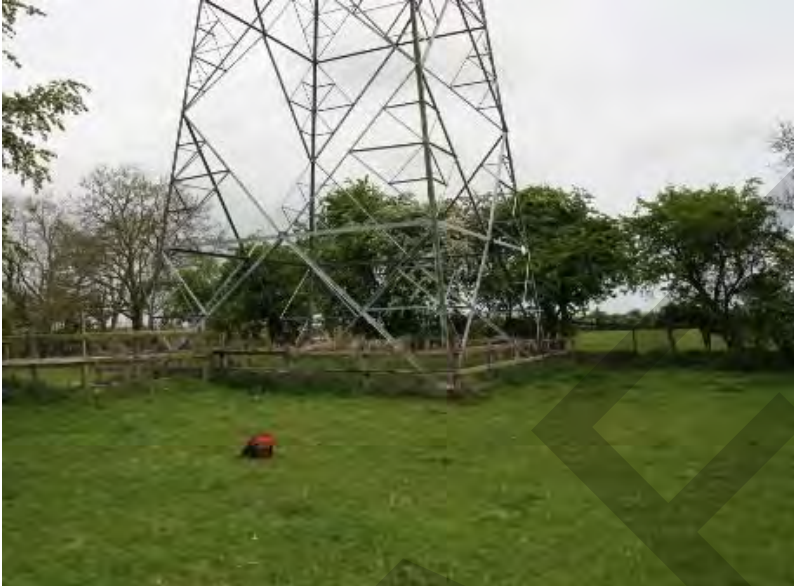
<p>Hedgerow completely removed at 12 m wide gap where intermediate tower located. No reinstatement. Fenced off</p>
17

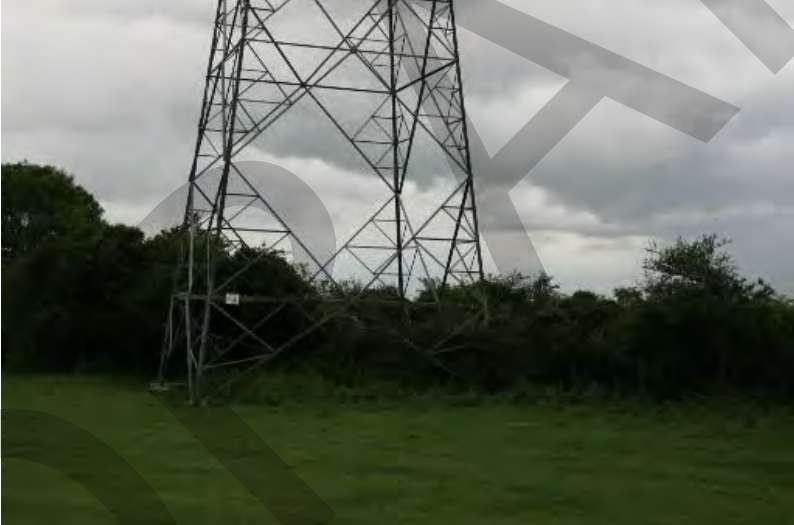
17	Intermediate	Arable	Re-establishment gorse, ivy, elder, hawthorn, blackthorn and bramble thicket under tower	Unmanaged hedgerow dominated by hawthorn, elder, ash and gorse. Grazed sheep, agricultural weeds at field layer. Arable	None	Moderate	Change in dominant woody vegetation with establishment of relatively vigorous pioneer woody plant growth under tower. Hedgerow connectivity retained.
22	Angle	Arable	Re-establishment of hazel, ivy, elder, hawthorn, blackthorn and bramble thicket under tower. Notably hedgerow and rank grassland wider at tower location	Unmanaged dense relatively species rich hedgerow. Some large mature standards present. Agricultural and plant verge species predominate ground flora. Arable	Rabbit, passerines	Moderate	No real difference besides trimming. Re-establishment of hazel, ivy, elder, hawthorn, blackthorn and bramble thicket under tower. Notably hedgerow and rank grassland wider at tower location

<p>Hedgerow connectivity retained at gap where tower straddles low hedgerow. Change in dominant woody vegetation with establishment of relatively vigorous pioneer woody plant growth under tower.</p>
22

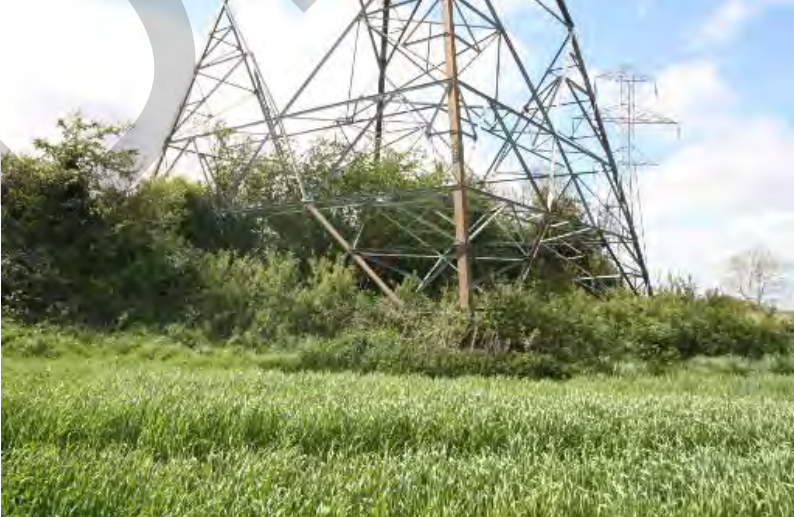
<p>Moderate value hedgerow. No real difference under tower besides trimming. Re-establishment of hazel, ivy, elder, hawthorn, blackthorn and bramble thicket under tower. Notably hedgerow and rank grassland wider at tower location</p>

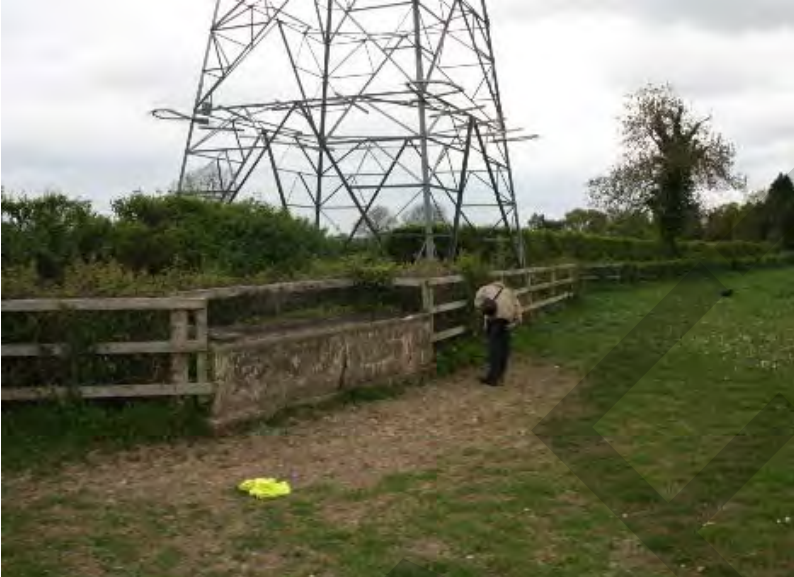
25	Intermediate	Livestock	7m gap with main woody vegetation (hawthorn) gone. Dense briars as fenced off. Fenced at tower location means remnant hedgerow wider than surrounding at tower location.	Managed (trimmed) species rich (woody) hedgerow.	Rabbit, passerines (including yellowhammer)	Moderate	Loss of woody hedgerow species at 7 m gap with no significant hedgerow re-establishment
29	Intermediate	Livestock (meadows)	Tower straddles low managed hedgerow. Hedgerow structure largely retained	Relatively species poor (woody) managed hedgerow. Agricultural weeds (ground flora).	Passerines (including yellowhammer)	Low	No significant impact - hedge re-established/ not completely cleared

<p>Moderate value hedgerow. Loss of woody hedgerow species at 7 m gap with no significant hedgerow re-establishment</p>
29

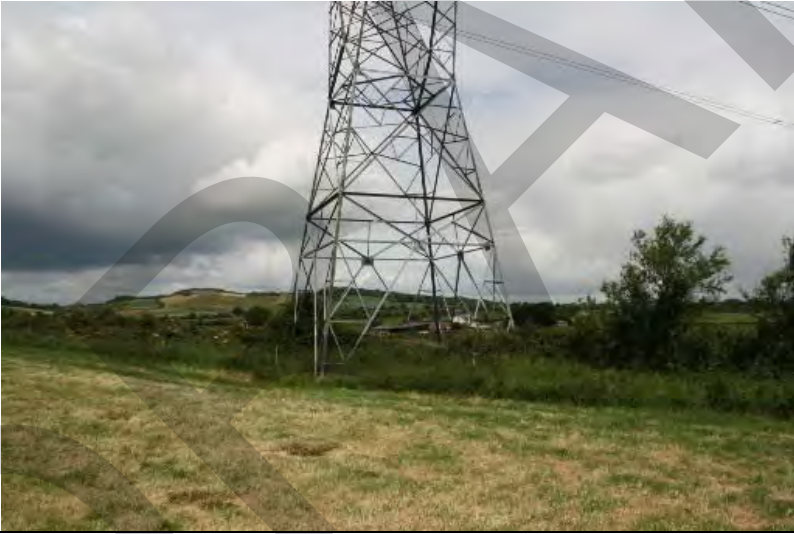
<p>Tower straddles a low managed hedgerow. Hedgerow structure largely retained</p>
33

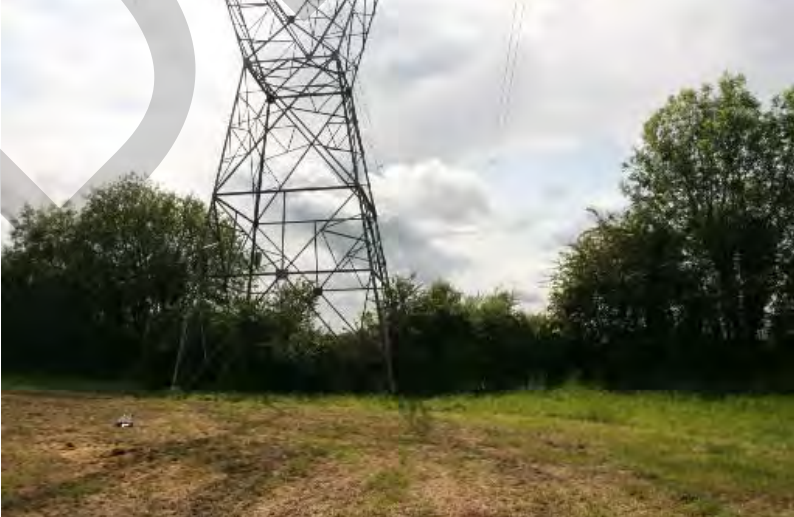
<p>Intermediate tower straddling retained "High" value hedgerow. Note height of hedgerow below line (c.a. 3 – 4m) which is much lower than hedgerow either side.</p>

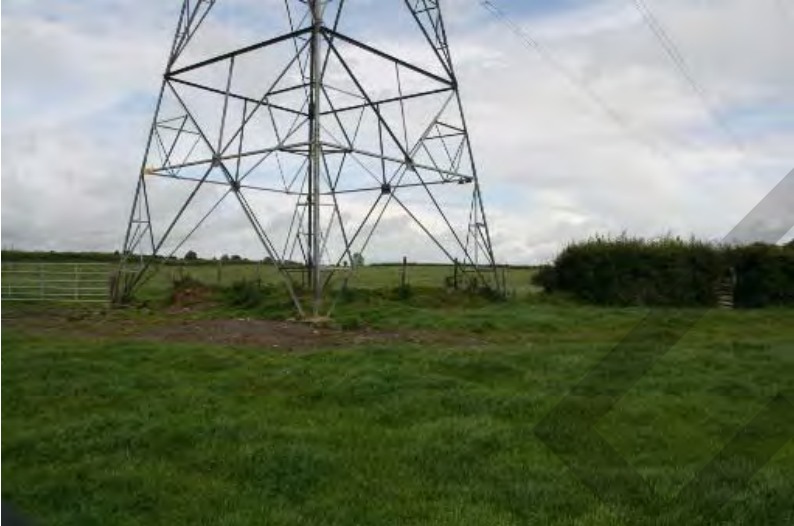
37	Intermediate	Livestock	20m of hedgerow permanently removed under tower.	hedgerow either side of tower is managed and species poor (hawthorn dominated)	None close to tower	Low	Loss of woody hedgerow species as 20m of hedgerow permanently removed under tower. No recovery/reinstatement
38	Intermediate	Livestock (meadows)	20 - 30m of hedgerow permanently removed under tower. (Includes an access track). The tower is located at the meeting point 3 hedgerows meaning larger impact.	Robust unmanaged narrow species rich (woody and ground flora) hedgerow. Species include alder, spindle, rose, blackthorn, hazel, hawthorn, ivy and holly. hedgerow is located on a townland boundary	Birds include common passerines.	High	Loss of woody hedgerow species as 20 - 30m of hedgerow permanently removed under tower. (Including an access track).
39	Intermediate	Livestock (meadows)	Hedgerow at tower location dominated by pioneer woody species of disturbed ground. Tower means hedgerow wider at this location	Species rich hedgerow either side of tower (willow, ash, hazel, ivy, blackthorn, gorse, hawthorn and elder)	Birds include common passerines.	High	Change in hedgerow plant community at tower location includes pioneer woody species of disturbed ground. Hedgerow wider at tower location

<p>20m of hedgerow permanently removed under tower.</p>
38

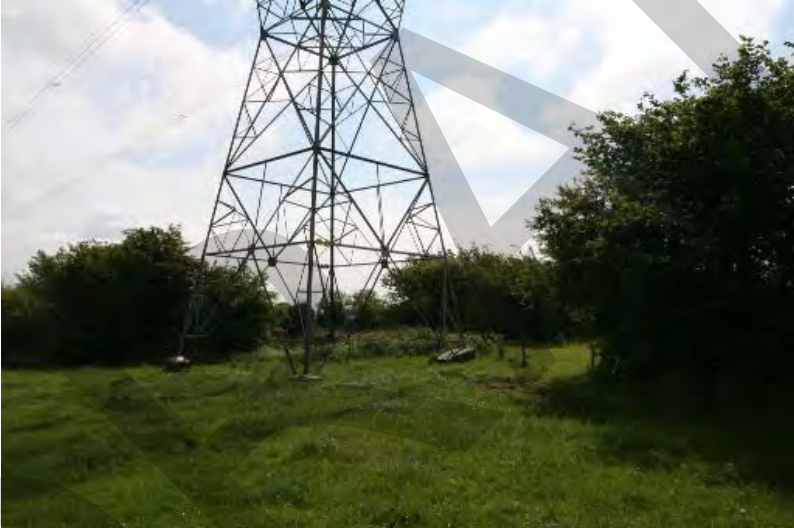
<p>Intermediate tower in gap where hedgerow permanently removed and access track retained. High value species rich hedgerow either side.</p>
39

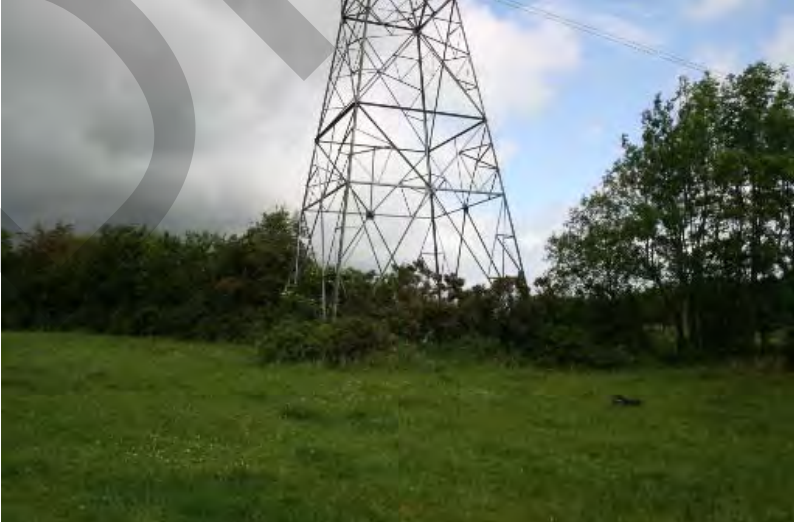
<p>Intermediate tower with disturbed ground species (gorse, bramble) dominating tower gap. High value hedgerow either side of tower has different woody vegetation to that under tower</p>

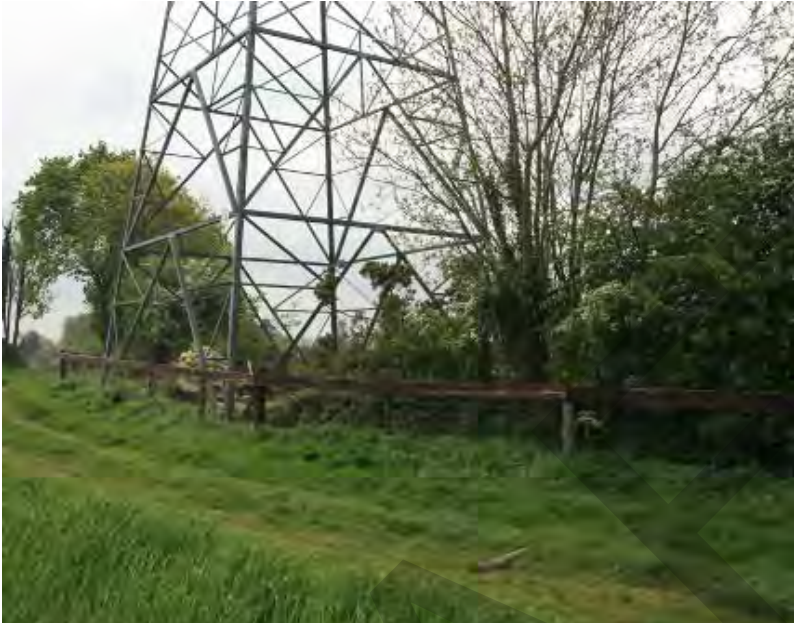
<p>Hedgerow effectively gone at tower location (c.a. 10m). Low bramble and gorse at tower base. No taller woody vegetation compared to hedgerow either side.</p>
