### **Pre and Post Construction Report on the Condition of Martello Tower**

**Martello Tower,**

**Re: Post Works Structural Report.**

Re: **Pre commencement Structural Report on  
Martello Tower,.**

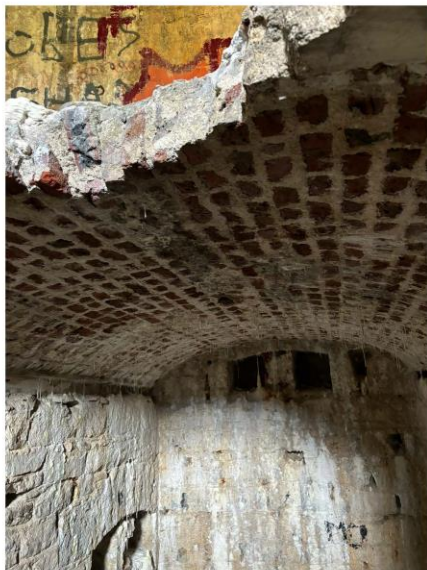
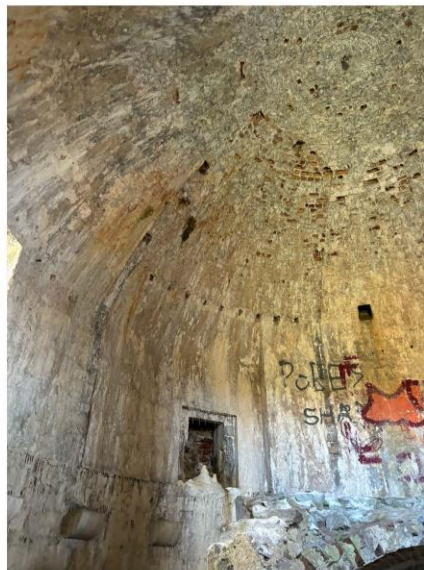
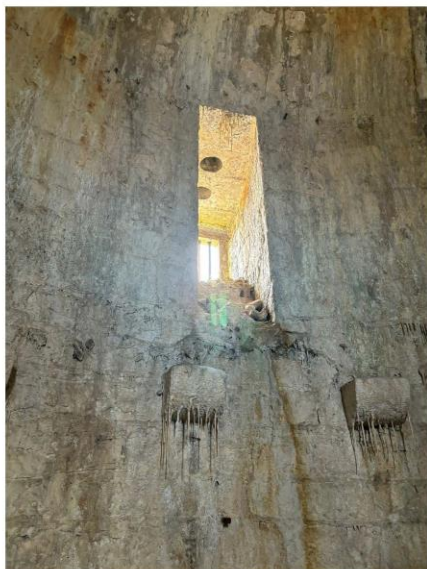
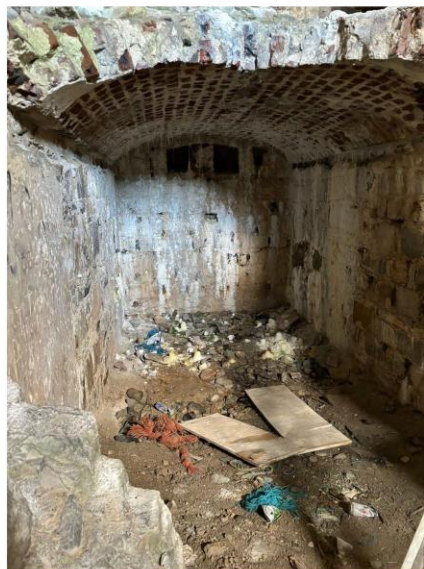
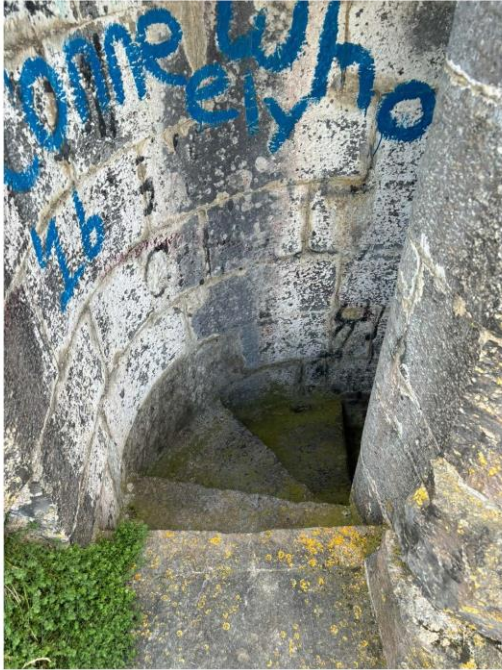
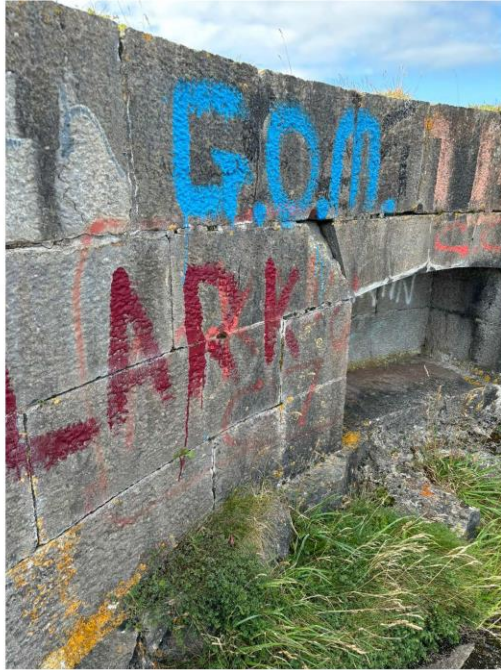
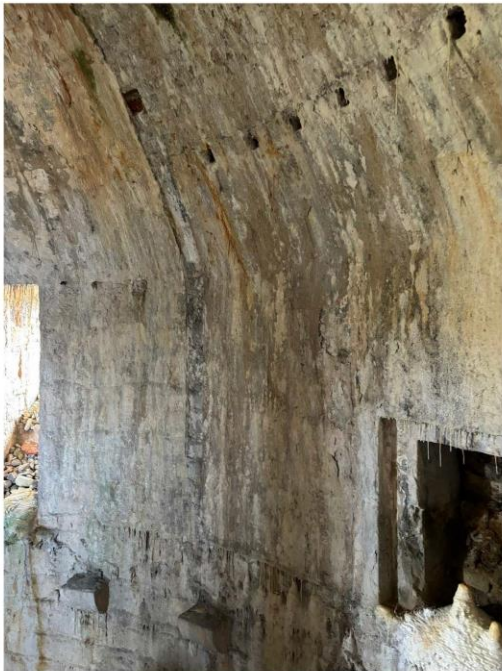
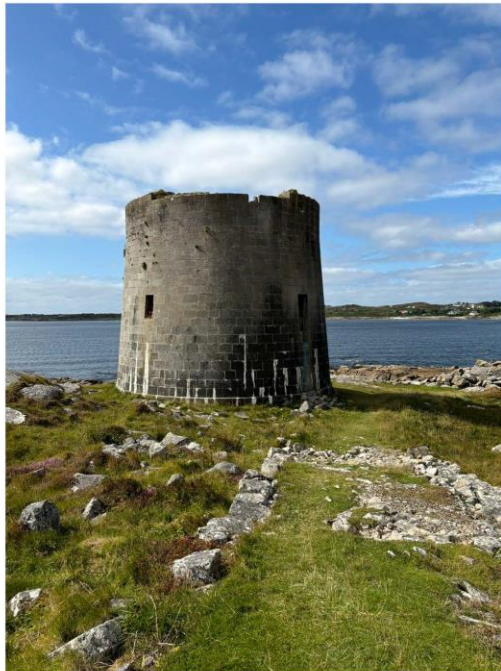
### **Images taken on the 25<sup>th</sup> Oct 2024.**

The writer noted at the time of his second inspection that there had been no change to the structure either on the interior surfaces or the exterior surfaces.

From the visual inspections which he undertook, the writer concluded that the works carried out to date at the DWQ site, including the blasting, did not have any negative impact on the Martello Tower and did not cause any structural or superficial damage to the tower.

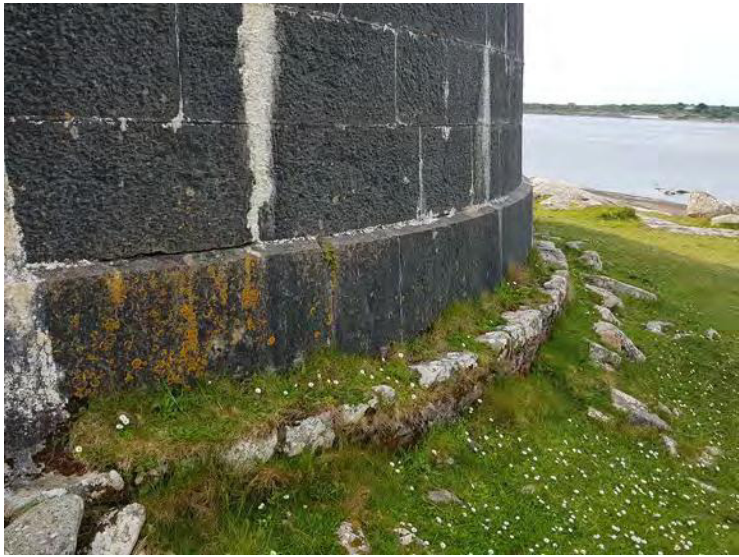
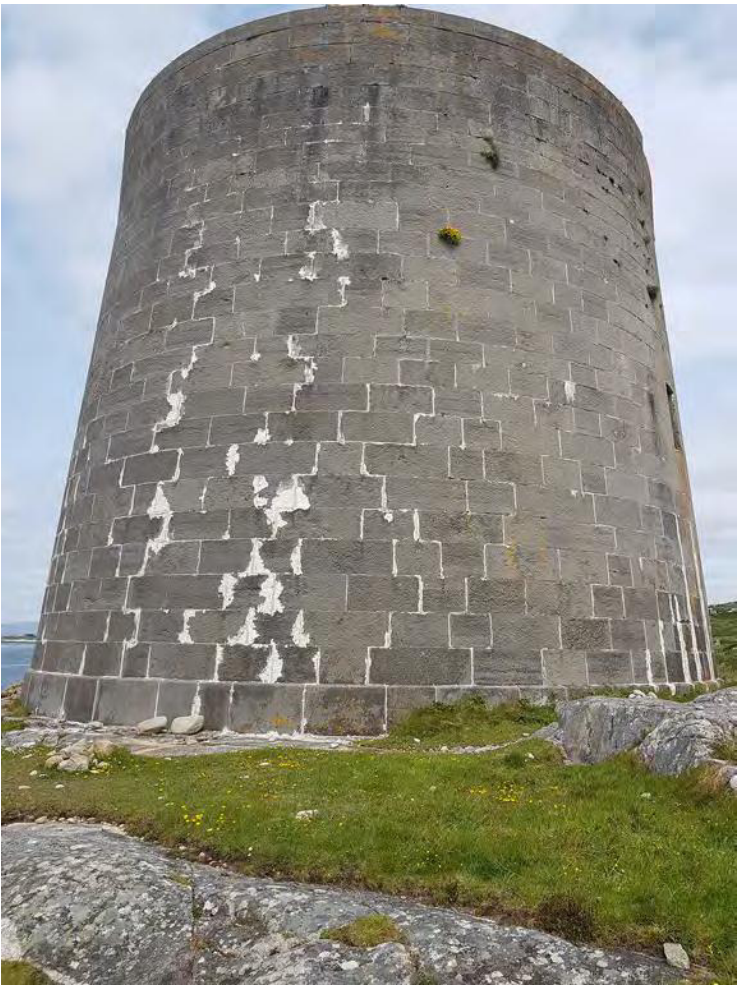
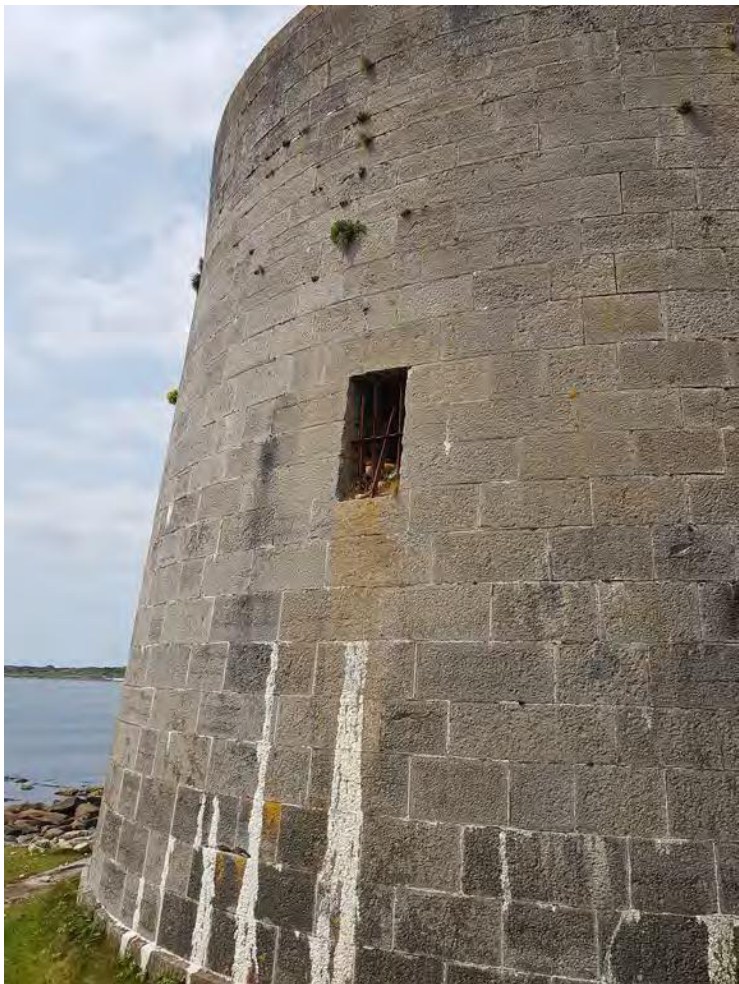
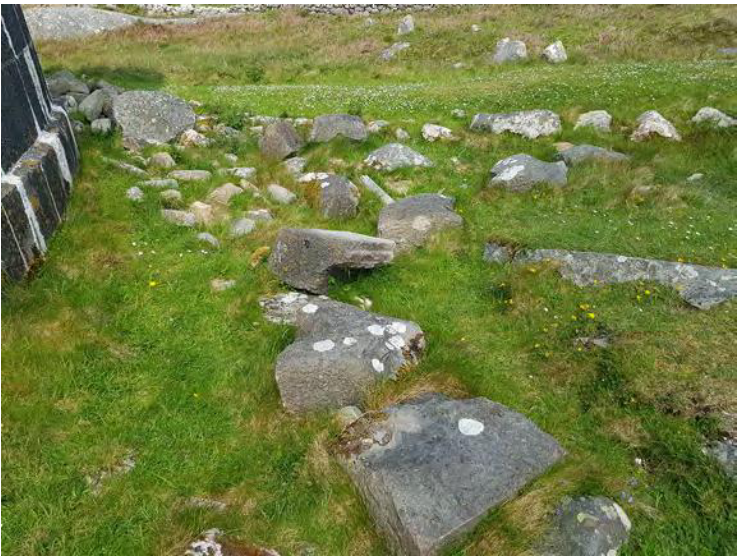
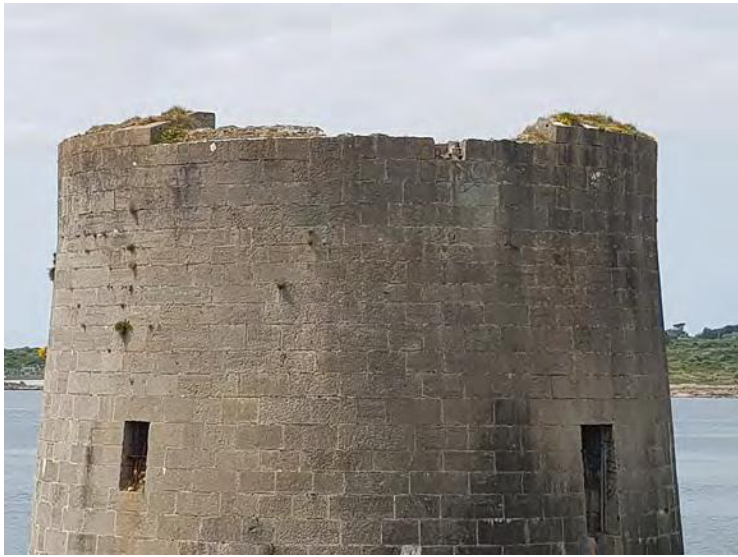
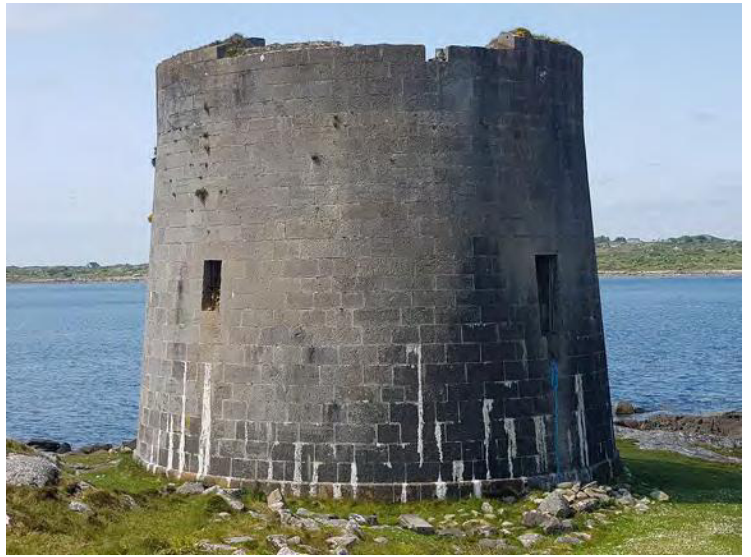
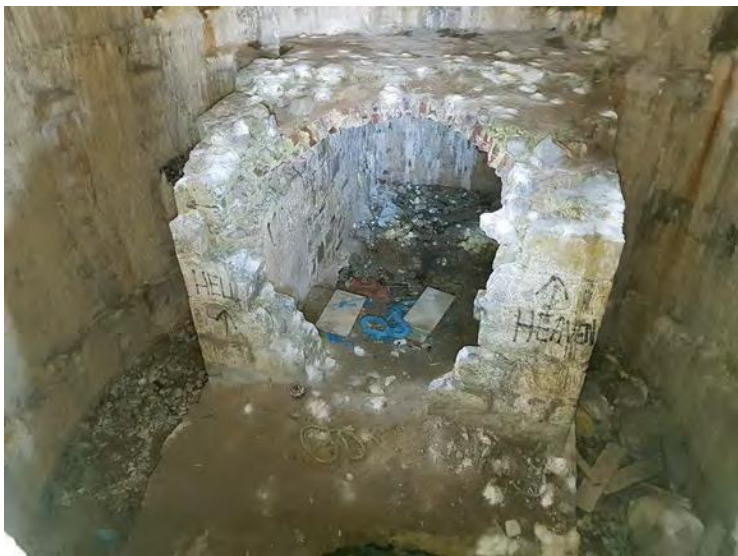
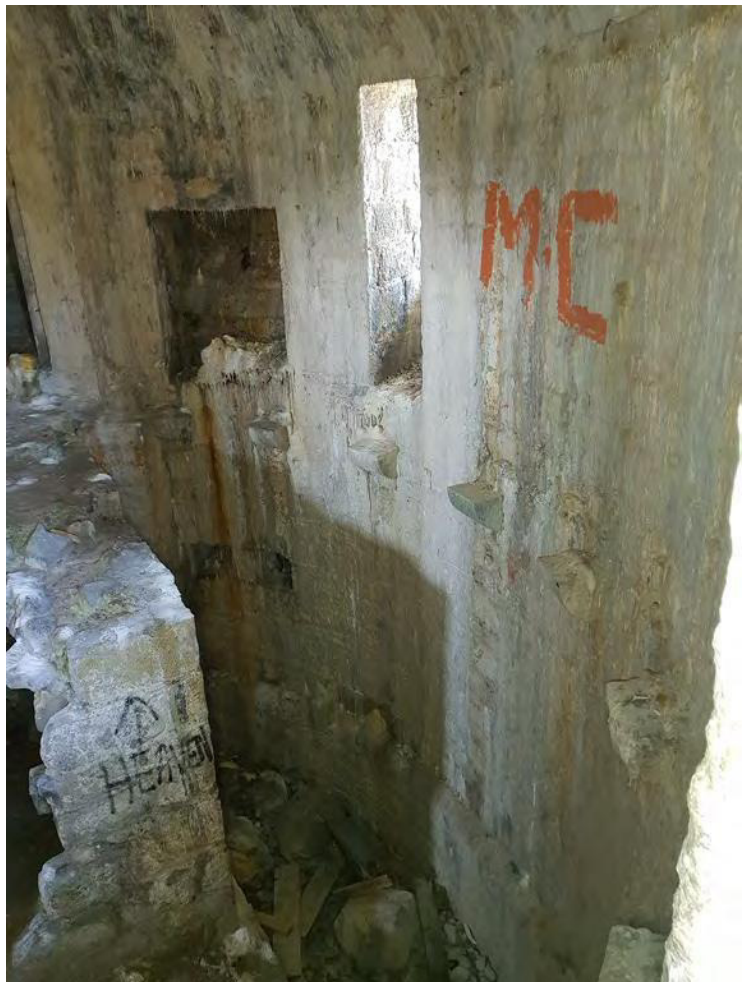
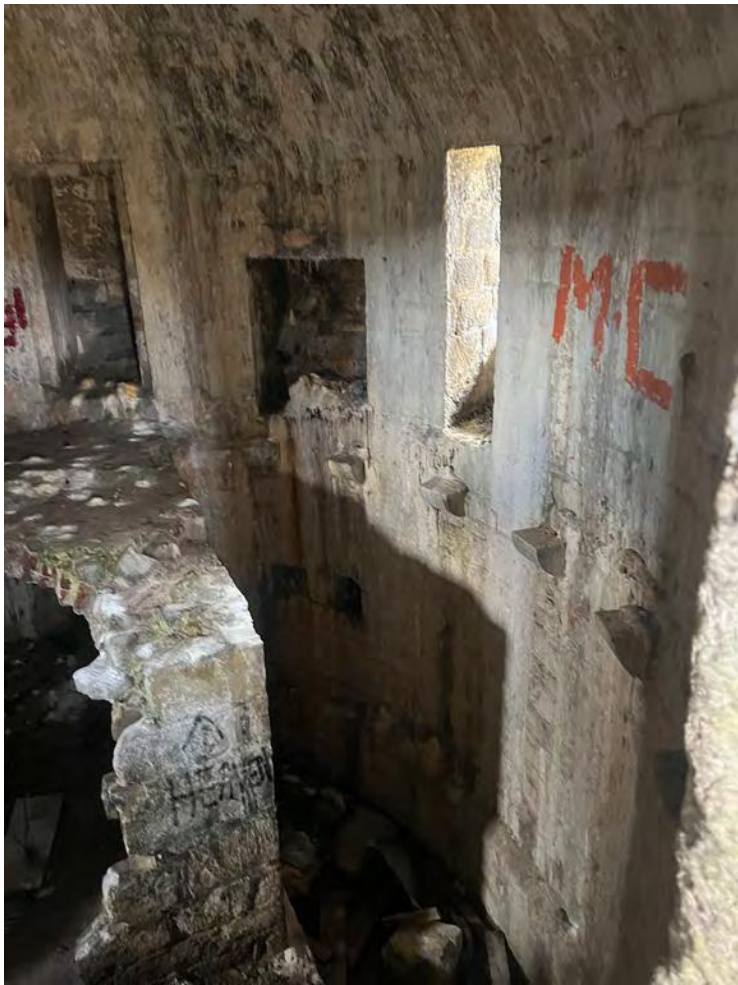
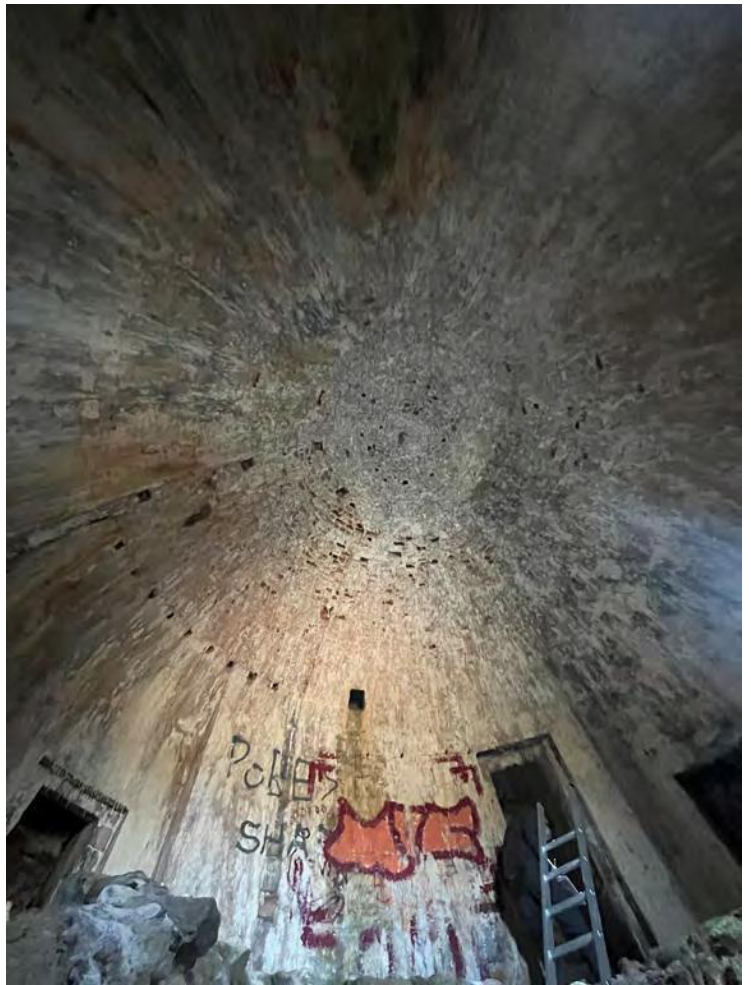
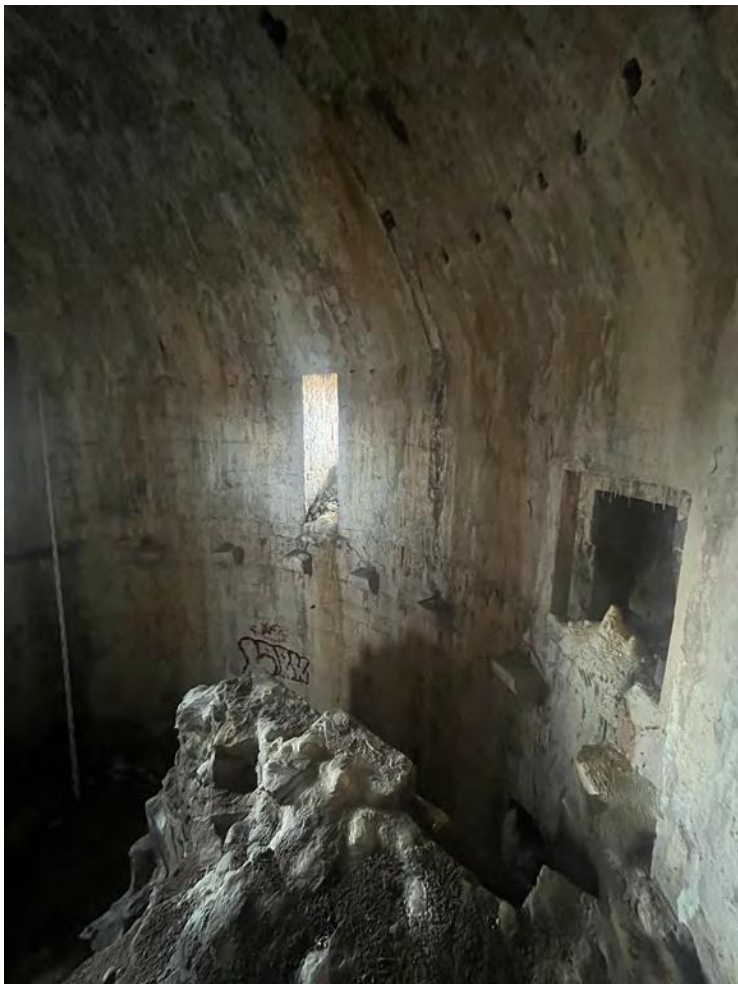
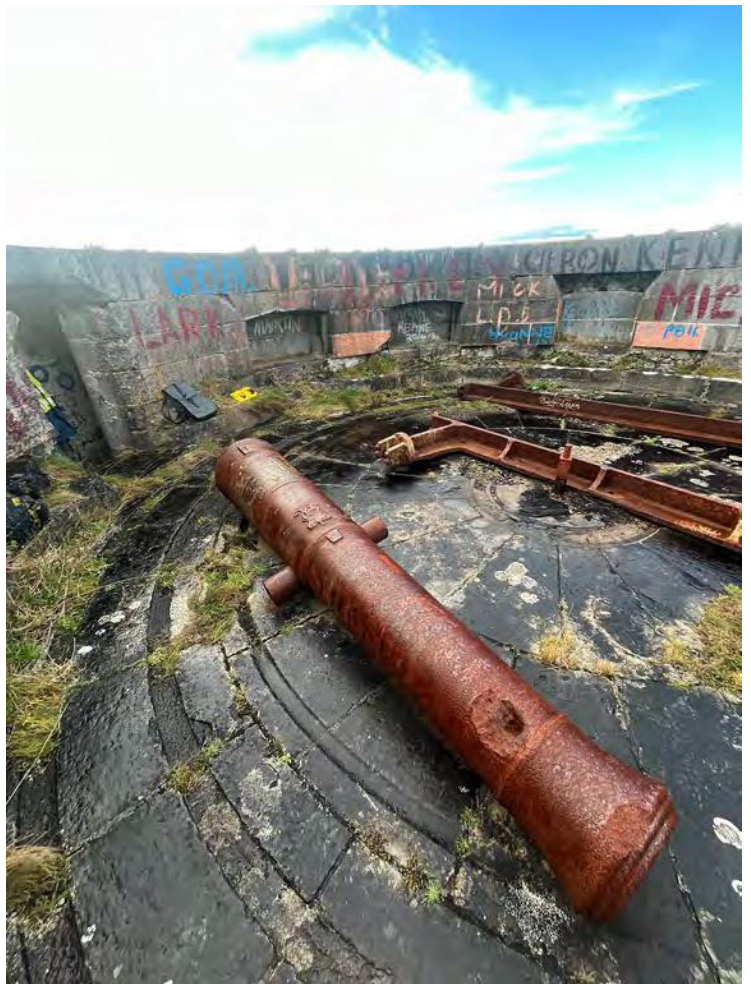
Images of Martello Tower

Generally, the external walls and roof structure are in very good condition, apart from sections of the parapet above roof level which appear to have been intentionally damaged by removal of some stones. Also, parts of the roof and walls of an internal structure, which was most likely the powder room, are damaged. Some large carved limestone blocks are present on the ground directly beneath the damaged areas of the parapet. This is surprising as it would require considerable effort to dislodge these larger stones from the parapet.

The very robust nature of the Martello Tower combined with the dry ashlar facing and its position remote from the proposed construction works make it unlikely that any damage should occur to its structure during the course of construction of the works. Nevertheless, it is recommended that during the course of construction which will involve blasting works, vibration monitoring of the Martello Tower should take place on a continuous basis over the period of construction works.
