*Structural Report and Construction/Augmentation Management Plan
at
Emlaghmore, Ballyconneely, Co. Galway.*

Client	Mr. Patrick Ridge
Project Number	1475.100
Project Title	Structural Report and Construction/Augmentation Management Plan
Location	Emlaghmore, Ballyconneely, Co. Galway.
Date of Inspection	13th of March 2020.
Weather Conditions	Cold and Dry

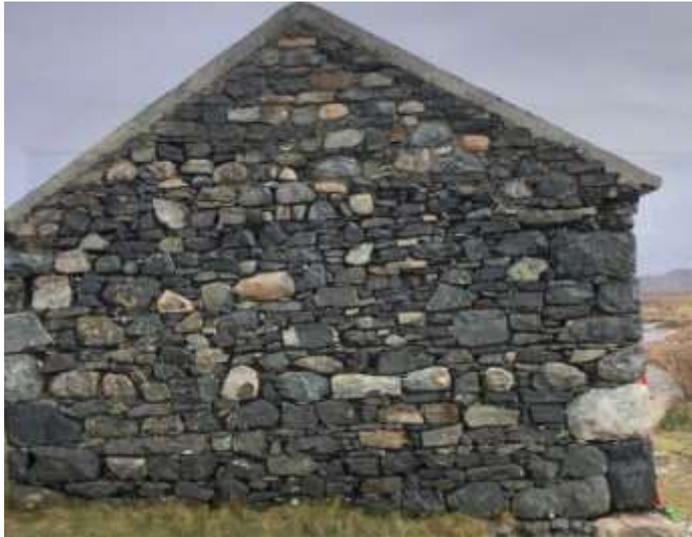
(Exterior has been inspected from ground level only). Due to the age of the existing house we noted several minor cracks throughout the building which is largely down to the age of the building. The existing buildings foundation was constructed out of random rubble stone. The foundations are close to the surface given the nature of the undulating ground conditions. The existing floors within the house is level and is comprised of concrete floors and some should be removed and replaced with new sub-floors. The original external 600-900mm masonry walls were constructed primarily of locally sourced stone with a binding agent comprising of a sand/lime mix mortar. Overall the original 600-900mm walls are structurally sound. Although the stone size in the existing wall are random, it is of good quality and has a high crushing value, which is common of the local stone in the area. The lintels over the windows and doors were constructed by bridging a large stone onto the load bearing wall. The rear elevation shed/ruin requires new floors and walls to be reconstructed at wall plate level.

Fig 1.1–Original External Walls Are In Good Order

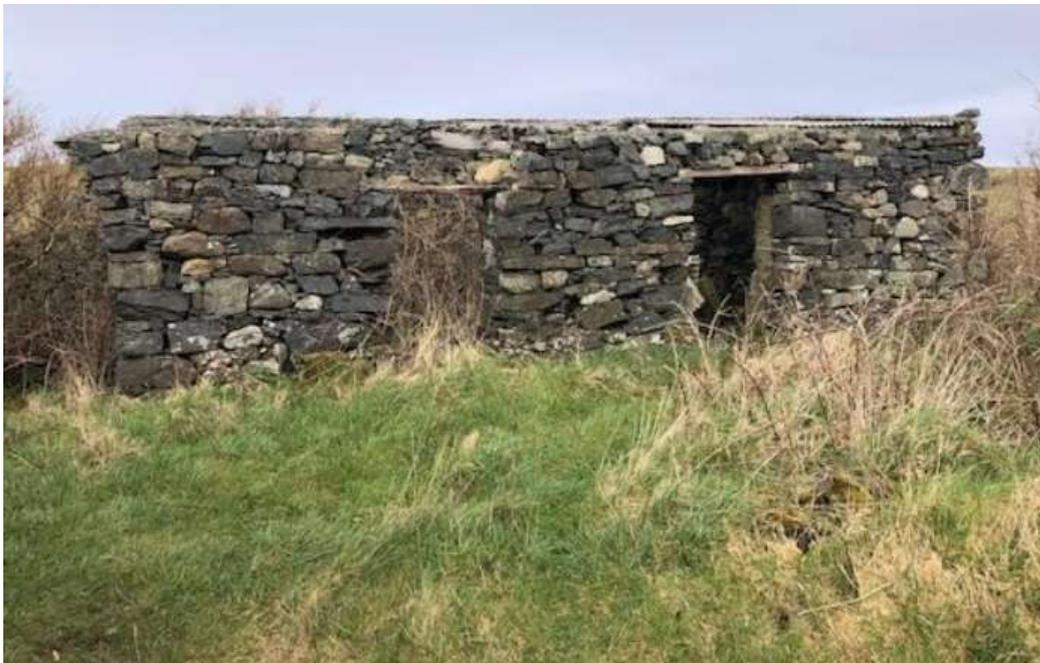
Fig 1.2–Works required to existing rear elevation ruin.

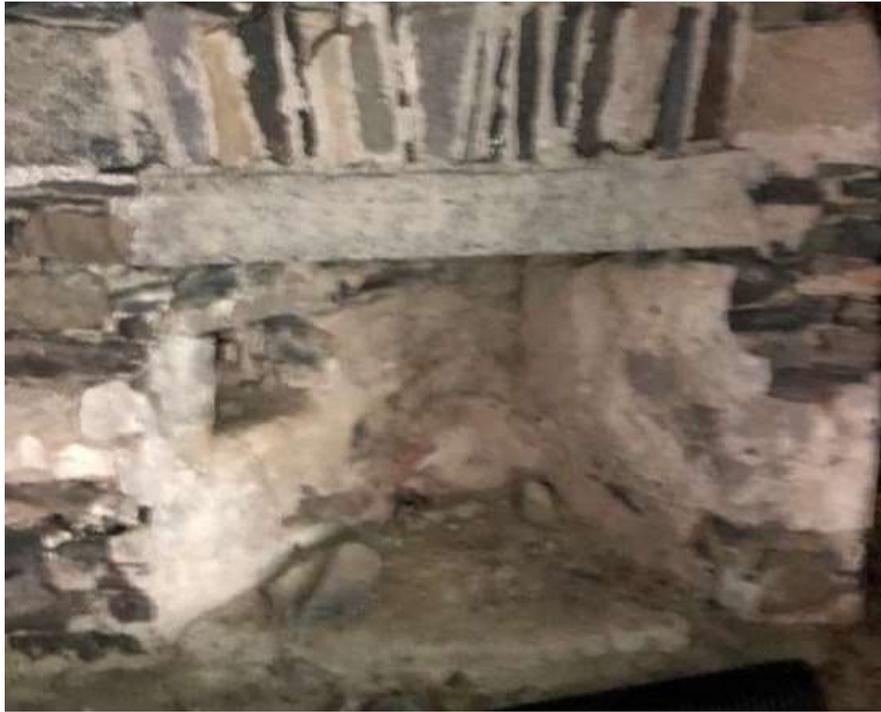
Fig 1.3–Chimney is still in position

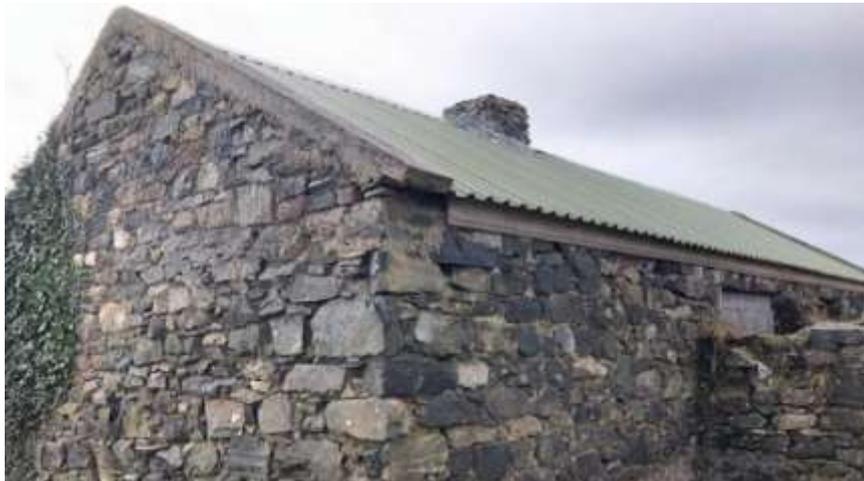
The main roof of this property is a cut pitch roof construction and finish to same appears to be replaced within the past 30 years with a metal roof cladding. The roof timbers are in poor condition and same will need to be replaced with heavy gauge roof timbers. The metal roof cladding is to be changed to architect's details and we have no structural concerns in relation to the additional loading of same. The timber battens and roof slates should also be replaced. New fascia and soffits are to be installed. It appears that some internal works were carried out in more recent times and that the quality of same is of poor quality. The existing chimney is still in place within the house and same appears to be structurally sound.

Fig 1.4. – Main External Roof – New Roof To Be Installed

1. The existing four external walls shall remain and same shall be re-pointed and dry-lined once the building has been weather proofed.
2. The existing roof shall be replaced. The existing roof battens and roof felts should be replaced with new materials.

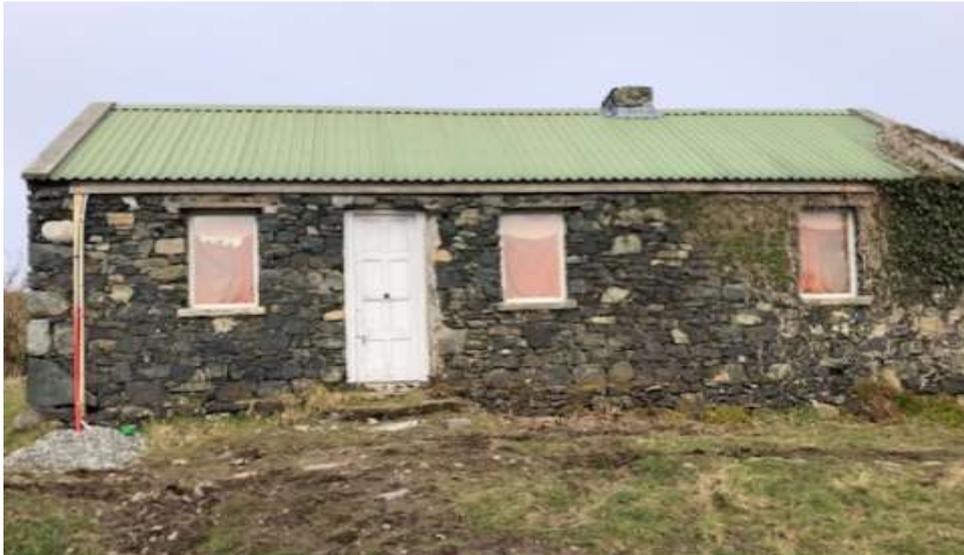
(Brief description of the type of windows and their condition, where possible to examine them) The windows throughout the property are single glaze, top/side hung timber material, and appear to be in poor condition. We note that some of the opening sections do not appear to close securely into the window frames leading to excessive draughts. We would recommend that all doors and windows be replaced with double/triple glaze windows and fitted by a suitably qualified window installer.

Fig 1.5. – Windows and Doors Require Replacement

7. The windows and door shall have triple glazed windows, with the front elevation retaining the windows of similar nature.
8. A proposed band beam be constructed at wall plate level to accommodate, and give a level base for the wall plate, the roof will also have a secondary function in that it will tie in the external walls.
