## Chapter 9

### The geotechnical reports

#### 9.1 Digest of Galway County Council report

## WINDFARMS AND BLANKET PEAT

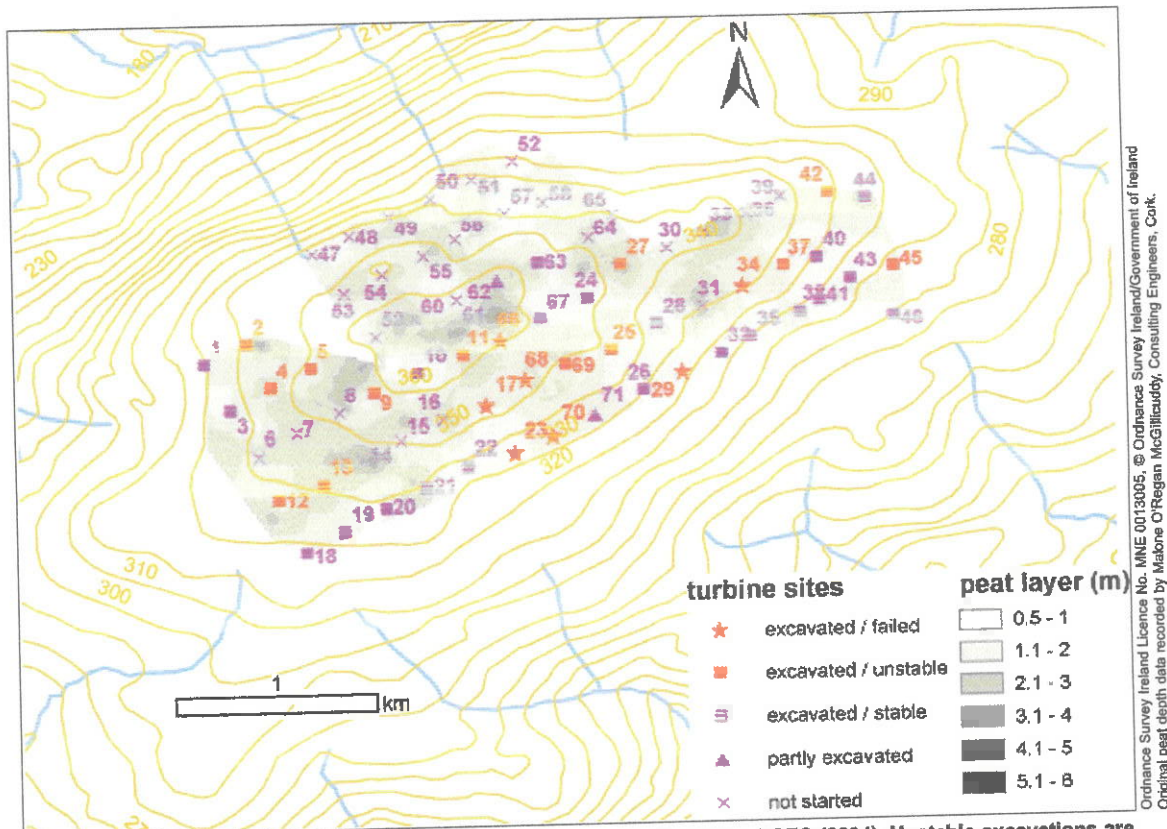
Figure 9.1: Summary of the stage and stability of turbine excavations from AGECE (2004). Unstable excavations are those where localised cracking or slumping has occurred. Sites marked as failed are those where downslope movement of peat has occurred or where incipient rotational failures were recorded.

and downslope peat movement had occurred at a further five (table 9.1): 47 per cent of the sites excavated show some evidence of instability.

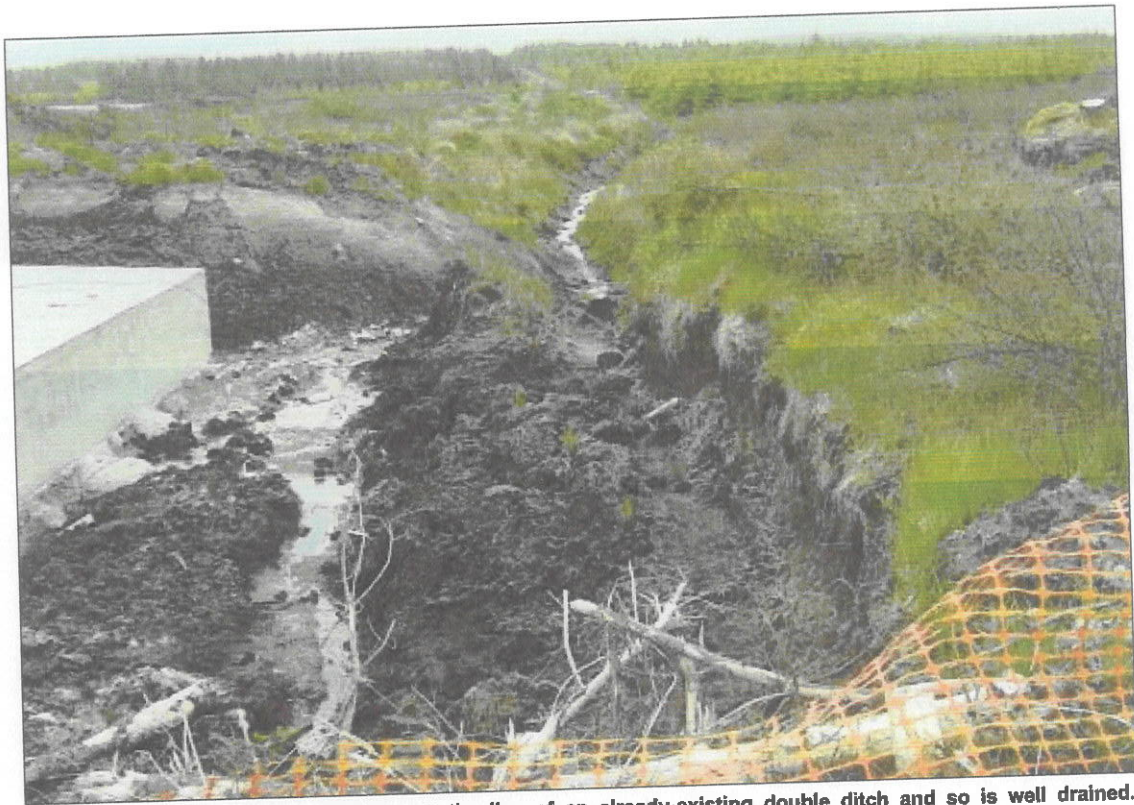
Plate 9.1: The excavation at T17 lies on the line of an already-existing double ditch and so is well drained. Nonetheless, it was the site of the first substantial bog slide.

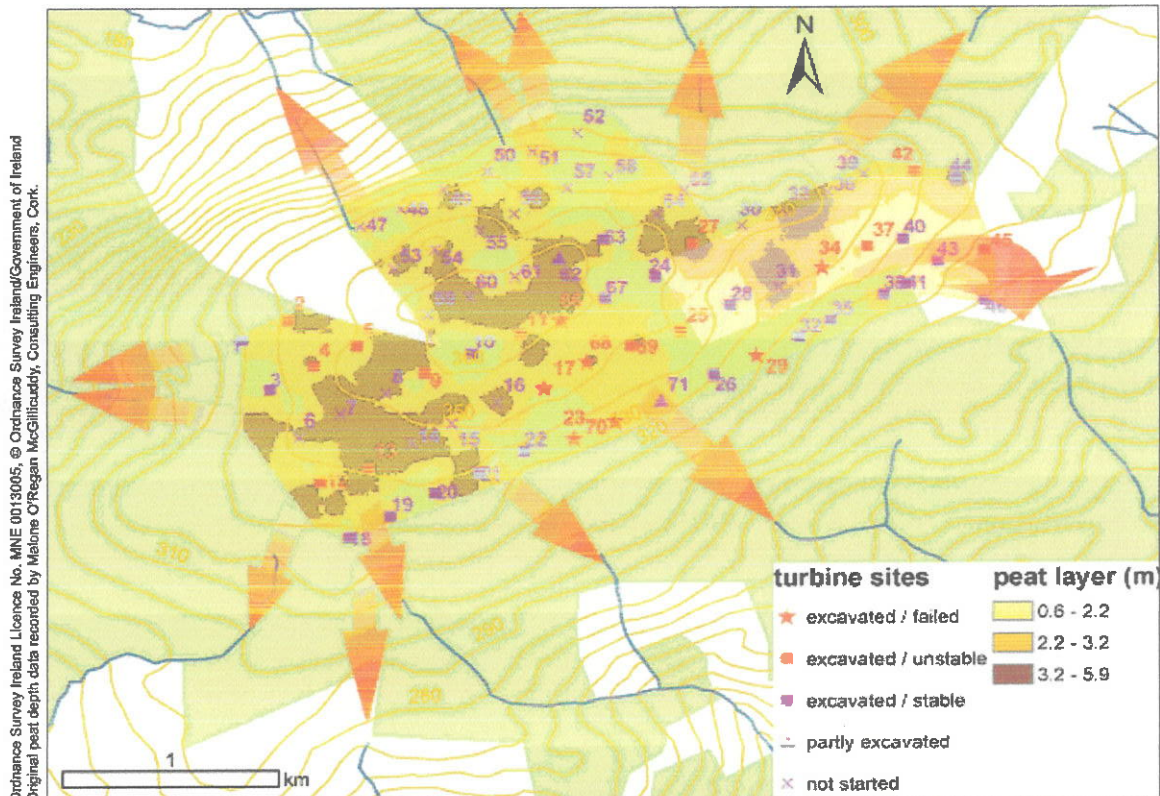
**Figure 10.1:** Distribution of differing peat depths within the area of the wind farm also showing the forest cover and locations of the turbine bases. These are coded according to their state of development and their assessed condition of stability. The red arrows highlight the likely direction of any peat movement towards stream

of habitation – Derrybrien – and that the two turbines constructed in the deepest part of this sloping peat have shown signs of instability (see fig 10.1). However, the picture is complex on this part of the hill as three watercourses have their origins in fairly close proximity and it is not clear quite which direction a mass of unstable peat might take were it to begin sliding from this south-west facing slope.

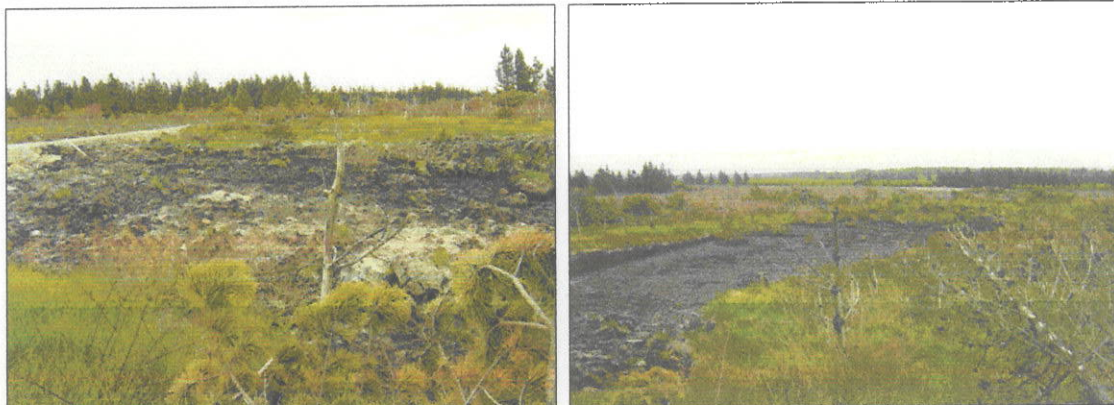
Plate 10.1: The scene of the bog slide that occurred at T17 only two weeks before the main slide. As can be seen from the small size of the trees in this vicinity, it includes areas that have already been drained for forestry, then suffered fire damage and were then drained again at replanting. So, although the area has been subject to considerable drainage, it has clearly not prevented peat failure.

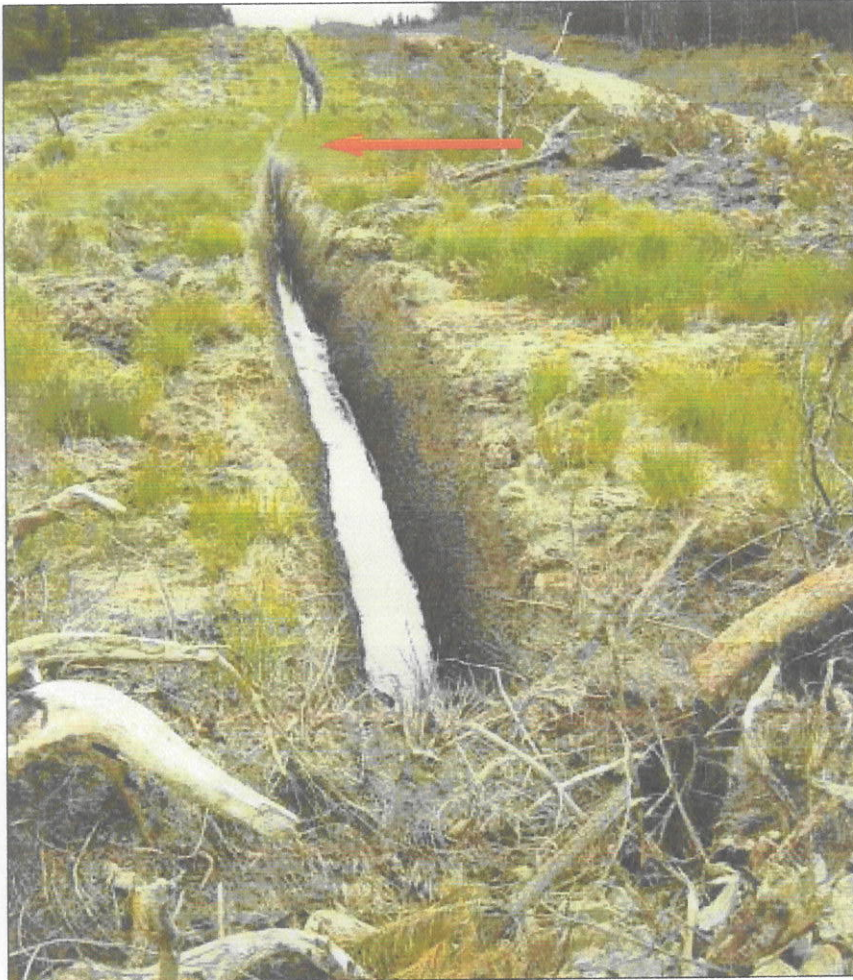
**Plate 10.2:** A ditch that runs ENE from T53 alongside a floating road across the northern slope of the mountain has obviously bowed and slumped downslope where it crosses deep peat. (It is assumed it originally ran straight.)

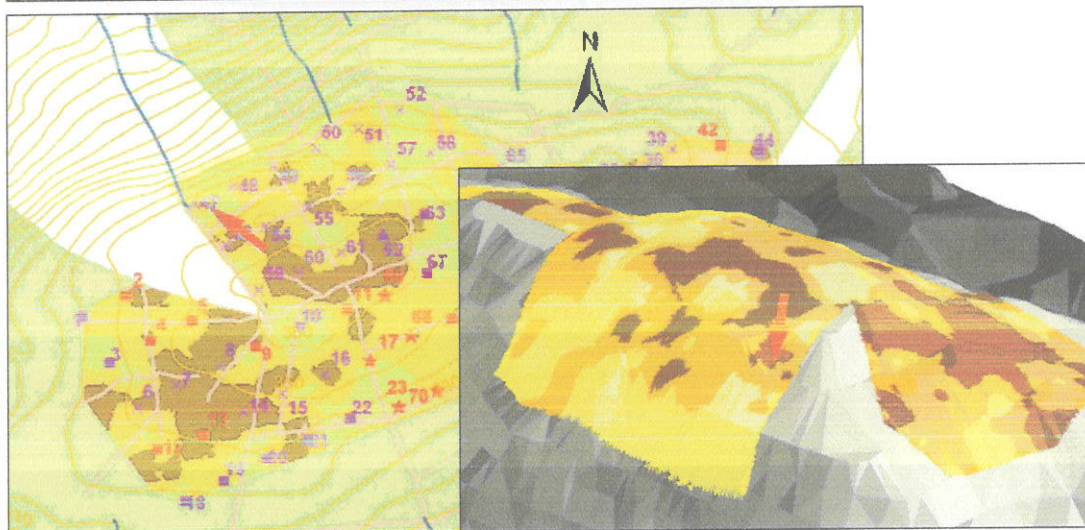
**Figure 10.3a, b:** The arrows on the two diagrams show the direction in which the peat moved.

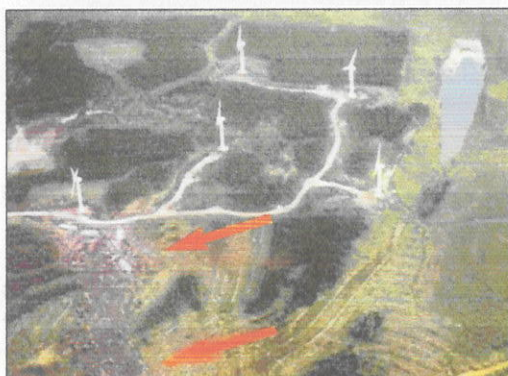
Plate 10.3b, above: The point of origin of the bog slide at Sonnagh Old, shown by the arrows.

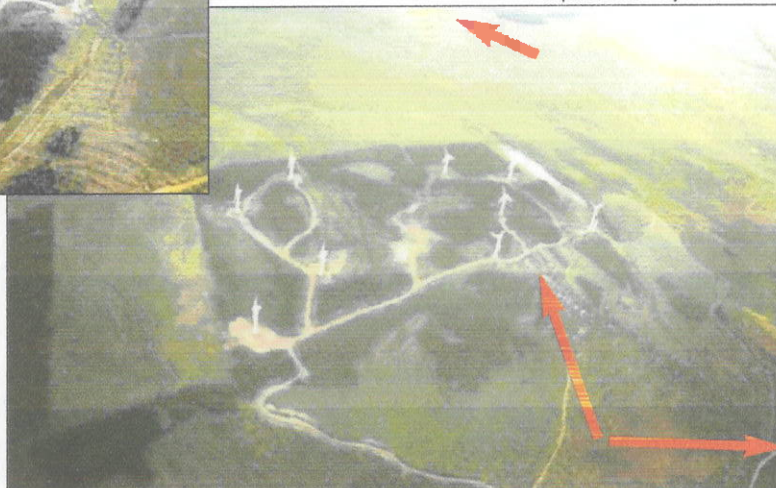
Plate 10.3c, right: The full extent of the slide at Sonnagh Old. The forestry associated with Cashlaundrumlahan can be seen in the distance (indicated by the arrow at the top of the photograph).

In October 2003, at much the same time as the Derrybrien incident, another slide occurred at Sonnagh Old, a recently installed 9-turbine wind farm on an adjacent summit four km to the north of Cashlaundrumlahan (grid reference M508093, fig 1). It involved 15,000 cubic metres of peat and appears to have originated at an access road.
