**2023 AFRY SITE INSPECTION
TECHNICAL NOTE**

Meenbog Wind Farm Site Inspection Technical Note

20 October 2023

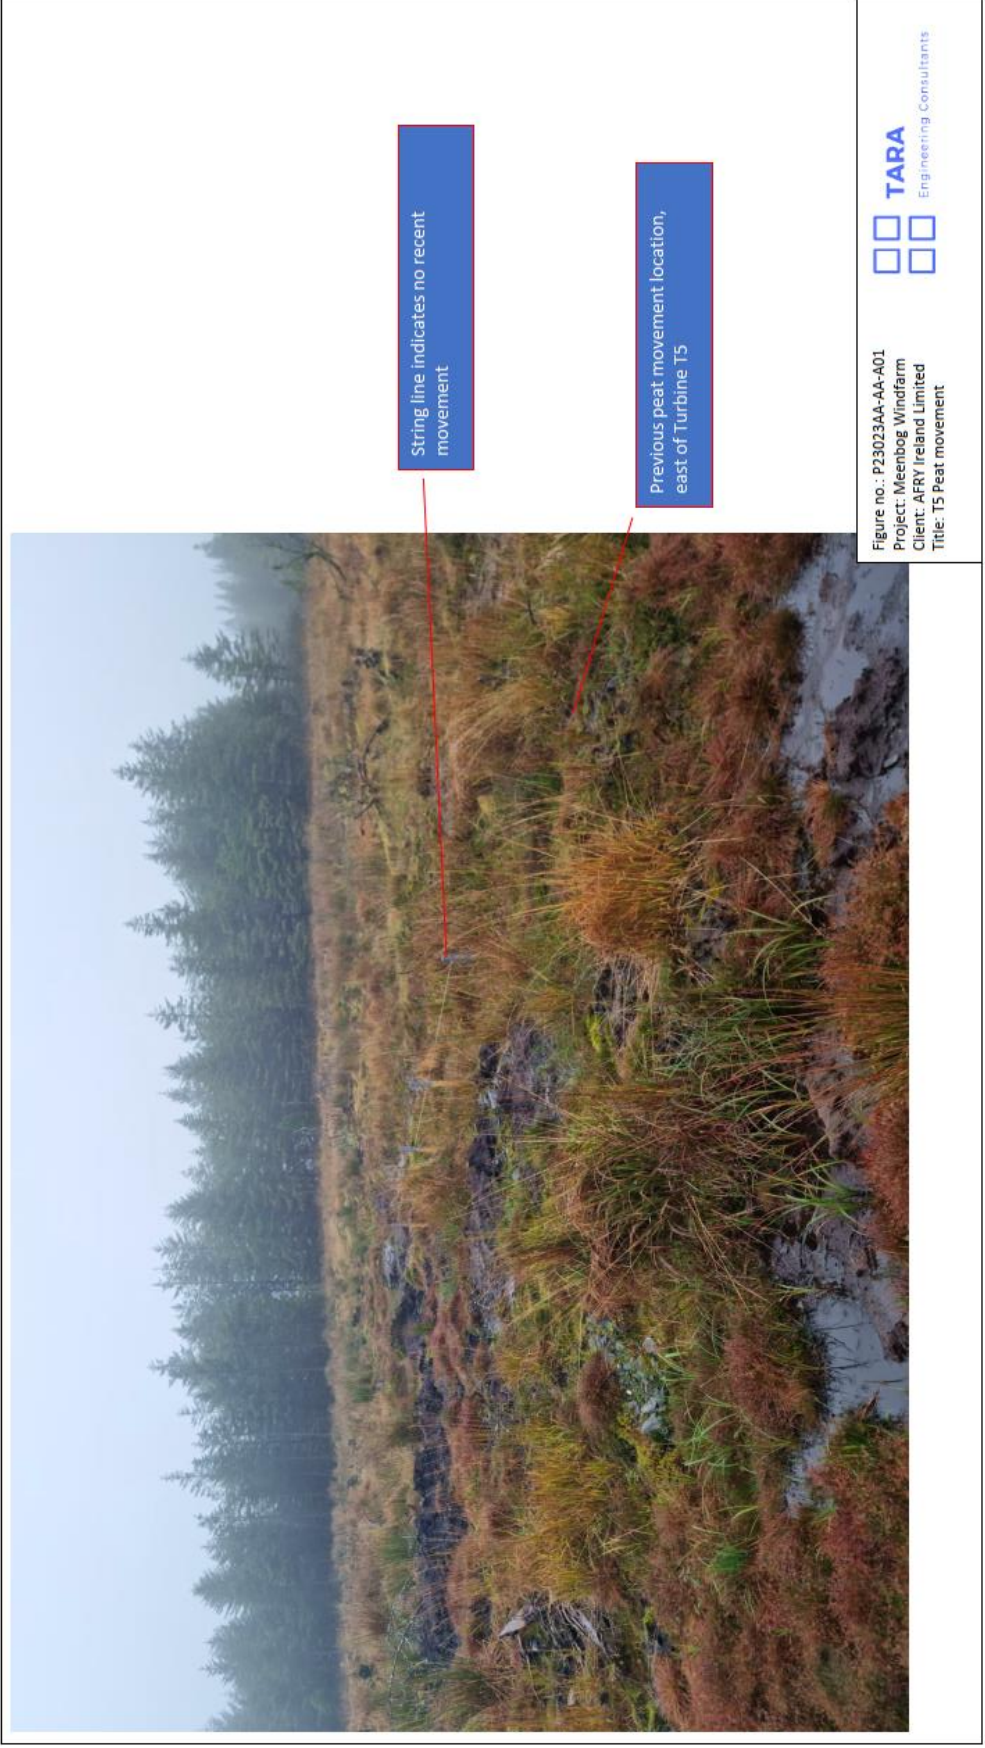
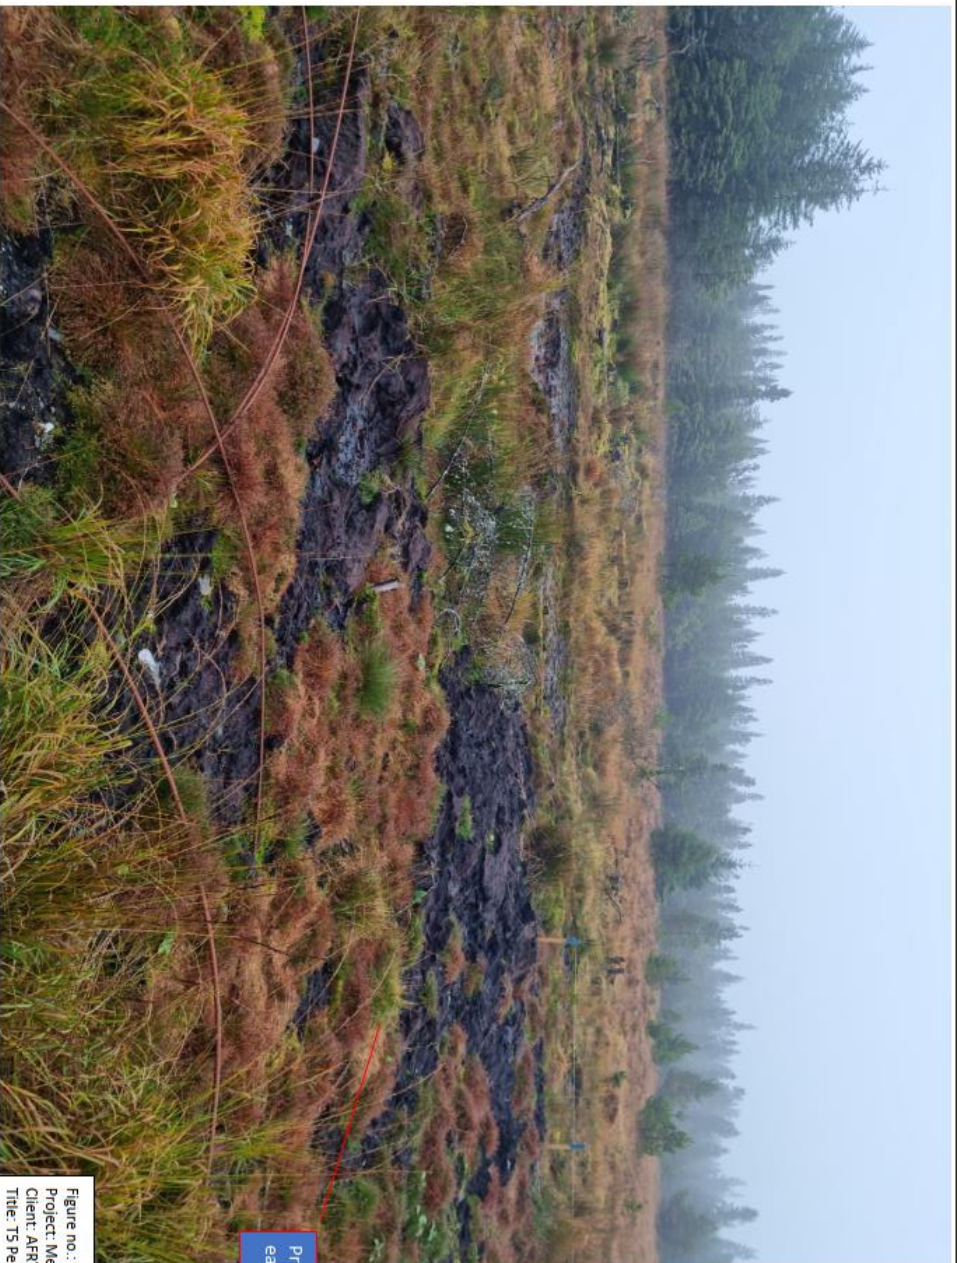
Figure no. : P23023AA-AA-A02
Project: Meenbog Windfarm
Client: AFRY Ireland Limited
Title: T5 Peat movement

Previous peat movement location,
east of Turbine T5

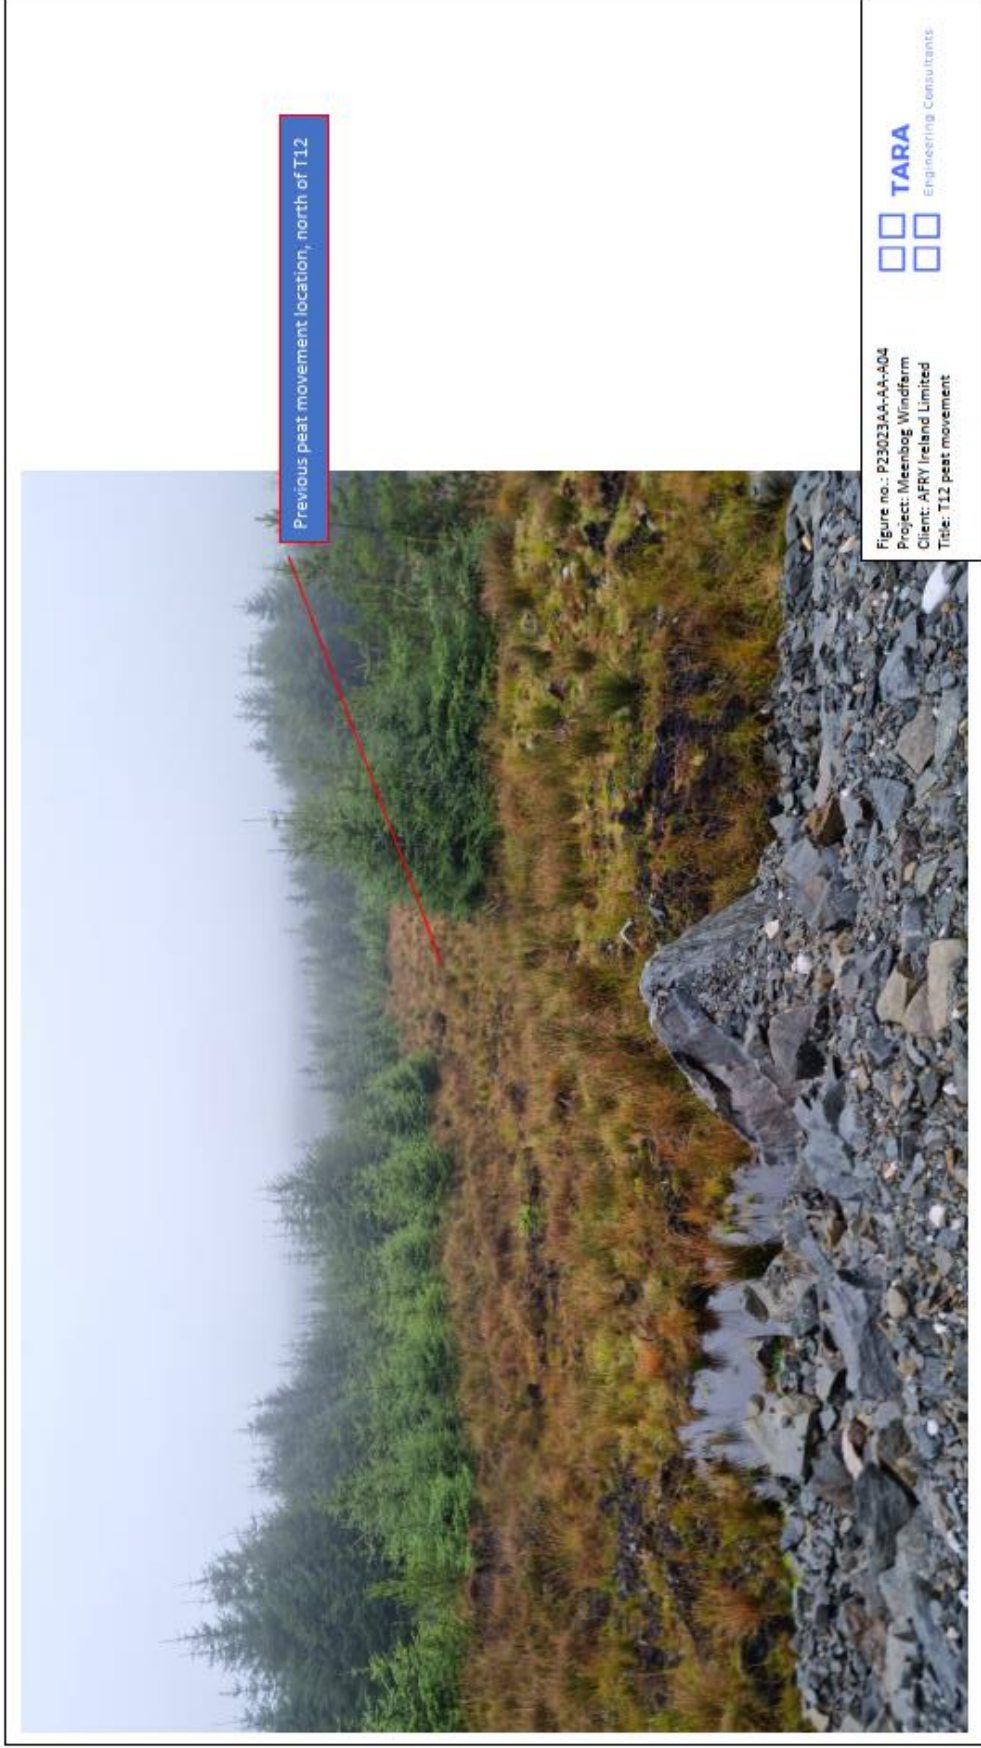
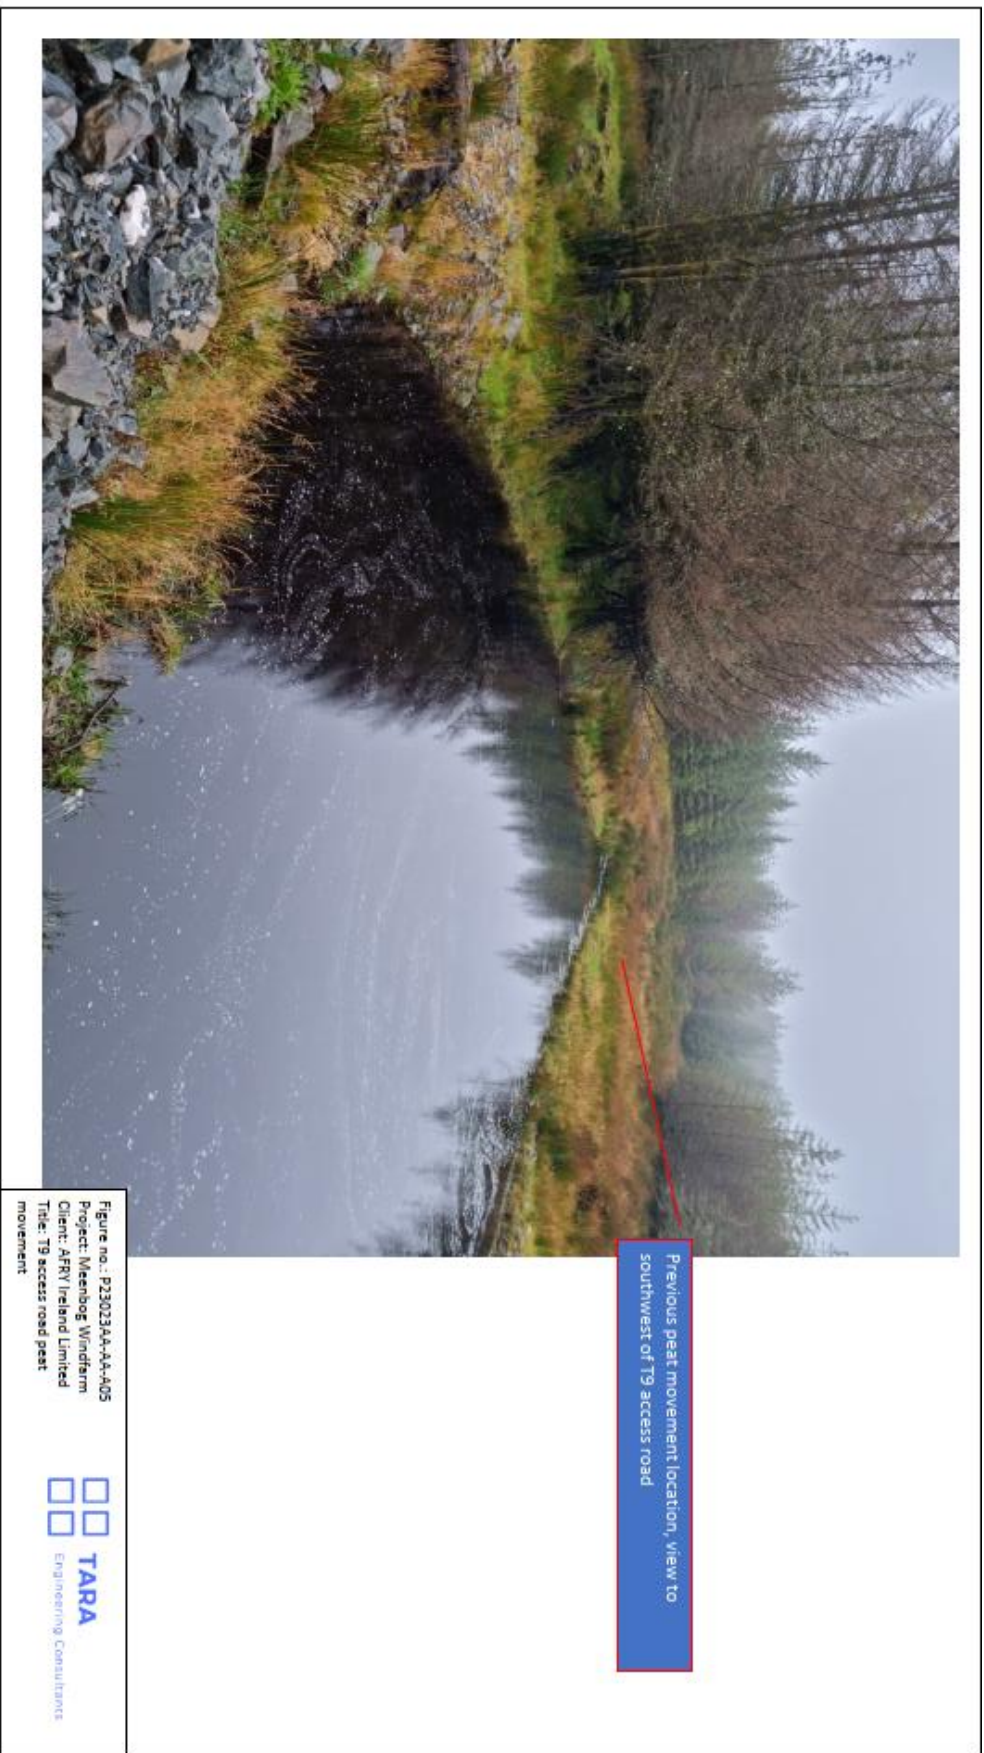
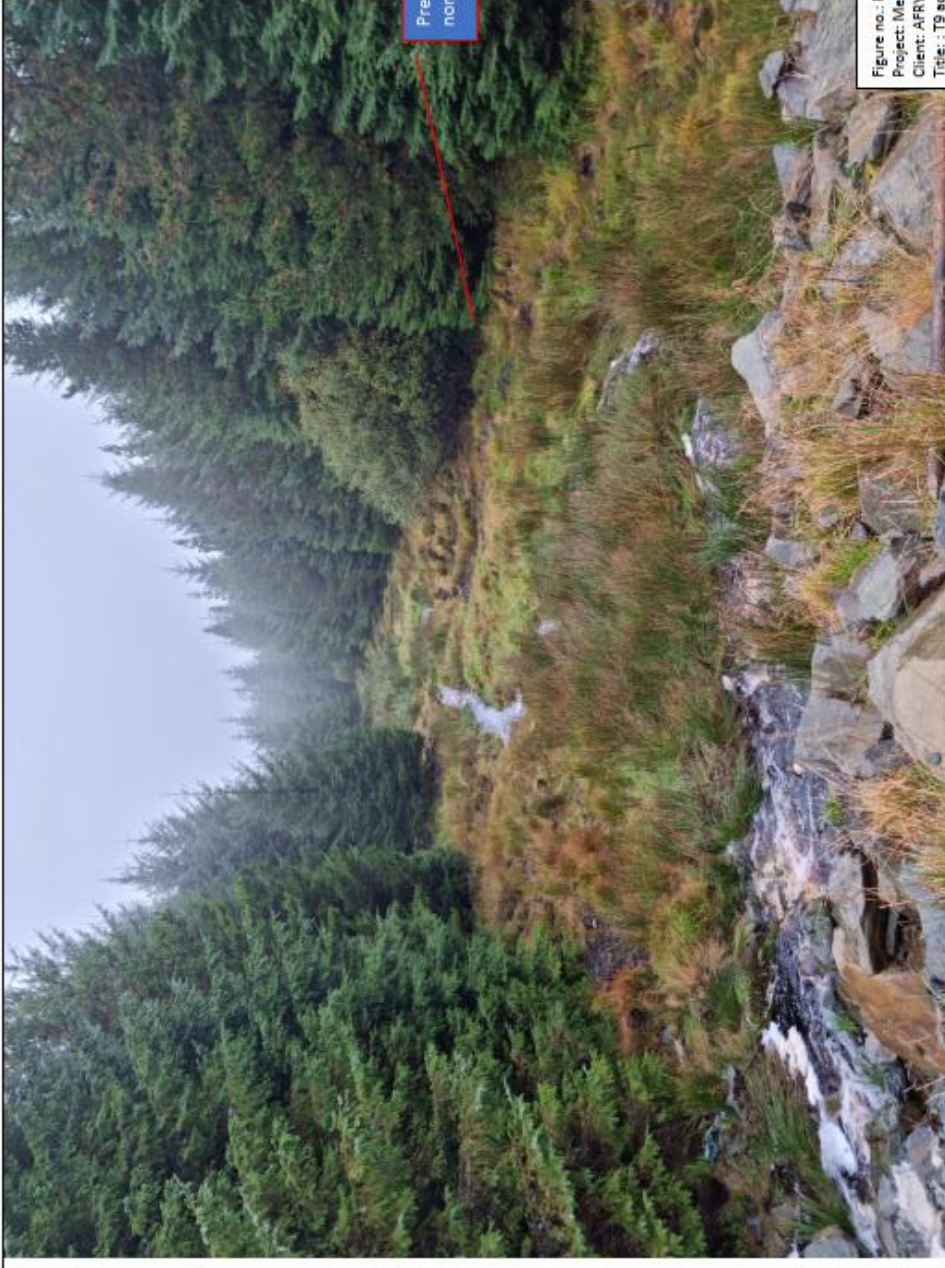
Figure no.: P23023AA-AA-A06
 Project: Meenbog Windfarm
 Client: AFRY Ireland Limited
 Title: T9 access road peat movement

Previous peat movement location, view to northeast of T9 access road

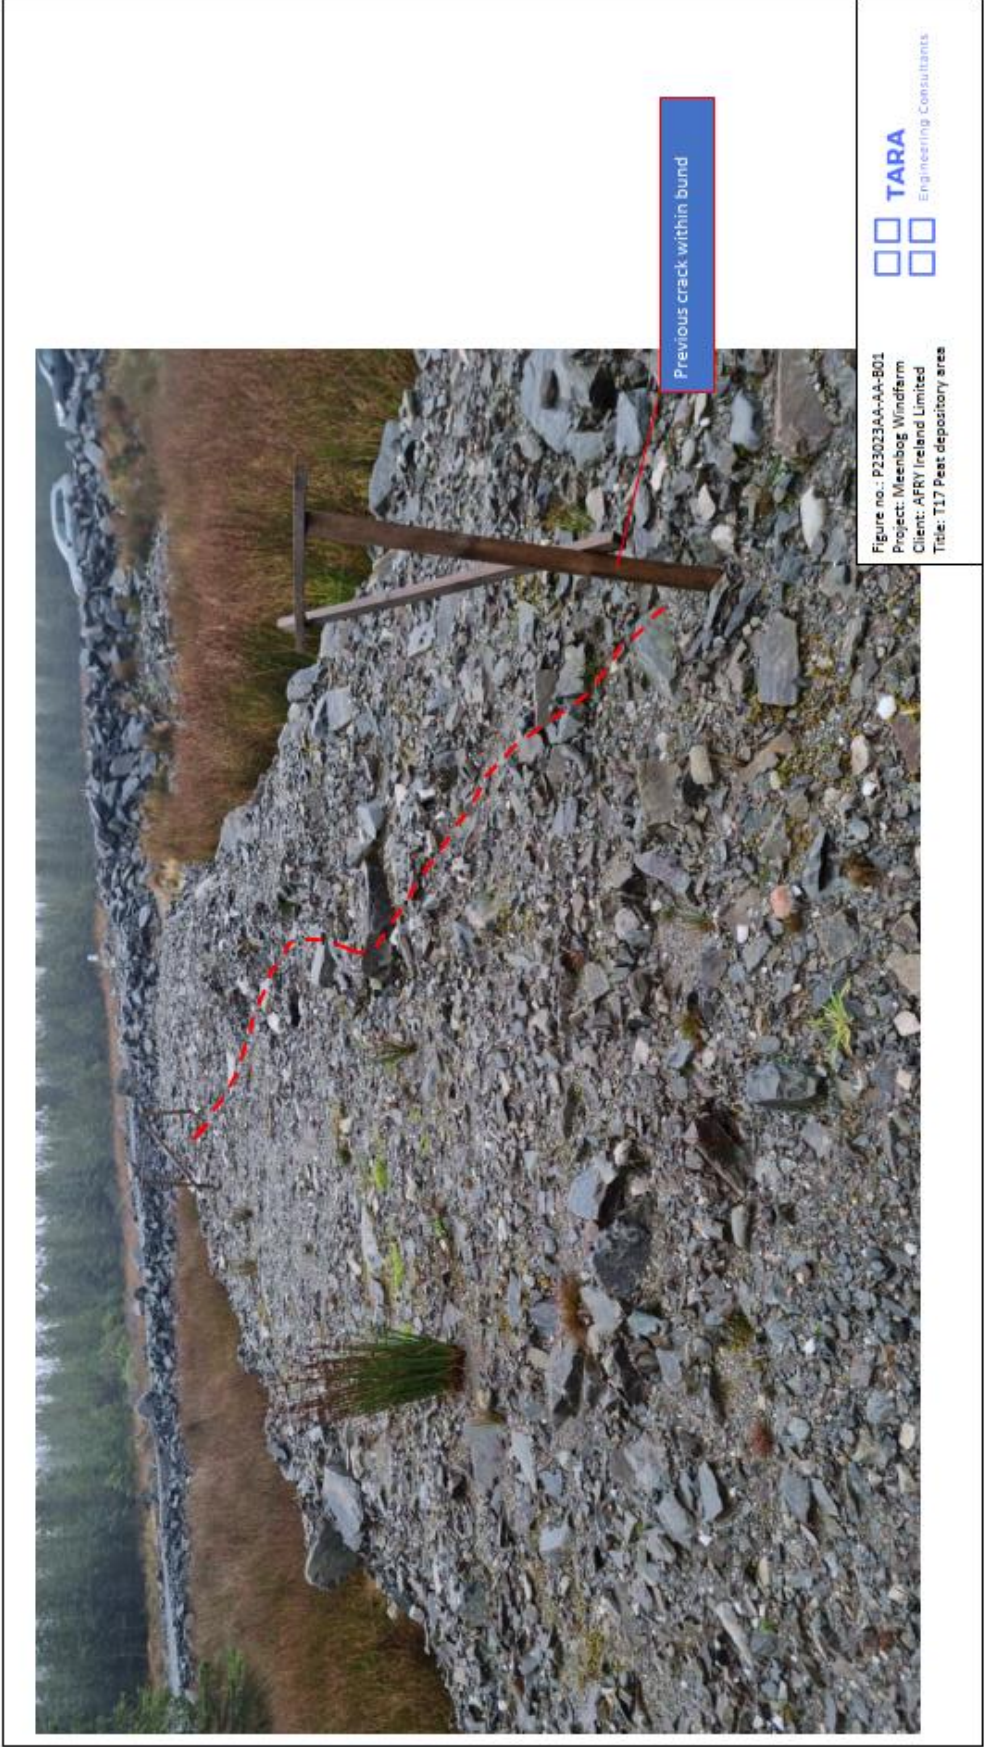
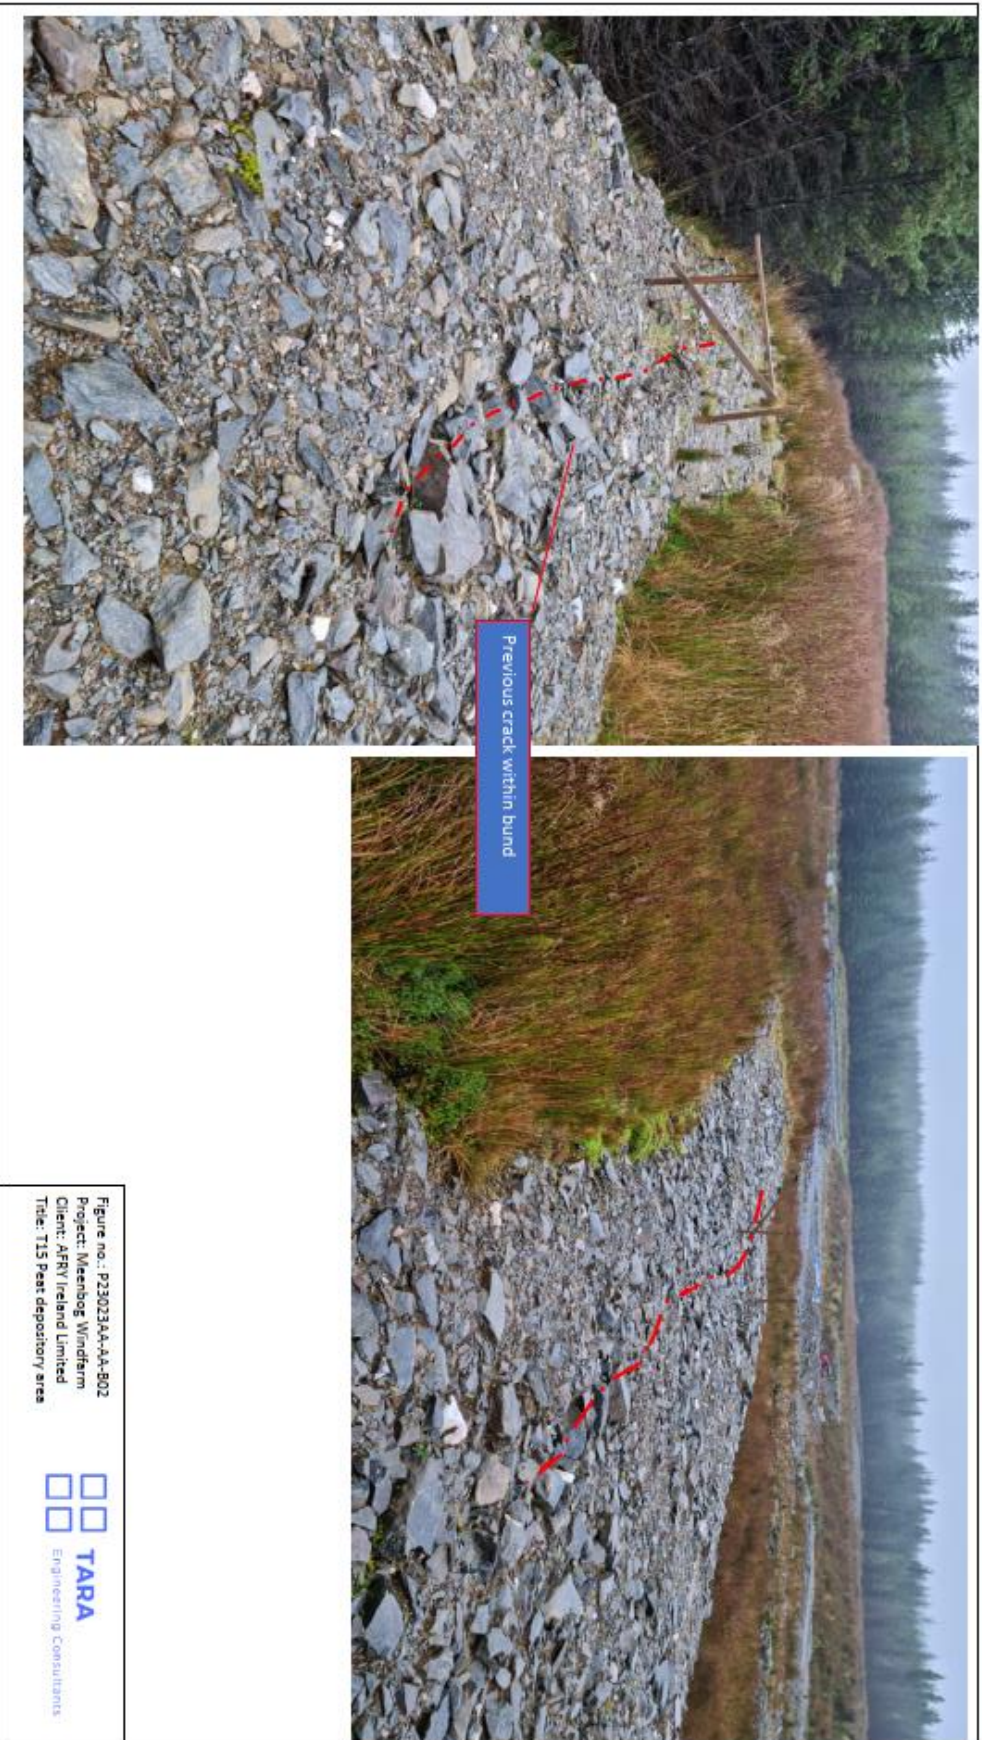
At two of the peat depository areas located at T15 and T17, cracks parallel to the embankment crest were recorded in the Ionic 2021 Report. The Tara and AFRY engineers inspected the cracks during the site visit. We did not observe any additional or recent movement at these areas which appear to have settled. This was confirmed by the inspection of monitoring posts which were installed at both depository areas in 2021. We observed that there is considerable vegetation growth within both depository areas which would further indicate that the areas have settled and are stable. Please see photographs included at Appendix [].
