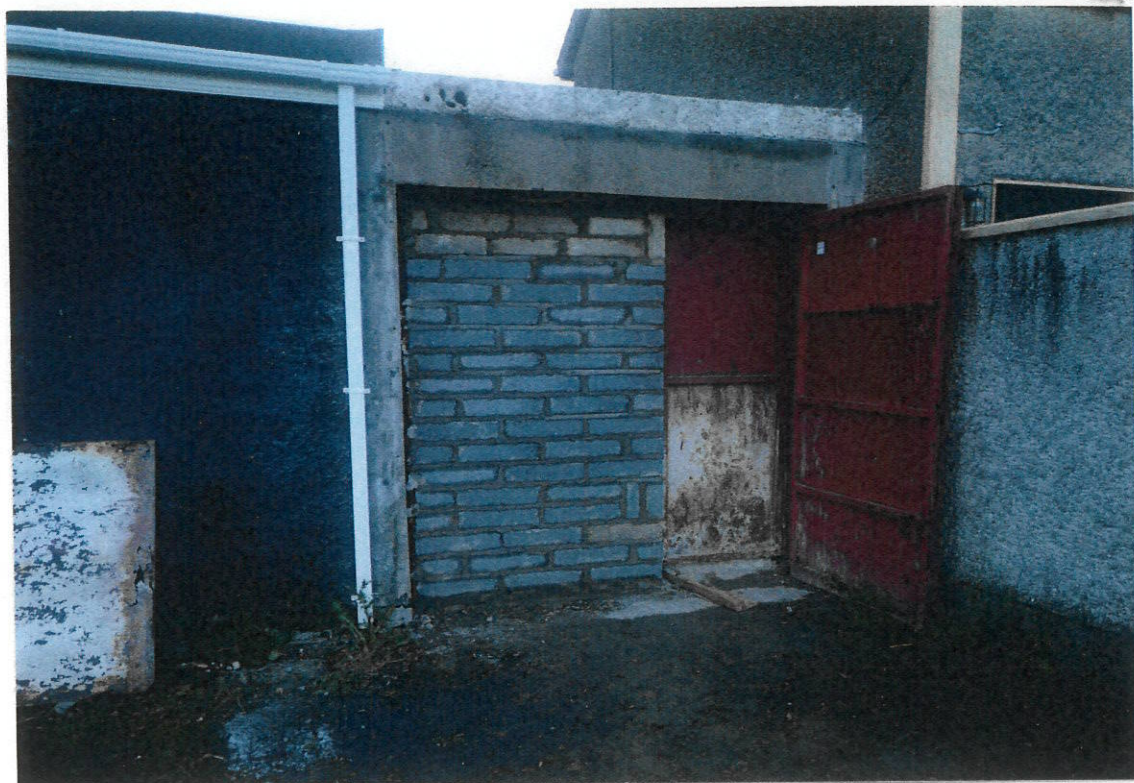
STARTED WITH A ROLLER
SHUTTER
THEN DOOR
NOW A WALL
HAS BEEN STEPPED
BACK FROM EXISTING WALL

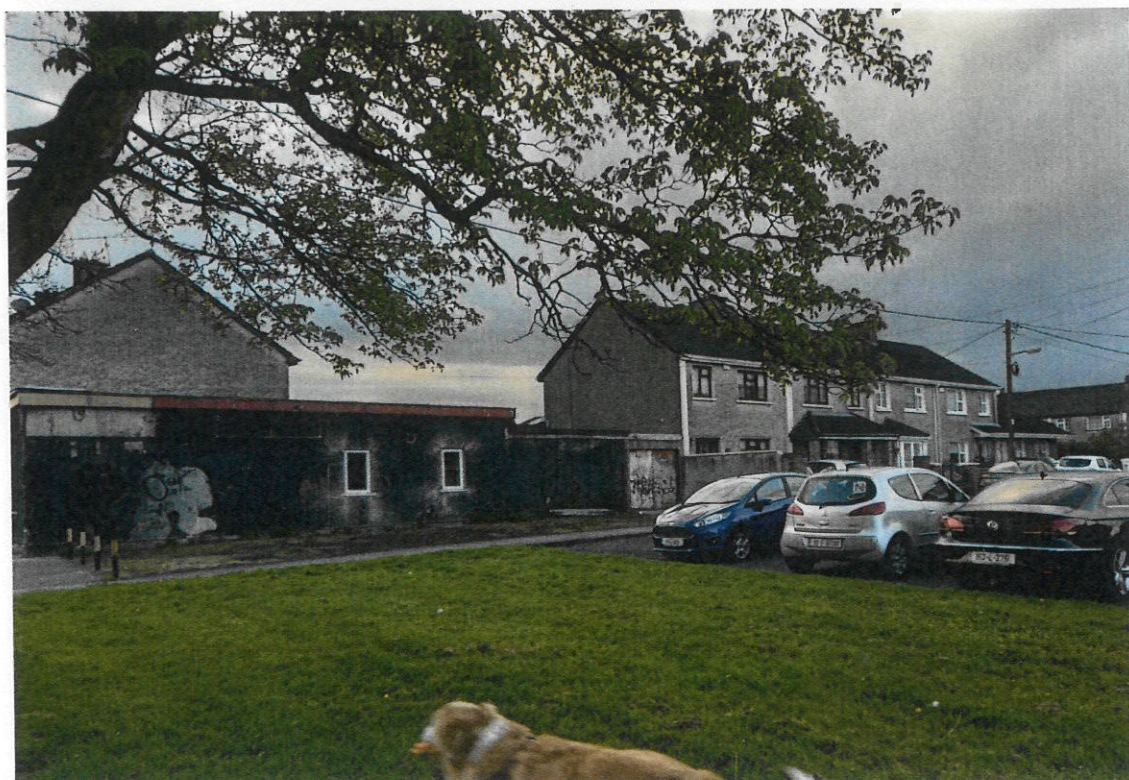
No Boundary WALL
To match Existing Houses

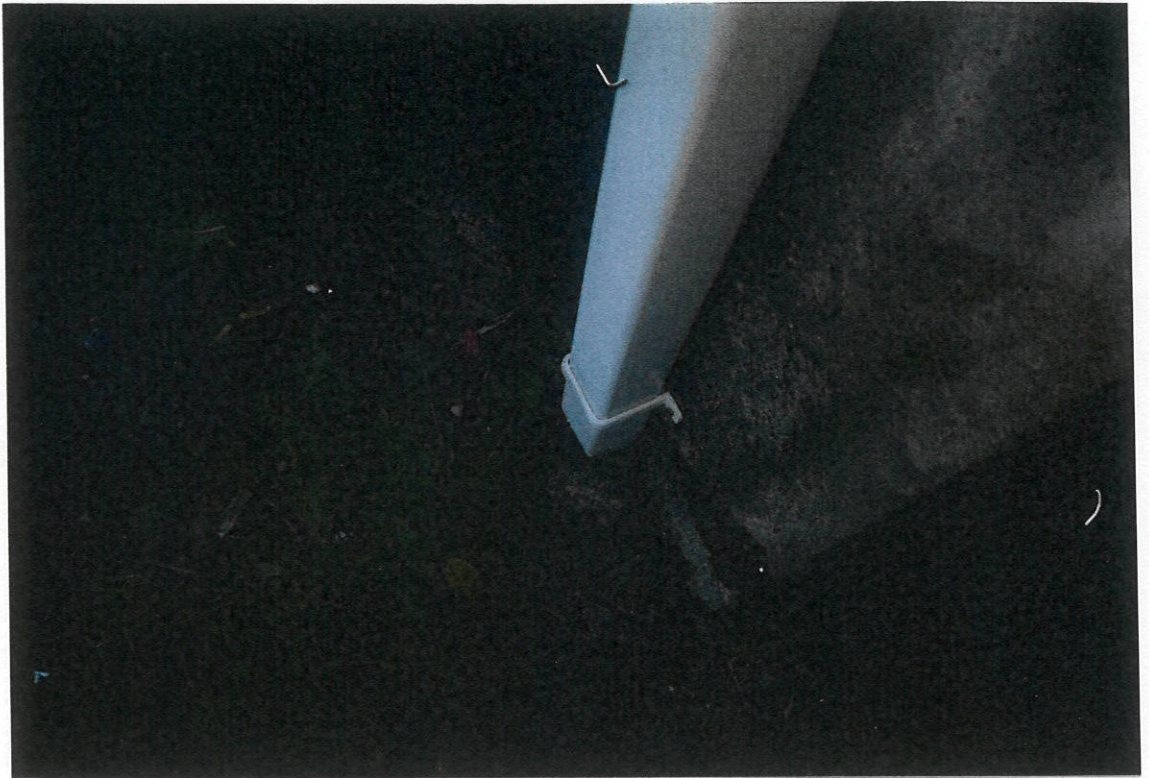
8 M Section of
Guttering TAKES RAIN
WATER OF COMPLETE
ROOF No Gully TRAP

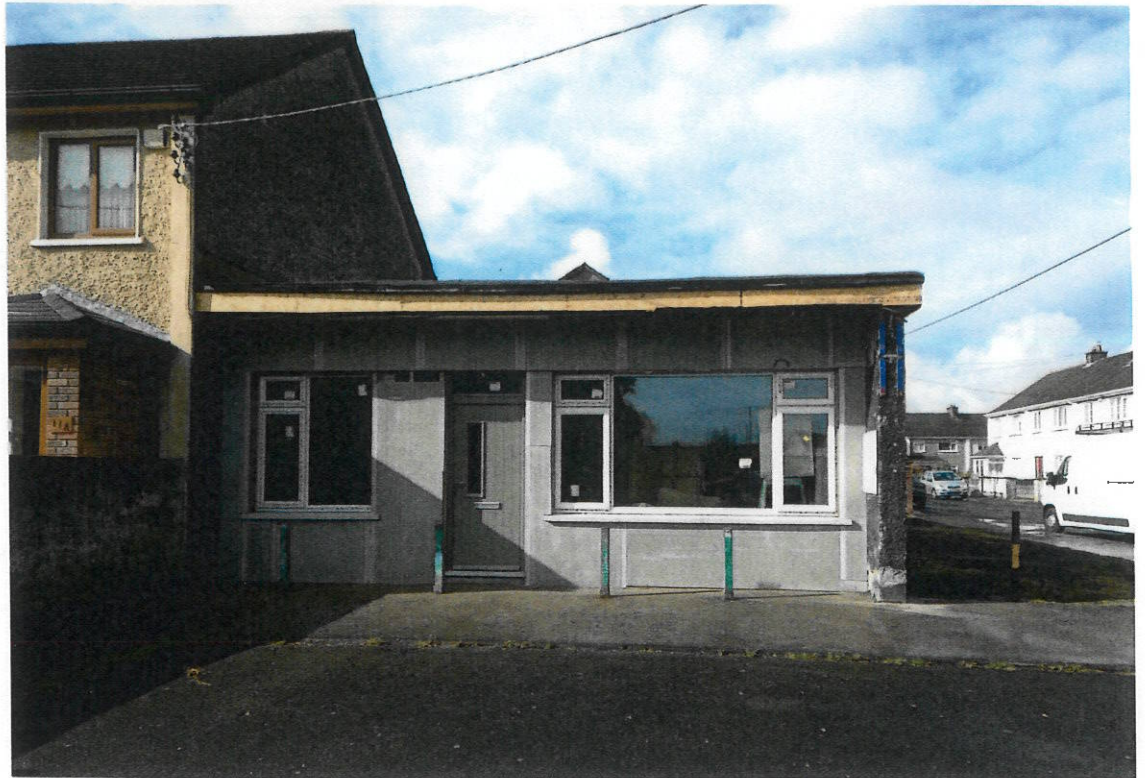
For some reason
THIS DOSE No seem
to Have Been converted
to Be Wheelchair
Friendly

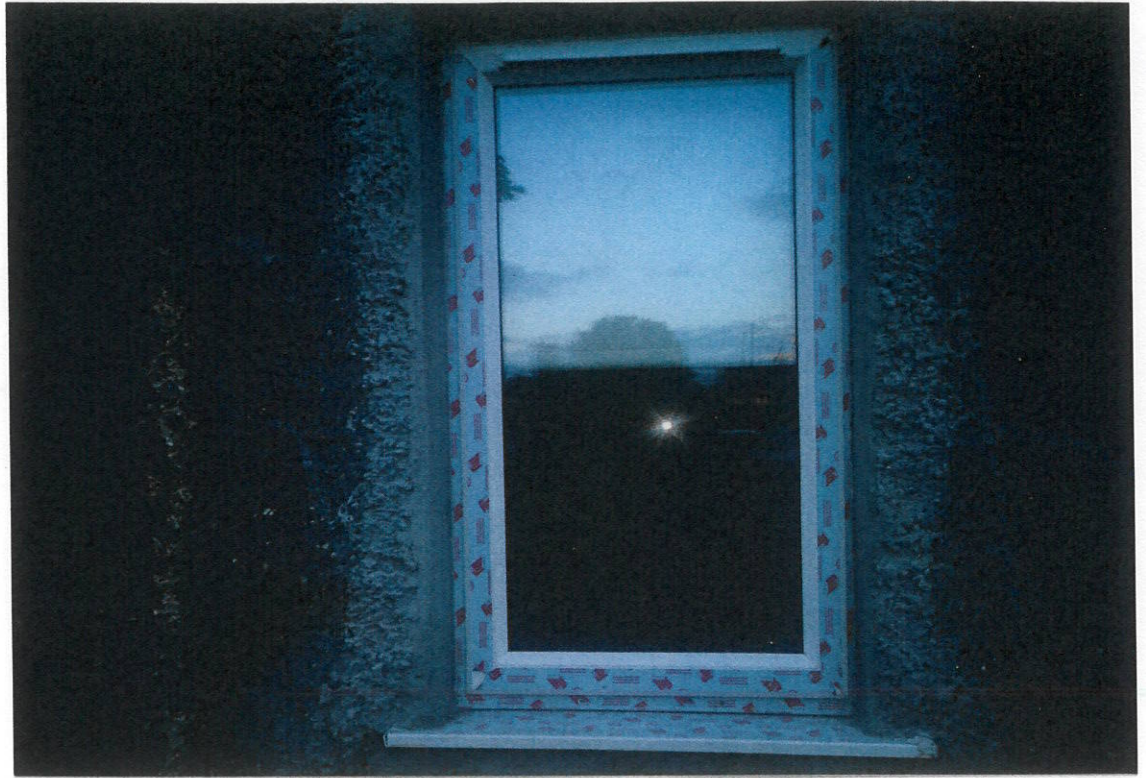
windows too small
No windows this size
in Existing Houses

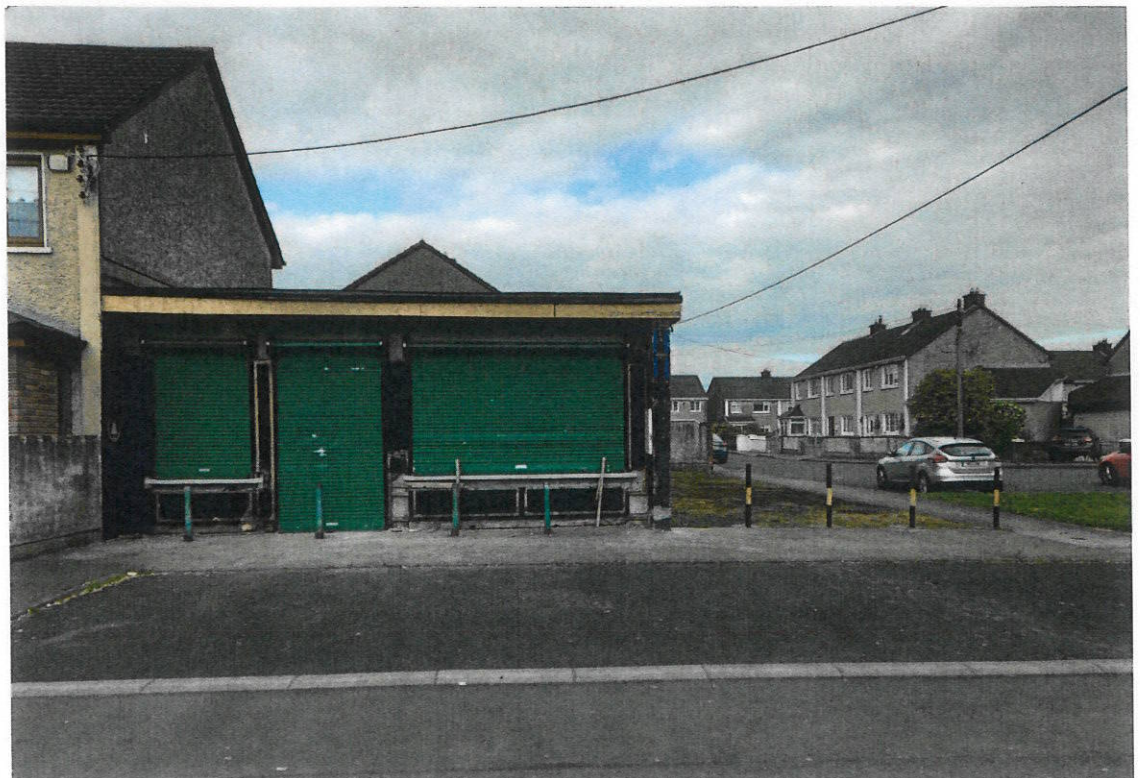
No Boundary WALLS
to MATCH Area.

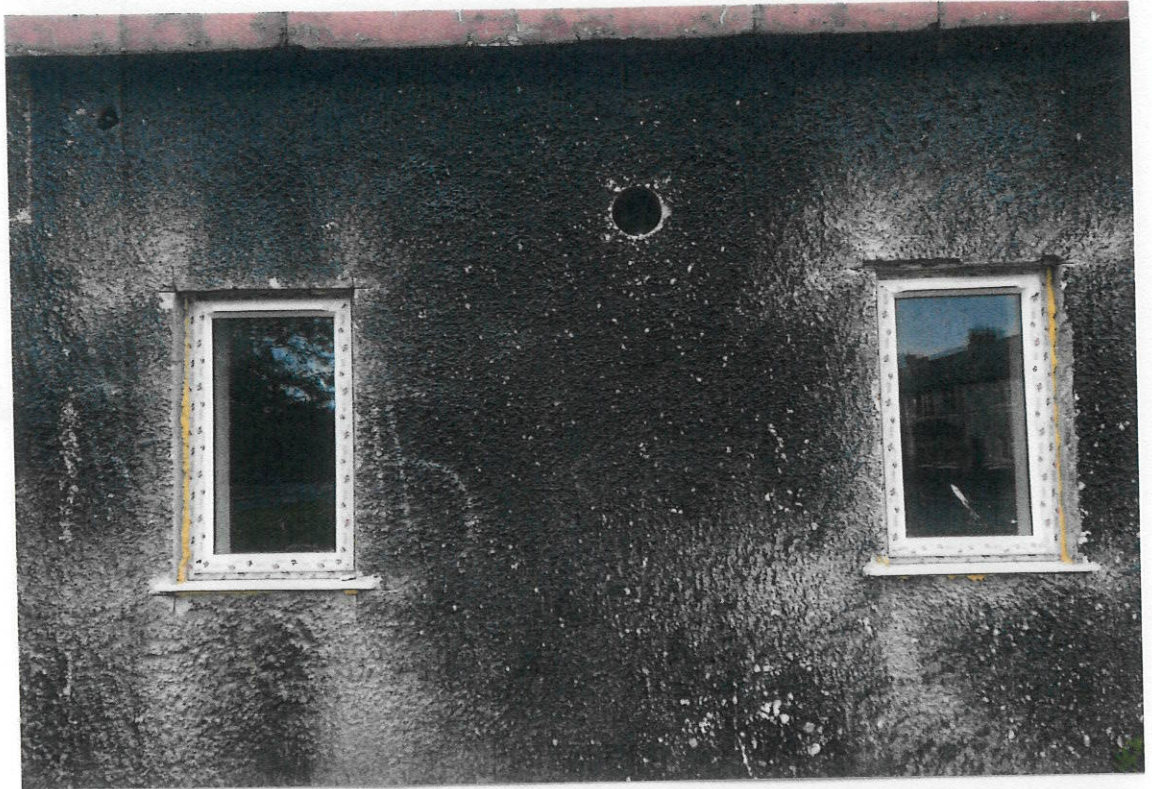
No Lenthals
Over HEAD windows
and No concrete
sills SAME AS
Existing Houses

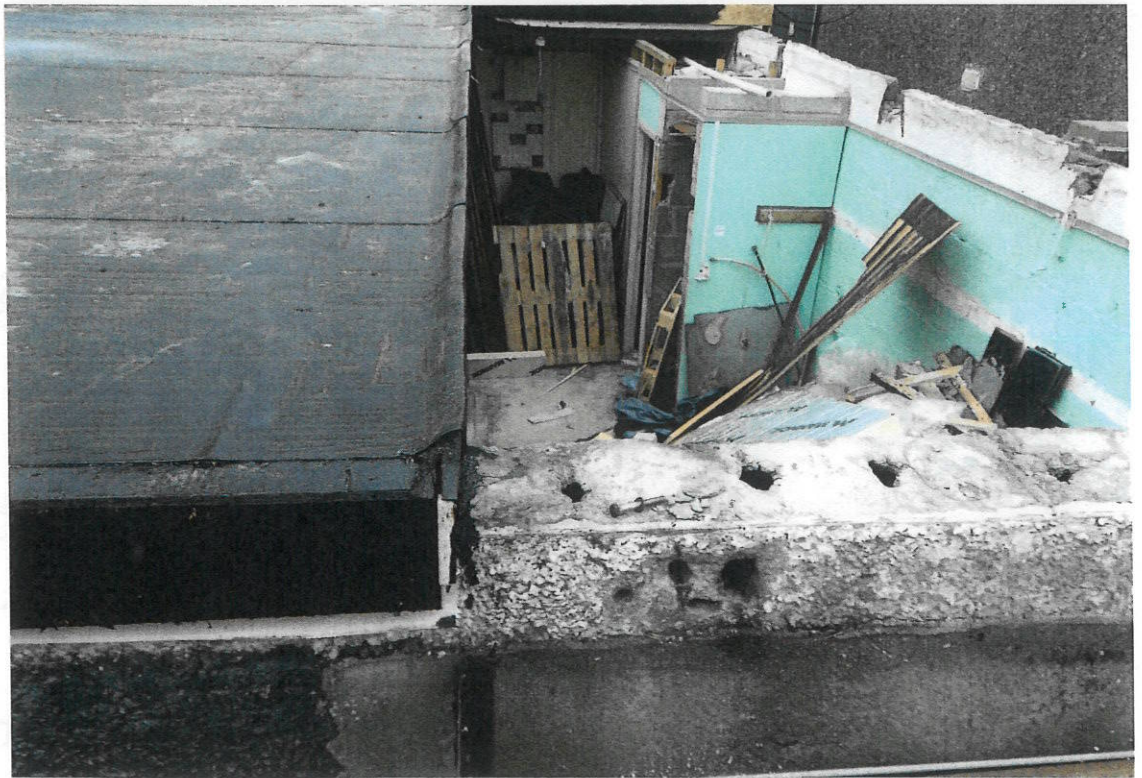
ROOF Removed
NOW Boundary WALL
standing with NO
Supporting Pillars
in place.
At Back of Building

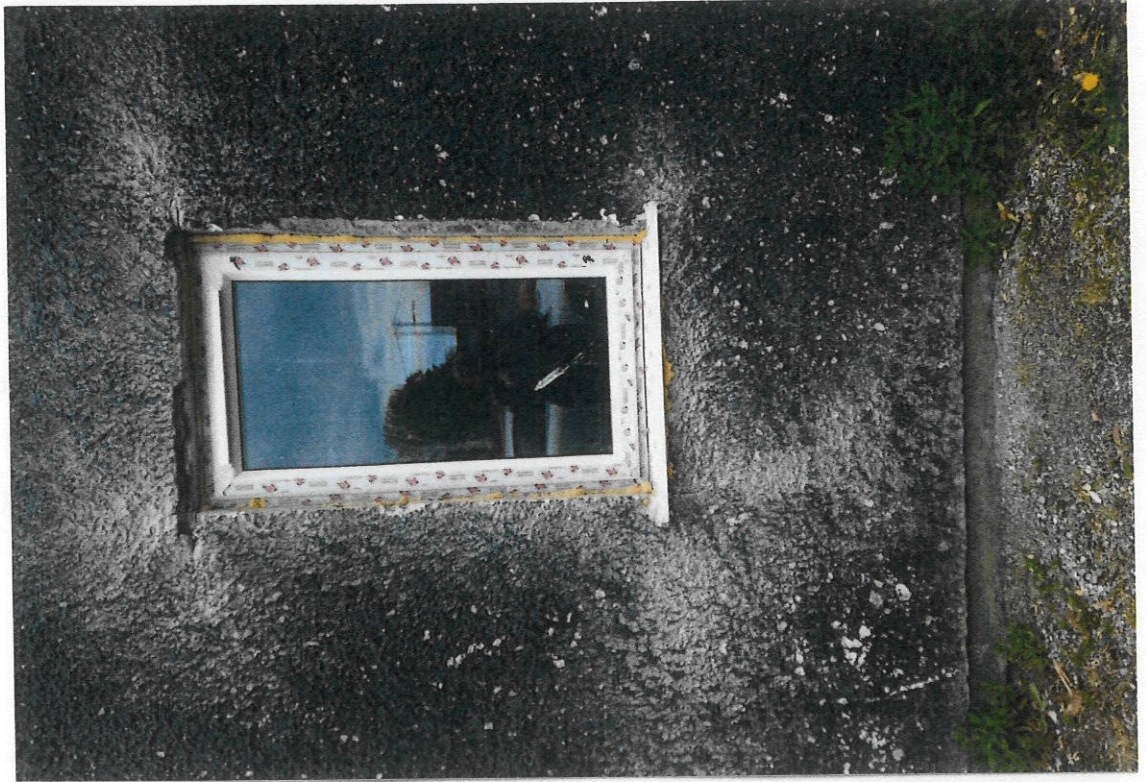
NO EFFORT TO MATCH
Finish Around windows
And windows in Area
Windows Also 2 small
Don't MATCH Area.

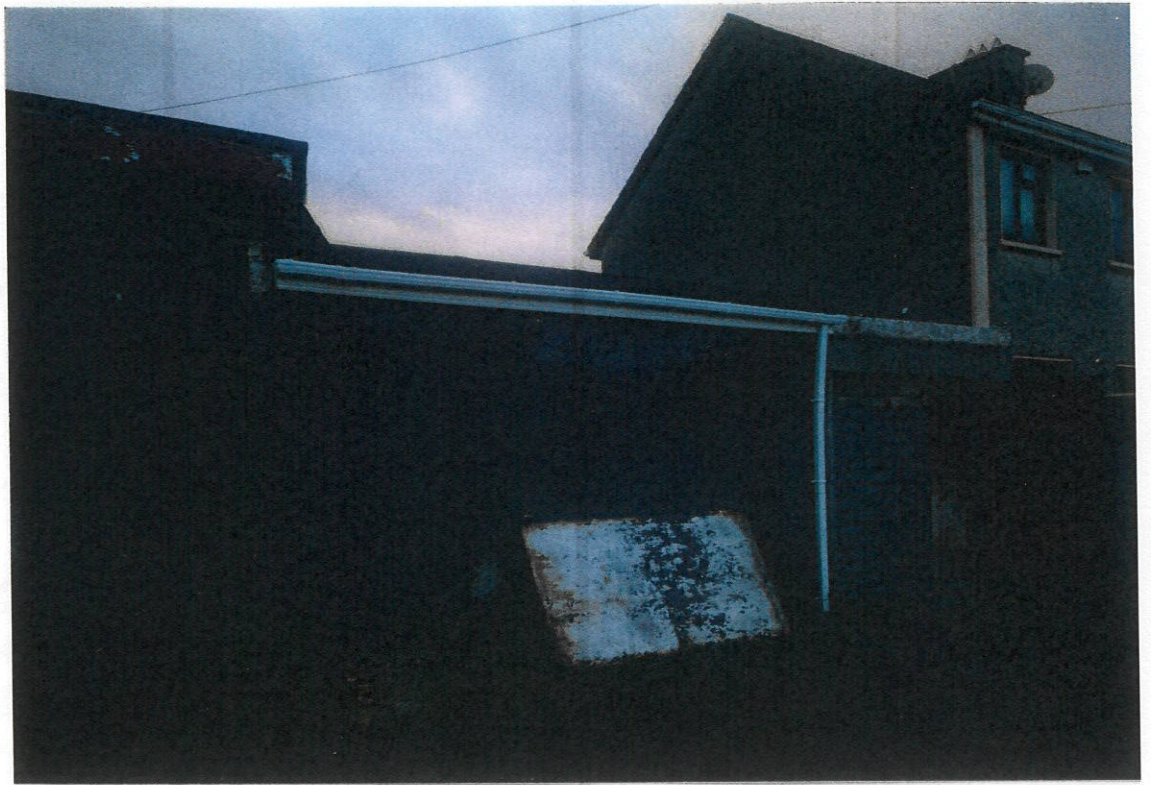
0000.JPG
J1276531752 JE1CF1D83112
1.1.19 8mm 14
Suttering Takes ~~ALL~~ RAIN
WATER OFF ROOF NO
Gully in place.
Door Removed And WALL
stepped Back from Existing
Building And smooth Plaster
Finish on ~~NEW~~ WALL HALF
OF ~~Old~~ Door installed And REVERSED
Bad side FACING out

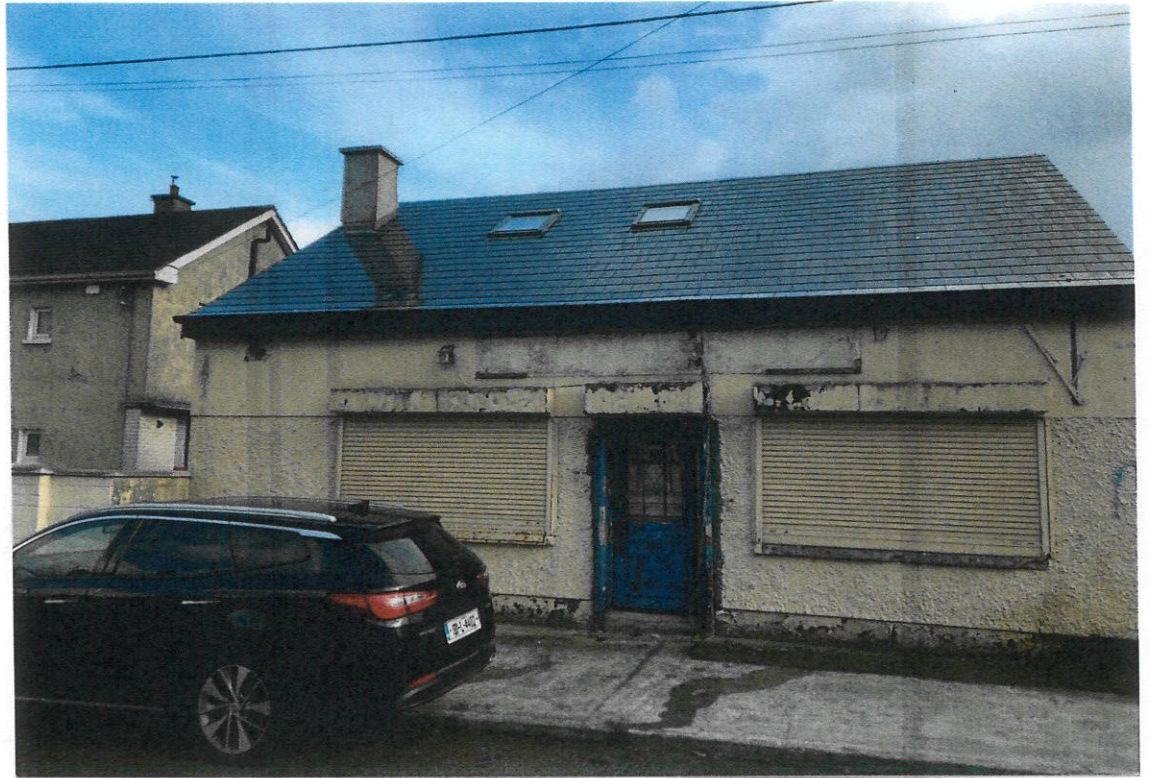
MAcks
SHOP CHAU LAGHAN Court
Garryowen
Currently Being renovated
WAS A LEFT ROOF
Building

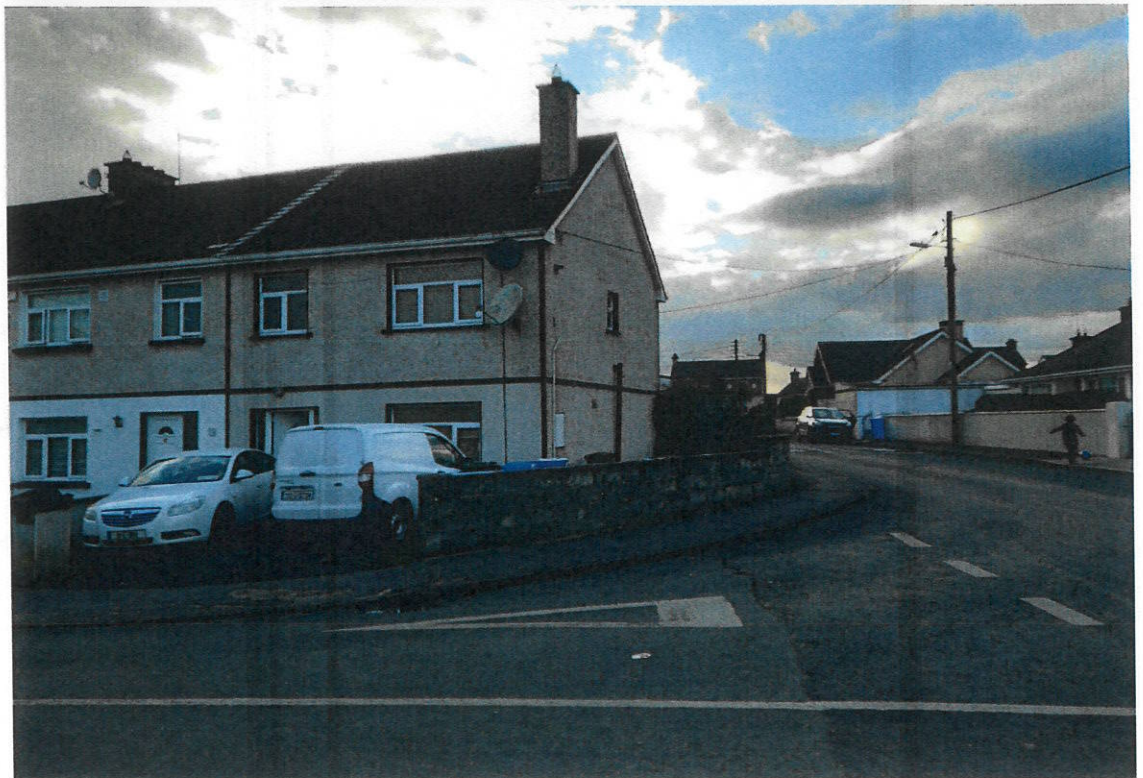
75 Lynwood PK
FORMALLY COONEYS SHOP
COMPLETED Demolished
And New House Built

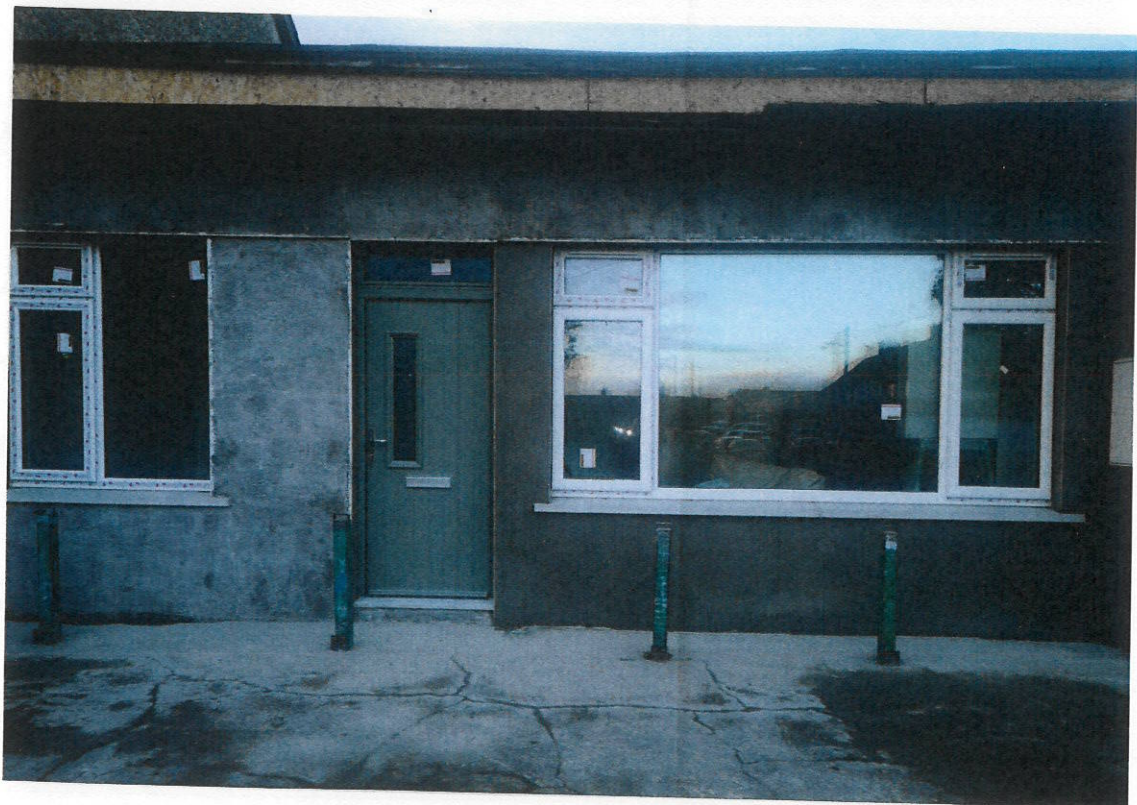
WINDOWS AND DOORS
DO NOT MATCH EXISTING
HOUSES SMOOTH PLASTER
FINISH EXISTING HOUSES
DASH FINISH
WINDOWS OVER SIZED
1 WINDOW ~~plus~~ DOOR IN EXISTING
HOUSES
