CONSERVATION

Section 5 Referral

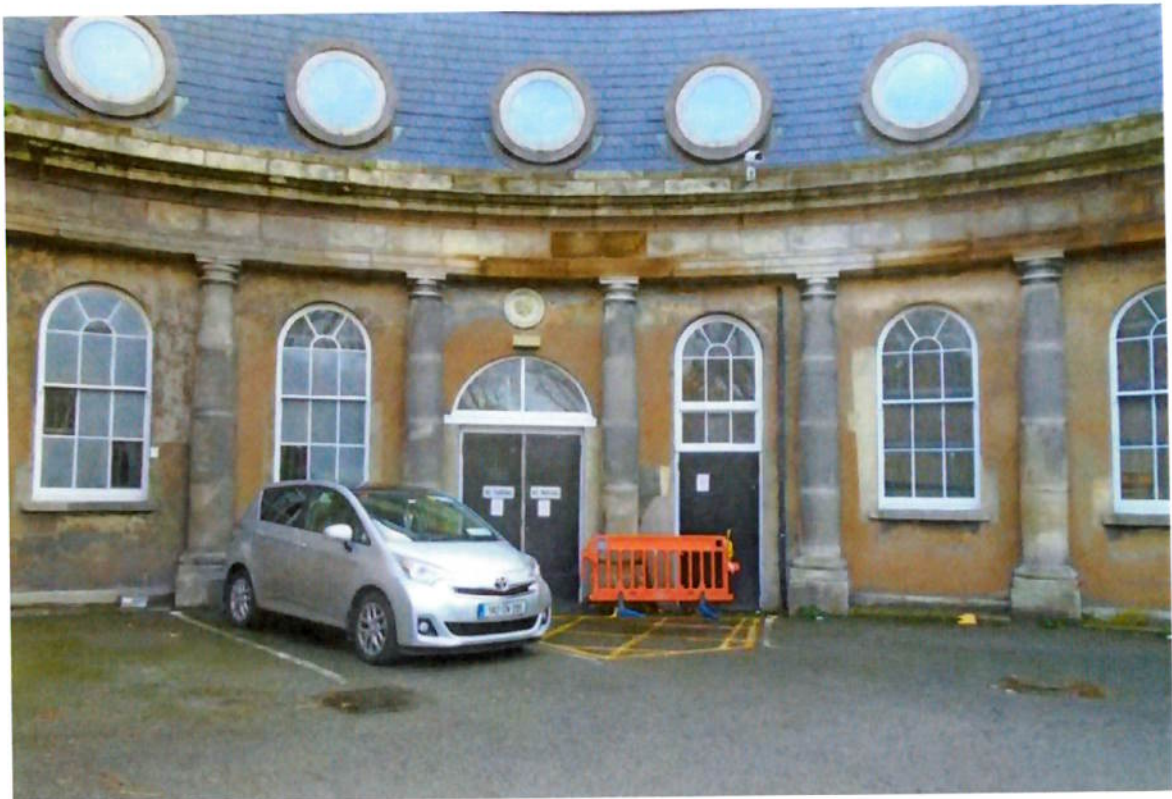
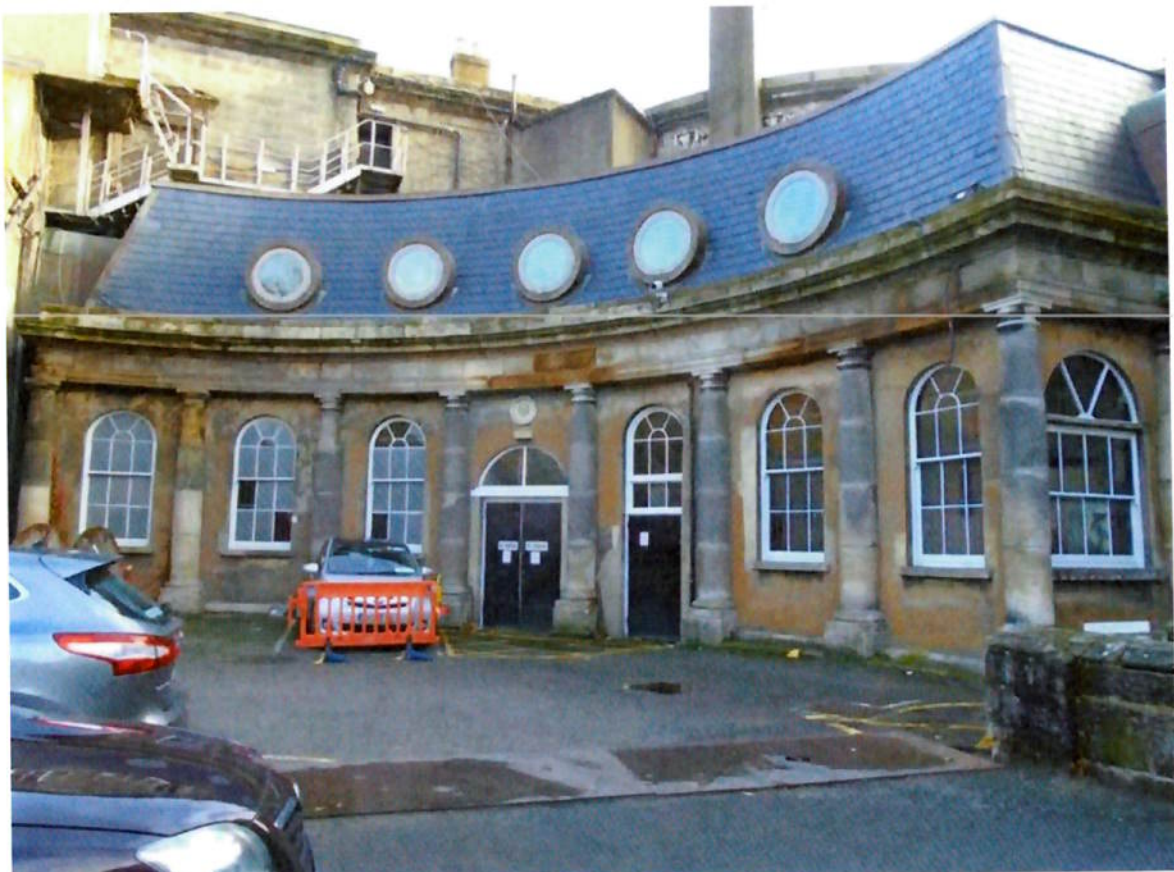
Figure 1 a, b, c d & e. External Elevations of the Ambassador Cinema

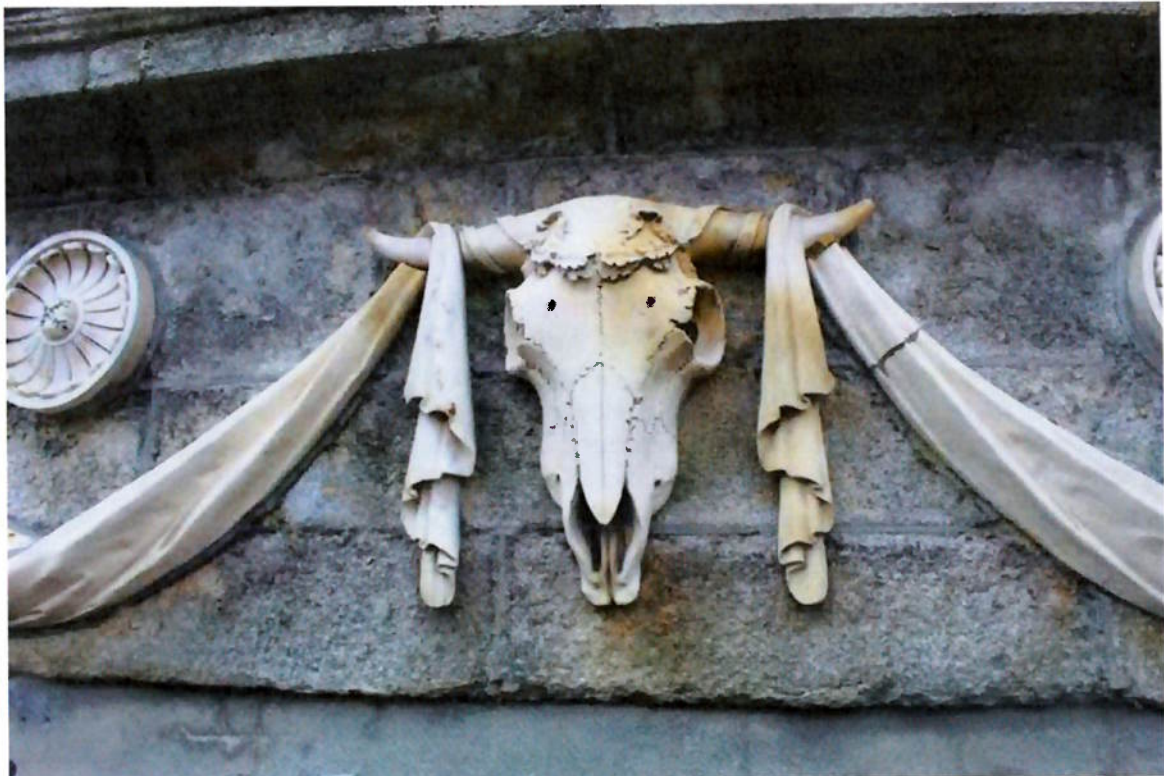
Figure 2a. Coade Stone decorative frieze to the rotunda theatre showing Bucranium and roundel.

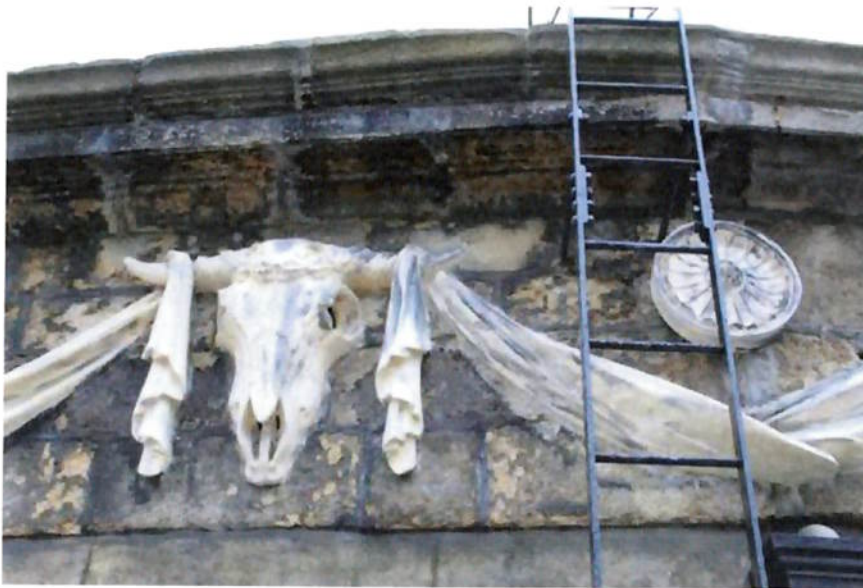
Figure 3. Replaced 'new' Coade Stone elements from a previous repair scheme. The moulds are still available for the replacement Coade Stone elements required.

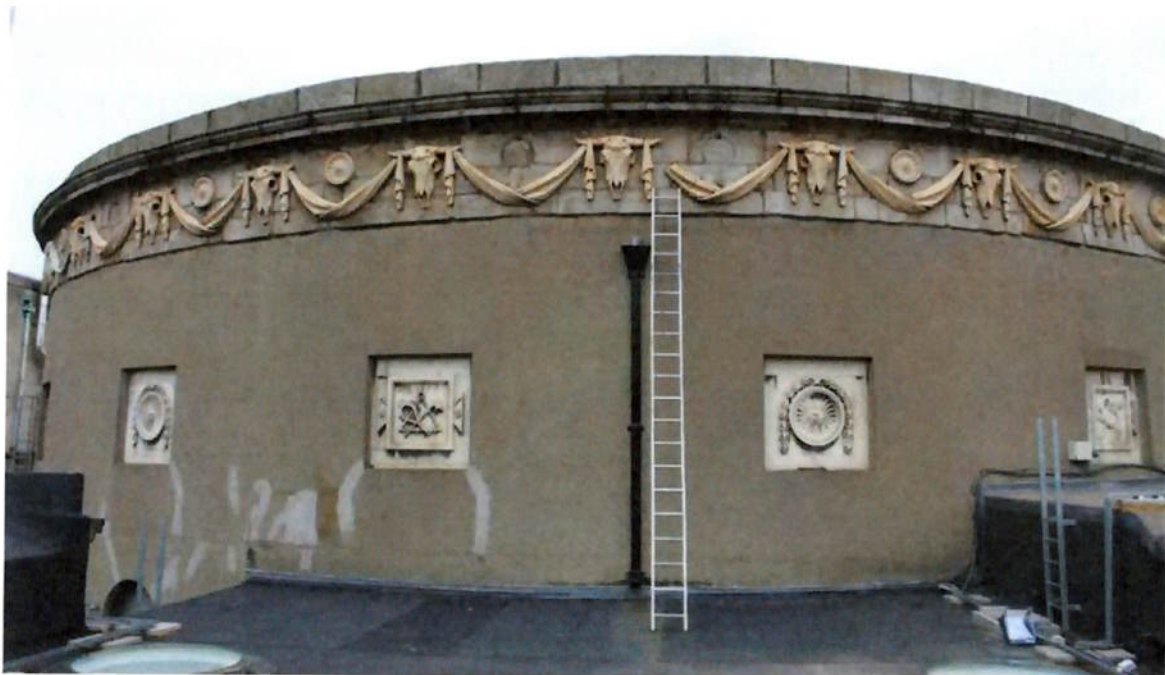
Figure 4. Elevation view of the rotunda theatre building. It is proposed that the missing Coade stone rounder and sections of swags are replaced and the cement render that is cracked and repaired is hacked off and re-rendered.

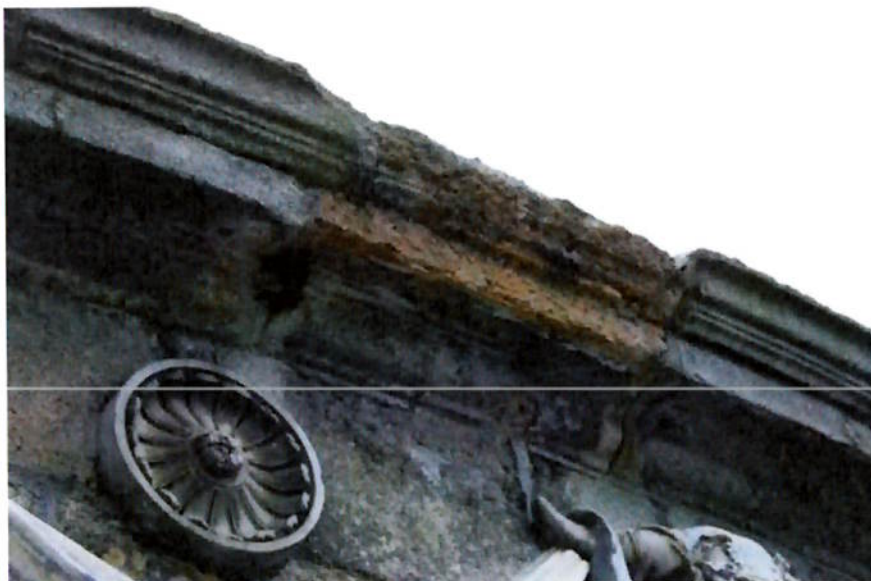
Figure 5. Deteriorated section of granite cornice to be replaced in Ballyknockan (Wicklow) Granite to match original.

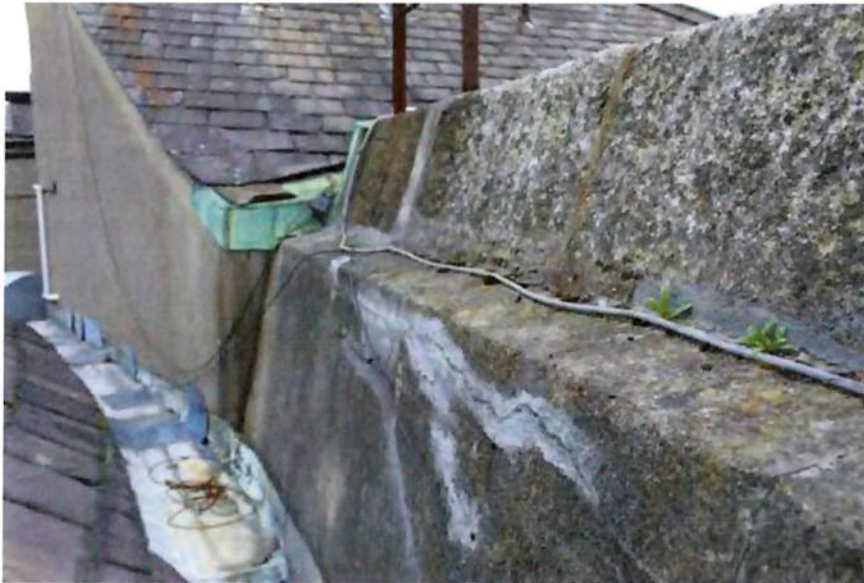
Figure 6. Inner parapet of the rotunda theatre building cracked cement render. Very deteriorated sections area to be repaired.

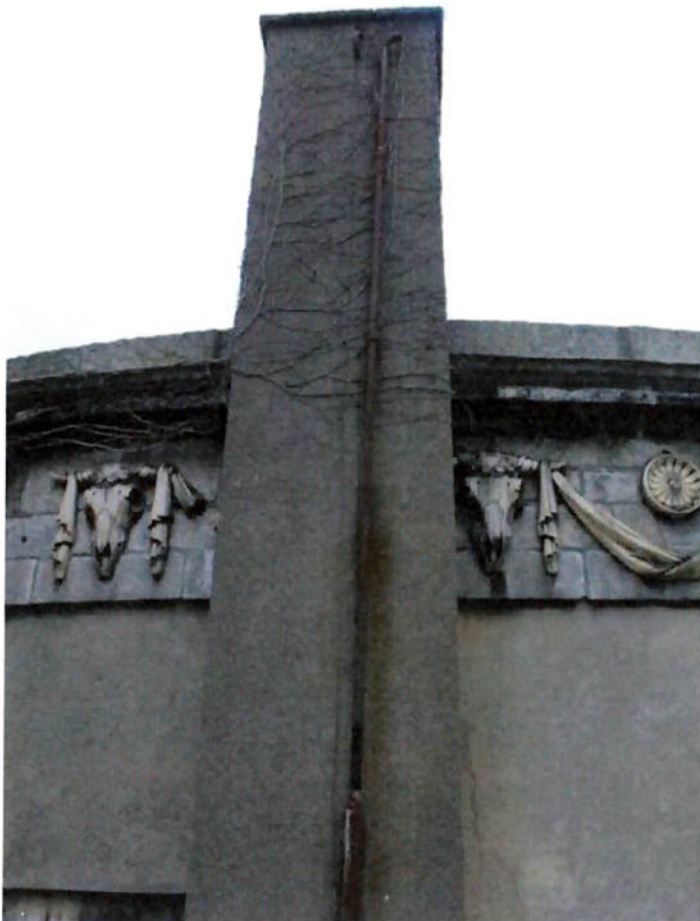
Figure 7. Defective render to chimney. Pipe to be removed and chimney re-rendered.

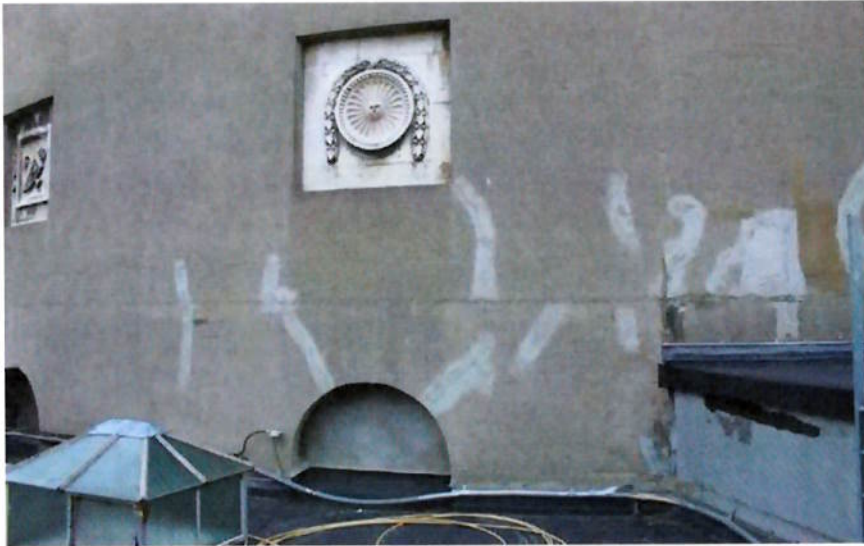
Figure 8. Defective cement-based render at roof level. Area to be re-rendered.

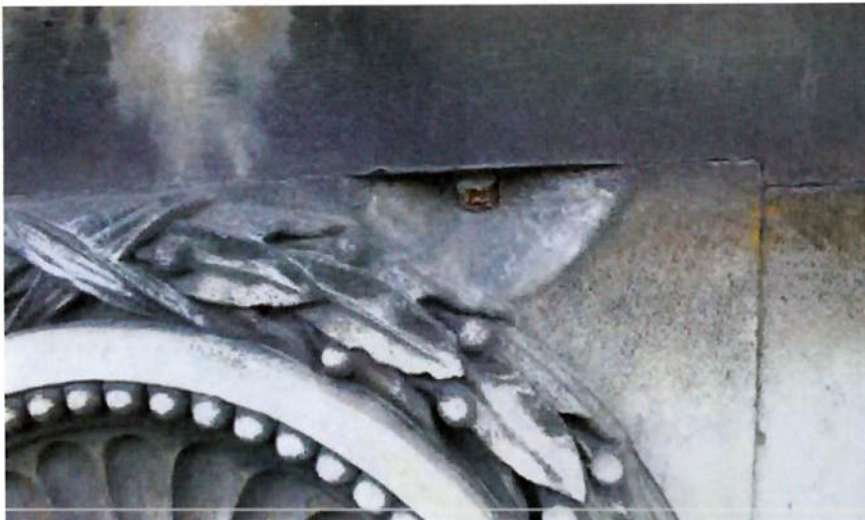
Figure 9 Corrosion of fixings causing stone damage to Portland limestone

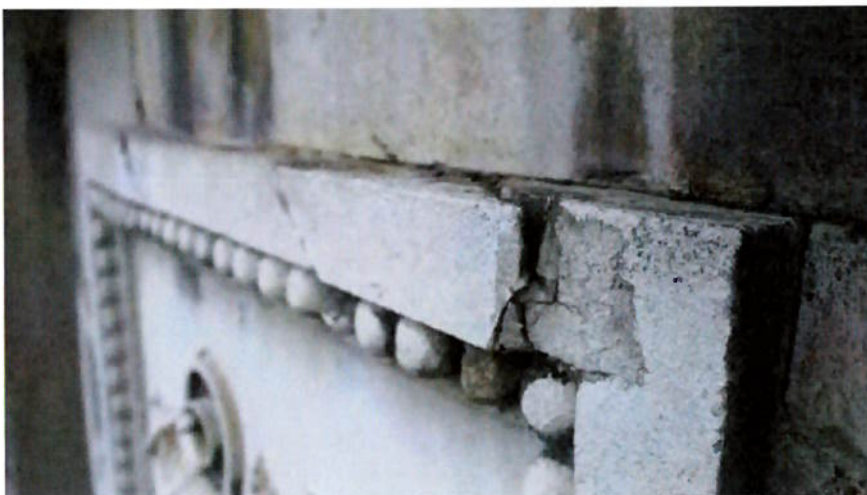
Figure 10. Corrosion of fixings causing stone damage to Portland limestone panels.

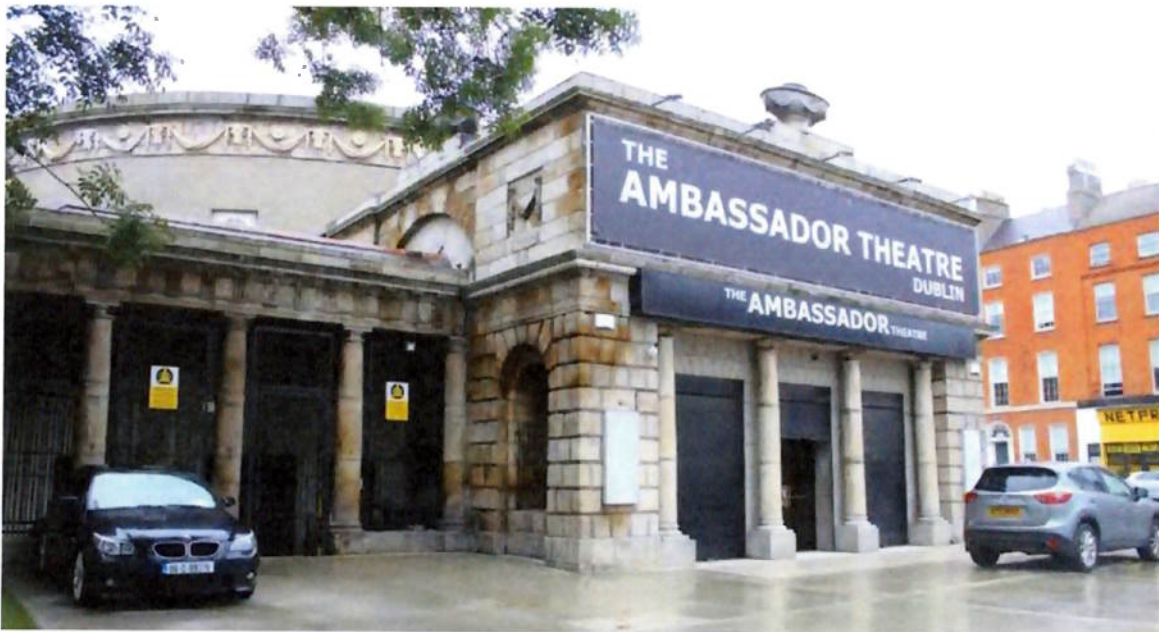
Figure 11. Front Elevation block and first section of the arcade.

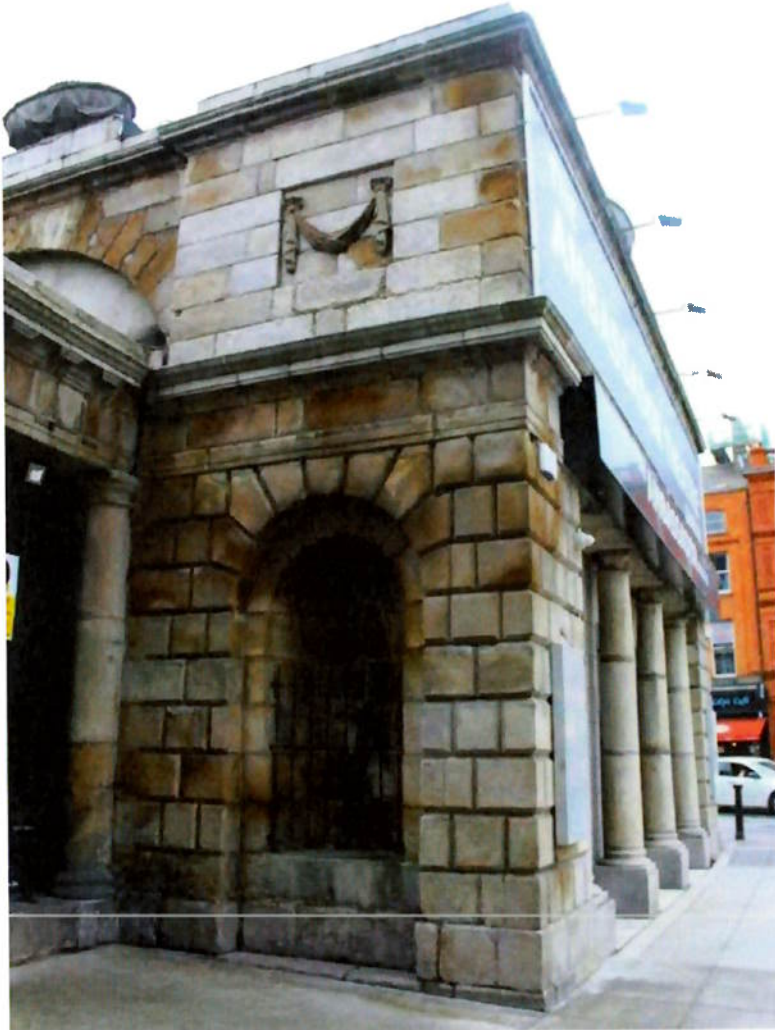
Figure 12. Return wall to front elevation. Proposed works are repointing open joints, replace decaying render swags and gentle cleaning to lighten staining in the niche.

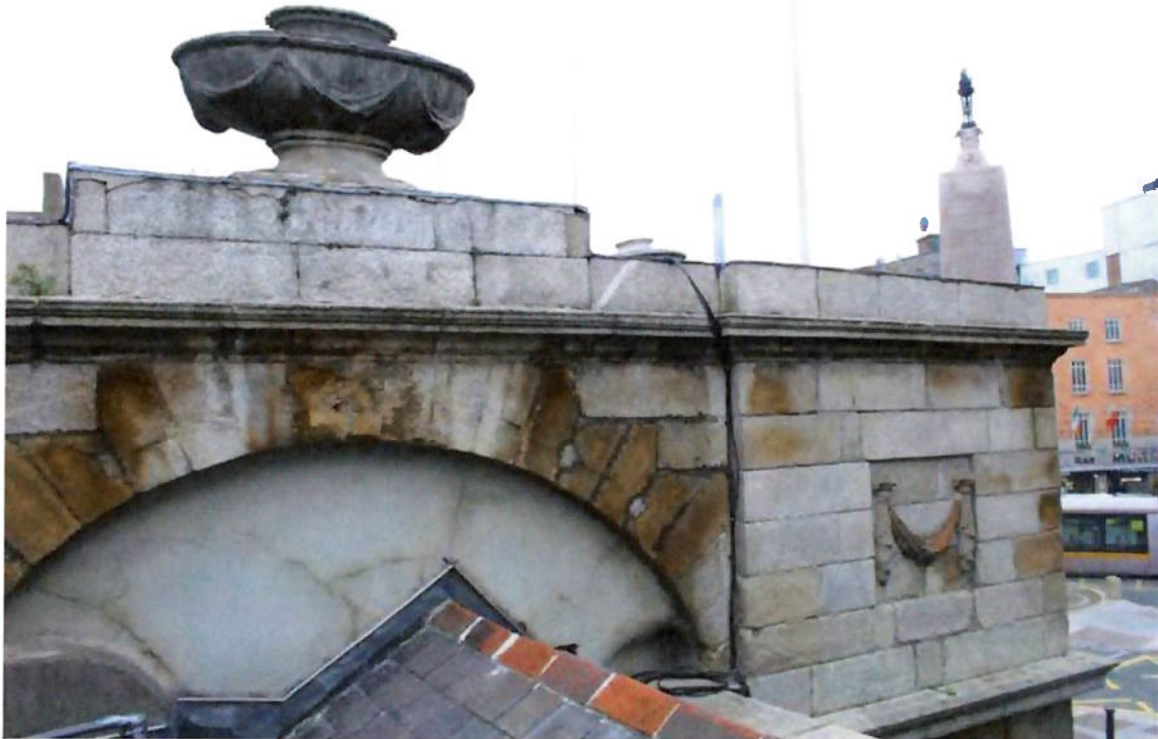
Figure 13. Upper level of the return elevation. Repair to defective lime render required and repointing of joints

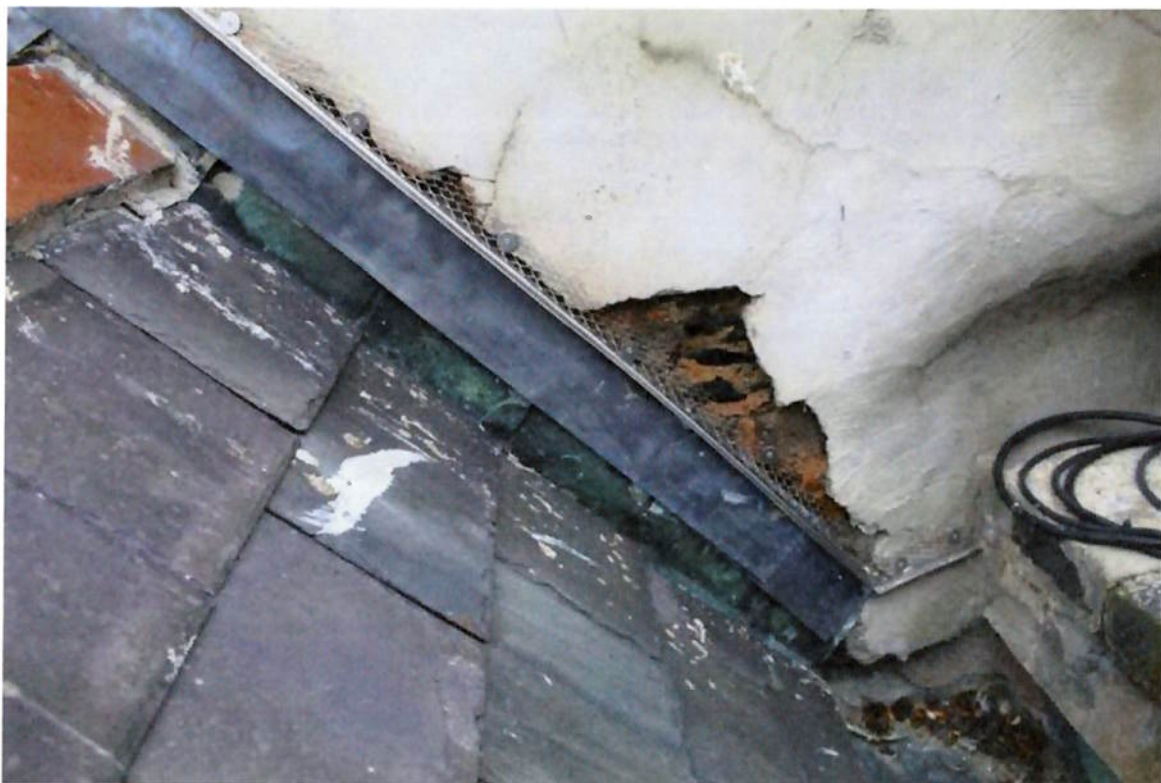
Figure 14. Defective (lime) render and flashing allowing water ingress. To be hacked off and re-done in lime render

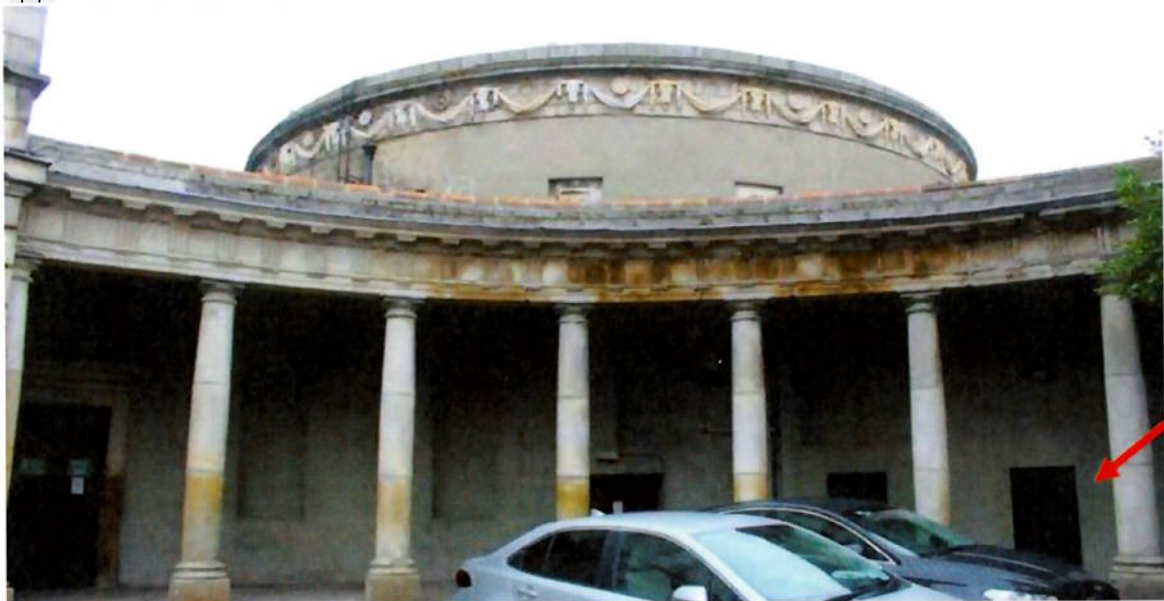
Figure 15 Arcade link to the Rotunda Hospital with the Rotunda Theatre building behind. Left had side was subject to a cleaning trial by Thomann-Harry. This has proved to be too severe and we do not recommend using it.

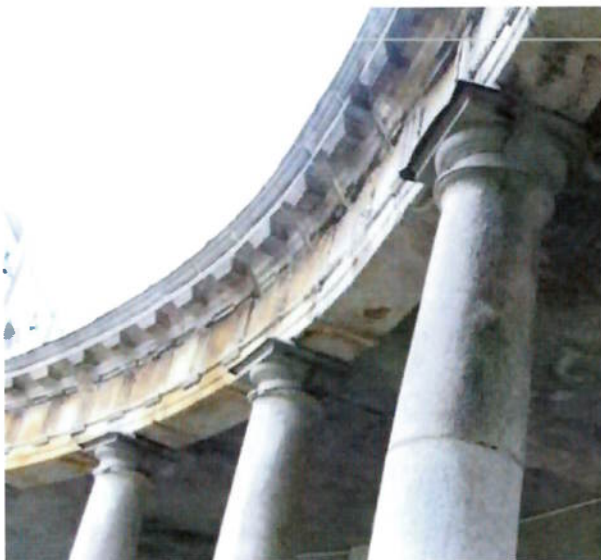
Figure 16 View of upper cornice to the arcade. Shows decaying elements of previous cement repair. Proposed works are to remove loose and spalling mortar with hand tools only

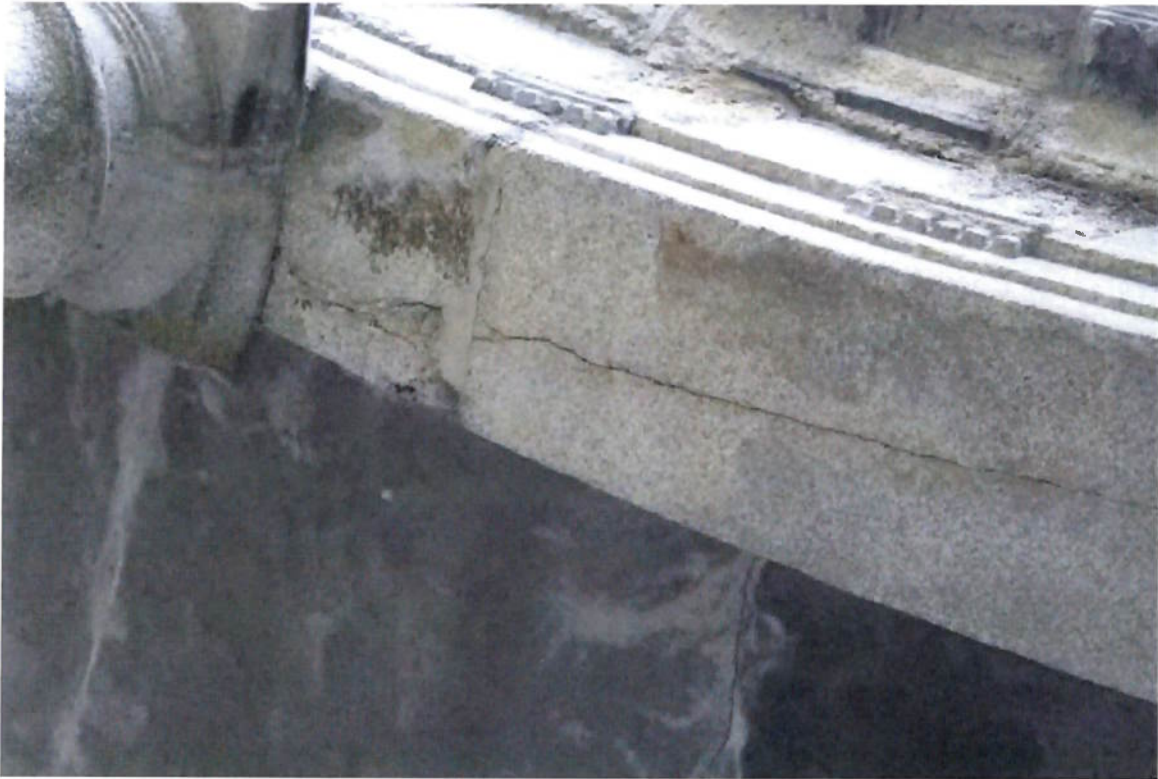
Figure 17 Cracks to the granite soffit. All soffit granite to be inspected by a conservation accredited engineer.

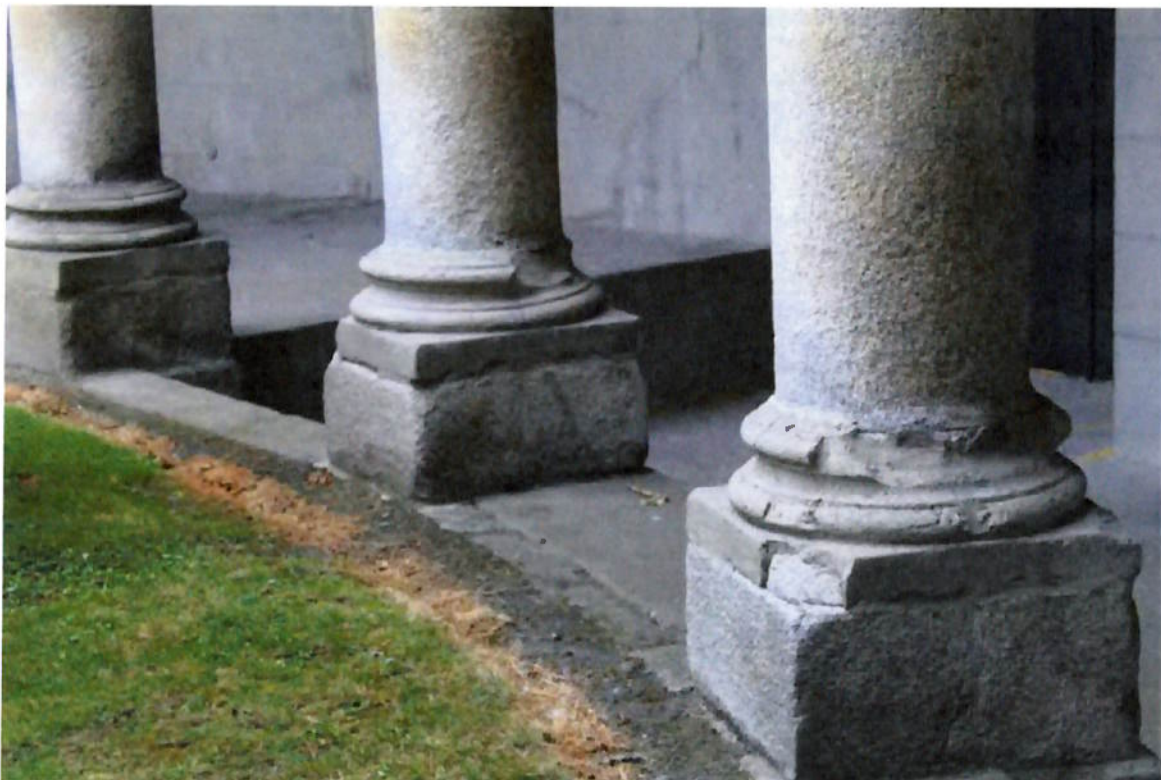
Figure 18. Deteriorating render repairs to column bases. Defective cement-render to be removed and replaced by moulded granite indents to match original.

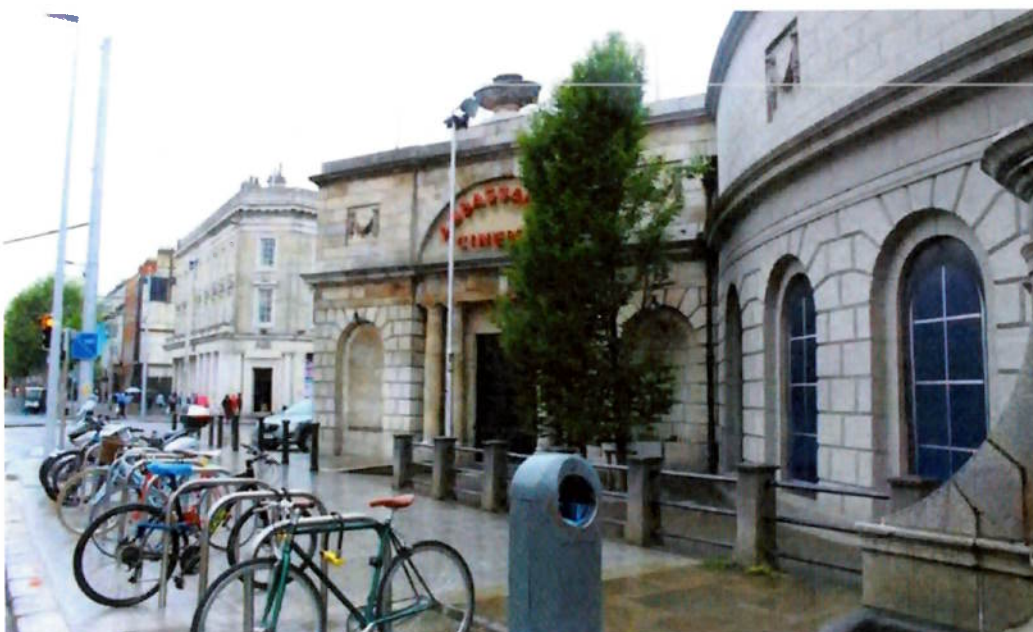
Figure 19 View of East elevation both granite and rendered facades

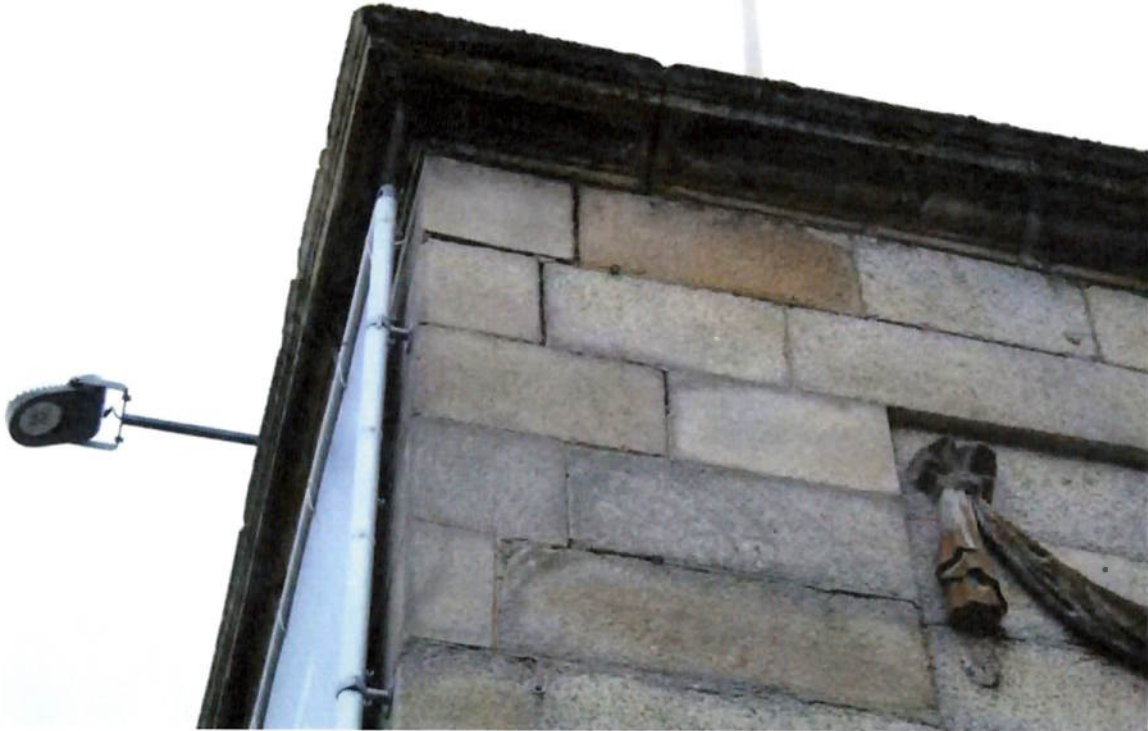
Figure 20 Open joints to the granite stonework to be repointed and missing section of swags to be replaced.

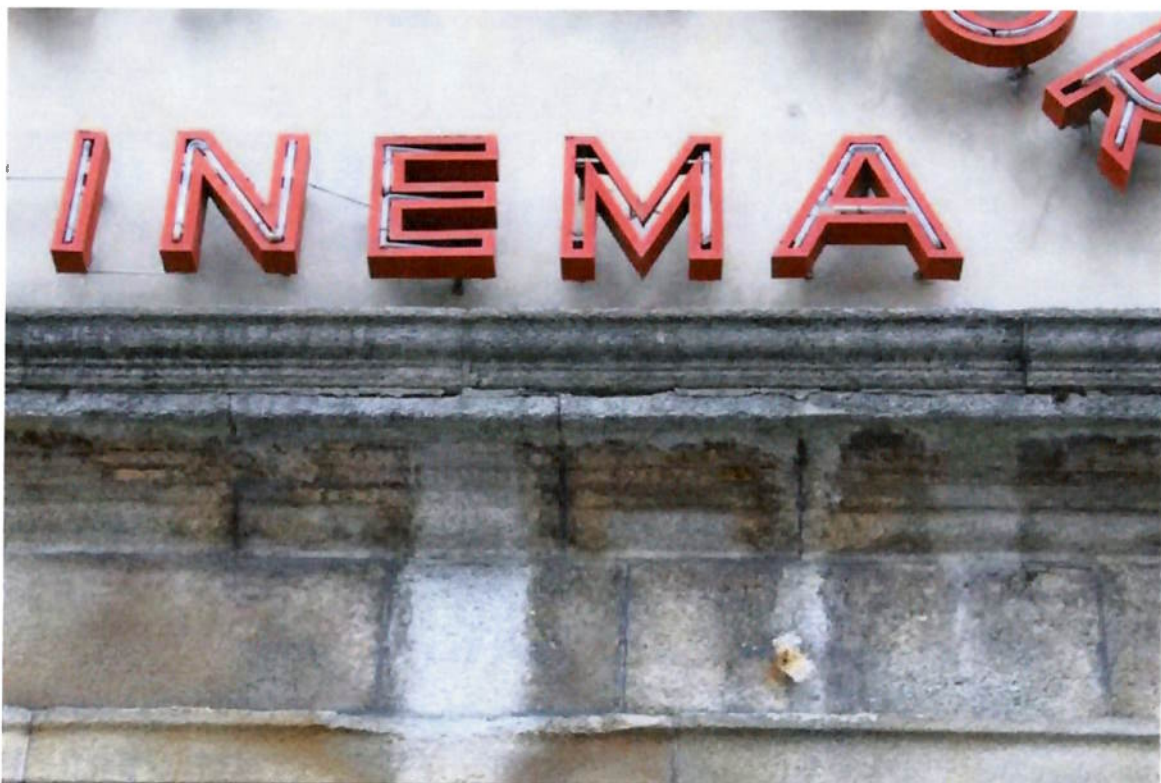
Figure 21 Poor condition of the underside of the granite cornice. Section of soffit granite to be replaced and all joints to be repointed with lime mortar.

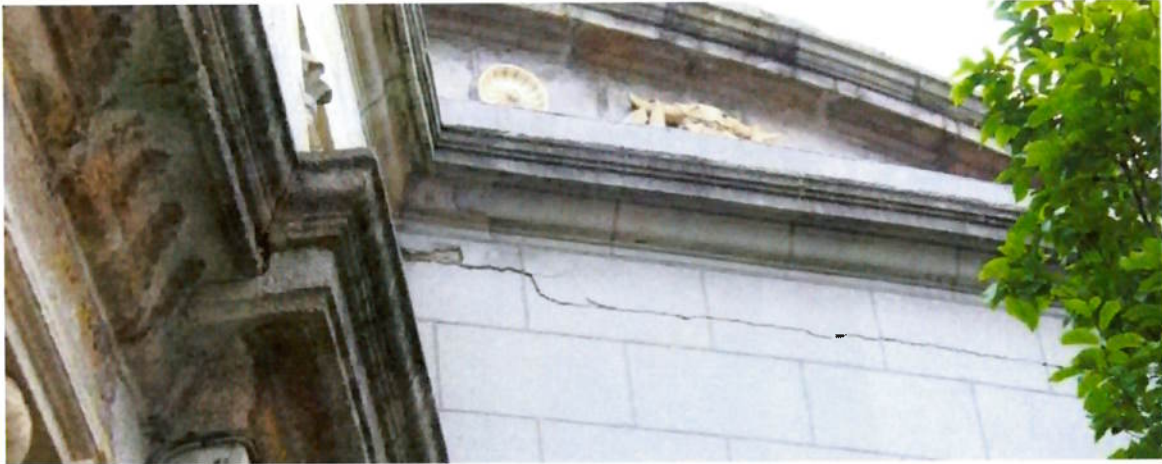
Figure 22. Horizontal cracking and detaching render to the East façade. Investigate cause under the supervision of a conservation accredited structural engineer.

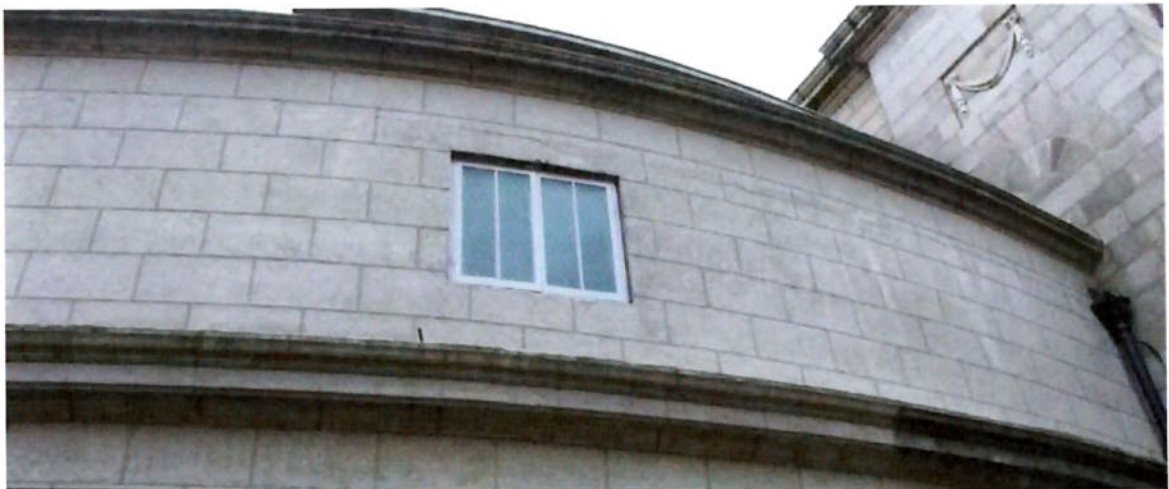
Figure 23. Continuation of the horizontal cracking to the East Elevation

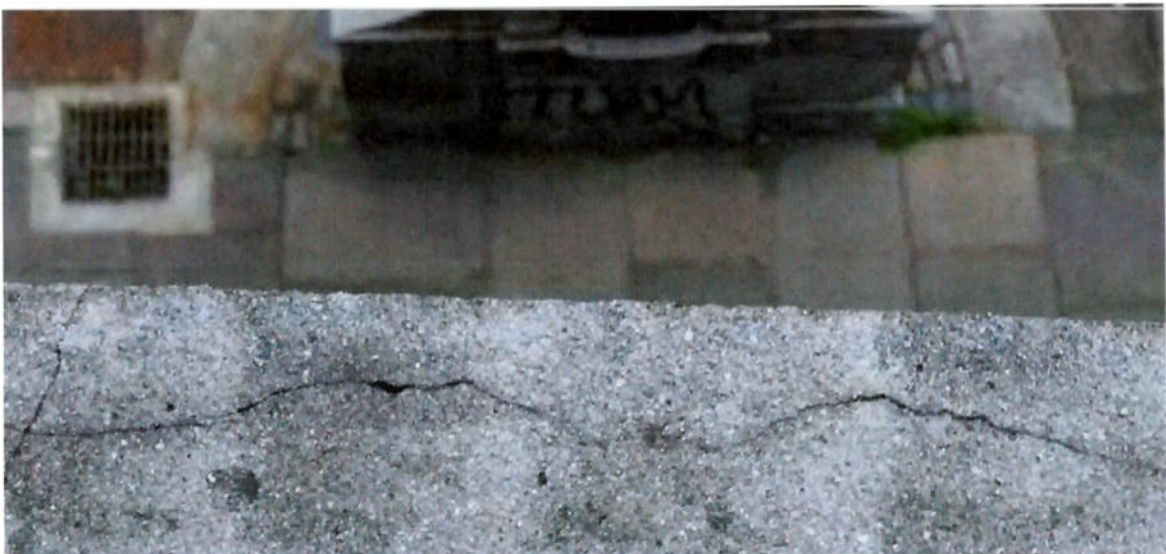
Figure 24. Cracks through the rendered cornice (viewed from the roof).

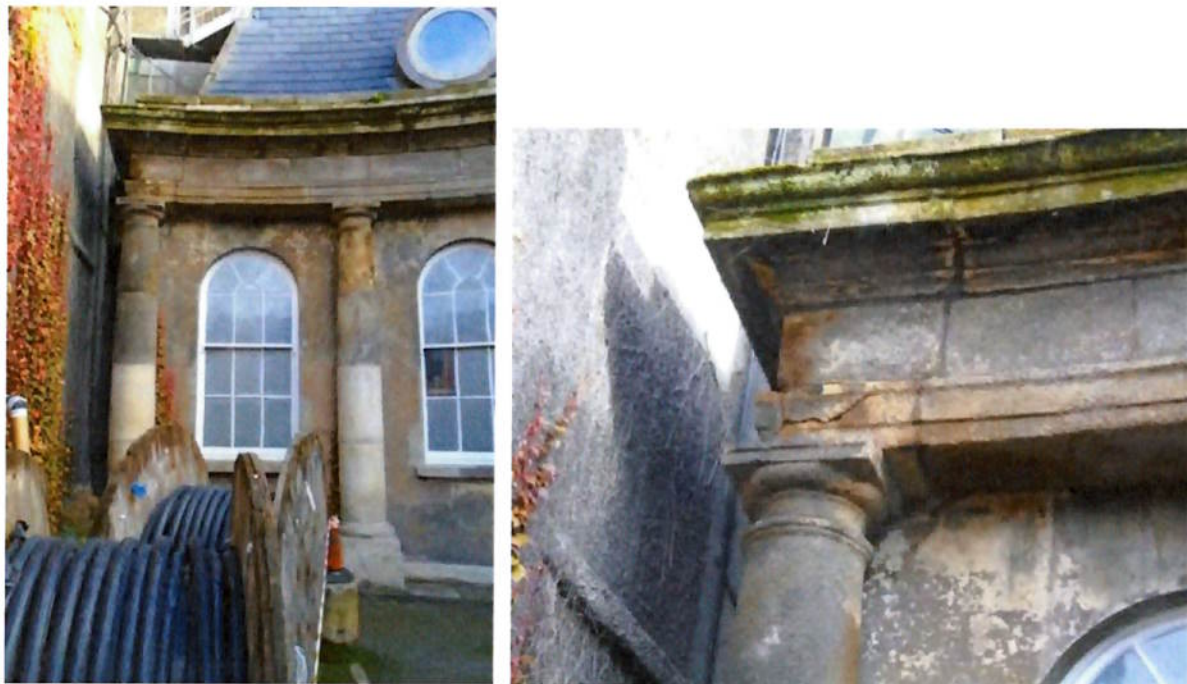
Figure 25 a & b. First bay of the façade has some cleaning samples to the lower sections of the columns, carried out previously, again using the Façade Gommage system, which is inappropriate and too aggressive. The granite at the top left hand side is damaged and requires a stone indent.

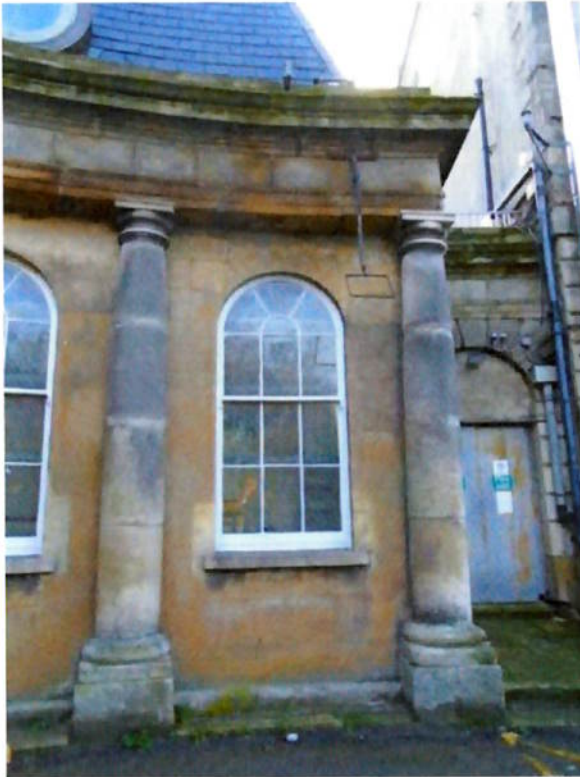
Figure 26. Staining evident on the granite frieze.

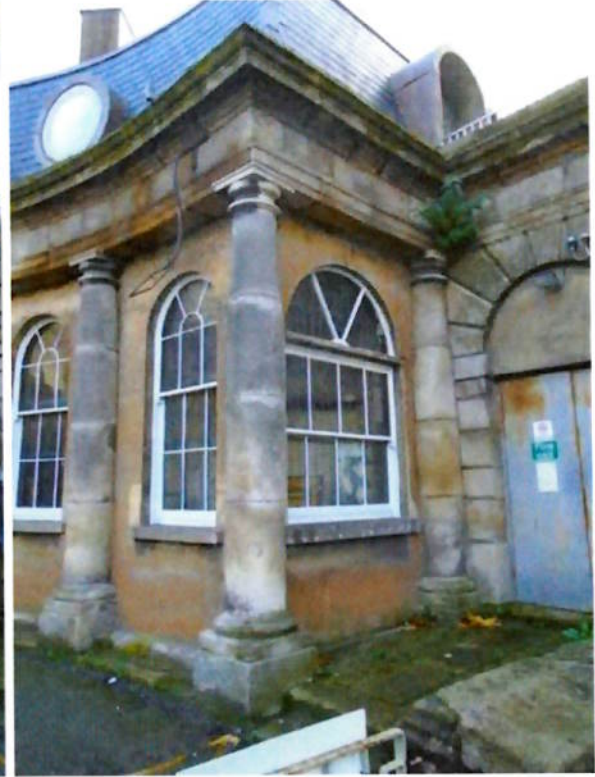
Figure 27. Altered window has an exposed timber head

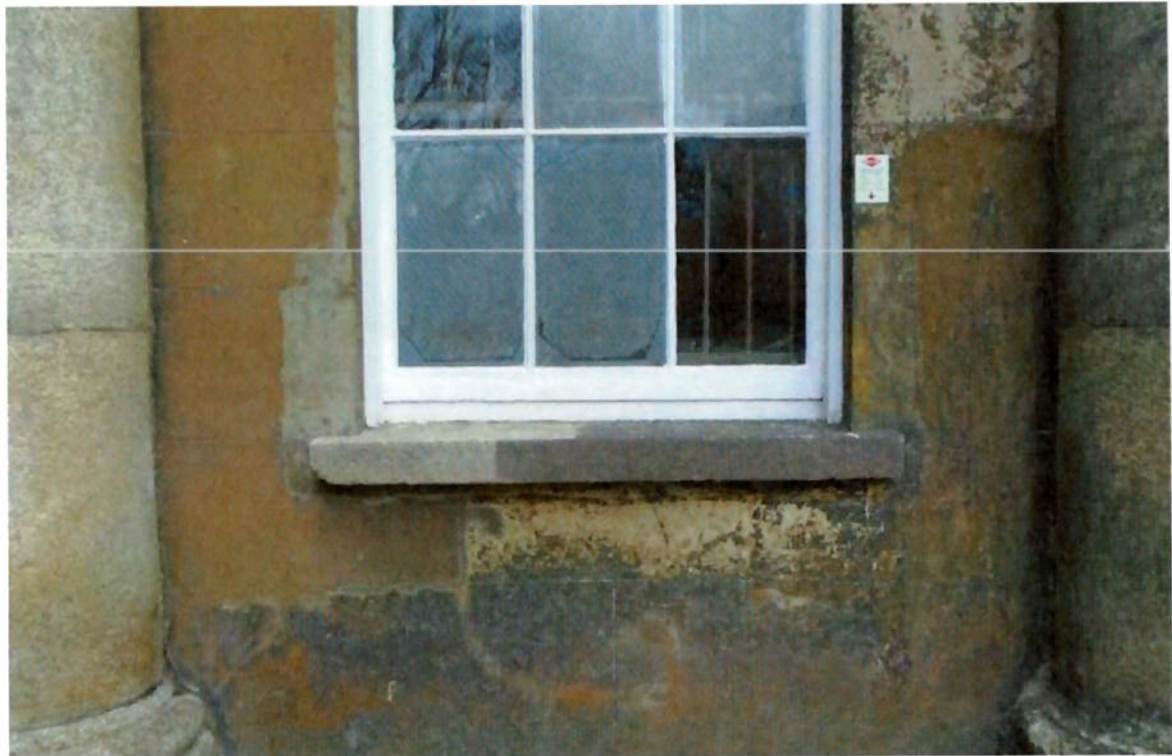
Figure 28. Current condition of rendered façade between engaged columns. Part of the sill has been cleaned using the Façade Gommage System, which is inappropriate.

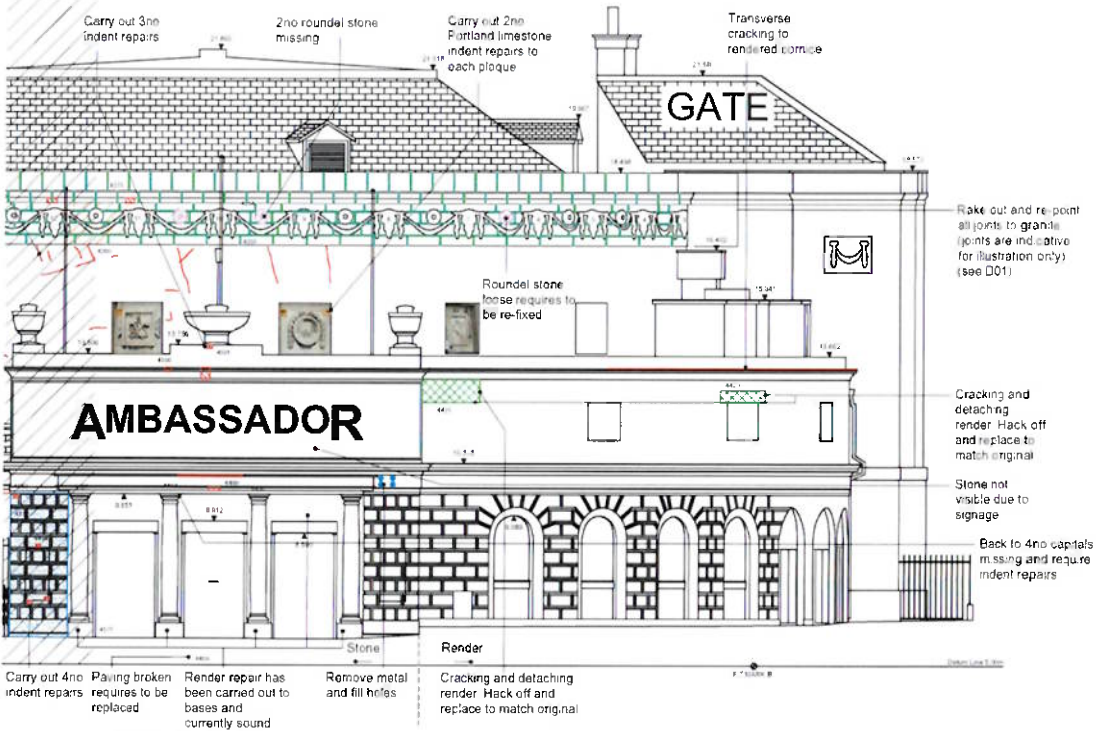
- Stone Indent Repair
- Cracks and open joints
Cutout or fill & Re-point
- Areas of render that is failing
- Coarse stone Repairs & Replacement
- Portland Limestone Indents and Replacement
- Areas of Frieze for careful raking out & re-pointing in lime mortar
- Areas for tooling of surface to remove gypsum crust and loose decaying material
- Area of significant staining
Specialist cleaning required
- Photo Reference
- Remove metal
- Areas for breaking out & Re-Render

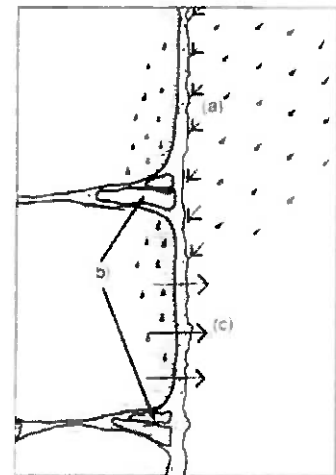
Pinning stones in joints to create an even surface for lime harling

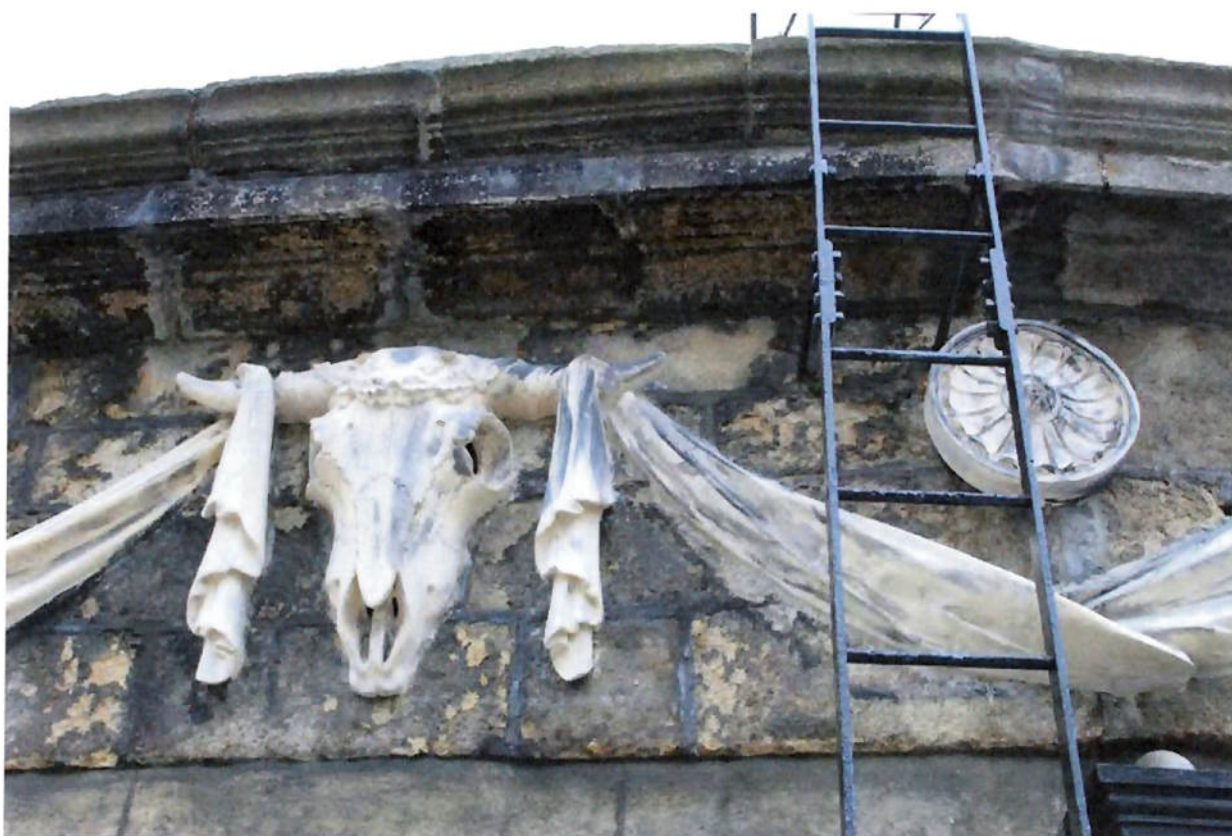
Figure 6. Replaced 'new' Coade Stone elements.
