CONSERVATION

Section 5 Referral

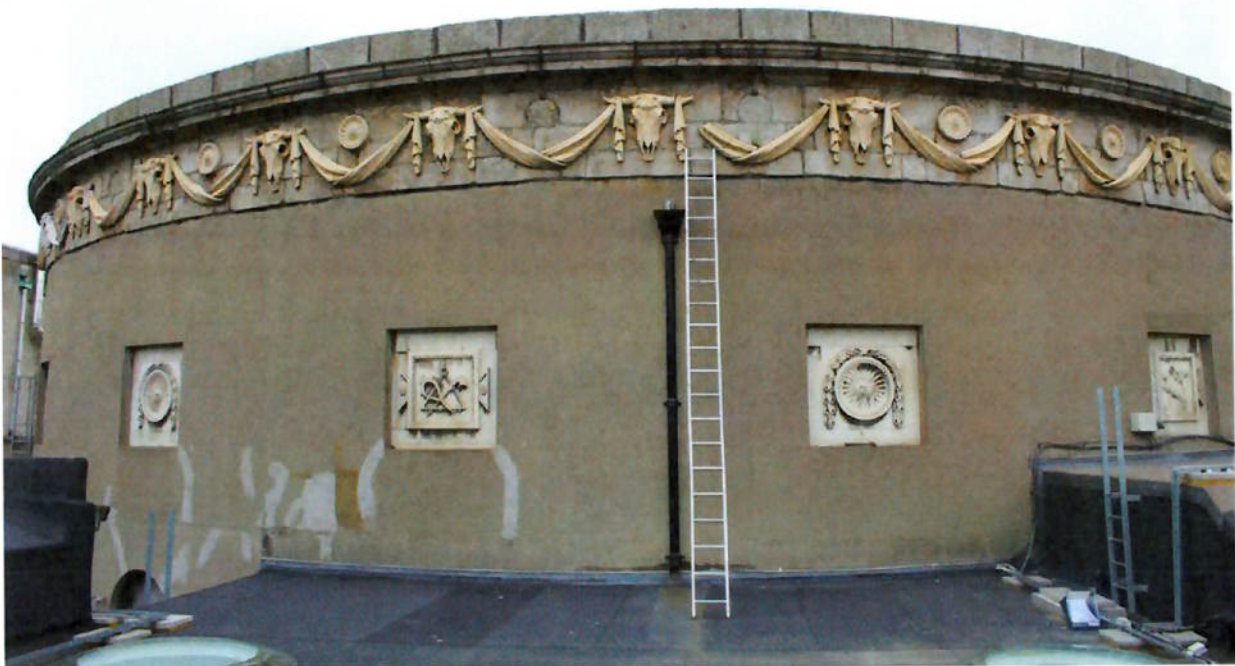
Figure 7. Elevation view of the rotunda theatre building.

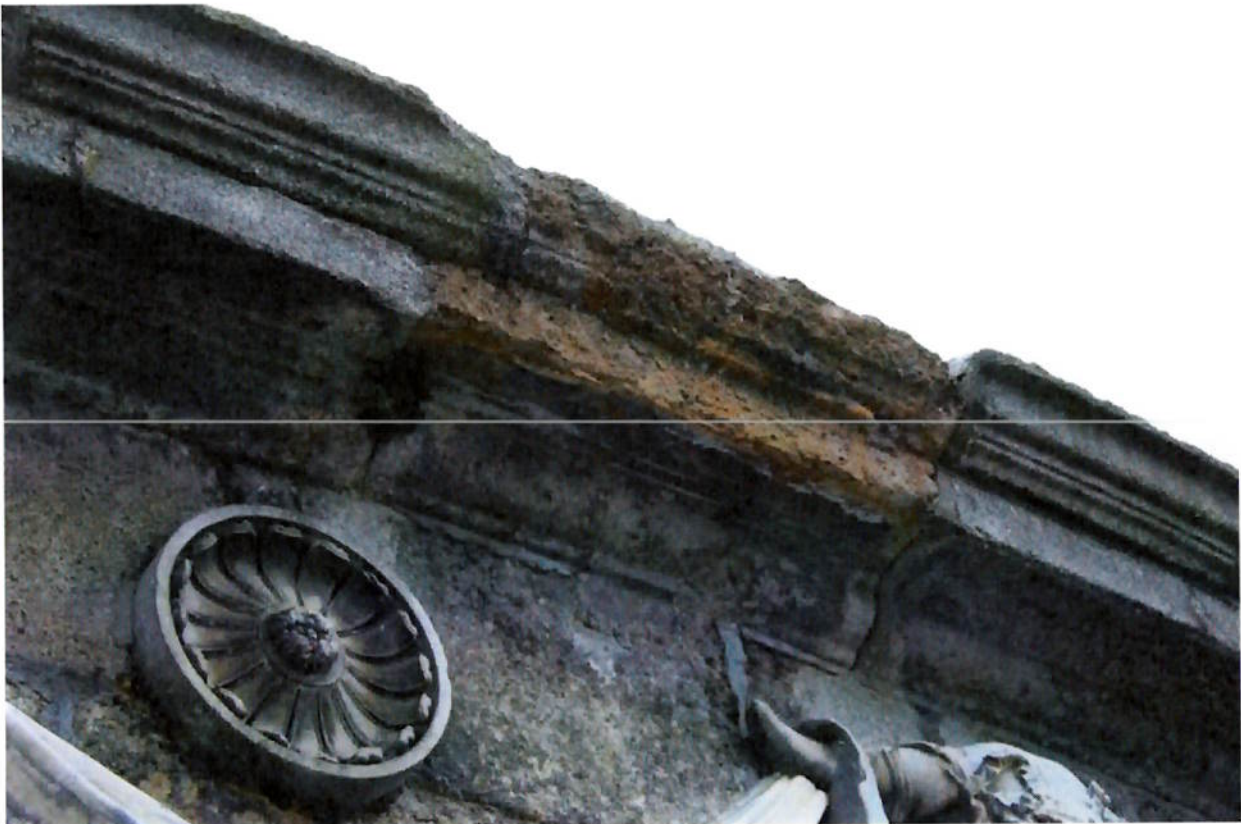
Figure 8. Deteriorated section of granite cornice.

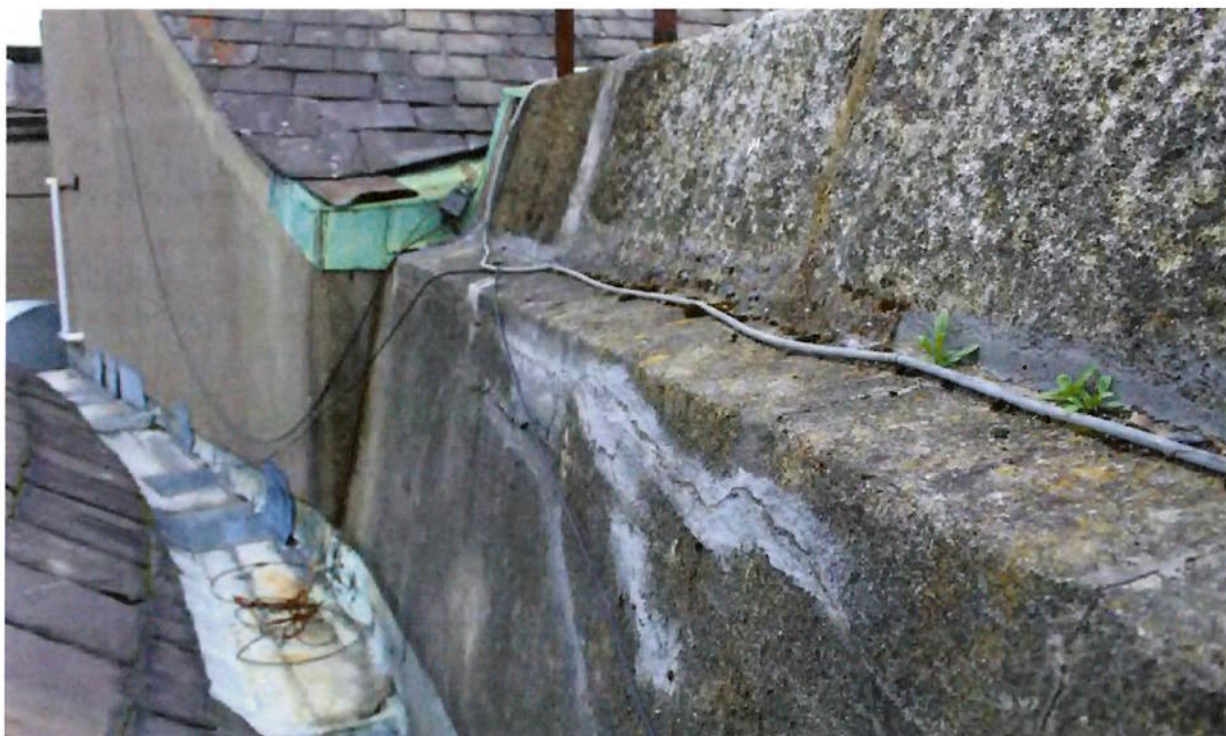
Figure 9. Inner parapet of the rotunda theatre building.

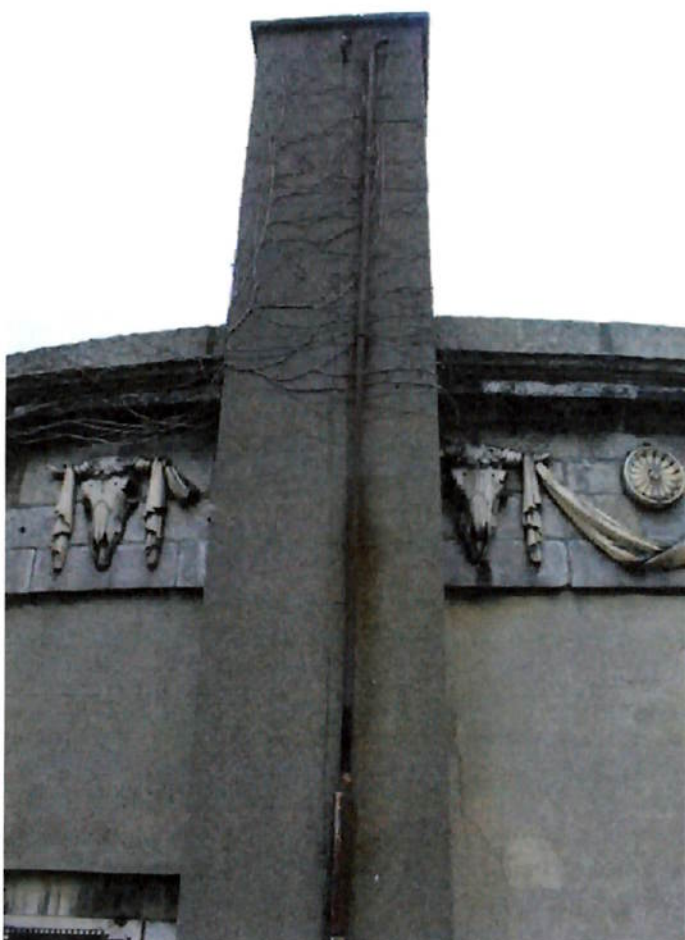
Figure 10. Defective render to chimney.

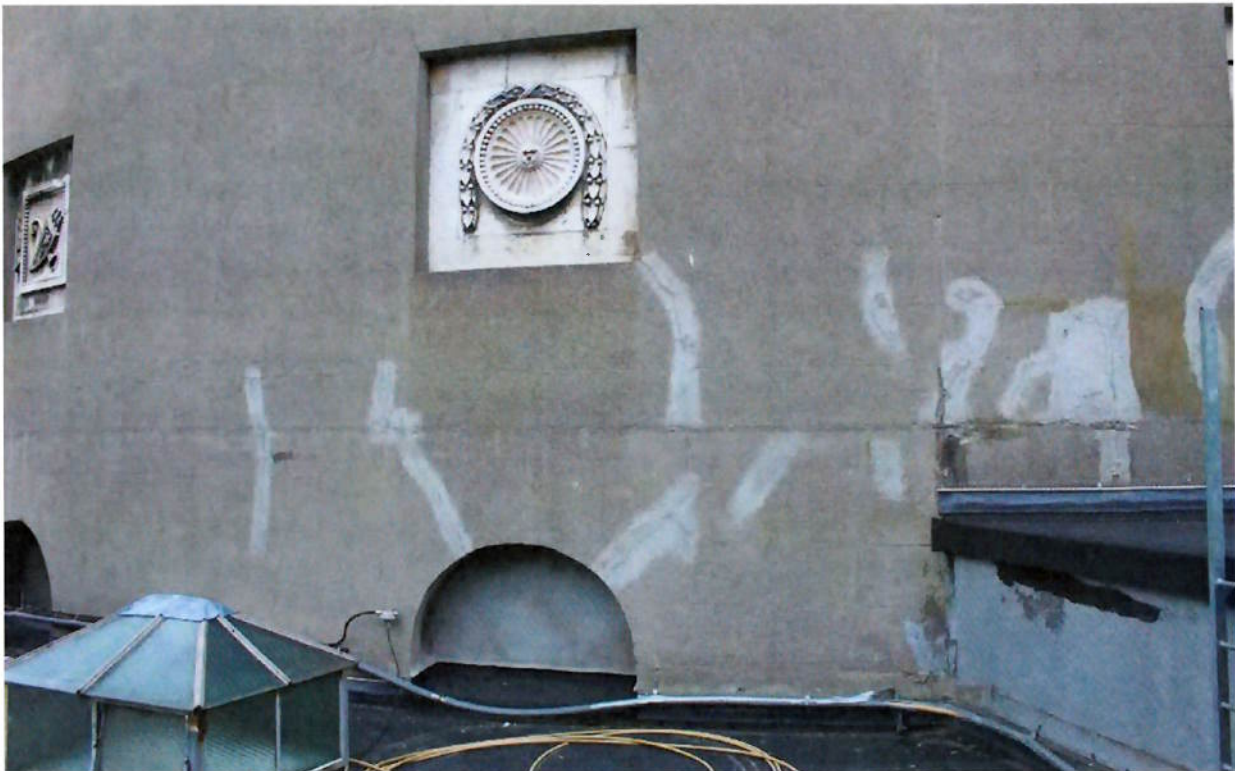
Figure 11. Defective render at roof level.

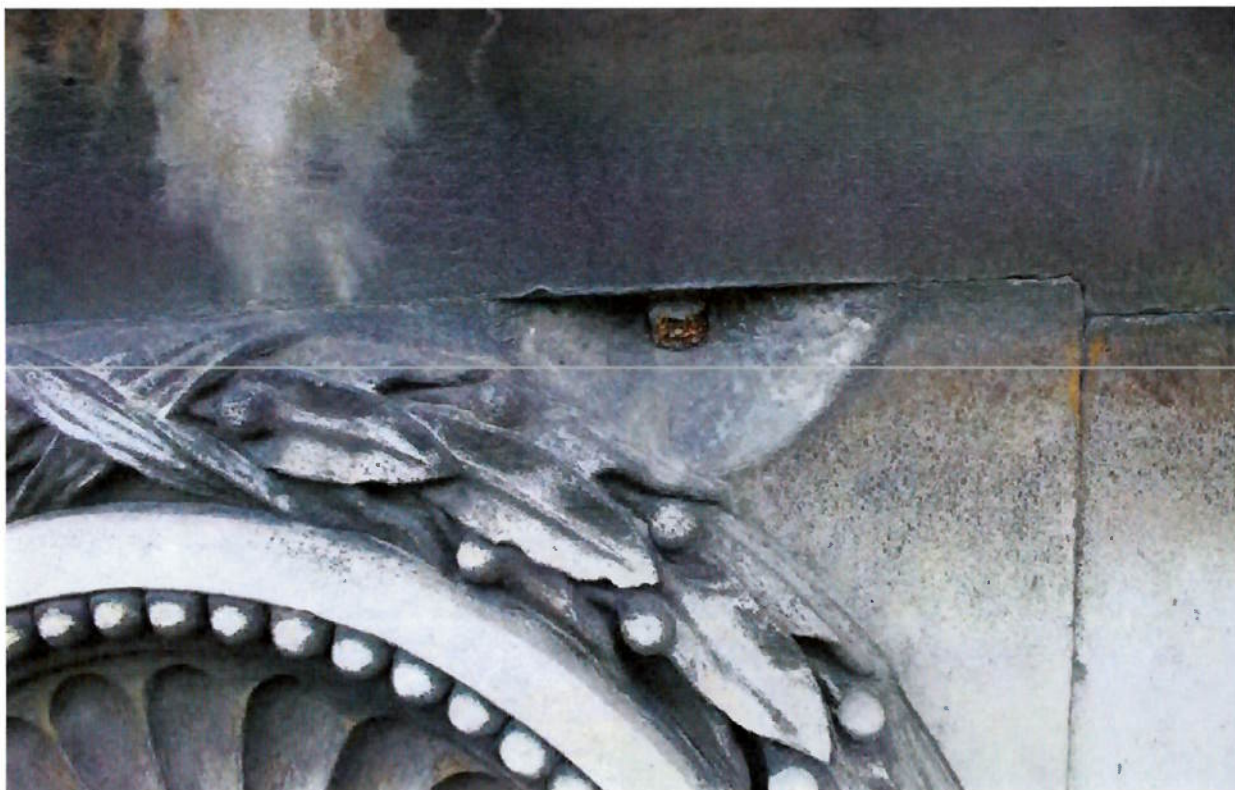
Figure 12. Corrosion of fixings causing stone damage.

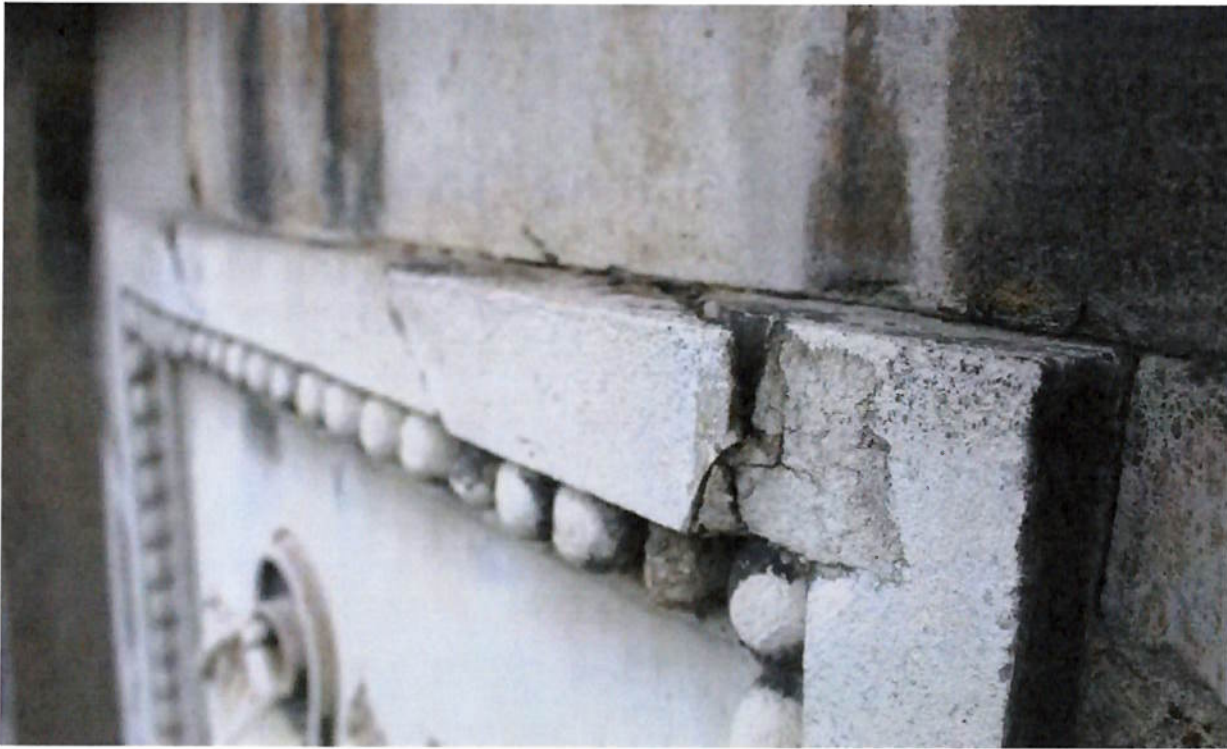
Figure 13. Corrosion of fixings causing stone damage to Portland limestone panels.

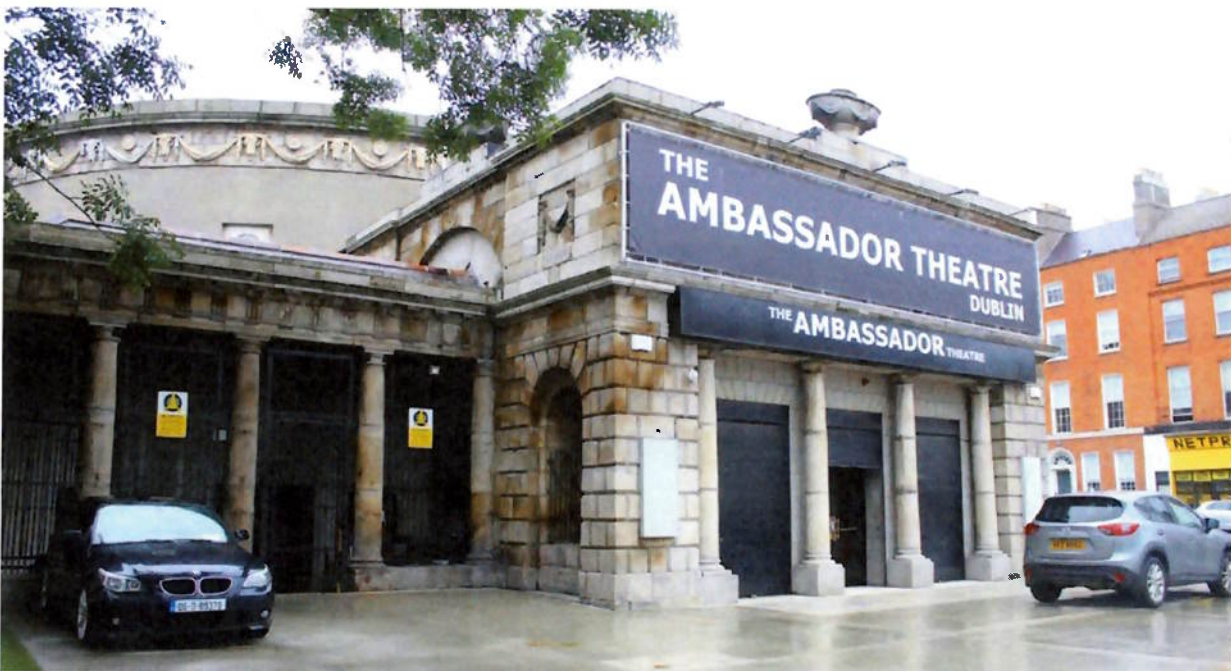
Figure 14. Front Elevation.

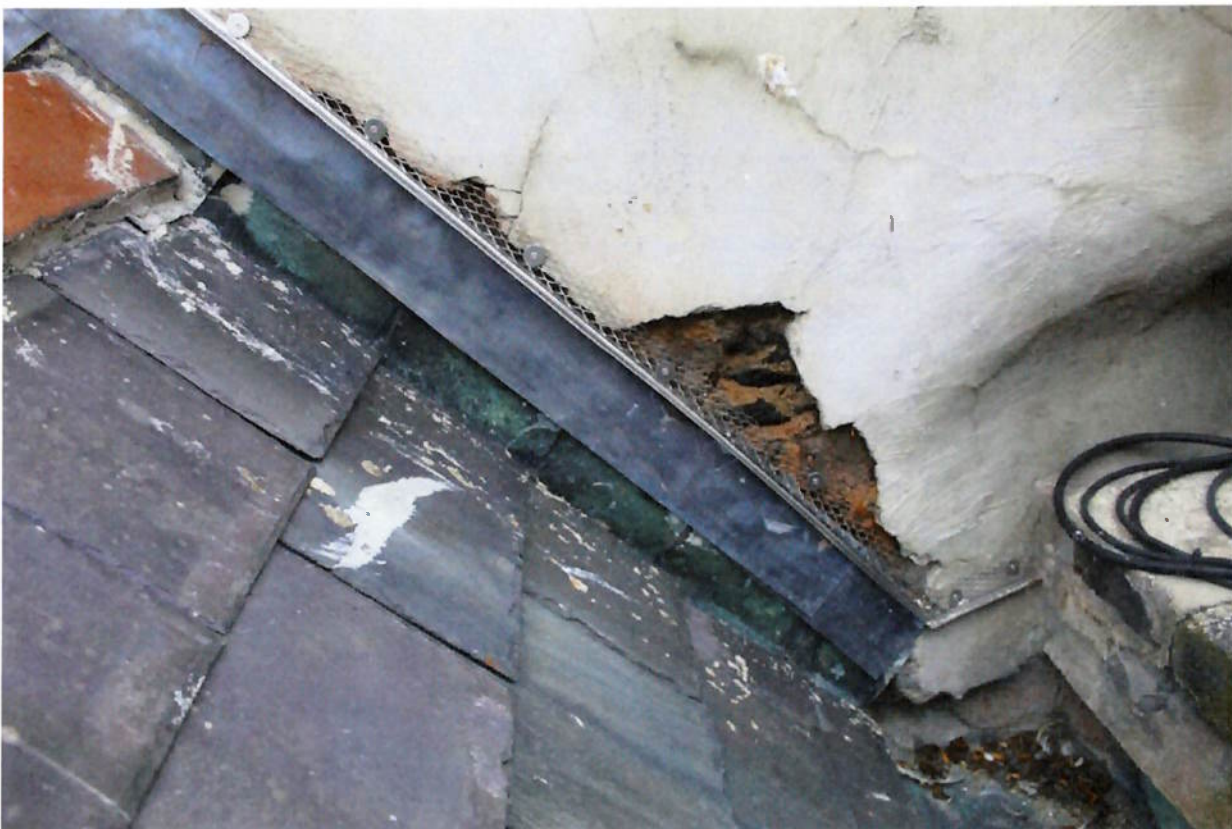
Figure 17. Defective render and flashing allowing water ingress.

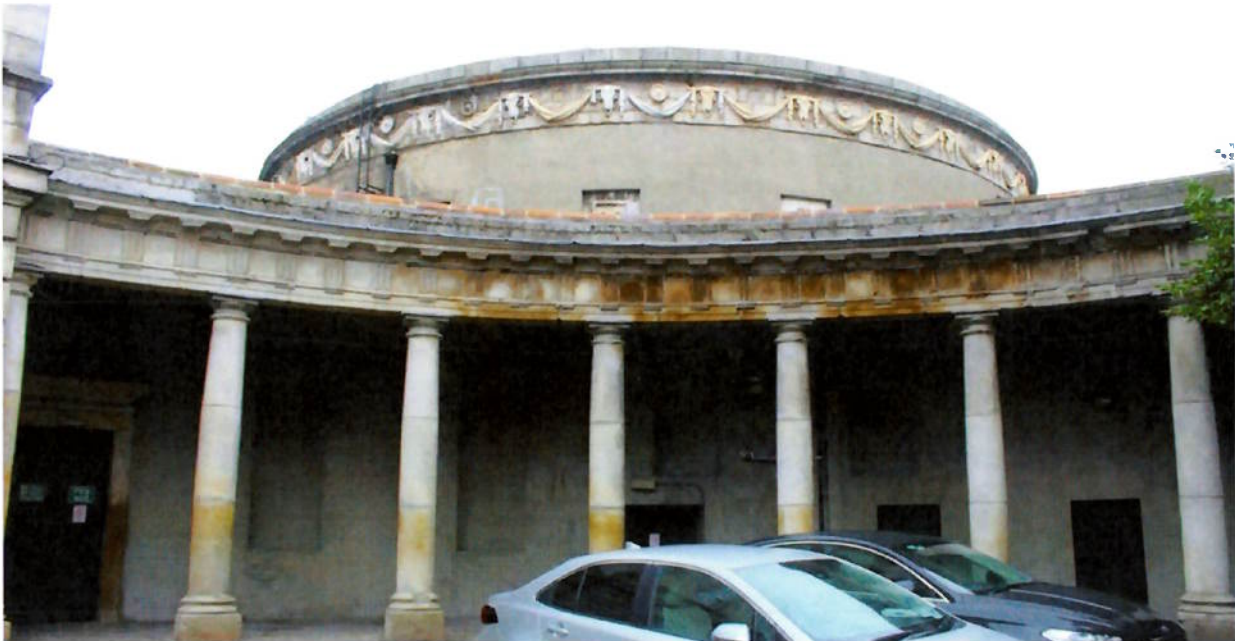
Figure 18. Arcade link to the Rotunda Hospital with the Rotunda Theatre building behind. Left hand side was subject to a cleaning trial by Thomann Hannery. This method is too severe and there is evidence of loss of fabric, which in turn will accelerate further deterioration of the granite.

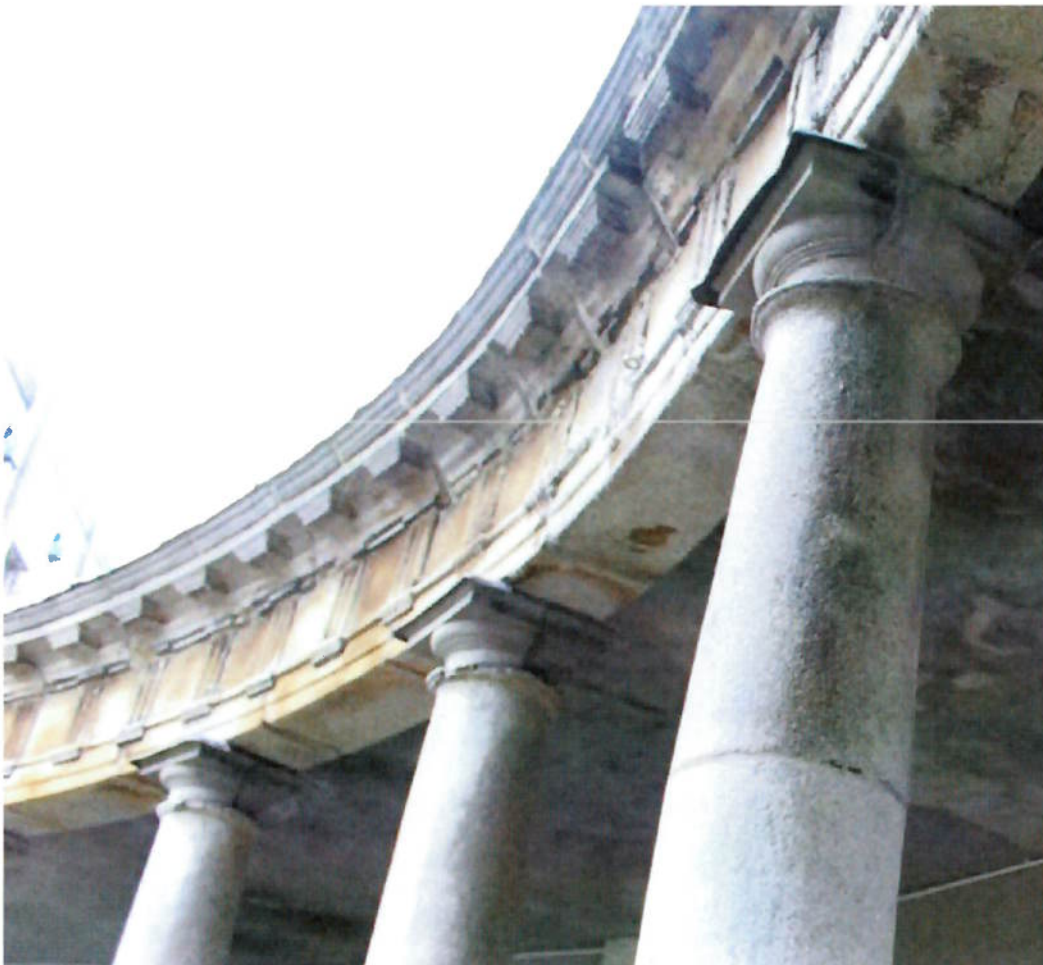
Figure 19. View of upper cornice to the arcade.

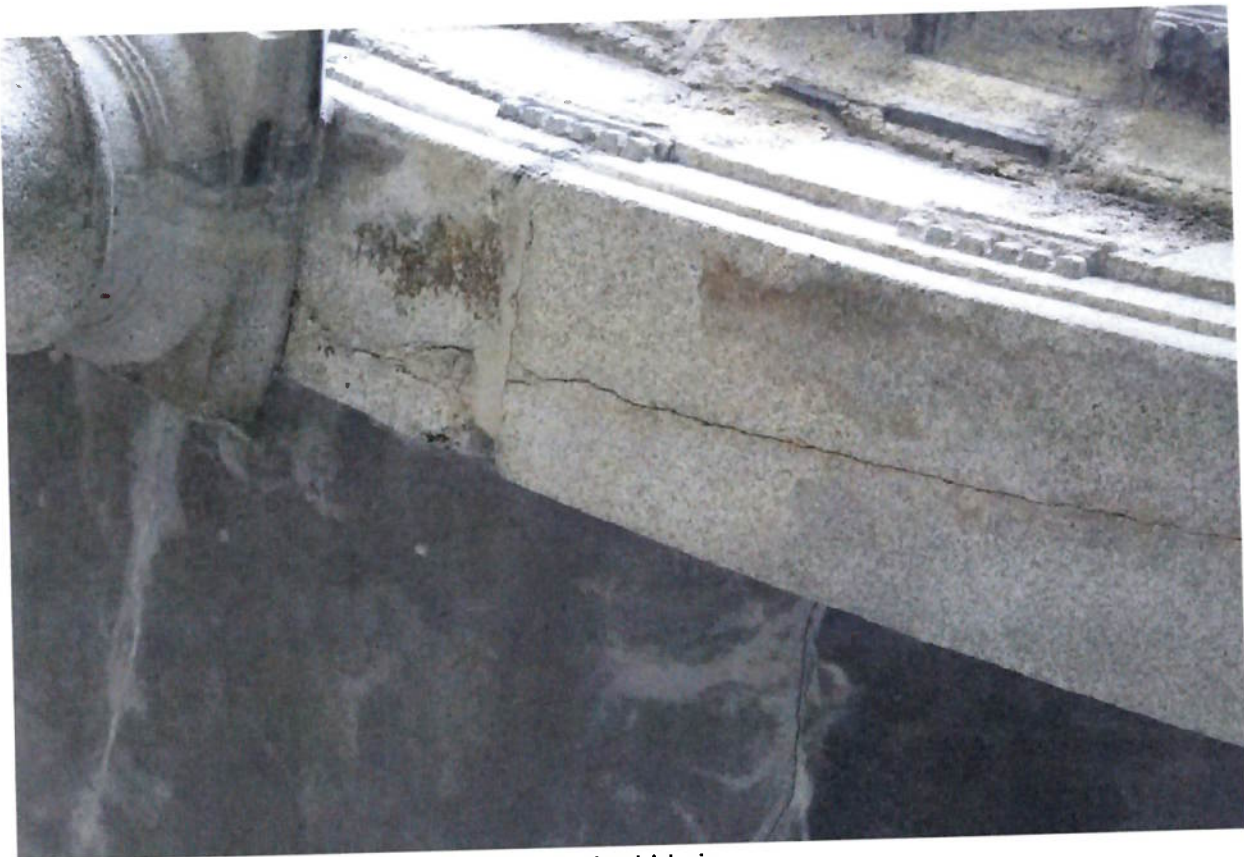
Figure 20. Cracks to the granite soffit that may be historic.

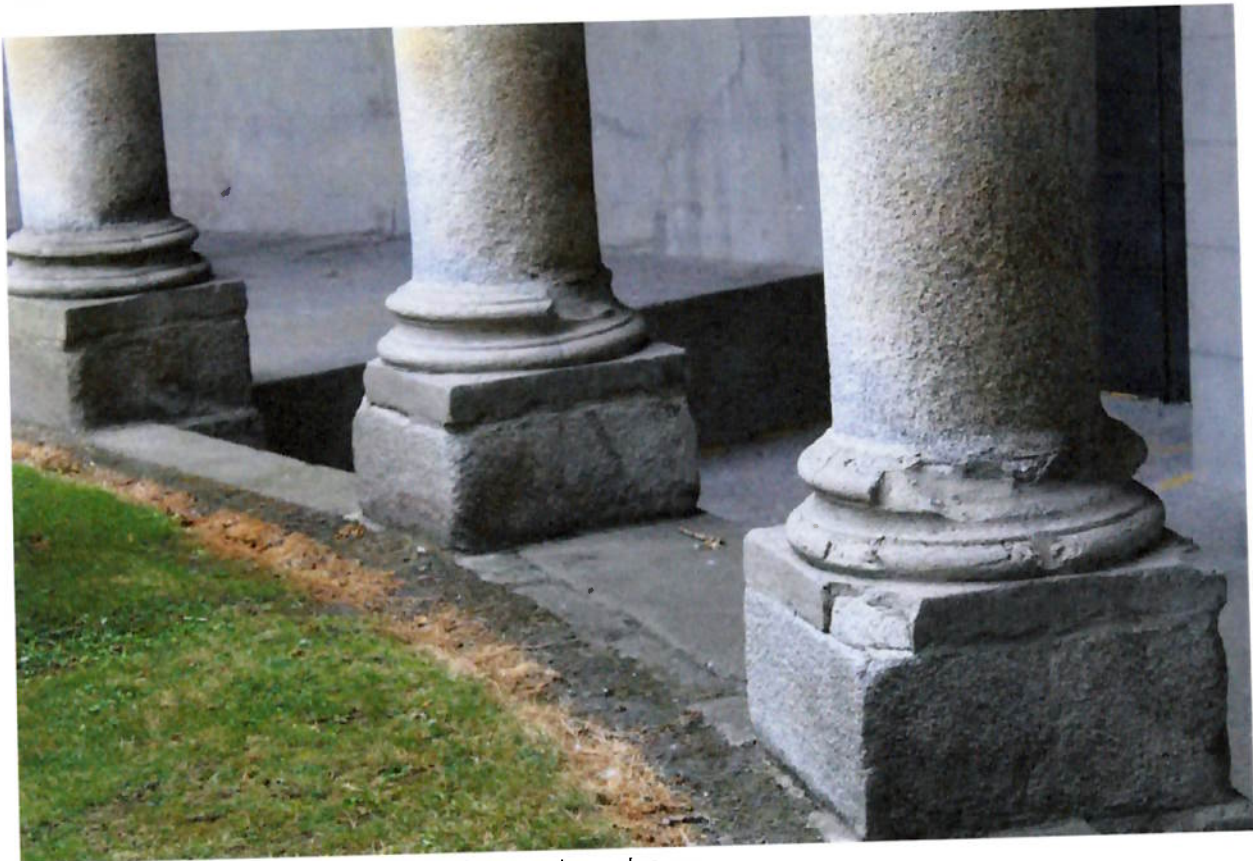
Figure 21. Deteriorating render repairs to column bases.

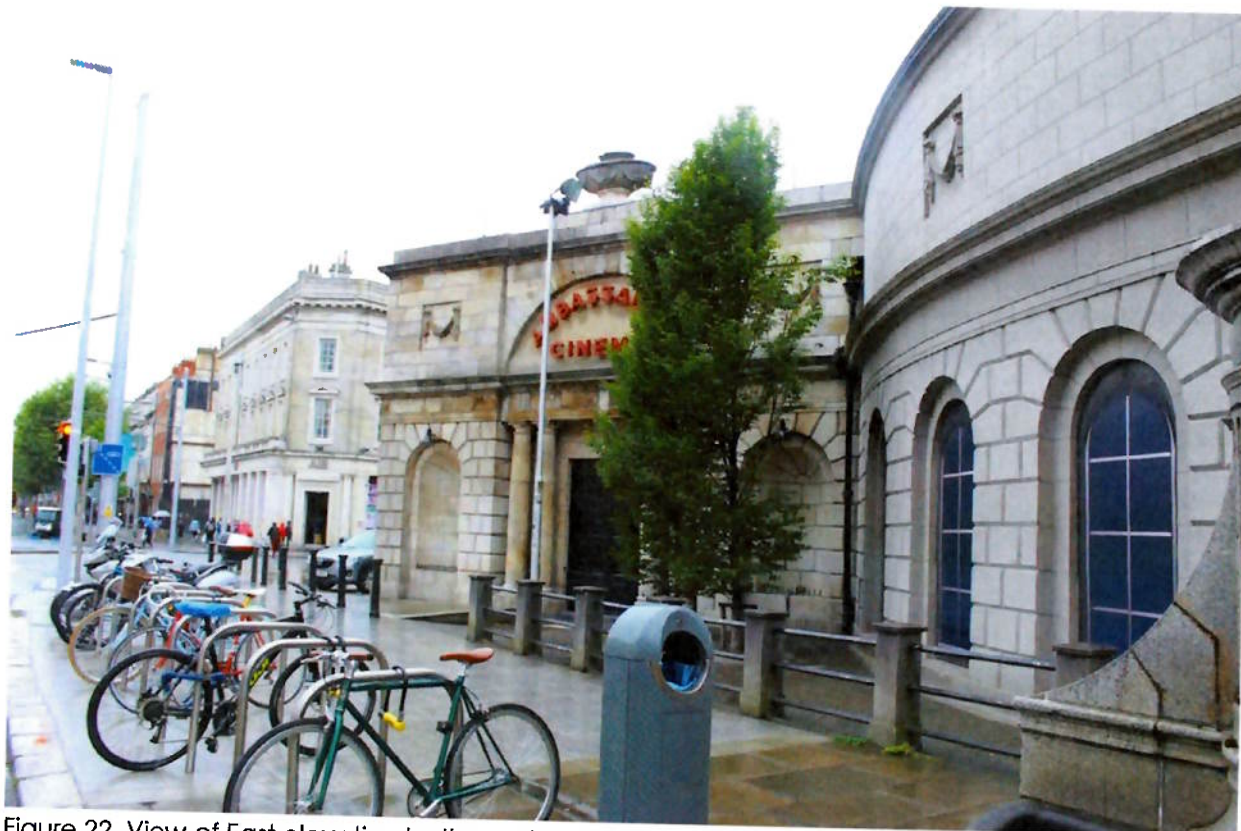
Figure 22. View of East elevation both granite and rendered facades.

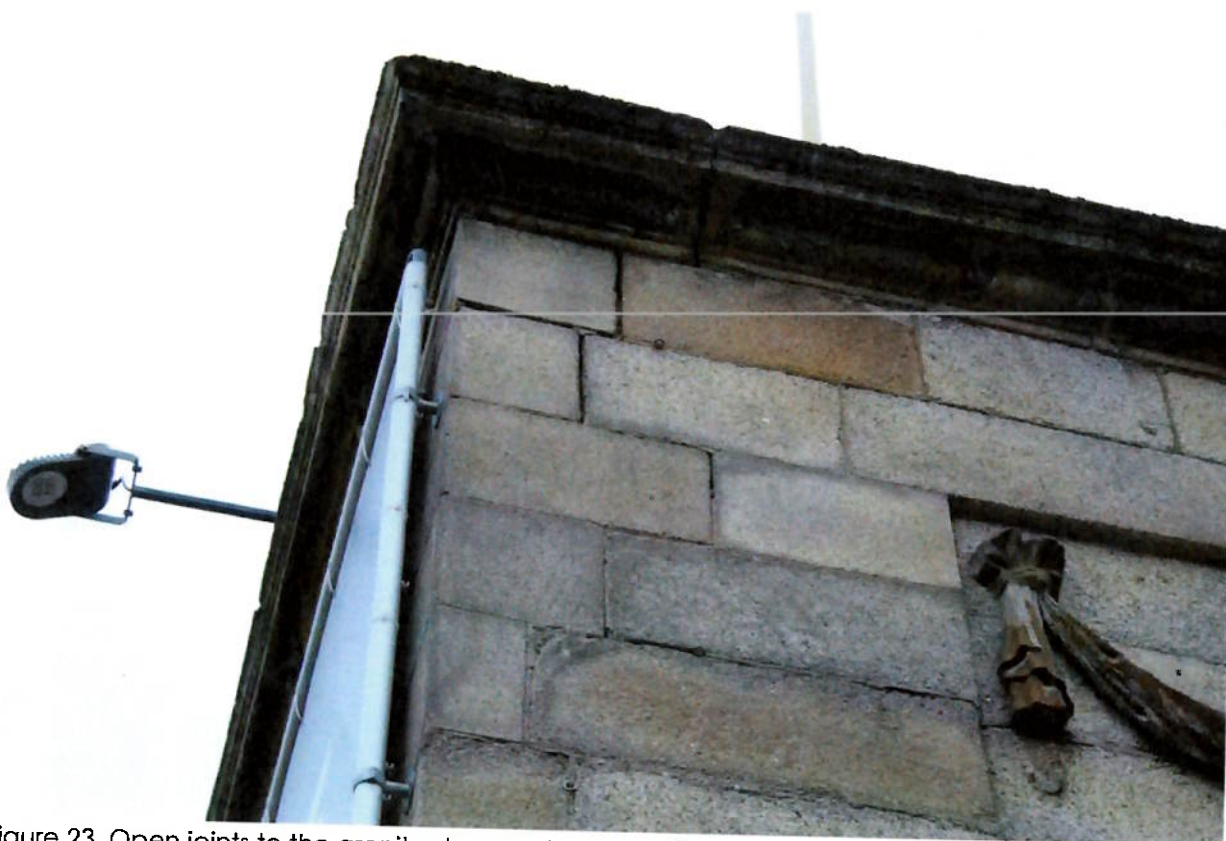
Figure 23. Open joints to the granite stonework and missing section of swags.

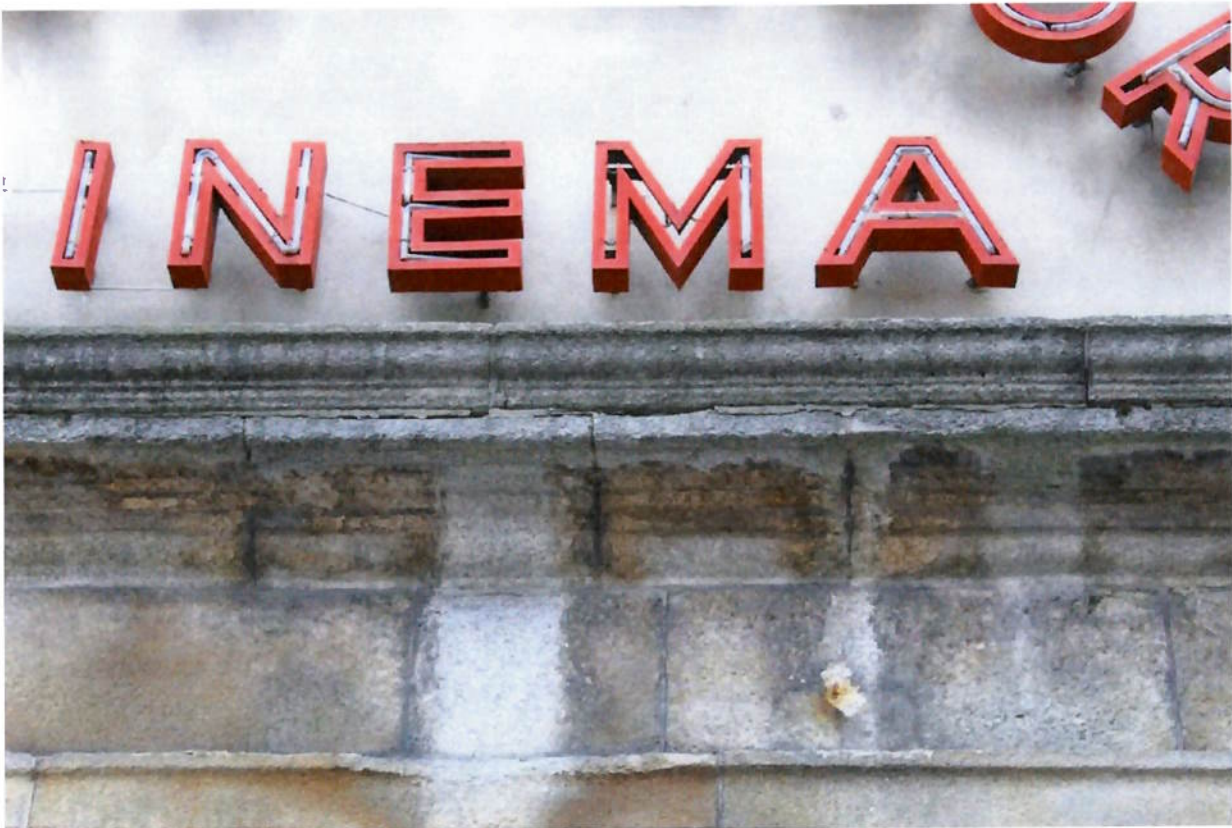
Figure 24. Poor condition of the underside of the granite cornice.

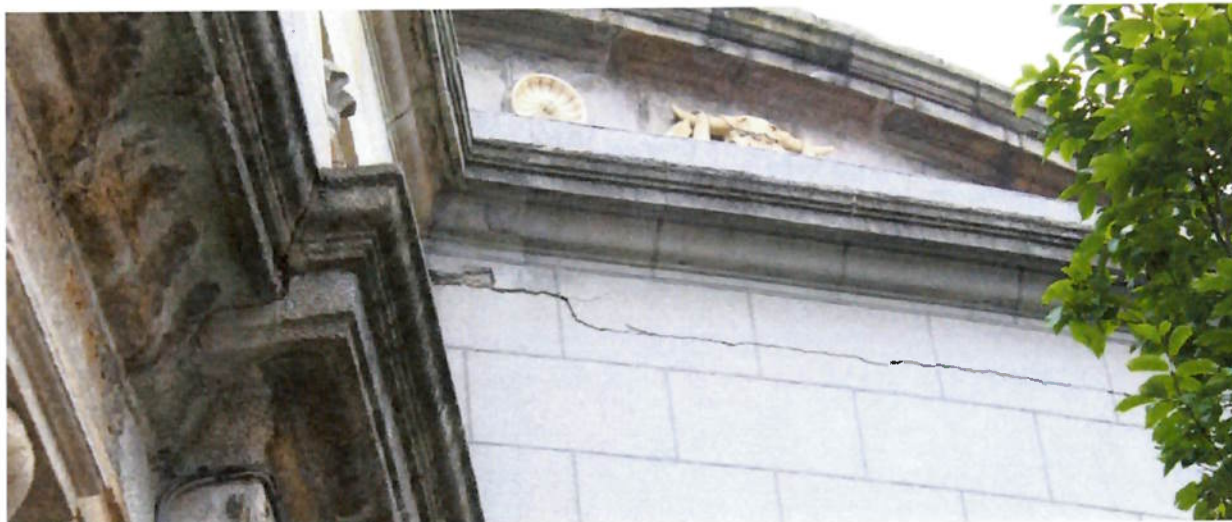
Figure 25. Horizontal cracking and detaching render to the East façade.

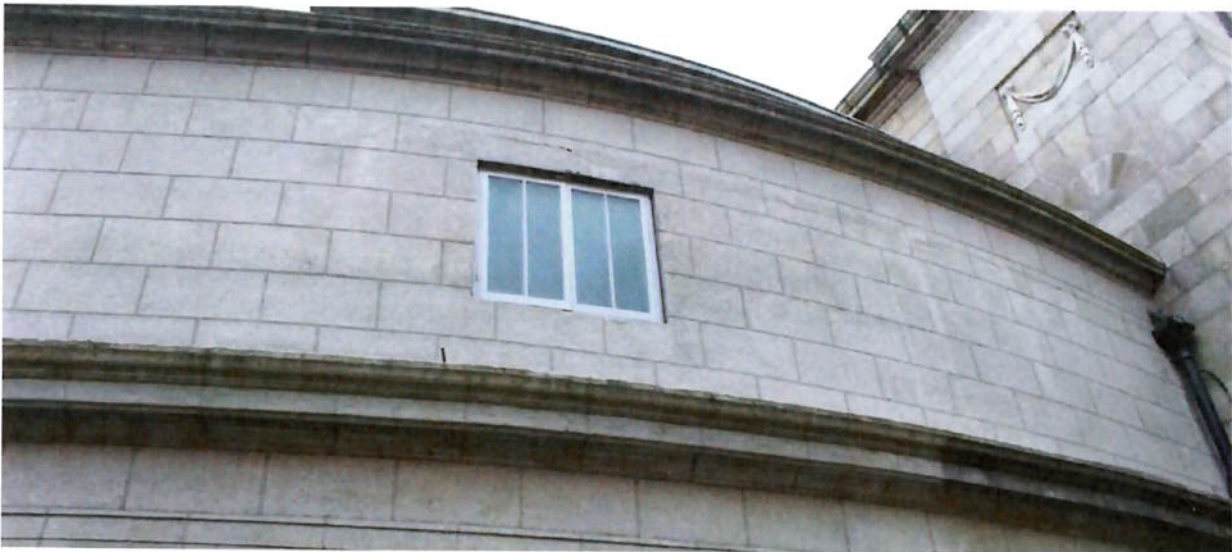
Figure 26. Continuation of the horizontal cracking to the East Elevation.

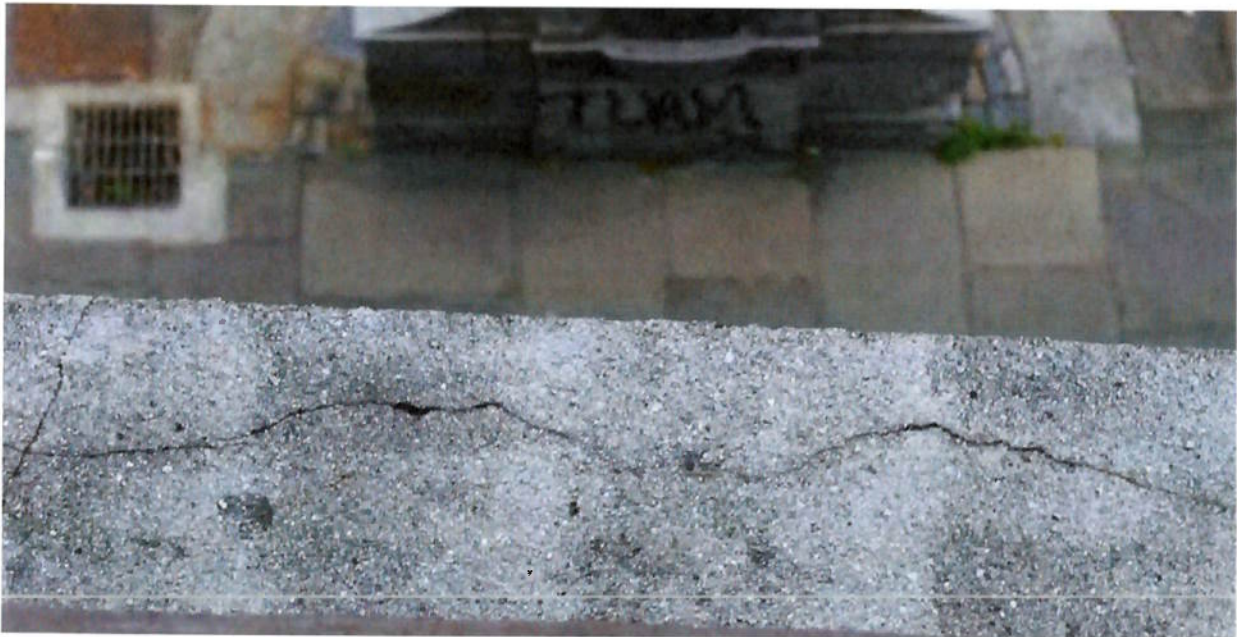
Figure 27. Cracks through the rendered cornice (viewed from the roof).

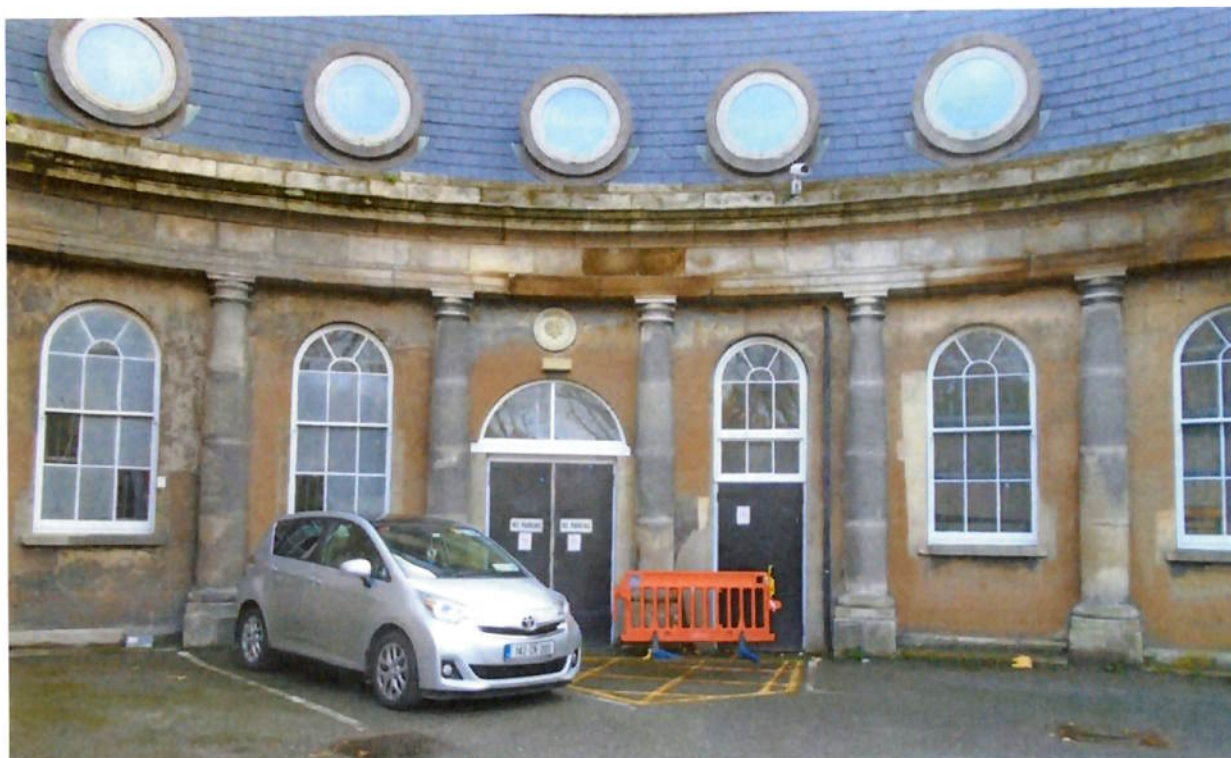
Figure 28. Rear elevation facing into courtyard

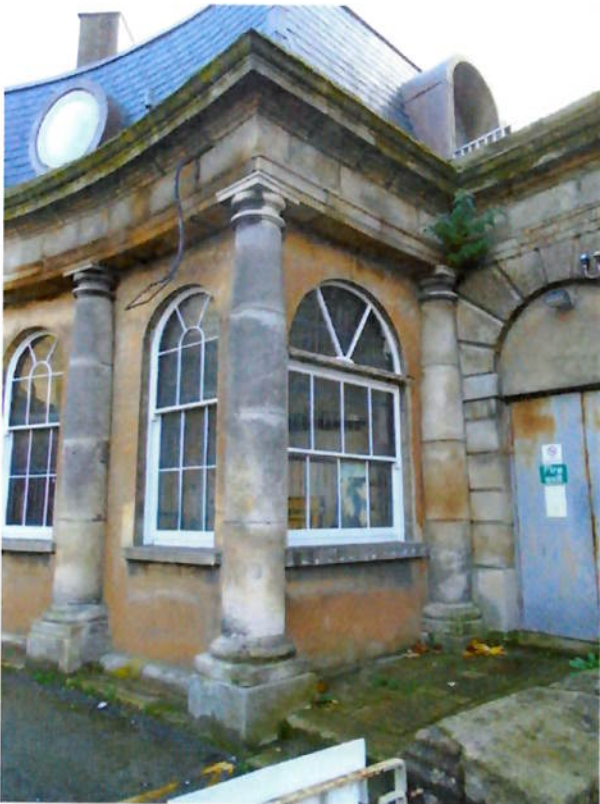
Figure 30. Corner showing inserted window with exposed damaged timber lintel

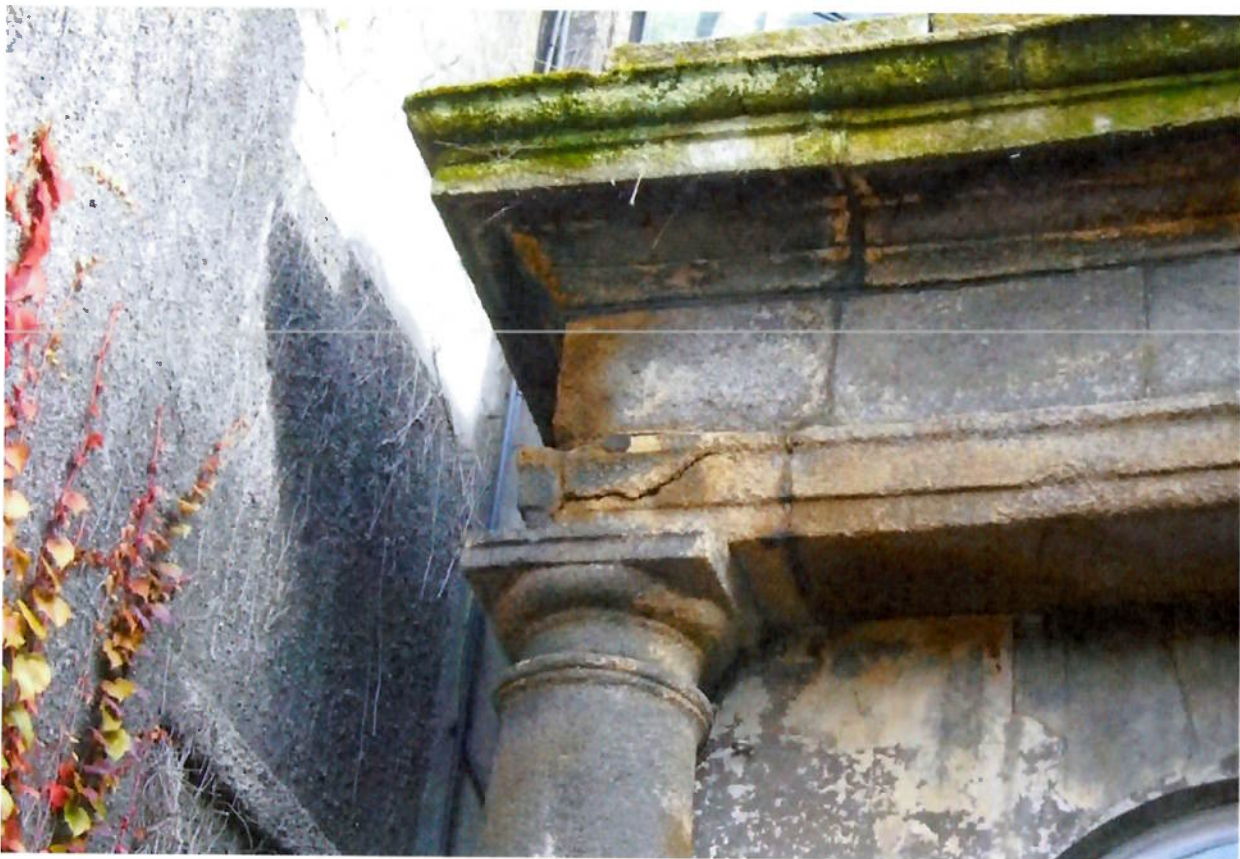
Figure 31. Stone indent required

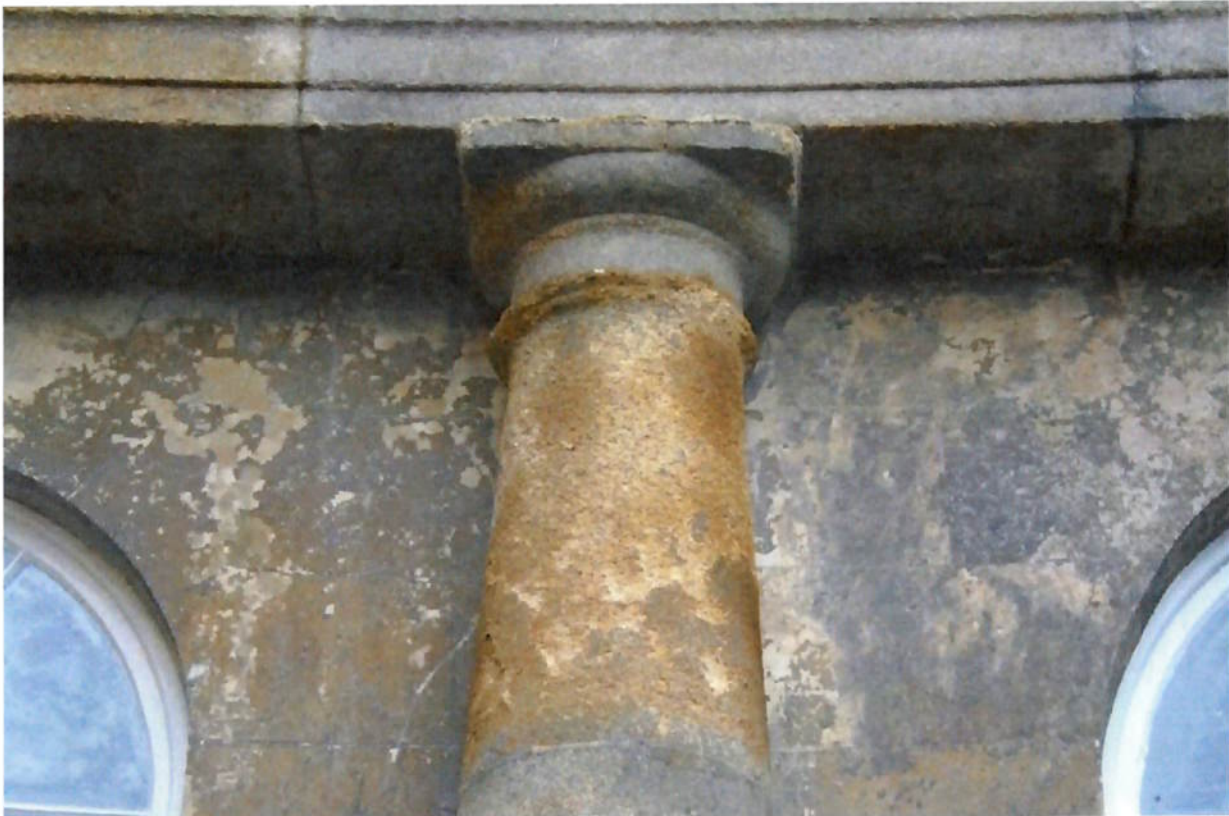
Figure 32. Staining to granite

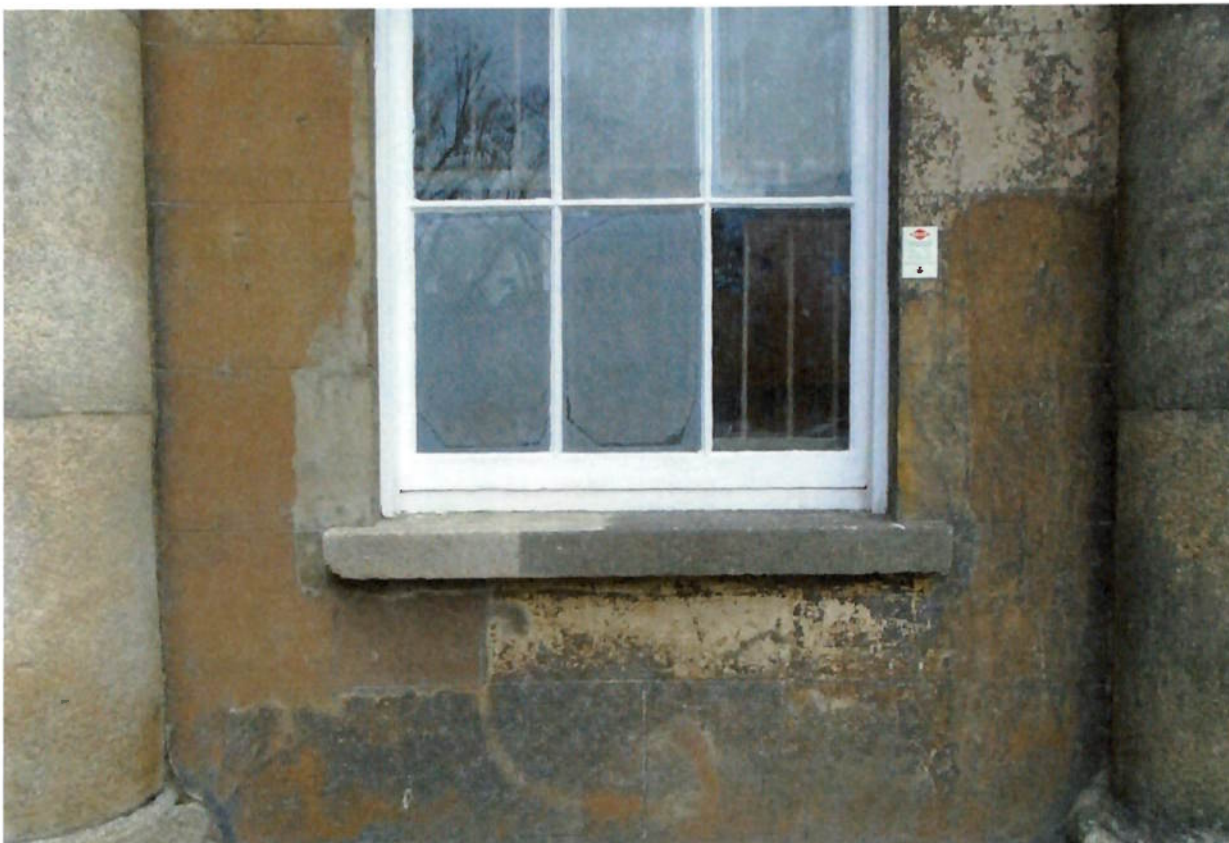
Figure 33. Shelter coat proposed to the rendered facade

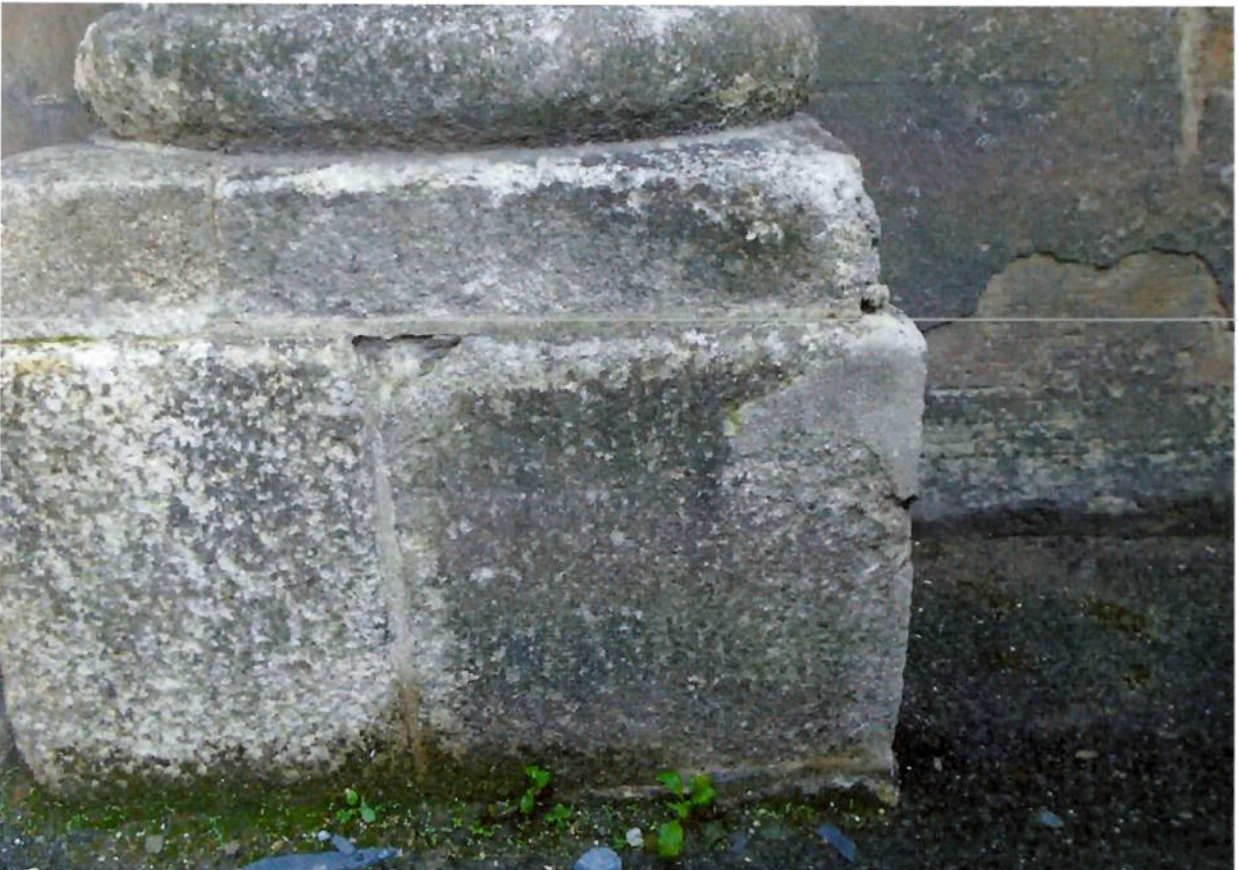
Figure 35. Replace cement with new graft
