CONSERVATION

Section 5 Referral

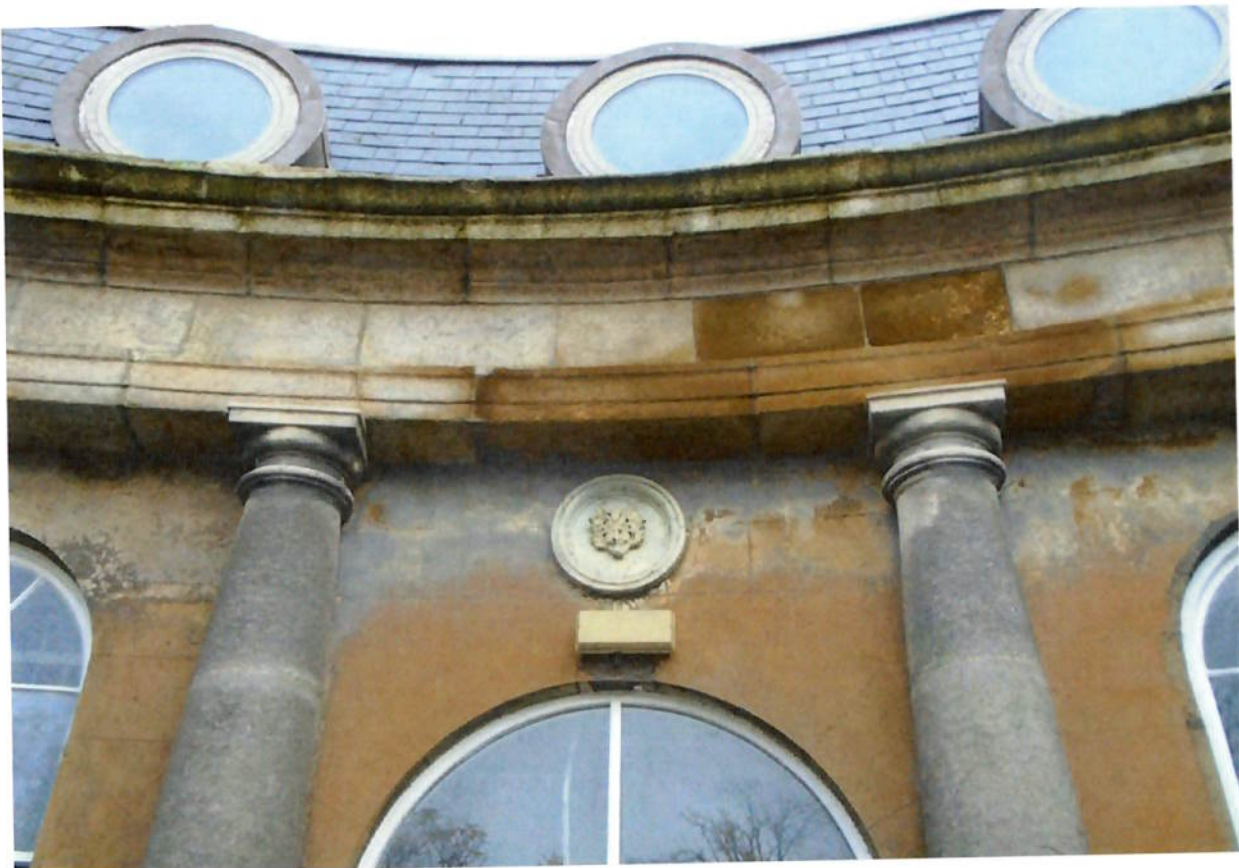
Figure 36. Further evidence of staining

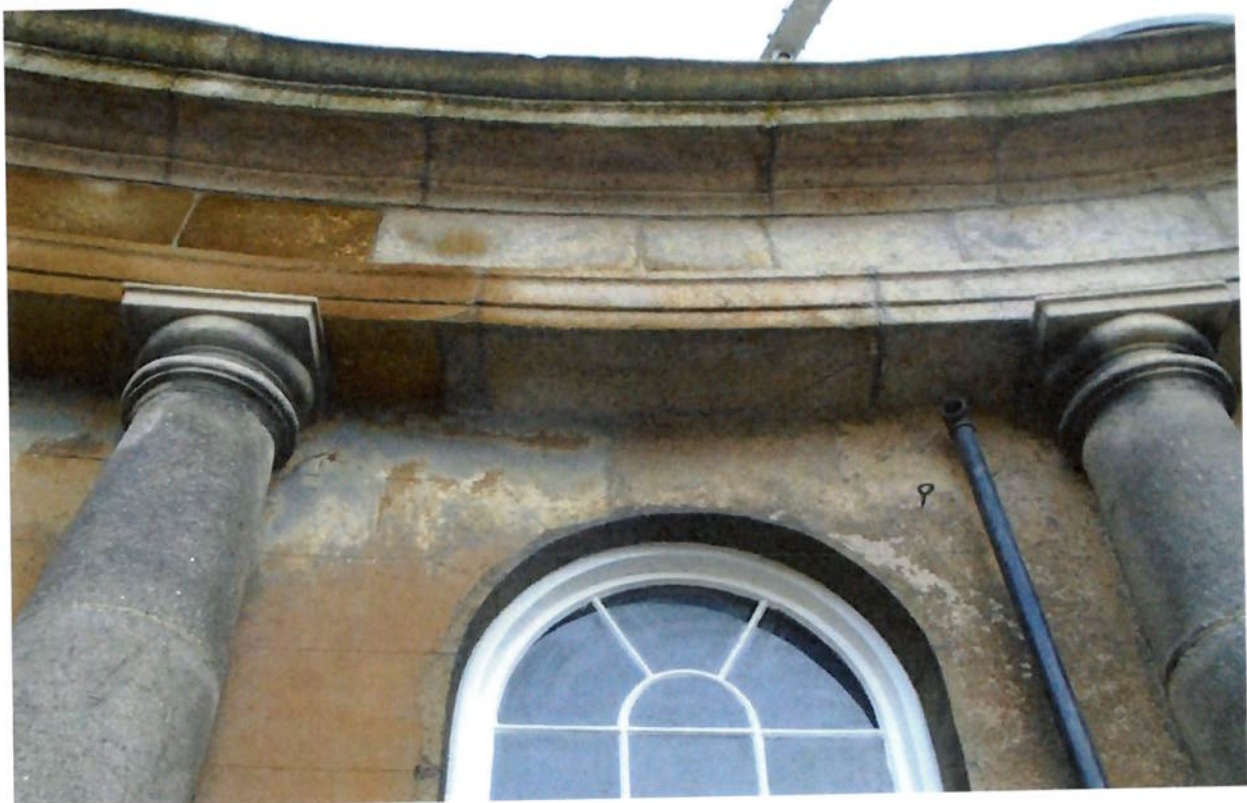
Figure 37. Note, concrete replacement capitals

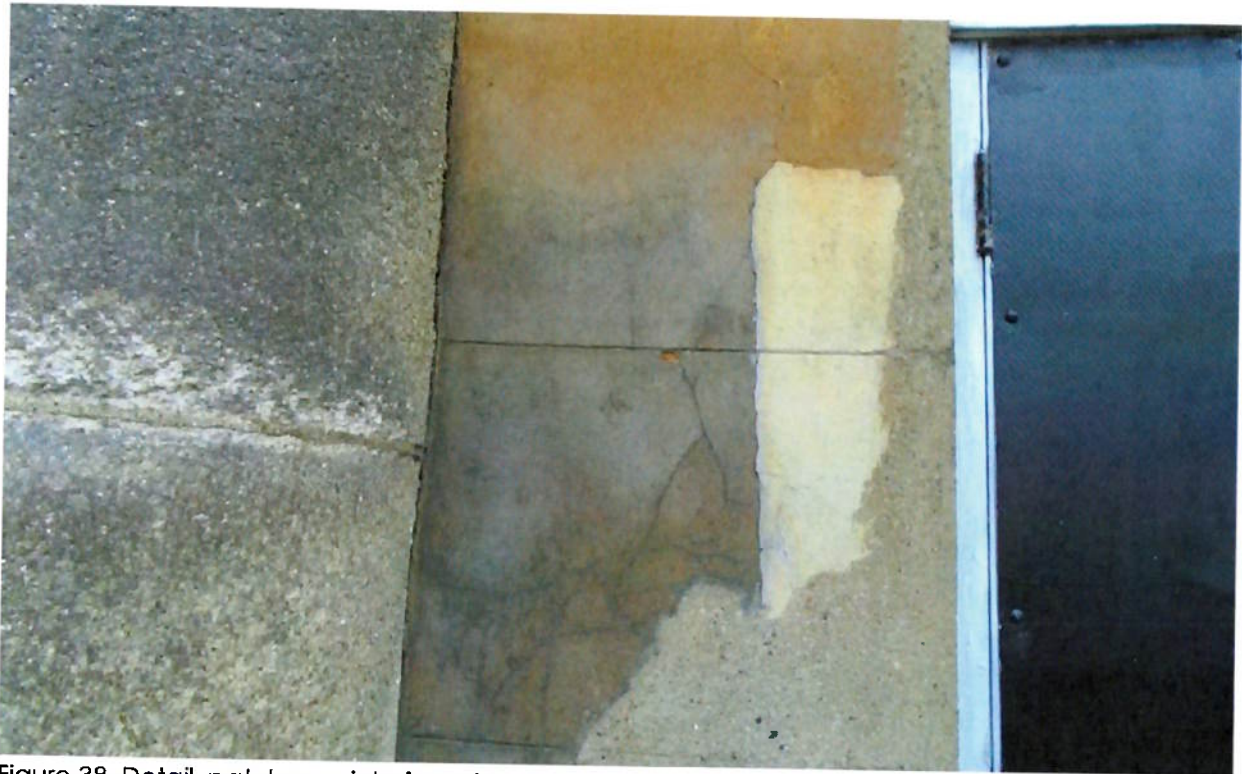
Figure 38. Detail, patch repair to facade

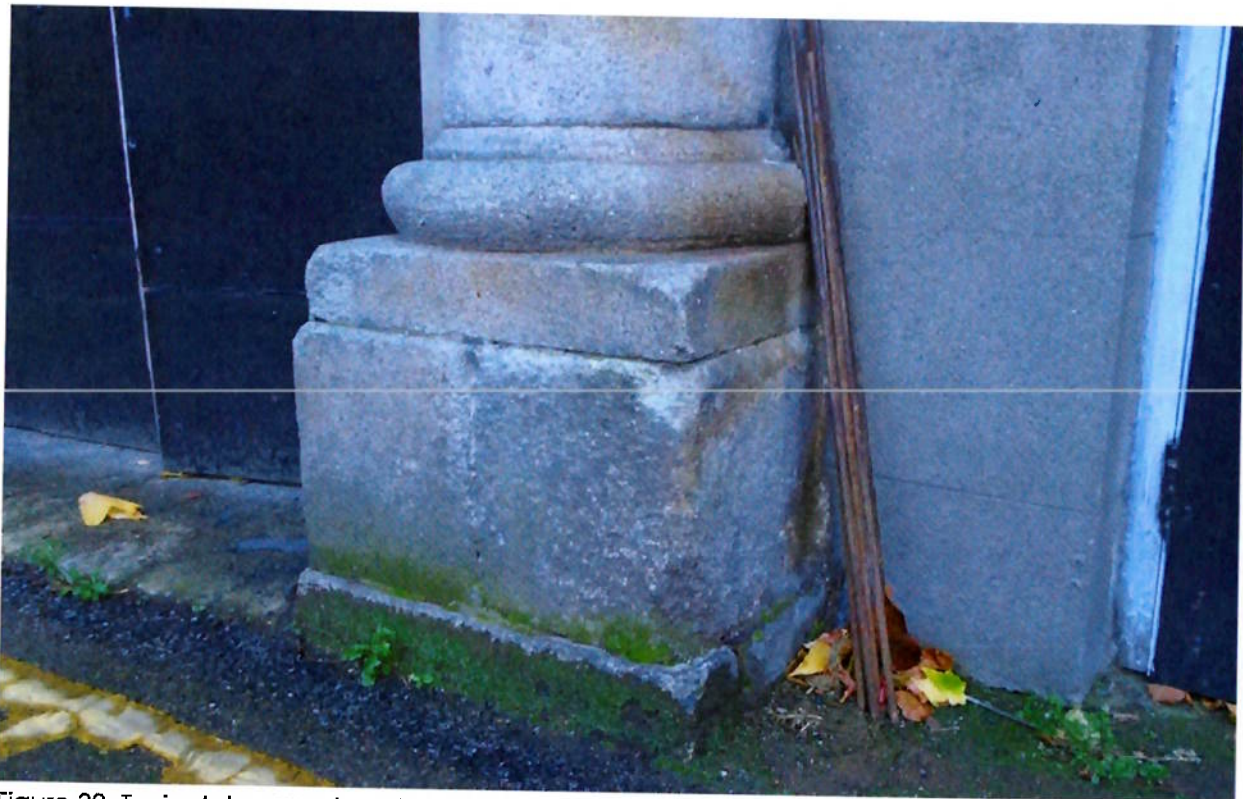
Figure 39. Typical damage to column bases

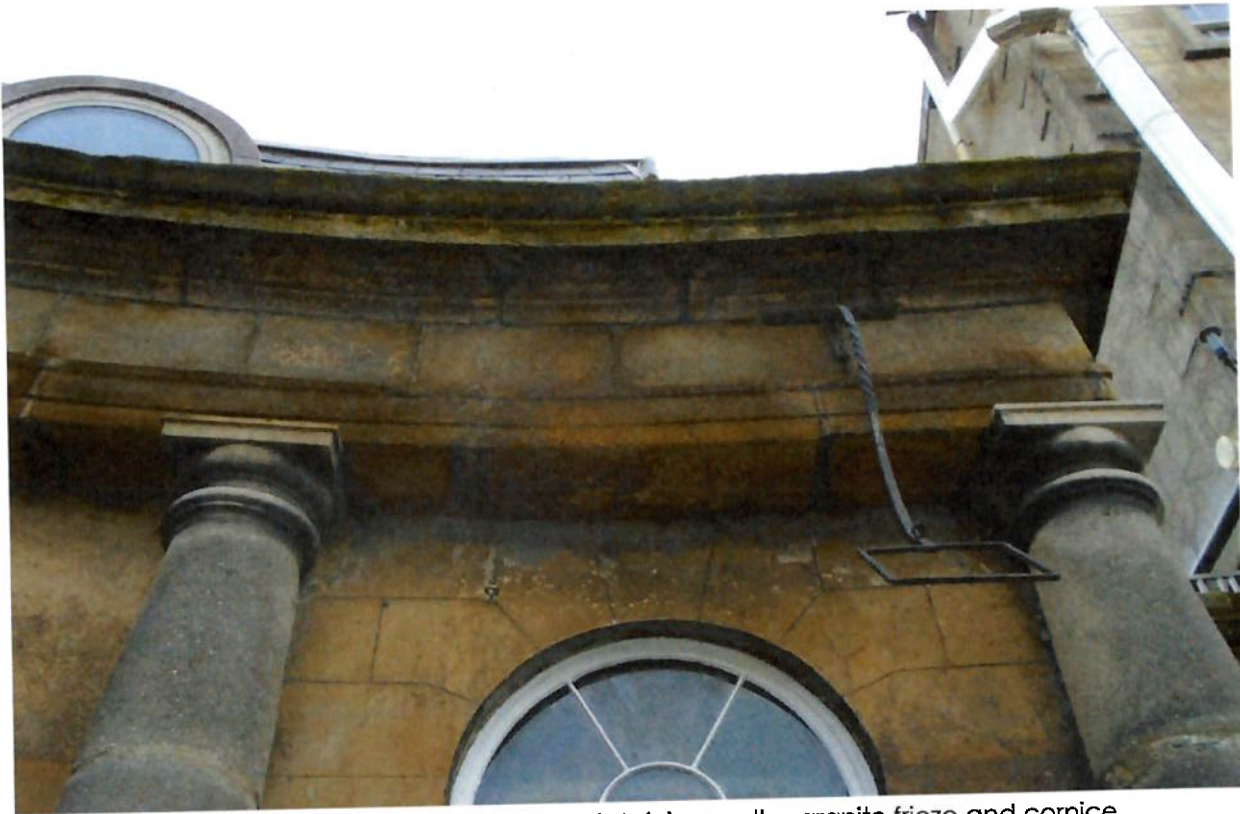
Figure 40. Last bay. Extensive algae growth and staining on the granite frieze and cornice

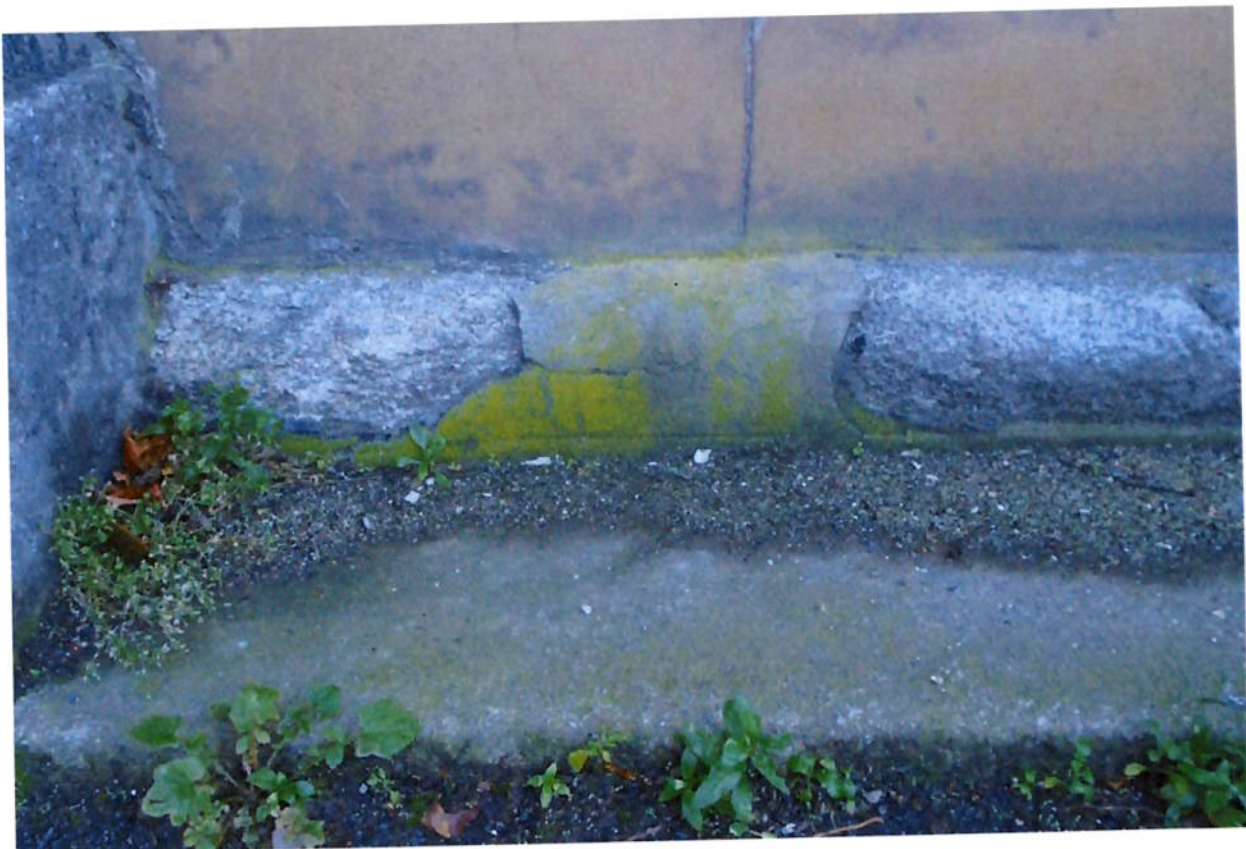
Figure 41. Replace cement with new graft

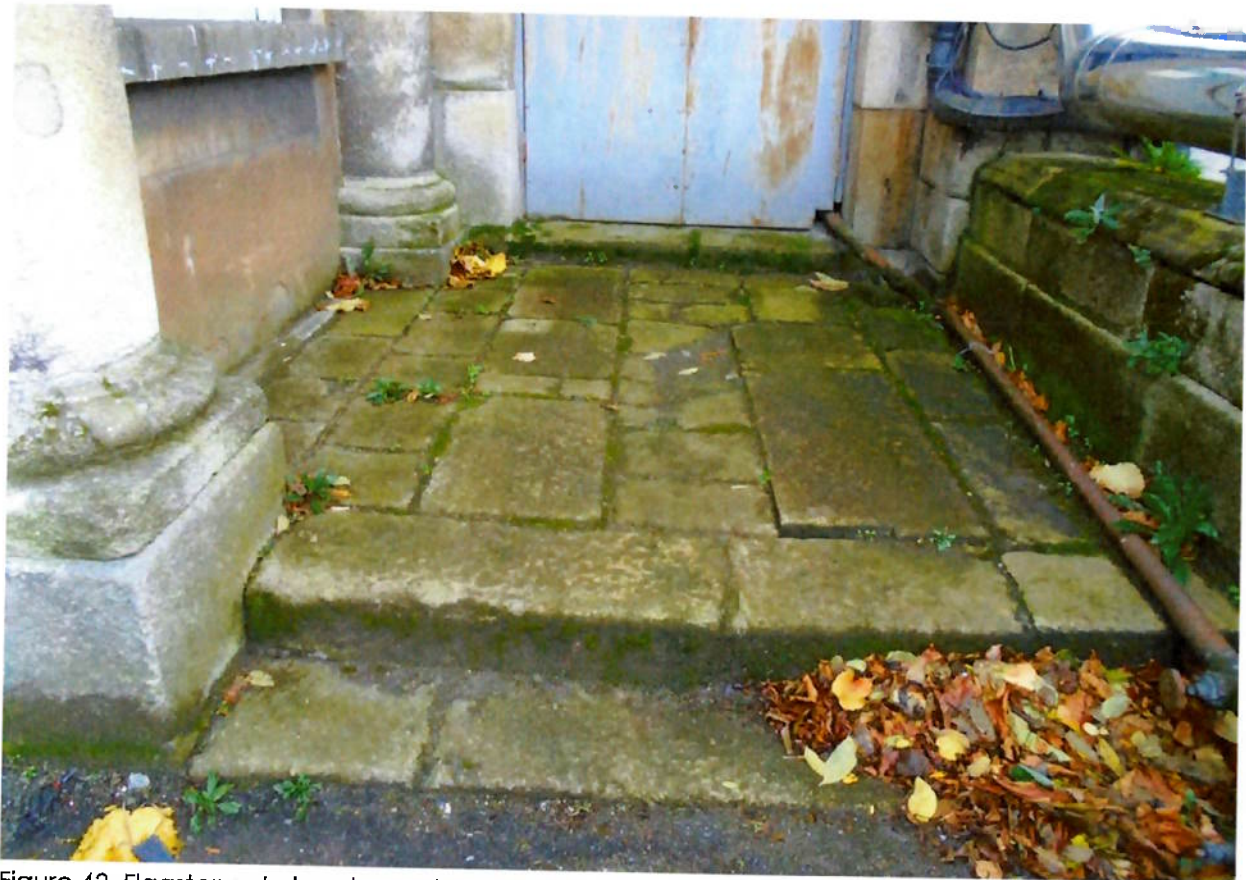
Figure 42. Flagstones to be cleaned and repointed

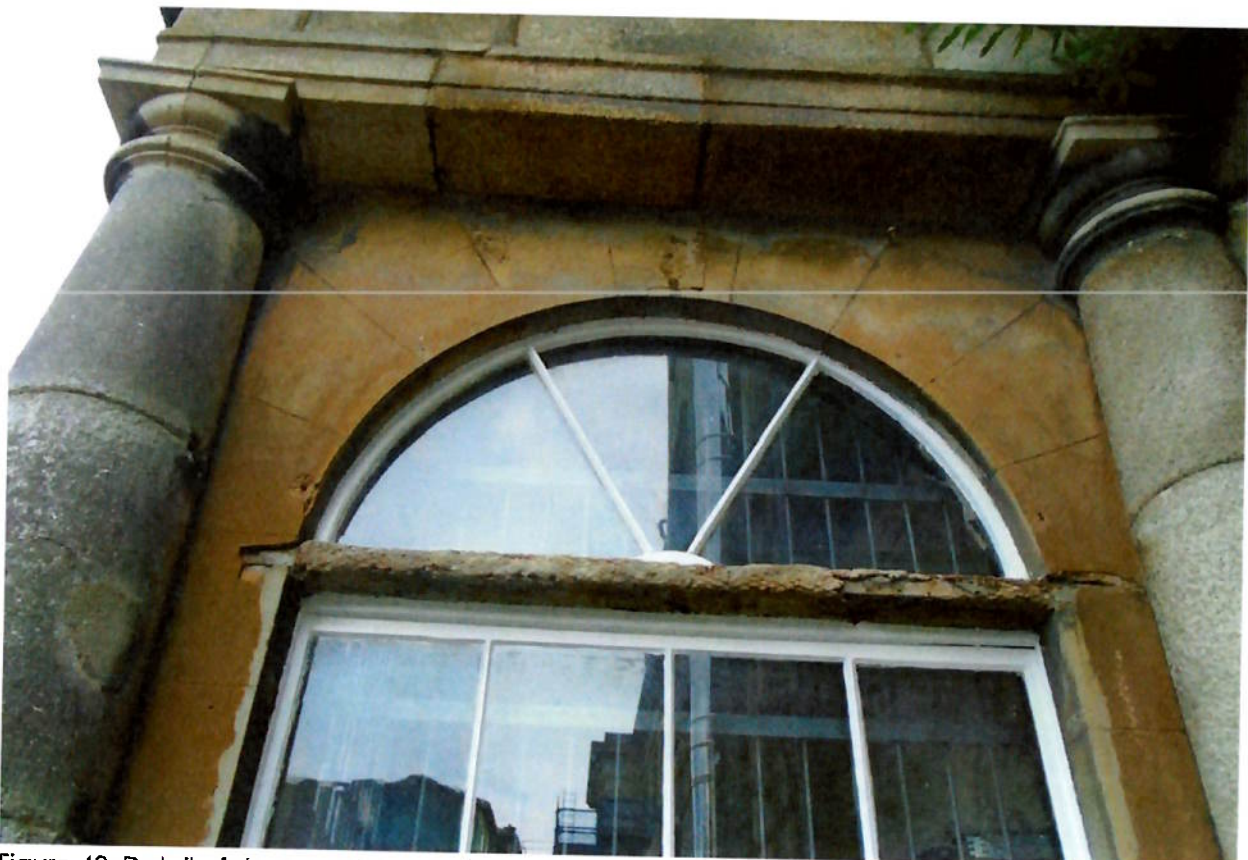
Figure 43. Detail of damaged timber lintel
