Technical Note to Inspector ABP-321405-24

Development Construction of a dwelling house,

wastewater treatment system and all

Location Cregg, Glandore, Co. Cork

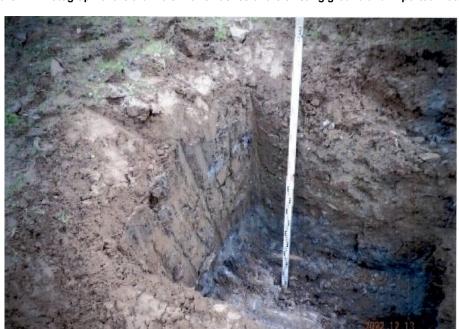
- 2.1.5. The trial hole photographs submitted with the site suitability assessment (SSA) appeared to show a clear delineation between the imported fill material and the existing ground (see figures 2.1 and 2.2). The existing ground was a dark grey/blue coloured subsoil whereas the imported material above the existing ground appeared to be a brown coloured soil with smearing evident which suggested a high CLAY content. The trial hole log (Section 3.2) did not record the distinction between the infill material and the previous existing ground level. The assessor should have recorded this information. The trial hole log and photographs suggested that approximately 1m of infill material existed above the previous ground level and that the existing soil/subsoil consisted of a shallow (<0.7m) layer of subsoil above

Figure 2.1 Photograph of the trial hole with evidence of the existing ground and imported material

- 2.2.2. The soil/subsoil was classified as a gravelly SILT/CLAY however the threads and ribbons data provided suggested the soil should have been classed as a CLAY. The photographs of the trial hole had evidence of smearing from the excavator bucket which is strongly indicative of high CLAY content soils.

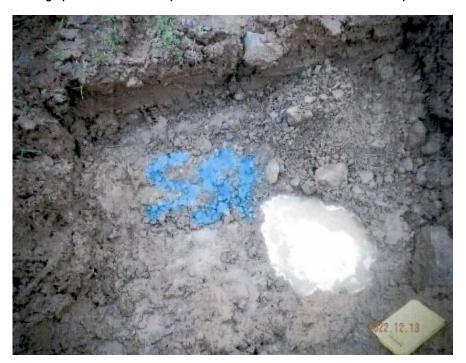
2.1.6. The SSA also contained photographs of the subsurface percolation test holes which were identified as SS1, SS2 and SS3 with blue spray-paint alongside the holes. Based on the colour of the soil in these photographs these test holes were not carried out in the existing ground but were carried out in the imported infill material (see figures 2.3, 2.4 and 2.5 for reference).

Figure 2.4 Photograph of the subsurface percolation test hole SS2 carried out in the imported infill material

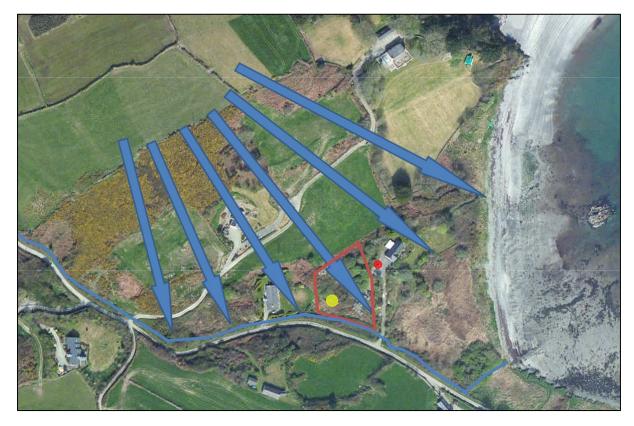
Figure 2.6 above illustrates the indicative groundwater flow direction around this site which shows that groundwater flows diagonally through the site from elevated ground in the NW towards the SE direction and the adjacent watercourse. Given this information and the distance from the proposed infiltration area to the neighbouring

- well (>45m) I am satisfied that the proposed location for the infiltration areas would not pose a risk to the quality of the water in the neighbouring drinking water well, subject to proper treatment facilities being in place.
- 2.3.2. Other relevant separation distances identified to be relevant to this site were for upgradient domestic wells, foreshore, watercourses, adjacent septic tank and percolation area, neighbouring dwelling house and road. Having reviewed the proposed location for the treatment system components I am satisfied that the separation distance requirements were compliant for all of the above features in accordance with Table 6.2 of the CoP, 2021.
