A Survey of Selected Rivers for
the Galway City Transport
Project with Potential for
Margaritifera (Moorkens, 2014a)

A SURVEY OF SELECTED RIVERS FOR THE GALWAY CITY TRANSPORT PROJECT WITH POTENTIAL FOR *MARGARITIFERA*

September 2014

Evelyn A. Moorkens

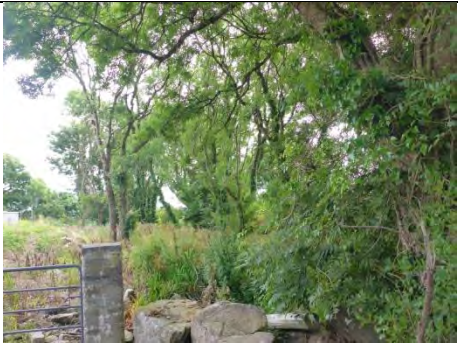
View upstream	View downstream

Site E	Old tree line marks where the stream was. It is now dry and absorbed into the surrounding land through drainage. No <i>Margaritifera</i> habitat	
Small stream		
M22088 23187

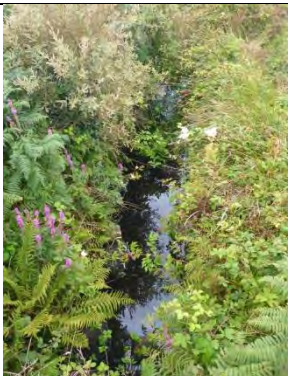
Site O	Tunnelled, overgrown, very little flow, <i>Callitriche</i> , sandbags, culverted pipe. Narrowed downstream, water with grey tinge	
Barna Stream main channel		
M25346 26206

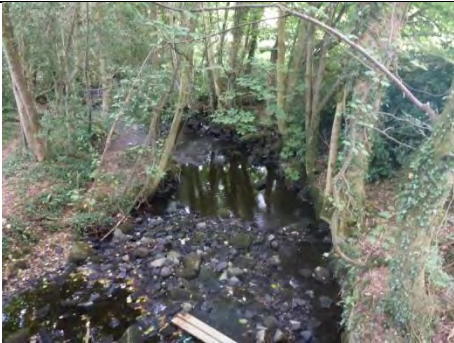
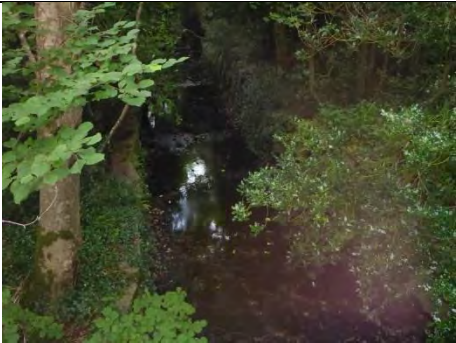
Site Q	Near roadbridge. Still good substrate and some flow in places, tree lined but very shallow	
Barna Stream main channel		
M24750 23794
