Galway County Council
N6 Galway City Transport Project
Karst Study

Karst Study Report

Issue 1 | 27 February 2015

Ove Arup & Partners Ireland Ltd

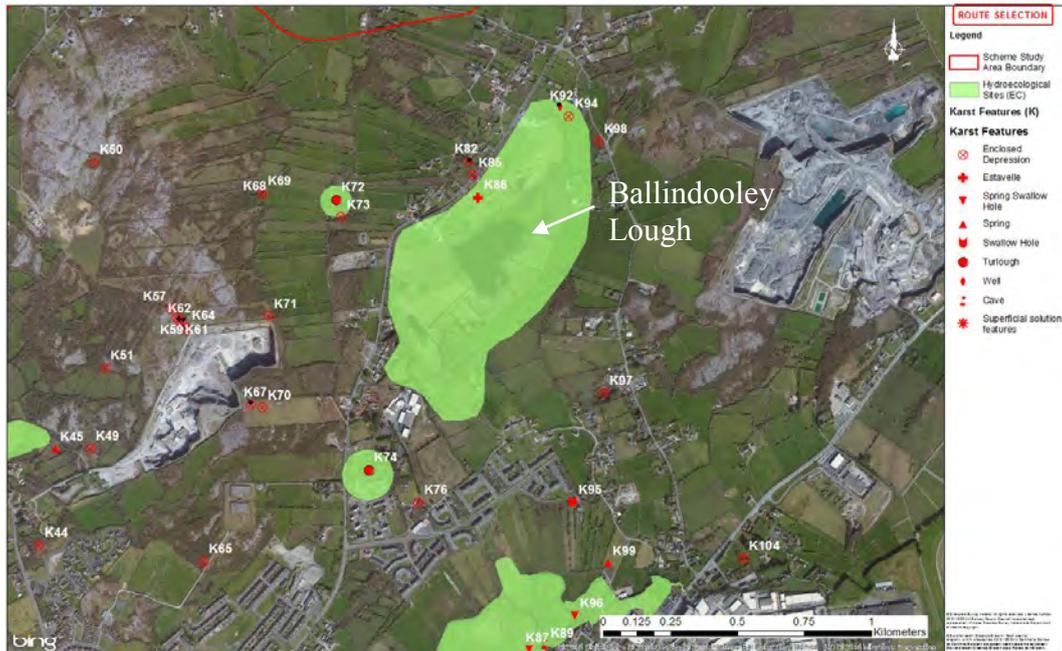
Figure 7 Ballindooley Lough karst features and water dependant habitats

Ballindooley Lough is a large shallow topographic depression (approx. 400m by 150m), which has a peaty/clayey base in the centre that also hosts permanent standing water. Refer to **Figure 7** below. The water level fluctuates seasonally throughout the year and floods most of the depression. There is no surface water input to the lough although there may be some runoff into the depression during intense rainfall. The fluctuation in water level is seasonal and likely to be a representation of the local groundwater level. It is likely that there is also diffuse flow to the lough via the fracture flow network.

There are a number of karst landforms in the area of Ballindooley Lough, particularly to the northeast and northwest of the depression. To the northeast the landforms include an estavelle¹ (K86) and two enclosed depressions (K82 and K85) (**Figure 7**). These landforms are aligned linearly and are indicative of fracture control of a karst flow path, most likely a conduit.

To the northwest there is an enclosed depression (K94) and a well (K92) and these again indicate a karstic flow path, most likely a conduit. Considering the rising topography both of these linear clusters of karst landforms suggest that two main fractures may provide conduit flow that feeds in to towards Ballindooley Lough.

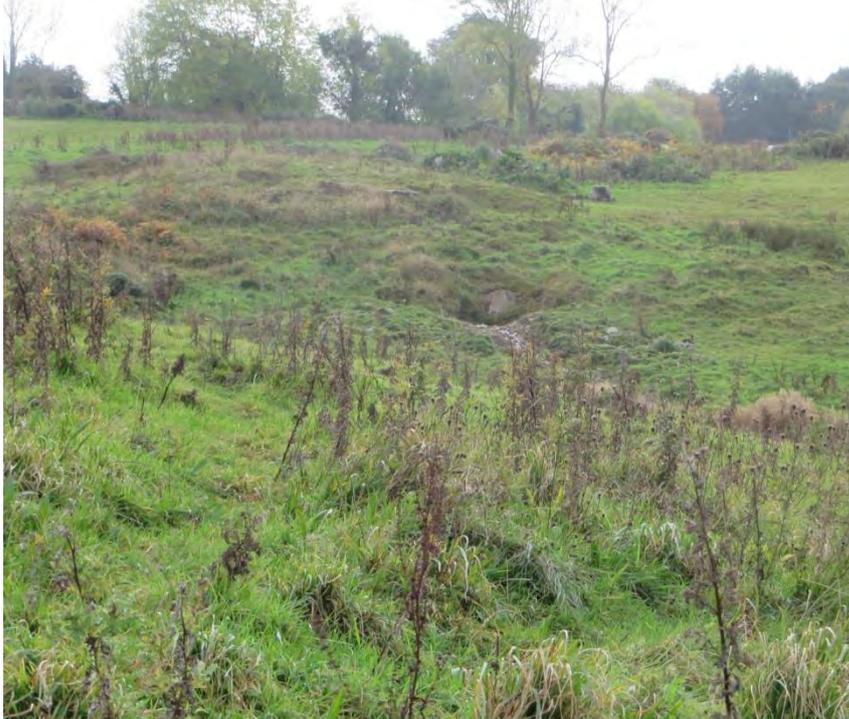
Feature ID	K9
Feature type	Spring
Coordinates	527285, 728284
Source	Field Survey
Field survey date	20/10/2014
Field survey status	Confirmed
Water present	Yes
Additional Information	
Site photo

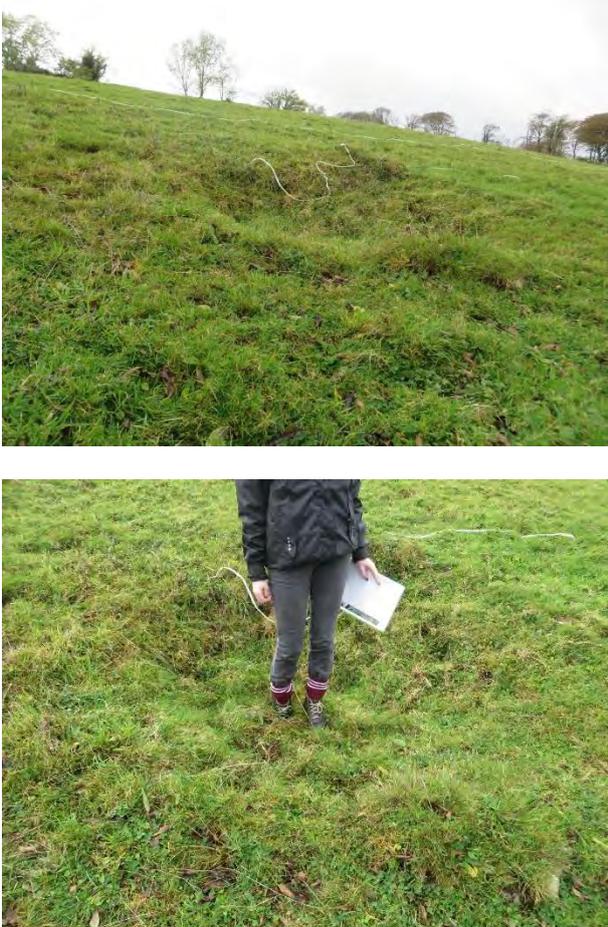
Feature ID	K10
Feature type	Enclosed depression
Coordinates	527301, 728143
Source	Field Survey
Field survey date	20/10/2014
Field survey status	Confirmed
Water present	No
Additional Information	1 m diameter small enclosed depression, base contains loose rocks
Site photos

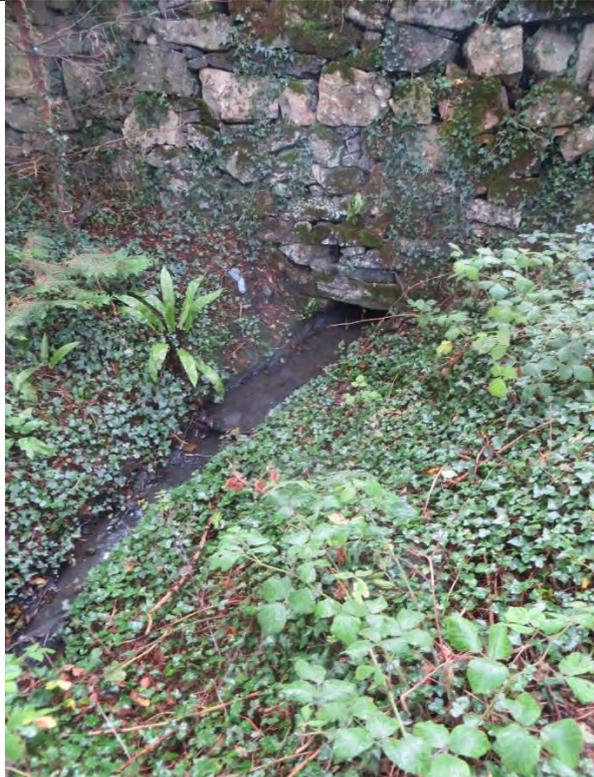
Field survey date	17/10/2014
Field survey status	Confirmed
Water present	Yes Electrical conductivity: 330 uS/cm Temperature: 12.8 °C pH: 8.34
Additional Information	Stream coming from drain under road. Exact source location of spring not found.
Site photo

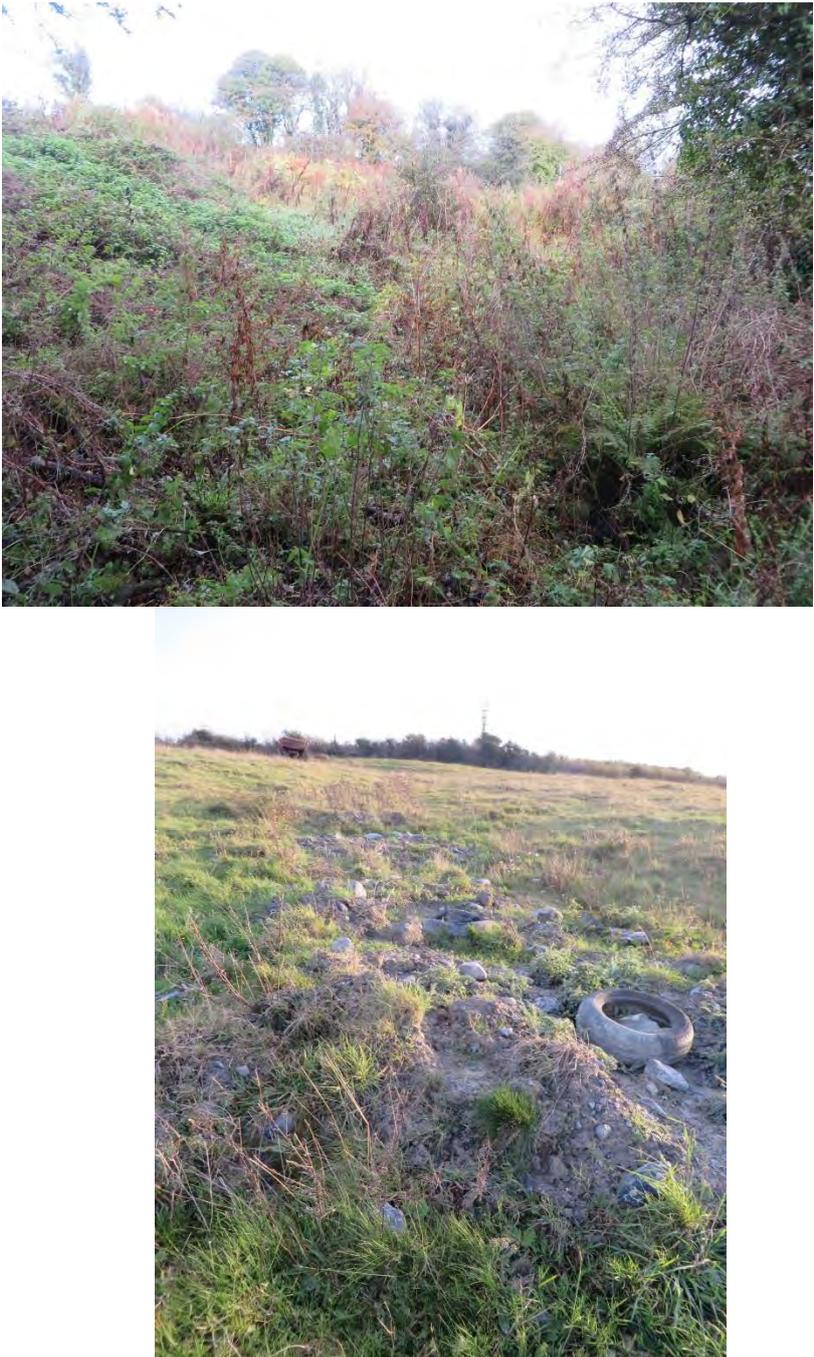
Feature ID	K70
Feature type	Enclosed depression
Coordinates	530671, 728317
Source	Field Survey
Field survey date	21/10/2014
Field survey status	Confirmed
Water present	No
Additional Information	15 x 3 m diameter enclosed depression Possibly filled in depression
Site photo

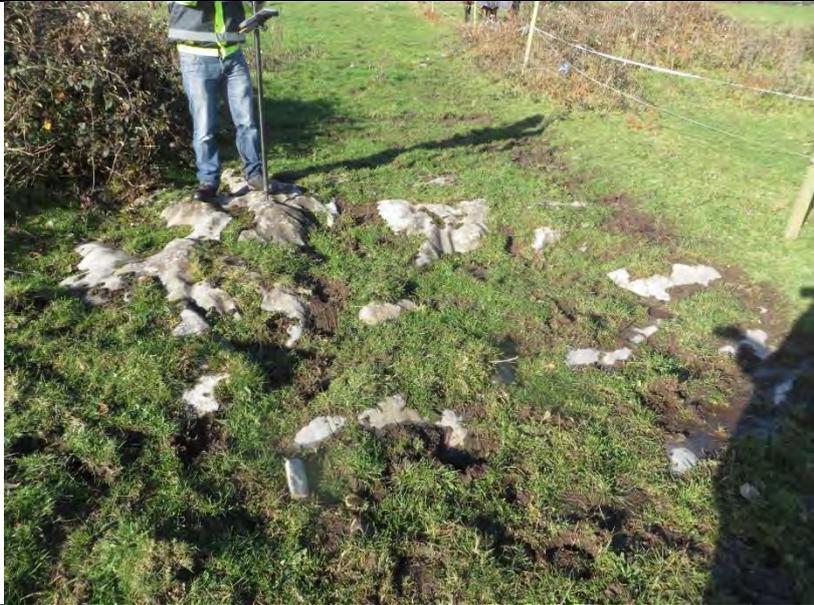
Field survey date	14/11/2014
Field survey status	Confirmed
Water present	No
Ground level elevation	44.19 mAOD
Additional Information	Area of superficial solution features noted by GSI database but not very obvious in field. Some rock visible with solution erosion, see photo.
Site photos

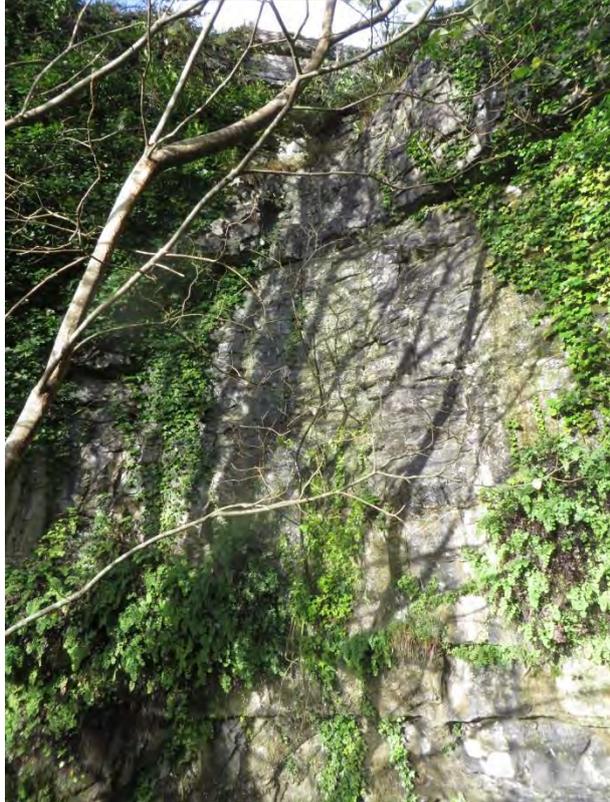
Field survey date	14/11/2014
Field survey status	Confirmed
Water present	Yes Electrical conductivity: 490 uS/cm Temperature: 12 °C pH: 8.23
Additional Information	Feature is located in old quarry. Water is discharging from fractures approx. 5m above ground level. It is likely that the natural flow and location of the spring has been modified due to the quarry excavation.
Site photos

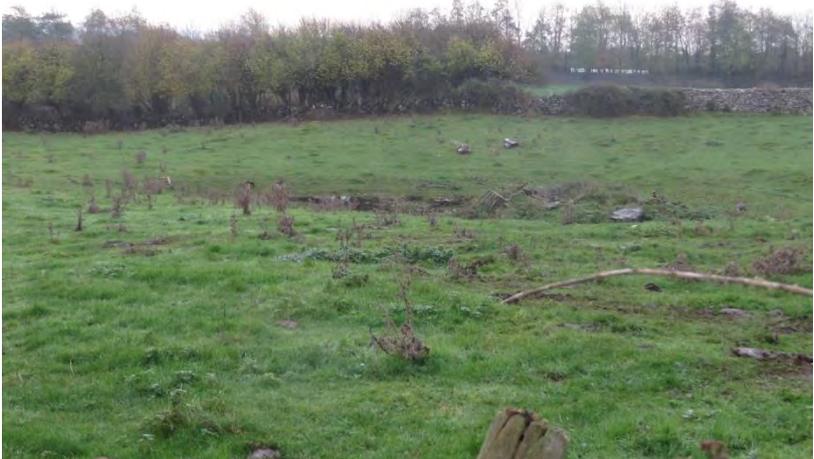
Field survey date	18/11/2014
Field survey status	Confirmed
Water present	Yes No water quality analysis recorded
Additional Information	Farmer noted that the depression fills with water
Site photos
