Preliminary Report on Metrolink Route and its Potential Effect on AerCap House

Waterman Moylan Consulting Engineers Limited

Client Name: Hines
Document Reference: 22-117r.101
Project Number: 22-117

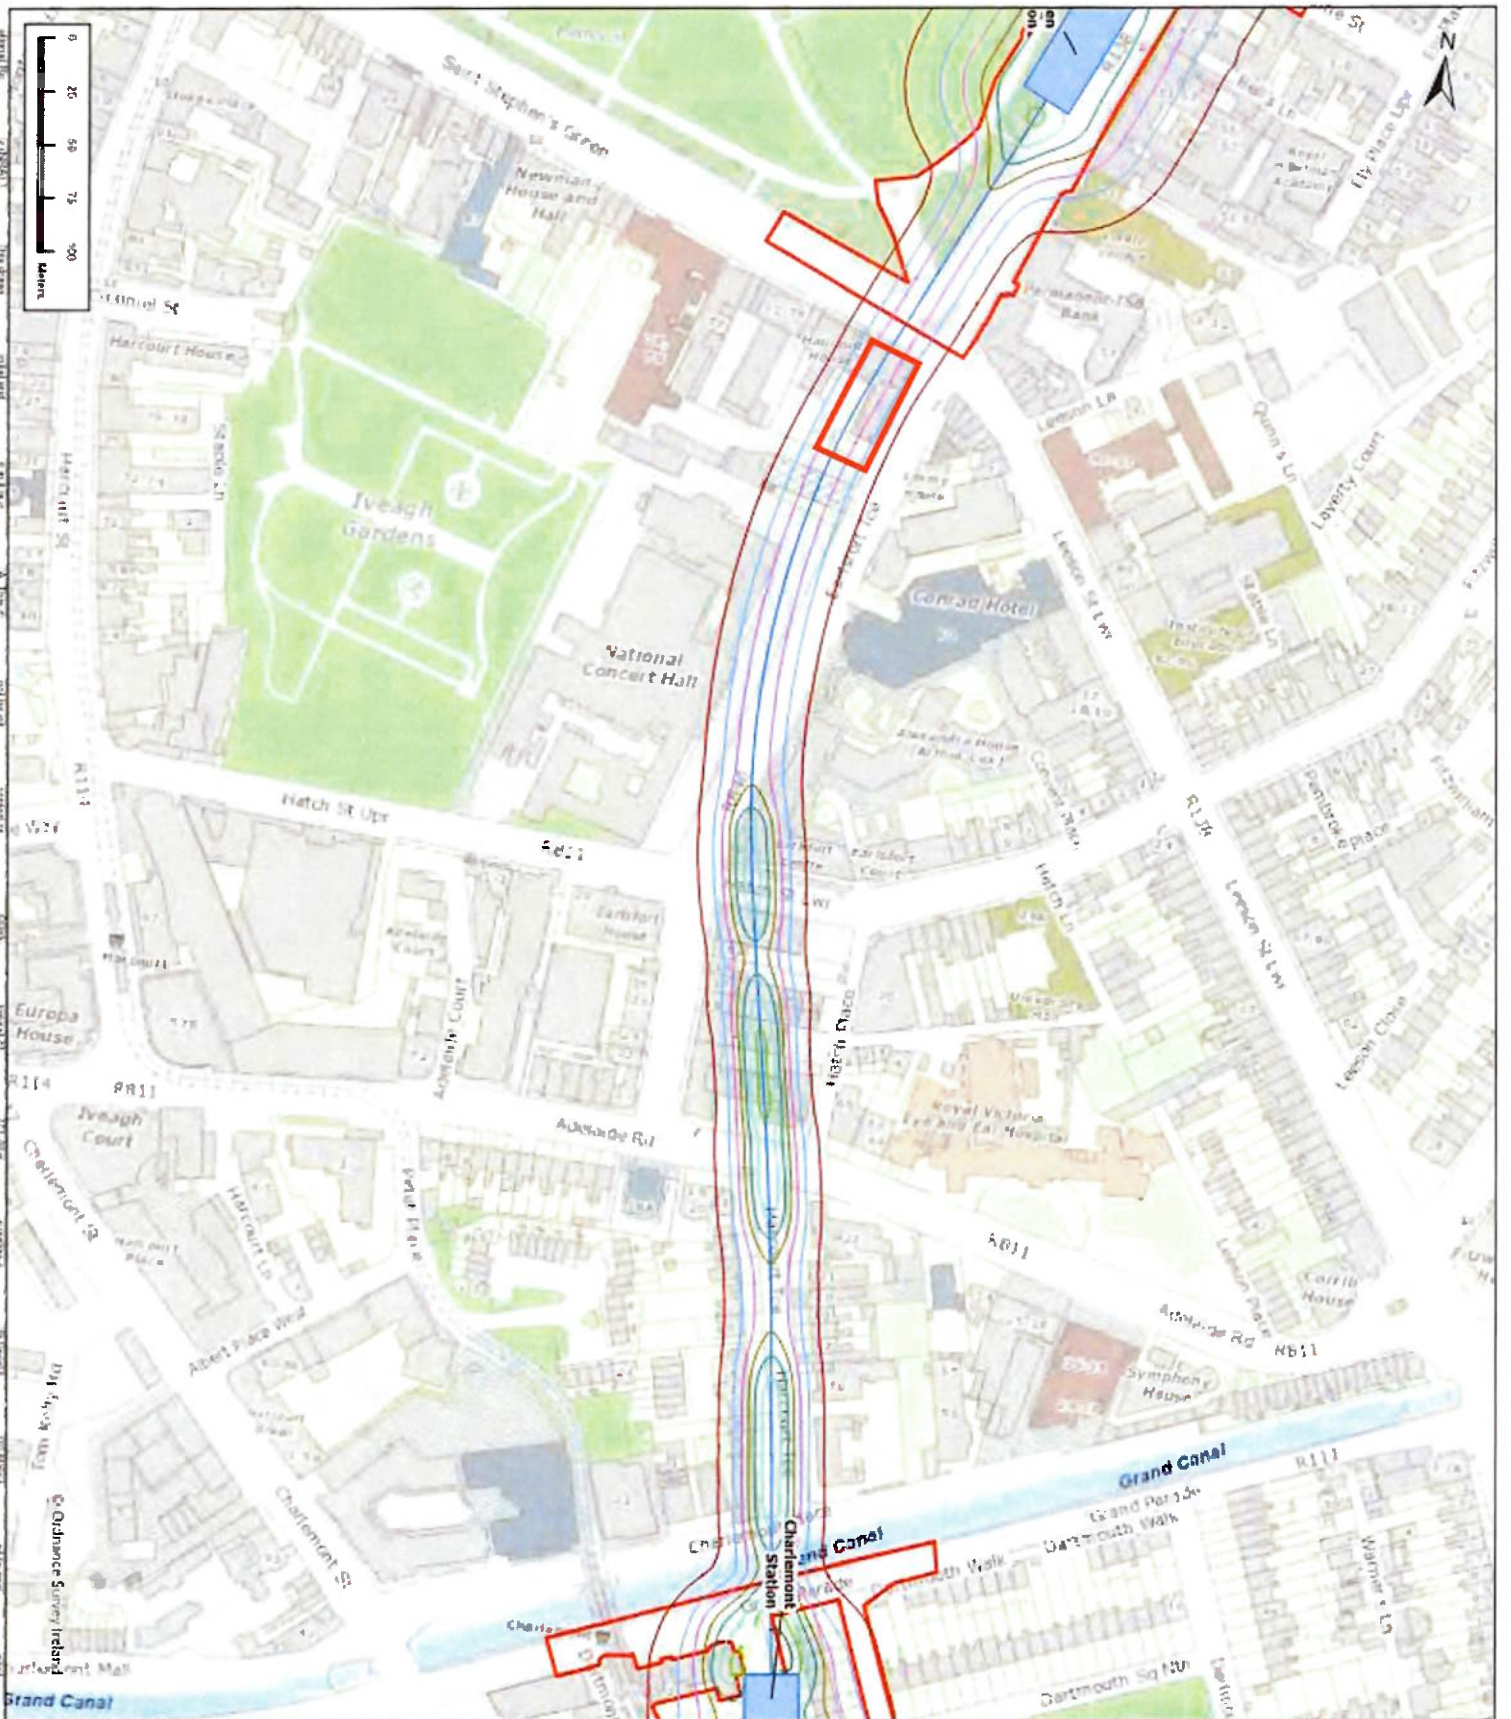
A. Jacob / IDOM drawing number ML1-JAI-EAI-ROUT_XX-DR-Y-21146

Jacob / IDOM drawing number ML1-JAI-EAI-ROUT_XX-DR-Y-21146, revision P02 dated 23 February 2024 (which appears to supersede ML1-JAI-EAI-ROUT_XX-DR-Y-21149 revision P02, which was included in Appendix C of the BDR), indicates the Jacob / IDOM engineers predict subsidence/settlement of up to 10mm under the footprint of AerCap House. This settlement was previously advised as 20mm in the original Rail Order submission. No explanation has been given for the reduction to a predicted 10 mm.

The magnitude of the subsidence/settlement under AerCap House is not uniform and varies from 0mm to 10mm. The maximum subsidence/settlement is experienced directly under one of the main stair cores, which provides stability to the building.

The settlement contours presented by Jacob / IDOM indicate that differential settlement/distortion of AerCap House is going to occur, resulting in the following damage:

- The basement uses a whitetank waterproofing system, which relies on the watertightness of the reinforced concrete basement floor slab and walls. Therefore, even minor cracking could lead to groundwater ingress;
- The internal reinforced concrete frame uses post-tensioned reinforced concrete floor slabs for large spans, which would be more sensitive to differential settlement than conventional RC slabs;

- The tunnel passes under one of the main structural cores for the building, and this incorporates a complex transfer structure at the first-floor level to accommodate a shift in the position of the core for the upper floors of the building;
- The building has a modern stone and glass façade, which would be more sensitive to distortion due to differential settlement along the perimeter secant pile wall than a masonry or blockwork structure.

AerCap House can not accommodate movement of this magnitude without damage to the structure, waterproofing and facades being caused.

A detailed Phase 3 assessment using the correct building geometry and structural form should be completed and independently verified, ensuring the maximum damage caused to AerCap House is limited to 0.1mm cracking. The proposed tunnel elevation may require to be lowered more than the current LOD downwards, i.e. more than the 10.0m indicated in the Wider Effects Report submitted as part of the application, considering the proximity and sensitivity of AerCap House.
