**External Envelope:
Glass & Aluminium and
Stone Façade Elements**

CADENZA METROLINK INTERFACE

Credenza, Earlsfort Terrace, Dublin

**Document No:
1087-BDA-XX-ZZ-RP-Y-0001-C01**

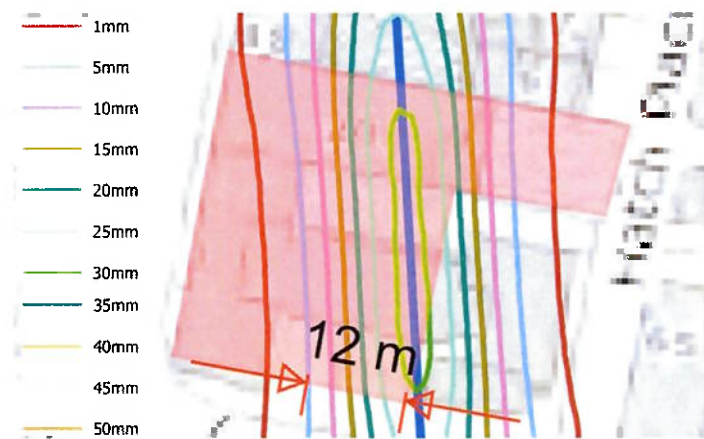
Figure 10 Plan of Cadenza with TII predicted ground settlement

MetroLink has assessed the predicted "Settlement" and presents its findings on drawing no. ML1-JAI- EIA-ROUT-XX-DR-Y-21146 rev P02. This drawing indicates MetroLink will be causing a 30mm settlement directly under the location of our client's building which is unacceptable. Settlements of this magnitude cannot be accommodated by the building's facades. Such settlement, particularly if introducing differential settlement between columns, will cause damage.

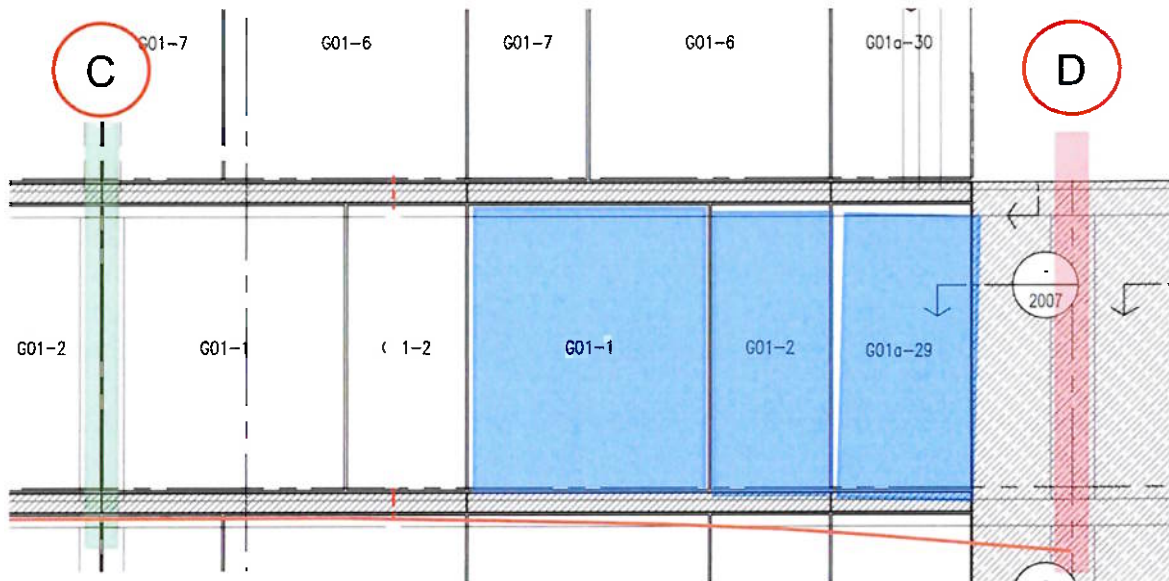
Figure 12 EWS-001 glass rotating due to differential settlement of one column (South elevation)

The vertical joint between double-glazed panels consists of 28mm silicone pointing with a 25mm PVC drainage tube. The silicone pointing can take small amounts of compression and tension. The PVC tube can accommodate small amounts of compression. If one column settles differentially, the glass panels either side of that column will rotate in plane compressing the silicone seal.

Due to the aspect ratio of the panels closest to gridline D on the South elevation, the TII predicted differential settlement of 25mm from Gridline C to D would result in 1.75m wide panels rotating in plane not less than 3.6mm at their base. As each panel is 3.5m tall this translates into 7mm rotation at the top corner of the panel. Such rotation would exceed the design parameters of the structural sealant at the glass to glass joint crushing and tearing the sealant and inducing stress in the glass. It may not cause breakage but will apply long-term stress into the structural sealant joint which may cause failure of the structural connection.

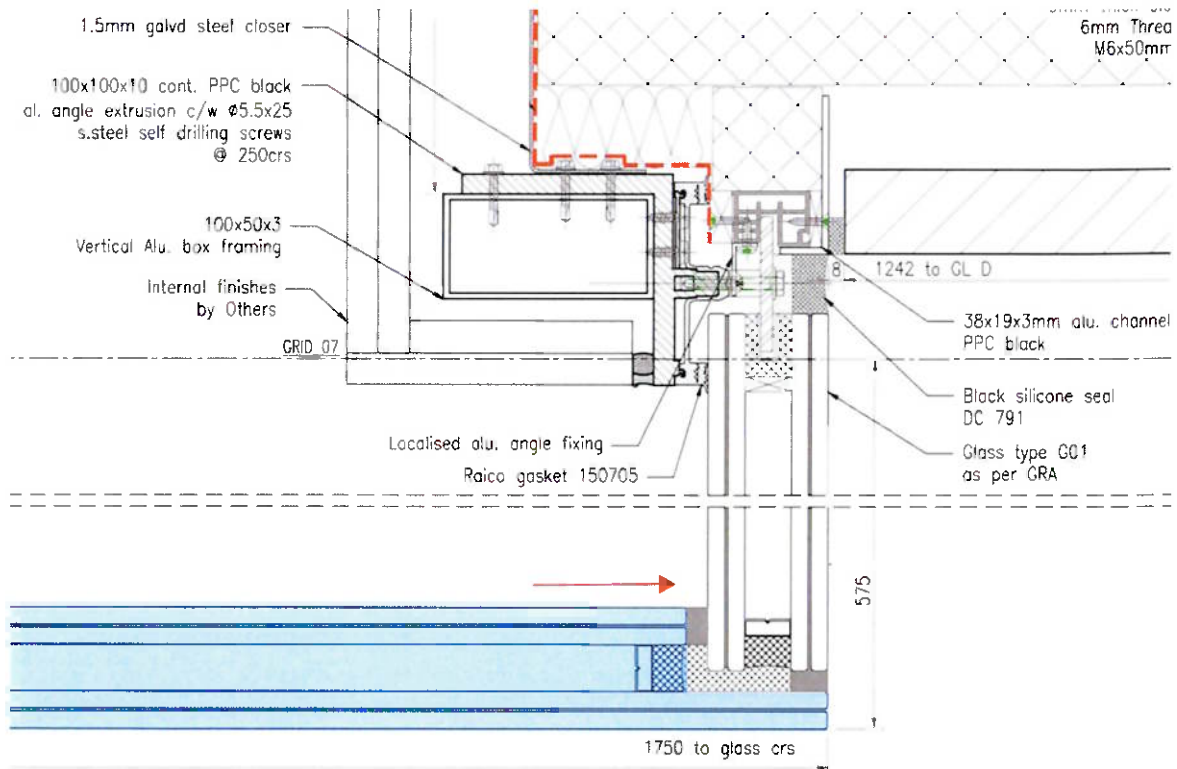
Figure 13 EWS-001 Plan view, glass-to-glass corner condition adjacent to Gridline D, South elevation.

- 1) The window wall system EWS-001 is susceptible to damage, breaking glass, if there is differential deflection of the primary structure at one column. The worst-case condition is at the South-East corner where there is a glass to glass corner. This is likely to be over-stressed if the predicted settlement noted in ML1-JAI- EIA-ROUT-XX-DR-Y-21146 rev P02 occurs.

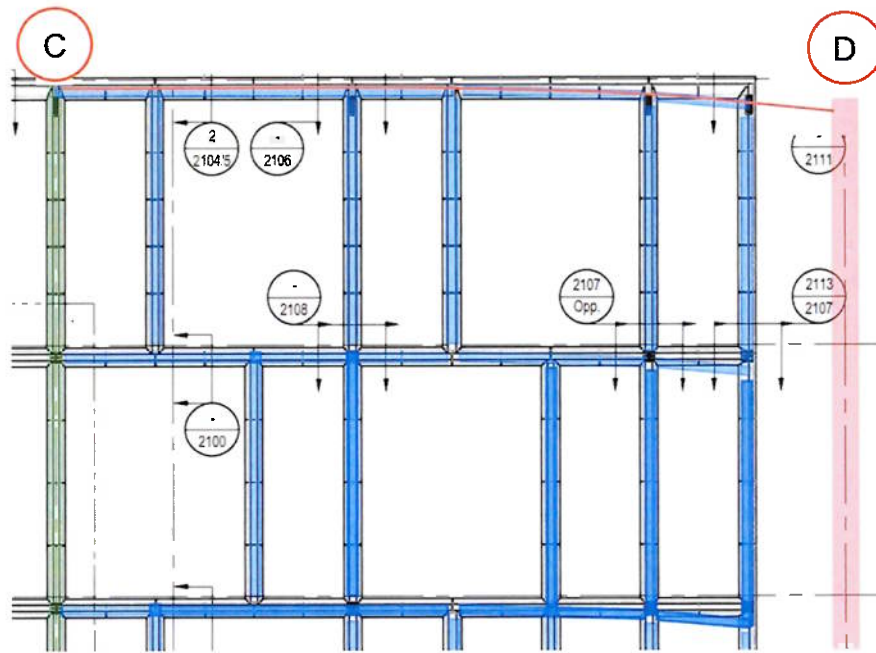
Figure 17 EWS-002 partial South elevation. Differential settlement of structure at Gridline D

The differential settlement of a column causes rotation of the connection between horizontal and vertical veil elements. These connections are typically formed with countersunk fixings tapped into a block of stainless steel. These connections were not designed to accommodate significant rotation. Detailed analysis would be required to determine how these connections react and whether the horizontal beams of the veil would rotate at these connections or be forced to go into bending ('S' shaped bend on elevation). If over-stressed the connections could fail.

If the horizontal beams or vertical mullions go into bending due to differential settlement, this could cause over-stressing of the fixings in the stone exceeding permissible safety factors and/or causing cracking of the stone.

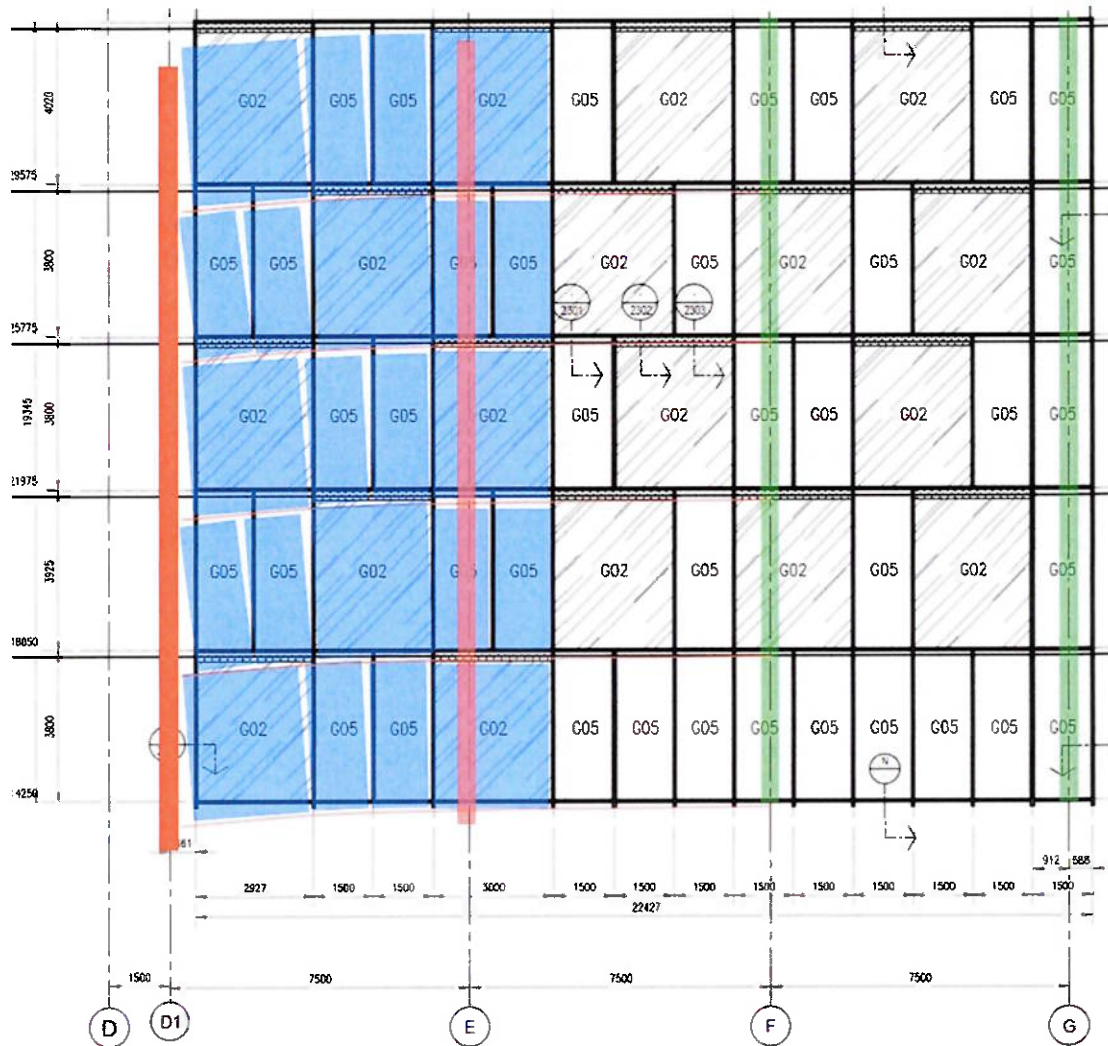
Figure 19 EWS-003 South elevation, Deformation due to ground settlement

The curtain wall system has very little capacity for racking of the glass on elevation. When the structure moves differentially as per the diagram above, the mullions remain vertical and the transoms rotate in plane. As each glass unit sits on a transom, the glass rotates with the transom. Based on the TII diagram there is approximately 30mm of differential settlement across quite a small width of approximately 10m.

Due to the aspect ratio of the panels closest to gridline D1 on the South elevation, the TII predicted differential settlement of 30mm in this area would result in 1.5m wide panels rotating in plane not less than 4.5mm at their base. As each panel is 3.8m tall this translates into 11mm rotation at the top corner of the panel. The toggle glazed system does not have capacity for this degree of movement. The mullion detail below shows the proximity of glass to metal. If the glass

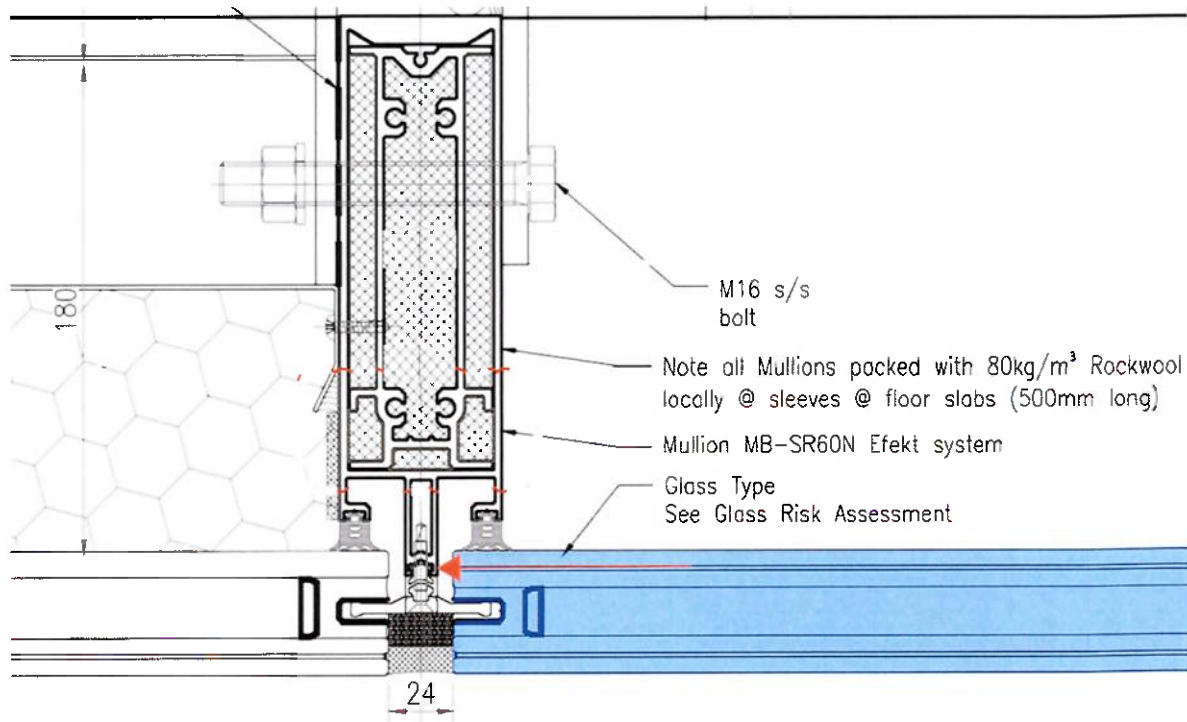
Figure 20 EWS-003 Plan section of glass to mullion interface.

rotates too far, the inner glass impacts the aluminium mullion profile. The design gap, excluding glass tolerances and installation tolerances would be less than 6mm.

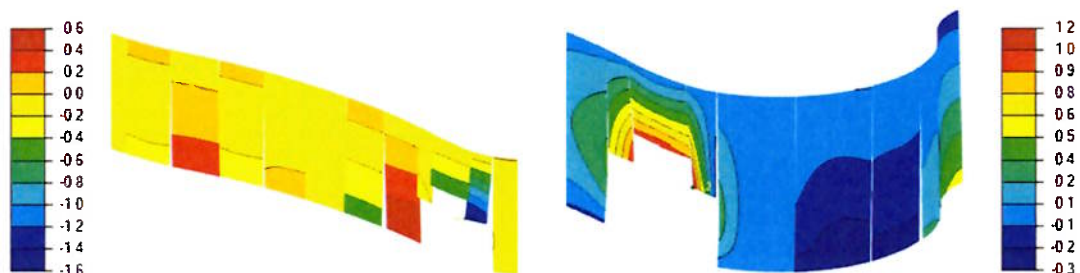
Figure 25 EWS-006 Horizontal displacement due to vertical deflection of Level G slab.

The differential deflection of the slab due to the design loads has been reviewed, and the in-plane rotation/deflection of each individual panel plotted. Although the worst case vertical displacement is on the South, the worst-case rotation due to differential deflection across the width of a single panel, occurs on the East elevation. This is illustrated in the diagram below.

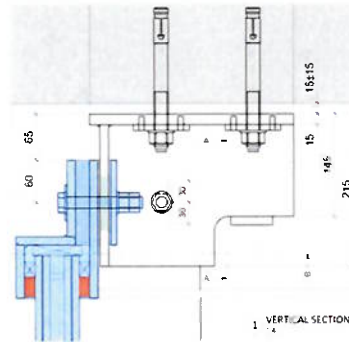
Figure 26 EWS-006 Head restraint detail.

Should settlement due to MetroLink works cause the Level G slab deflect more than anticipated in the current design, it is possible the permissible long-term shear load in the structural silicone at the head detail will be exceeded. If the head restraint were to fail, allowing the panel of glass to rotate in plane (along the elevation), there is a high risk of glass breakage due to metal to glass contact and/or glass to glass contact.

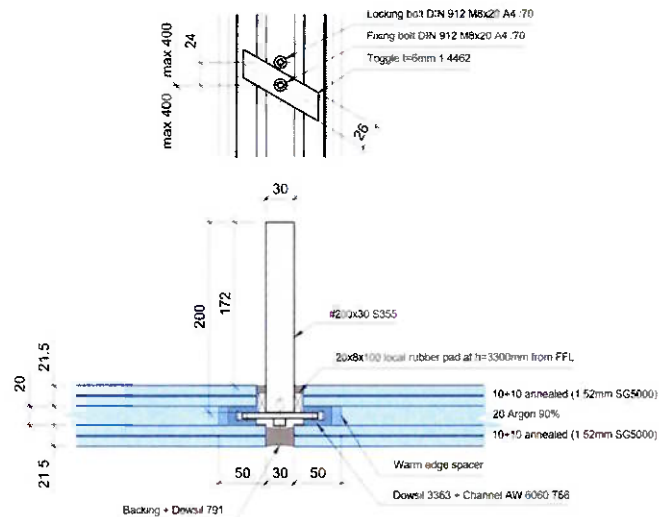
Figure 28 EWS-600 Plan detail of glass to glass joint with steel fin

The glazing system has vertical fins between each double glazed unit. The fin is intended to provide resistance to wind load but has limited capacity to resist lateral in-plane loads. As can be seen in the diagram below, should the glass restraint at the head fail and the glass rotate in plane, there is a high risk the perimeter internal silicone seal would be crushed resulting in glass to metal contact.
