**External Envelope:
Glass & Aluminium and
Stone Façade Elements**

CADENZA METROLINK INTERFACE

Cadenza, Earlsfort Terrace, Dublin

**Document No:
1087-BDA-XX-ZZ-RP-Y-0001-C02**

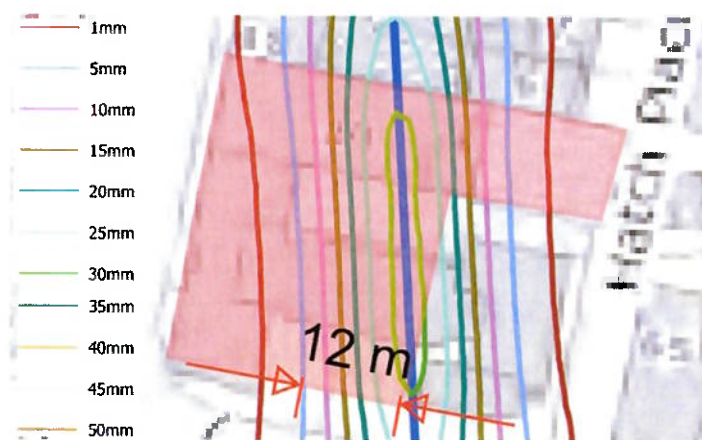
Figure 10 Plan of Cadenza with TII predicted ground settlement. Max. settlement is now predicted as 19.45mm

The new document 'Addendum to the EIAR – Downward Tunnel Realignment: St Stephen's Green Station to Charlemont Station (P01 06.03.2024)' indicates a revised settlement of maximum 19.45mm. Settlements of this magnitude cannot be accommodated by the building's facades. Such settlement, particularly if introducing differential settlement between columns, will cause damage.

From the published response received from TII, we understand they will be reviewing in more detail, the potential for ground settlement. The notes below are intended to assist TII in understanding the effect ground settlement could have on the facades at Cadenza. As there is risk of damage from the action of tunnelling and the subsequent settlement of the ground, we recommend the façades on Cadenza are monitored prior to the TBM arriving, during the TBM tunnelling under the building and for a period afterwards in order to fully understand and see in real-time the deformation of the facades and ensure against damage.

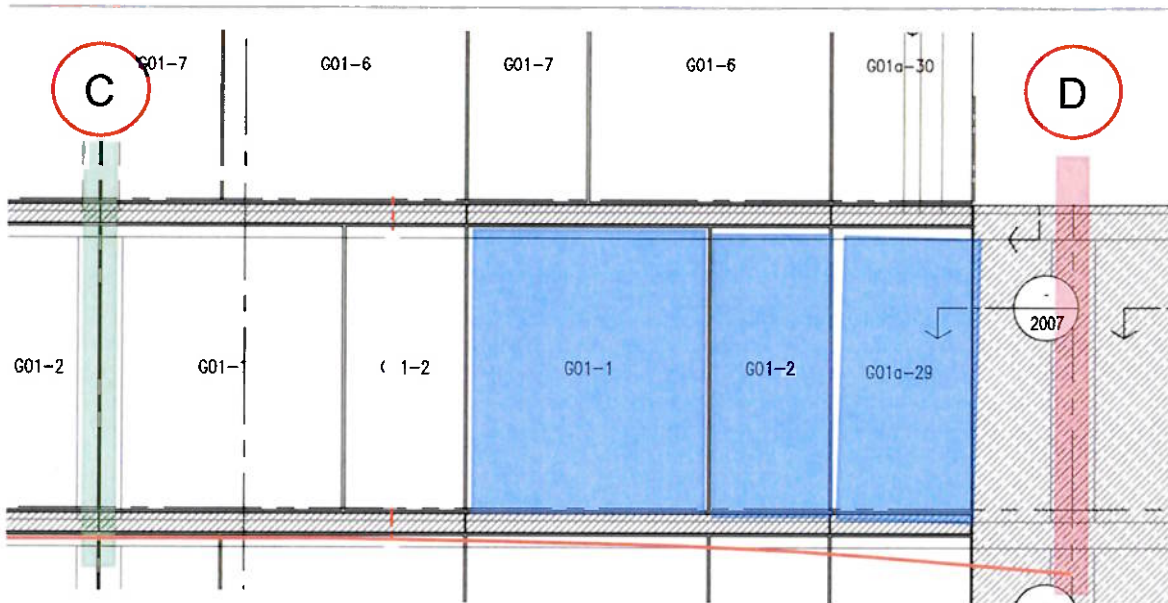
Due to the aspect ratio of the panels closest to gridline D on the South elevation, the TII predicted differential settlement of 19.5mm from Gridline C to D would result in 1.75m wide panels rotating in plane not less than 2.8mm at their base. As each panel is 3.5m tall this translates into 5.3mm rotation at the top corner of the panel. Such rotation would exceed the design parameters of the structural sealant at the glass to glass joint crushing and tearing the sealant and inducing stress in the glass. It may not cause breakage but will apply long-term stress into the structural sealant joint which may cause failure of the structural connection.

Figure 12 EWS-001 glass rotating due to differential settlement of one column (South elevation)

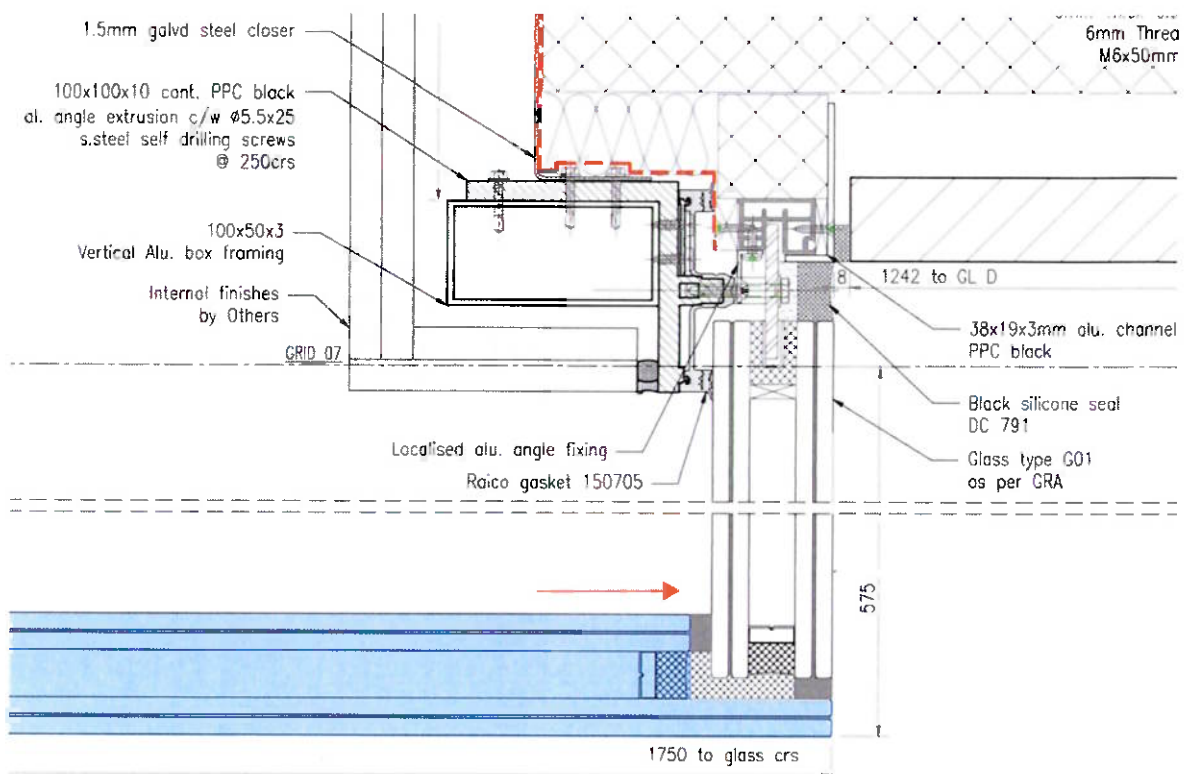
- 1) The window wall system EWS-001 is susceptible to damage, breaking glass, if there is differential deflection of the primary structure at one column. The worst-case condition is at the South-East corner where there is a glass to glass corner. This is likely to be over-stressed if the predicted ground settlement occurs (19.45mm).
- 2) The stone veil EWS-002 which is suspended from Level 05 slab is susceptible to damage, over-stressing of bracket assemblies, and possible stressing of stone if there is differential deflection of the primary structure at one column. The worst-case condition is on the South-East corner. The stone veil steel sub-structure will suffer stresses outside of its original design intent.

Figure 13 EWS-001 Plan view, glass-to-glass corner condition adjacent to Gridline D, South elevation.

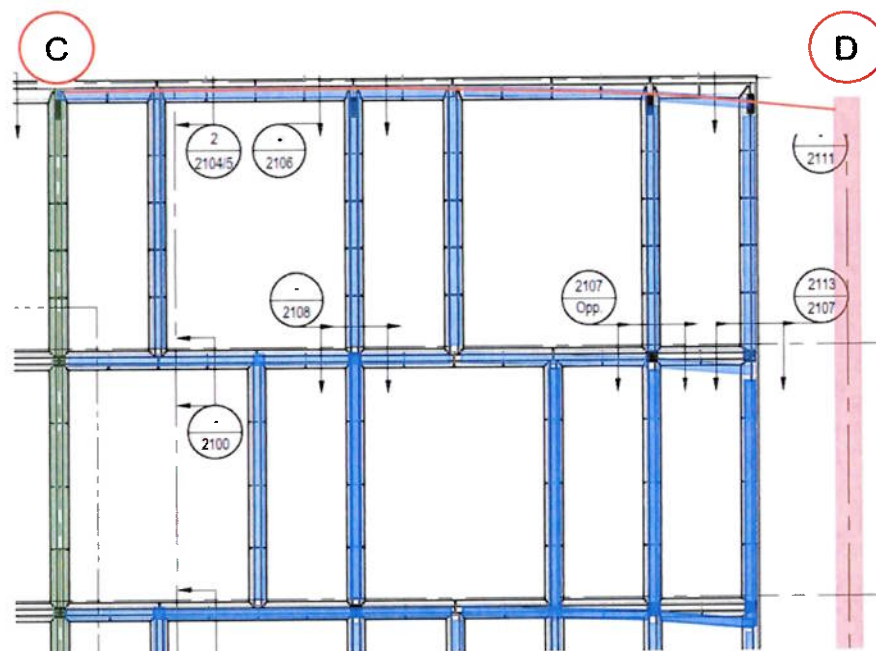
Figure 17 EWS 002 partial South elevation. Differential settlement of structure at Gridline D

The differential settlement of a column causes rotation of the connection between horizontal and vertical veil elements. These connections are typically formed with countersunk fixings tapped into a block of stainless steel. These connections were not designed to accommodate significant rotation. Detailed analysis would be required to determine how these connections react and

whether the horizontal beams of the veil would rotate at these connections or be forced to go into bending ('S' shaped bend on elevation). If over-stressed the connections could fail.

If the horizontal beams or vertical mullions go into bending due to differential settlement, this could cause over-stressing of the fixings in the stone exceeding permissible safety factors and/or causing cracking of the stone.

In a worst case scenario this could result in pieces of stone falling onto the public pavement below.

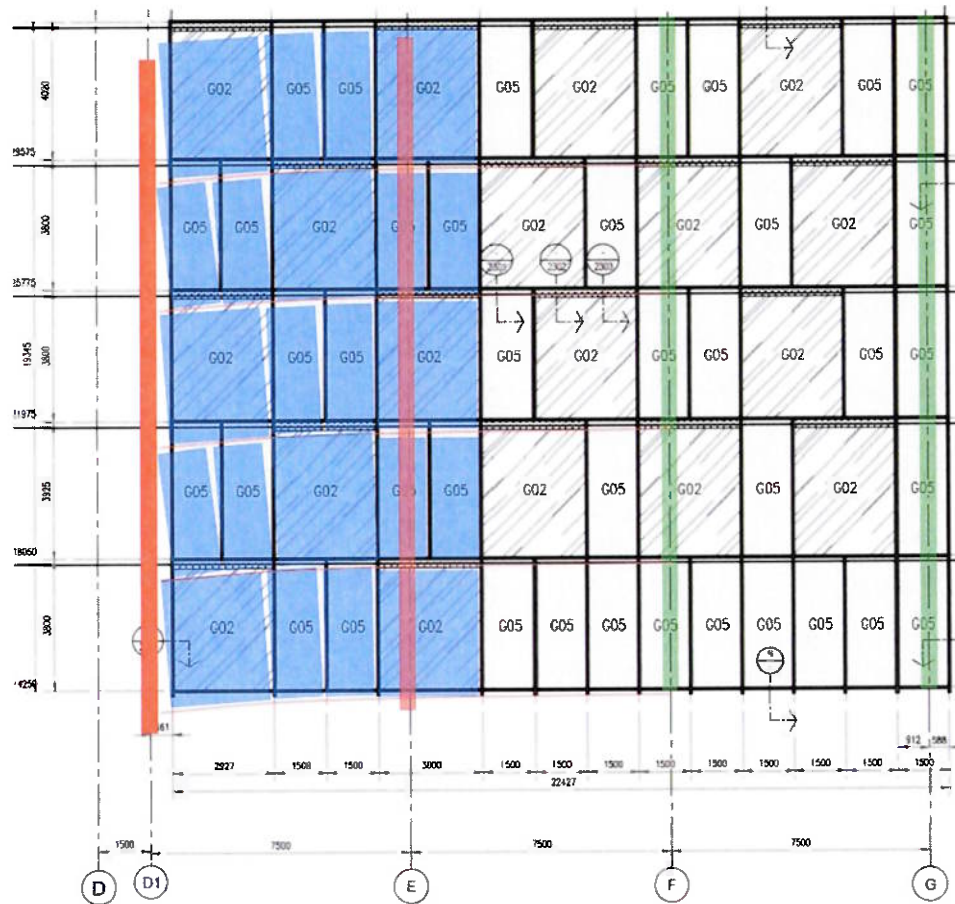
Figure 19 EWS-003 South elevation. Deformation due to ground settlement

The curtain wall system has very little capacity for racking of the glass on elevation. When the structure moves differentially as per the diagram above, the mullions remain vertical and the transoms rotate in plane. As each glass unit sits on a transom, the glass rotates with the transom. Based on the TII EIAR addendum there is approximately 19.5mm of differential settlement across quite a small width of approximately 10m.

Due to the aspect ratio of the panels closest to gridline D1 on the South elevation, and along the Eastern elevation, the TII predicted differential settlement of 19.5mm in this area would result in 1.5m wide panels rotating in plane not less than 2.9mm at their base. As each panel is 3.8m tall this translates into 7mm rotation at the top corner of the panel. The toggle glazed system does not have capacity for this degree of movement. The mullion detail below shows the proximity of glass to metal. If the glass rotates too far, the inner glass impacts the aluminium mullion profile causing breakage. The design gap, including glass tolerances and installation tolerances would be estimated as between 2mm and 6mm.

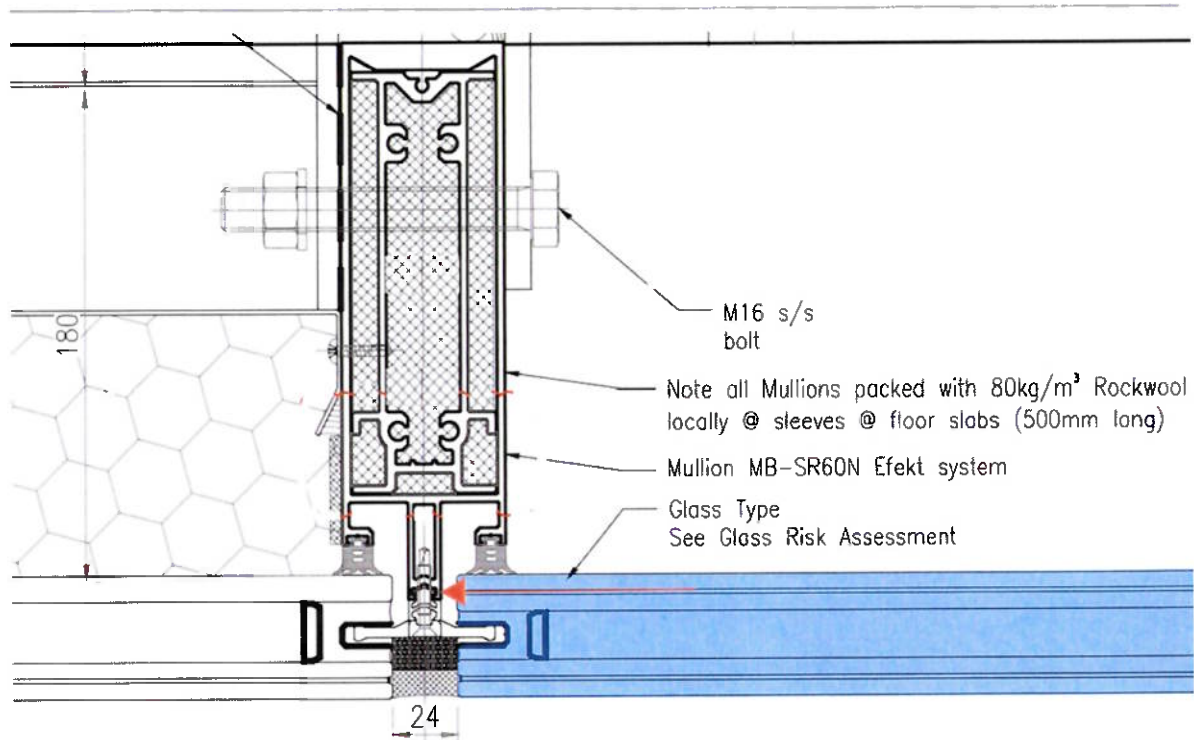
Figure 20 EWS-003 Plan section of glass to mullion interface.

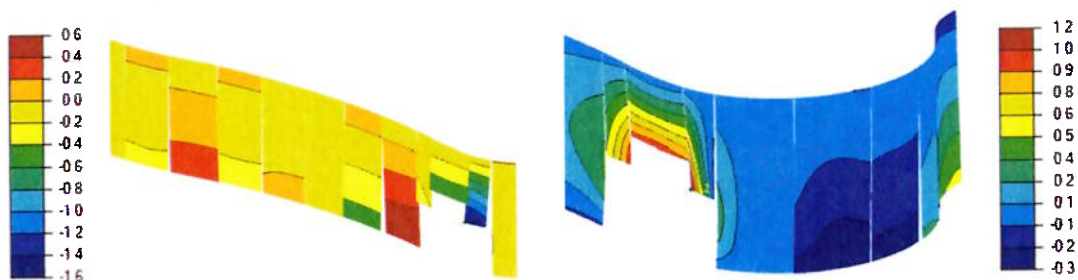
The differential deflection of the slab due to the design loads has been reviewed, and the in-plane rotation/deflection of each individual panel plotted. Although the worst case vertical displacement is on the South, the worst-case rotation due to differential deflection across the width of a single panel, occurs on the West elevation. This is illustrated in the diagram below.

Figure 25 EWS-006 Horizontal displacement due to vertical deflection of Level G slab.

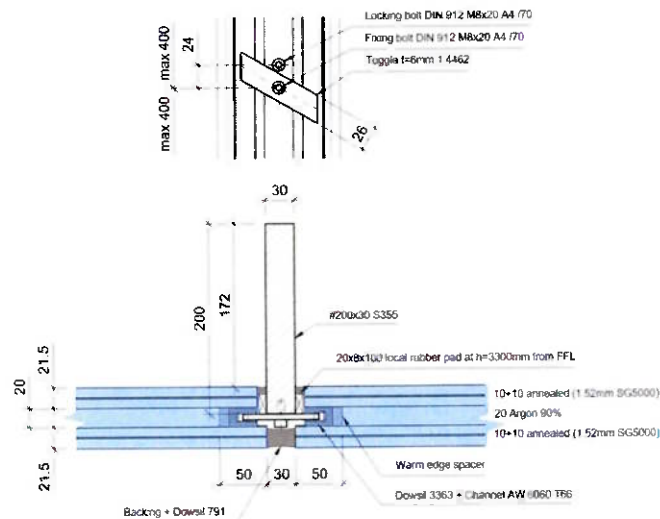
The glazing system has vertical fins between each double glazed unit. The fin is intended to provide resistance to wind load but has limited capacity to resist lateral in-plane loads. As can be seen in the diagram below, **should the glass restraint at the head fail and the glass rotate in plane, there is a high risk the perimeter internal silicone seal would be crushed resulting in glass to metal contact.**

Figure 28 EWS-600 Plan detail of glass to glass joint with steel fin

Should settlement due to MetroLink works cause the Level G slab deflect more than anticipated in the current design, it is possible the permissible long-term shear load in the structural silicone at the head detail will be exceeded. If the head restraint were to fail, allowing the panel of glass to rotate in plane (along the elevation), there is a high risk of glass breakage due to metal to glass contact and/or glass to glass contact.
