**Project Metrolink Railway Order  
Estuary to Charlemont via Dublin Airport  
(ABP-314724-22)**

Statement of Evidence

Tunnelling Induced Ground Movements & Building Damage Assessment for the  
**Cadenza Building**, Earlsfort Terrace, Dublin 2

**Lowered Tunnel Level**

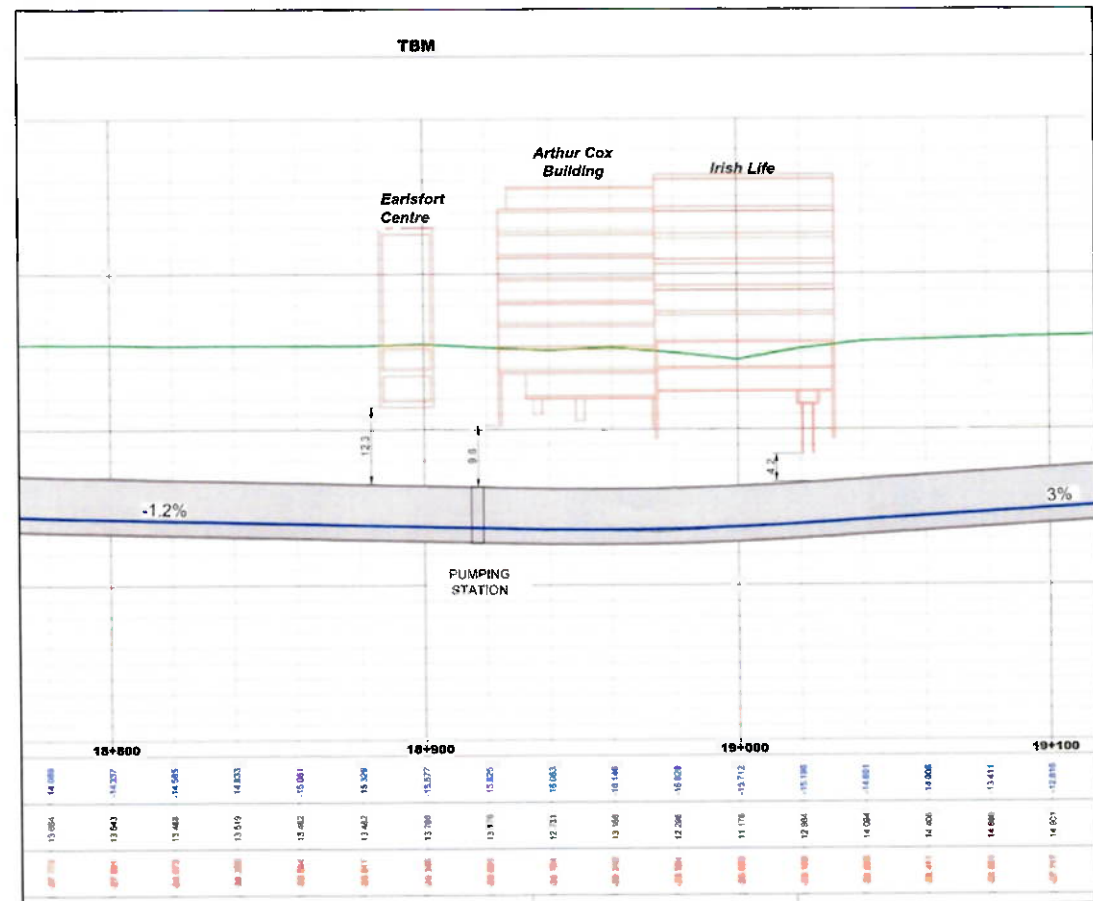
- Drawing No. ML1-JAI-RTA-ROUT\_XX-DR-Y-01027 (Rev.P02)
- Lowered tunnel alignment below Arthur Cox & Cadenza Buildings
- Avoids Anti-Flotation Anchors
- Increased Clearance below secant pile wall and foundations (10-15m)
- EIAR Addendum does not state that proposed LoD apply at this level and that upward LoD of +1.0m from this level will not be implemented.
- Stated at Oral Hearing (4/3/2024)

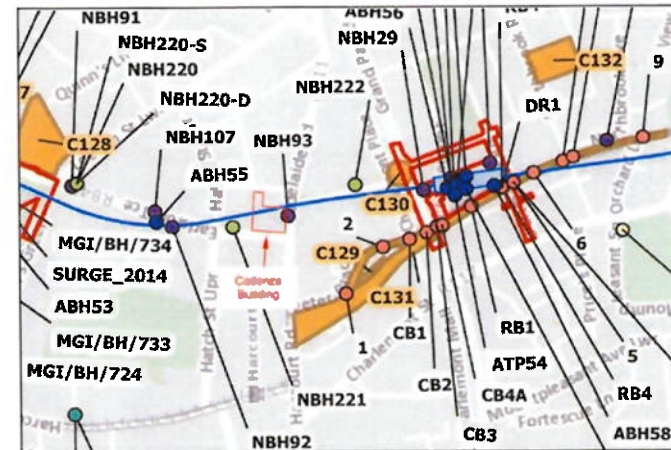
Figure 4-1 Site Investigation Location Plan [from Figure 20.6 (Sheet 7 of 8) in Chapter 20 of the ELAR]

- The boreholes show a similar but higher profile for the competent rock level compared to MetroLink Geotechnical Profile.

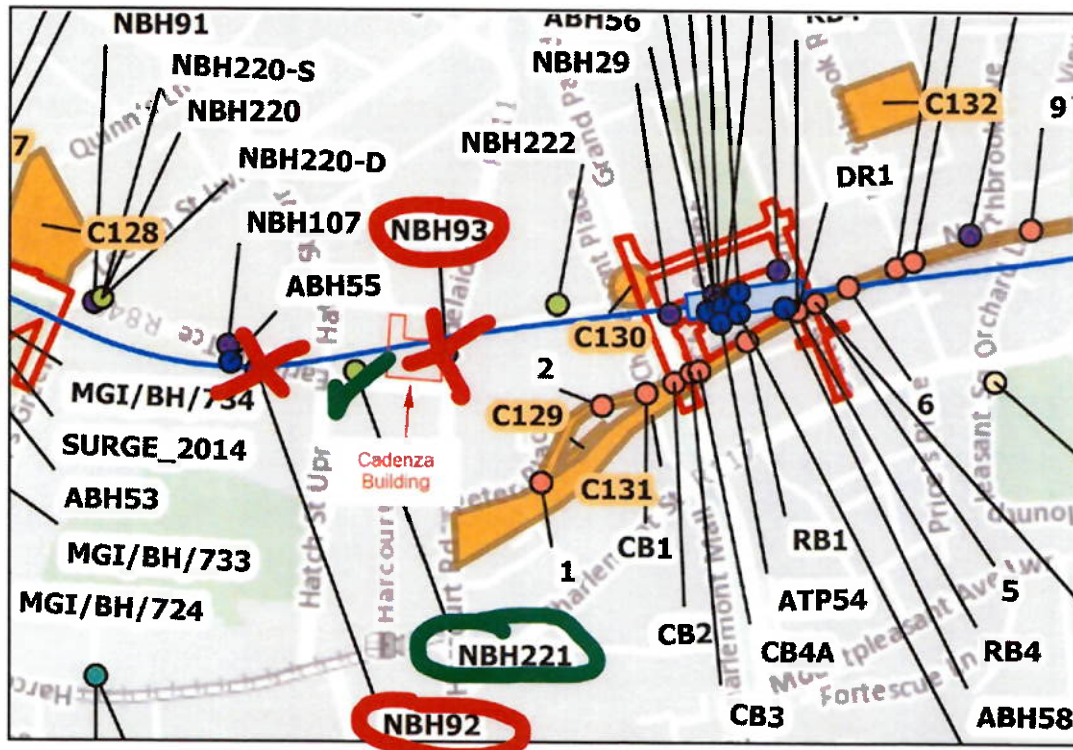
Figure 4-1 Site Investigation Location Plan [from Figure 20.6 (Sheet 7 of 8) in Chapter 20 of the EIAR]

- NBH92 & NBH93 do not exist
- Borehole NBH-221 only Metrolink SI data relevant to Cadenza Building.
- SI Location plan in the EIAR should be updated (Ch. 20)

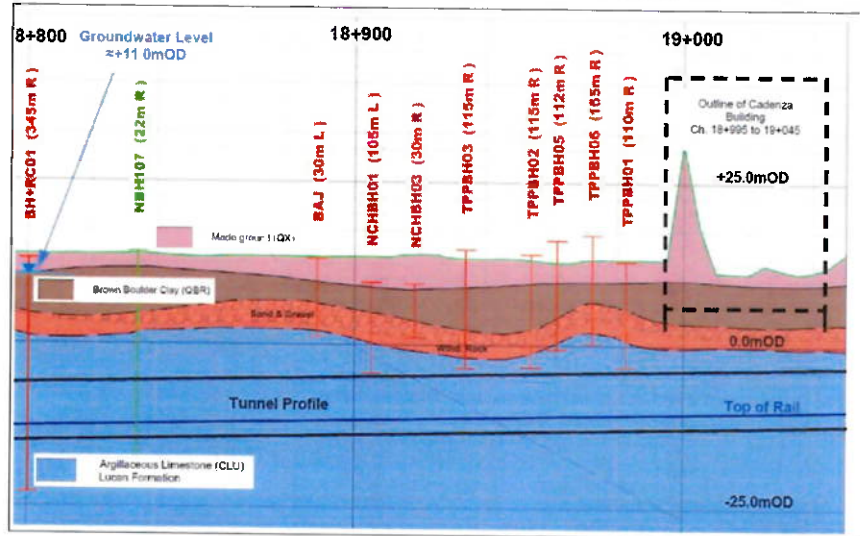
- Geological Profile in Appendix A20.9 of the EIAR shows rock at **+0.0mOD** under Cadenza Building & between **- 2.5mOD** and **+2.0mOD** under Arthur Cox Building.
- Top of competent rock at **+6.25mOD** in Borehole NBH-221
- Geological profile in EIAR is incorrect and should be updated to reflect actual rock levels - Relevant to further Phase 3 assessment and construction monitoring
