Appendix 12.1

Hydrology Field
Observations

Hydrology Field Observations Shancloon Wind Farm

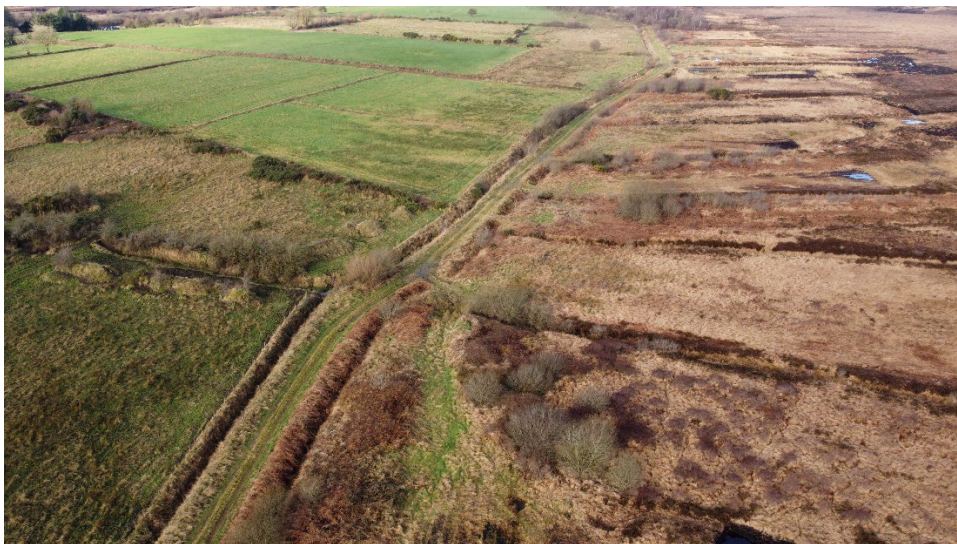
Figure 1: *Example of drainage network associated with cutover bog habitat*

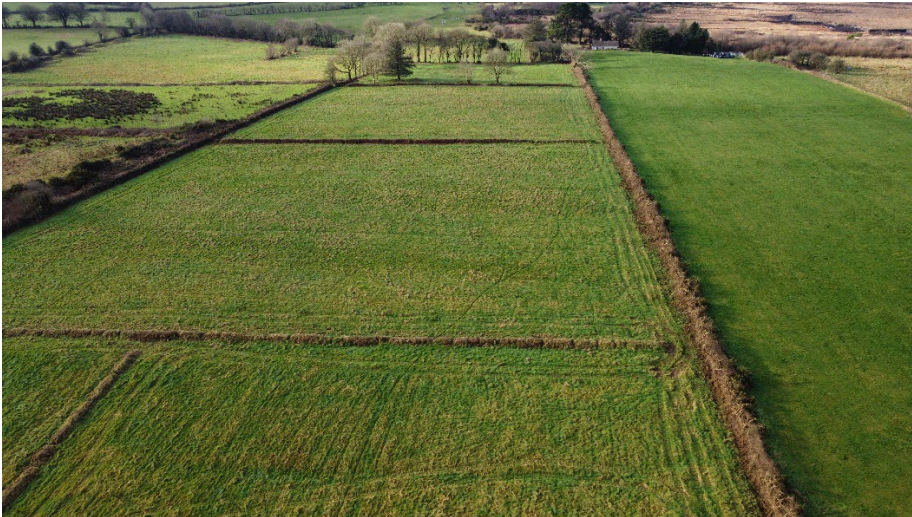
Figure 2: *Example of drainage network associated with agricultural grasslands*

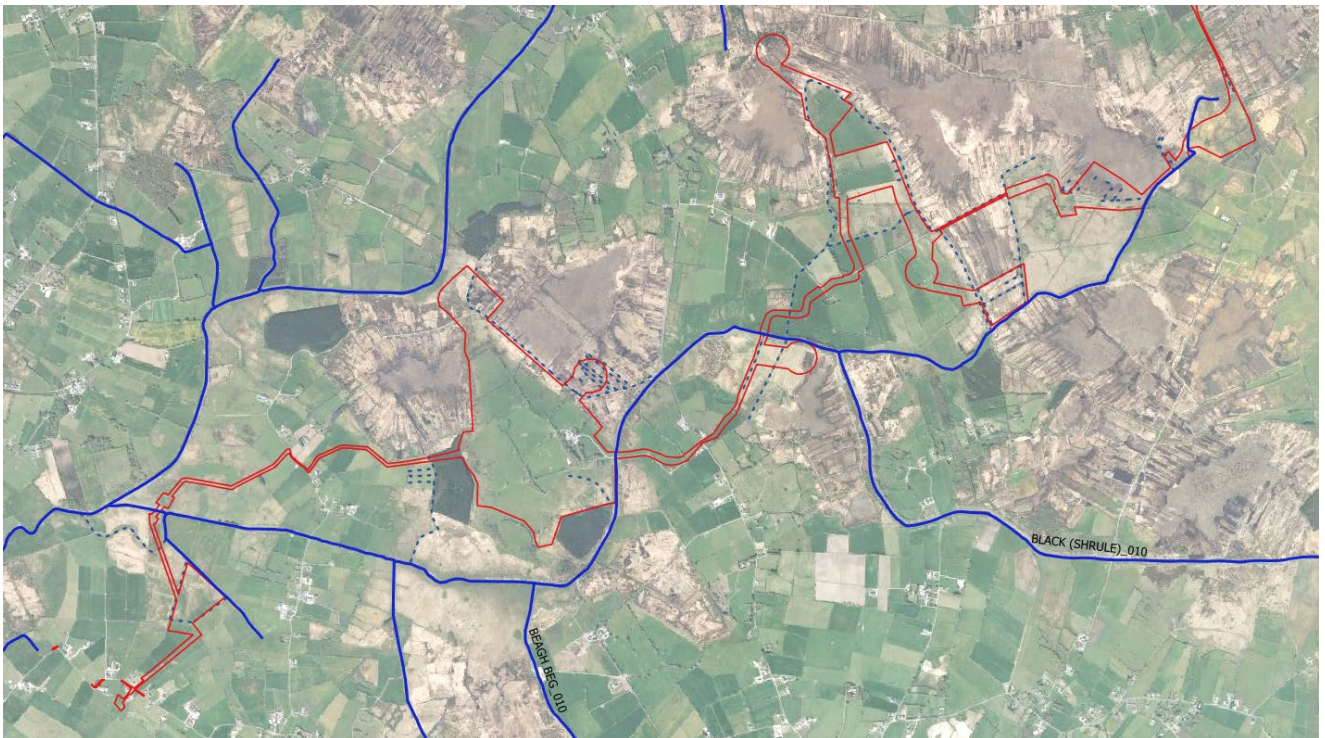
Land and bog drainage flow direction within the Site is towards the BLACK (SHRULE)_010 (Togher) river (see Figure 3).

Figure 3: *Existing land drainage on site*

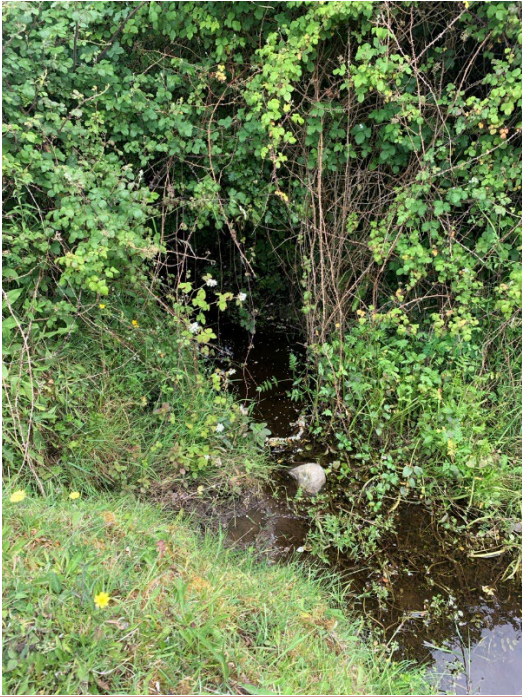
| Watercourse Crossing Ref | ITM Coordinates | | Width at Base (m) | Width at top of bank (m) | Bank Height (m) | Depth of Water (m) | Type of Crossing | Site Photos |
|---|---|---|---|---|---|---|--|---|
| CV03 | 533228.5454 | 754414.8103 | 1.42 | 2.8 | 1.8 | 0.62 | Upgrade existing farm access piped culvert on land drain | |

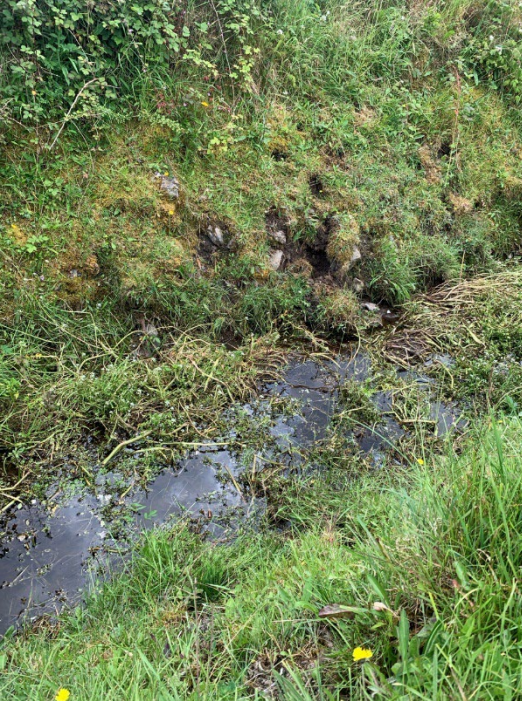
| Watercourse Crossing Ref | ITM Coordinates | | Width at Base (m) | Width at top of bank (m) | Bank Height (m) | Depth of Water (m) | Type of Crossing | Site Photos |
|---|---|---|---|---|---|---|--|---|
| CV04 | 533543.7619 | 754815.8888 | 0.8 | 4.1 | 1.5 | 0.44 | piped culvert on land drain | |

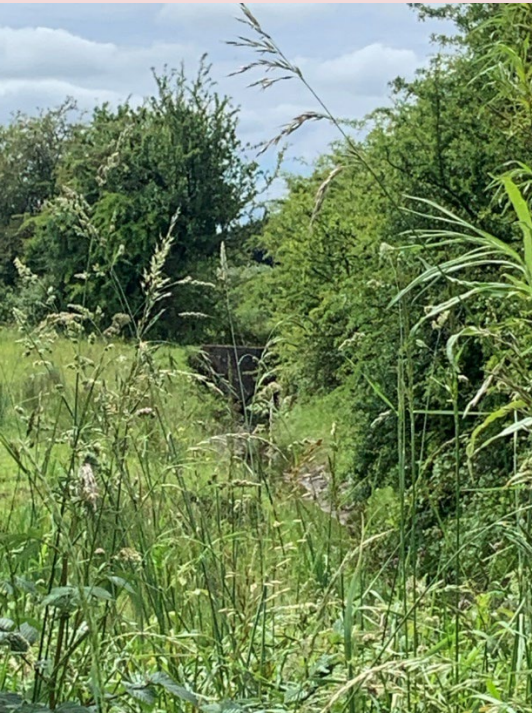
| Watercourse Crossing Ref | ITM Coordinates | | Width at Base (m) | Width at top of bank (m) | Bank Height (m) | Depth of Water (m) | Type of Crossing | Site Photos |
|---|---|---|---|---|---|---|--|--|
| CV06 | 533874.0242 | 754968.9821 | 1.14 | 3.64 | 1.53 | 0.48 | Upgrade existing farm access piped culvert on land drain | |

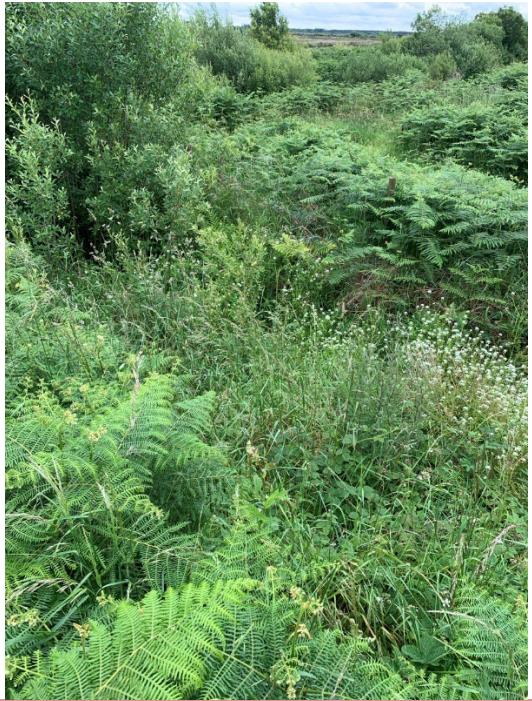
| Watercourse Crossing Ref | ITM Coordinates | | Width at Base (m) | Width at top of bank (m) | Bank Height (m) | Depth of Water (m) | Type of Crossing | Site Photos |
|---|---|---|---|---|---|---|--|--|
| CV07 | 534245.0059 | 754535.1195 | 0.54 | 2.87 | 0.8 | 0.35 | piped culvert on land drain | |

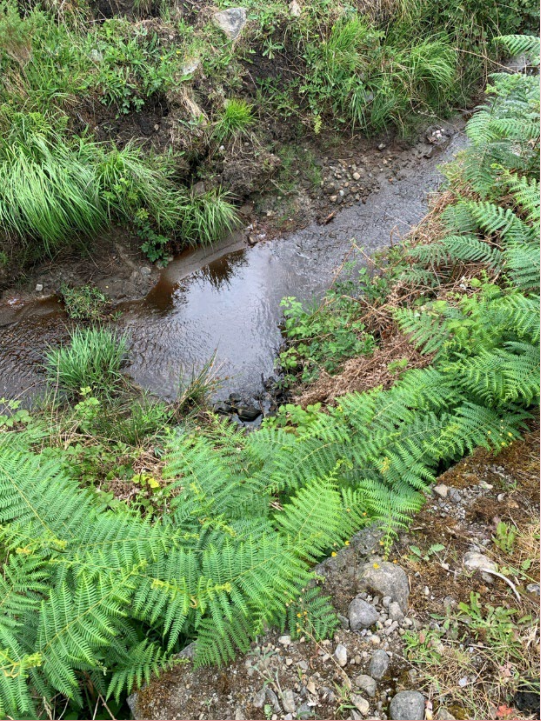
| Watercourse Crossing Ref | ITM Coordinates | | Width at Base (m) | Width at top of bank (m) | Bank Height (m) | Depth of Water (m) | Type of Crossing | Site Photos |
|---|---|---|---|---|---|---|---|--|
| CV08 | 534419.3487 | 755076.0733 | 0.78 | 3.5 | 1.82 | 0.38 | pipcd culvert on land drain | |

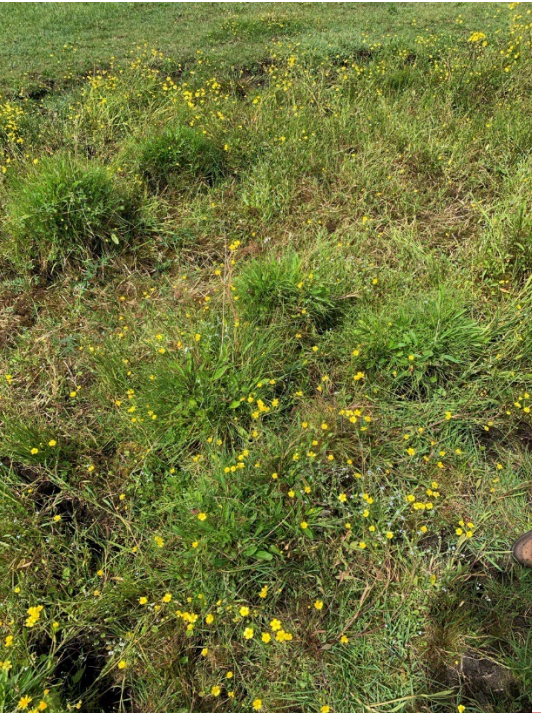
| Watercourse Crossing Ref | ITM Coordinates | | Width at Base (m) | Width at top of bank (m) | Bank Height (m) | Depth of Water (m) | Type of Crossing | Site Photos |
|---|---|---|---|---|---|---|---|--|
| CV09 | 534699.8902 | 755083.9407 | 0.51 | 0.51 | 0.1 | 0 | pipcd culvert on land drain | |

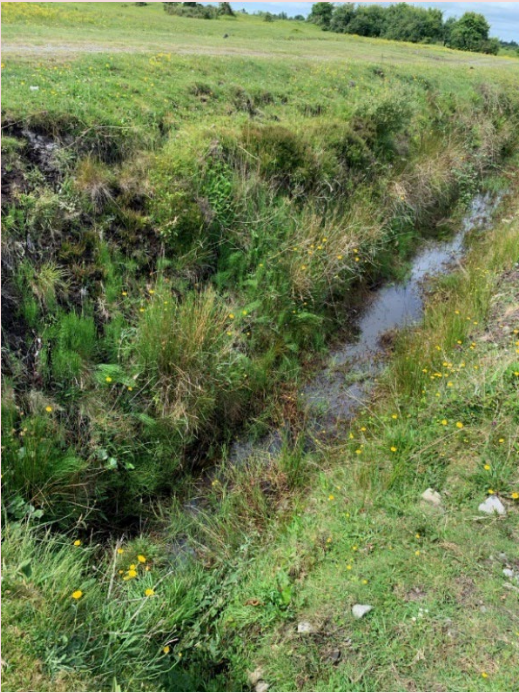
| Watercourse Crossing Ref | ITM Coordinates | | Width at Base (m) | Width at top of bank (m) | Bank Height (m) | Depth of Water (m) | Type of Crossing | Site Photos |
|---|---|---|---|---|---|---|--|--|
| CV10 | 534787.3713 | 755074.1173 | 1.2 | 1.2 – 4.5 | 0.2 | 0 | pipd culvert on land drain | |

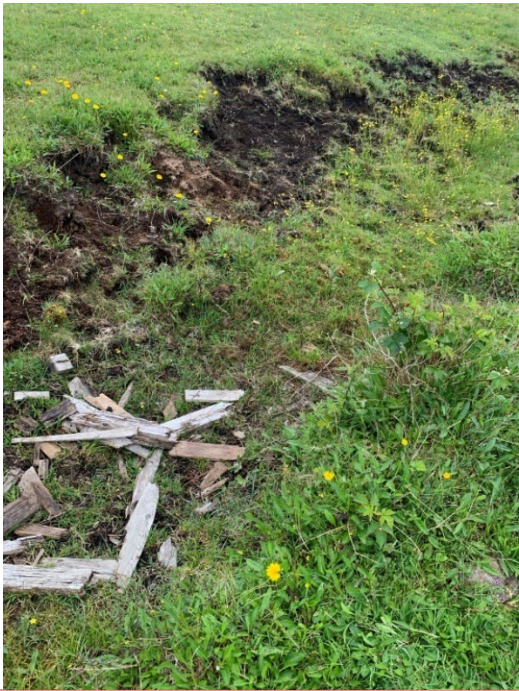
| Watercourse Crossing Ref | ITM Coordinates | | Width at Base (m) | Width at top of bank (m) | Bank Height (m) | Depth of Water (m) | Type of Crossing | Site Photos |
|---|---|---|---|---|---|---|--|--|
| CV11 | 534764.4714 | 755050.5955 | 1.27 | 4.07 | 1.25 | 0.42 | pipd culvert – replace existing 600mm diameter culvert on land drain | |
