# Geotechnical Karst Risk Assessment

Document Ref. 22098-R-03-02

Project Title Cooloo Wind Farm

Date 19/09/2025

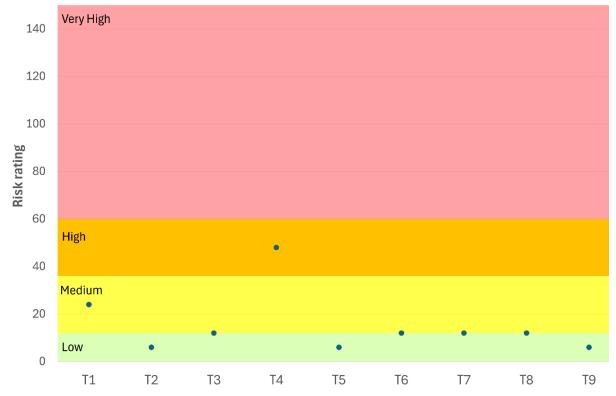
Figure 5-1: Karst hazard at each turbine location.

The assessment findings showed that the majority of the proposed infrastructure locations are located in areas of low to medium karst hazard, with additional localised areas of high and very high hazard identified. One turbine (T4) was identified as being located in an area of high karst hazard, with a section of the access track immediately north of T4 also being classified as having a high karst hazard. Areas identified as being of very high karst hazard within the Proposed Wind Farm site do not interact with any of the proposed infrastructure footprint.

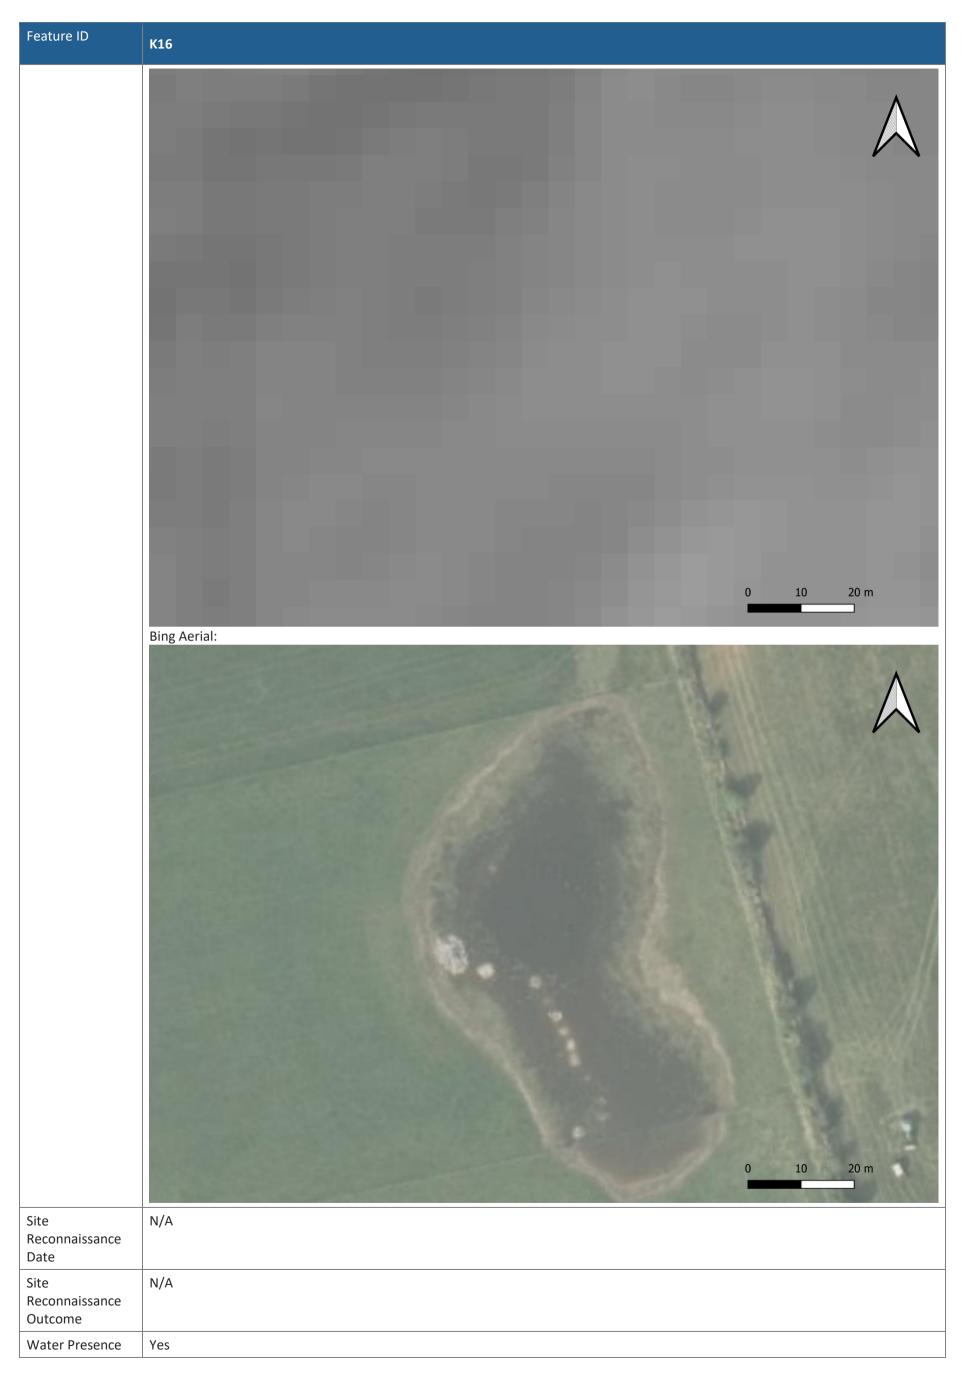
**Table G-16: Site Reconnaissance at Karst feature K16**

Feature ID	K16
Feature Type	Enclosed Depression
Coordinates	E:556060, N:748231
Source	GSI
Imagery	DTM:

Feature ID	K16
Additional Information	Described by GSI as an enclosed depression, however, this feature appears to hold significant amounts of water, and is recorded in the GSI historic groundwater flooding database. It is therefore considered as a possible turlough.
Site Photos	N/A
