Preliminary Design Report Addendum (TII Departure No. 36213)

N2 Road, Ardee (Ardee 2040 Regeneration Project)

Title: STAGE 2 ROAD SAFETY AUDIT

VERSION: March 2025 Addendum FINAL (28-3-2025)

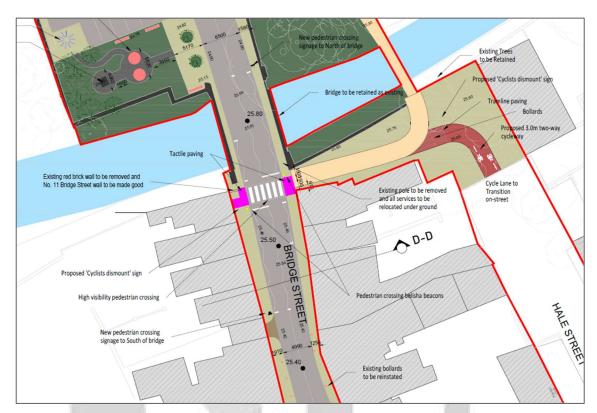
Figure 1: Extract from Proposed Site Layout

- 7. The following summarises the characteristics of the proposed amended design. The amendments relate to the portion of the proposed development located on / to the south of the existing bridge at Bridge Street (see **Figure 1**):

- The raised table has been removed from the proposed design. The proposed road at this section of the proposal will have a standard kerb height of 125mm. This will ensure the structural integrity of the existing bridge is not impacted and improve safety for pedestrians crossing the bridge through the inclusion of a vertical change between the public road and footpath.

- The proposed high visibility pedestrian crossing will be realigned to be perpendicular to the footpath and will be accessed via a dropped kerb. Tactile paving is positioned on either side of the crossing. Belisha beacons are proposed on both sides of the crossing to ensure that approaching vehicles are aware of the crossing.

- It is proposed that the existing brick wall adjacent to no. 11 Bridge Street will be removed and the wall of no. 11 Bridge Street made good.
 - The existing wall to the south west corner of the bridge (protected structure), adjacent to the access to the riverside walk, will remain unaltered. The removal of the adjacent brick was will provide an opening width of approx. 1.36m. The existing opening width is 0.96m therefore the proposed layout will improve the existing situation.

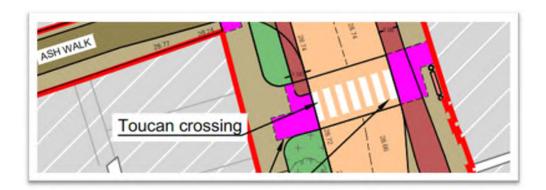
The northbound cycle track commences within the L-shaped tactile paving. This area should be shared use and access to the push buttons should be available. The Zebra type road markings should not be provided at toucan crossings as priority may be confusing. A lack of clarity could lead to collisions between vulnerable road users and passing traffic.

It is recommended that a standard layout toucan crossing be provided.

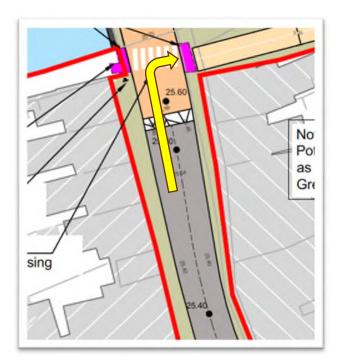
There is no provision for northbound cyclists to exit the N2 and wait to cross the signalised crossing. Cyclists will therefore continue travelling northbound on the Main Street carriageway thereby increasing the risk of collisions with general traffic. A proposal to direct cyclists via Hale Street was suggested in the Feedback Form of the Stage 1&2 Road Safety Audit. That proposal does not appear to be included in this design update.

It is recommended that a transition from on-road to off-road be provided for cyclists.

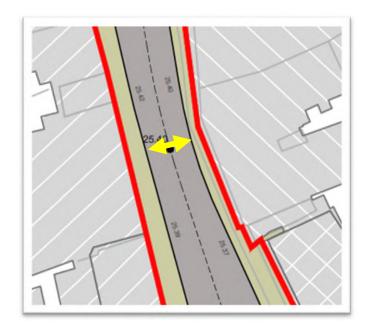
Problem

There is a pinch point in the carriageway south of the bridge. Wide vehicles currently operate an informal shuttle system to pass each other. This may not be possible with the introduction of the new crossing as vehicles may be stuck in position while queuing at the signals. This could lead to side-swipe collisions, damage to bollards and mounting of the footpath. It is noted from the site visit that queuing on the N2 is common for long periods of each day. (It was observed during the most recent site visit that flexible bollards in the footpath at this location have been struck many times and have collapsed)

It is recommended that an analysis be carried out of the likelihood of queues at the pinch point and the possible need for a longer formal shuttle system.

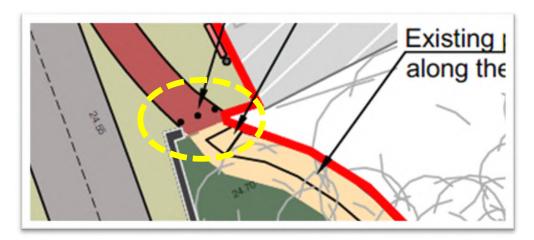
Problem

The two-way cycle track leads to a shared use area on approach to the bridge. Pedestrians have no area to join the shared use area. This could result in pedestrians crossing the road bridge which has a very narrow footpath and pedestrians would be subject to wind forces from heavy goods vehicles possibly leading to loss of balance.

It is recommended that an area be provided for pedestrians to access the pedestrian bridge.

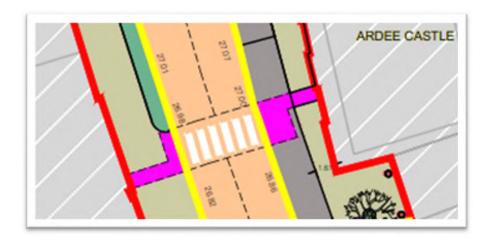
The pedestrian crossing at Ardee castle has a two-way cycle track on the eastern side. A lack of warning could lead to blind or partially sighted pedestrians not realising they are sharing space with cyclists.

It is recommended that a well-defined shared area be provided with suitable ladder and tramline tactile paving at either side. This applies to other similar crossings throughout the scheme.

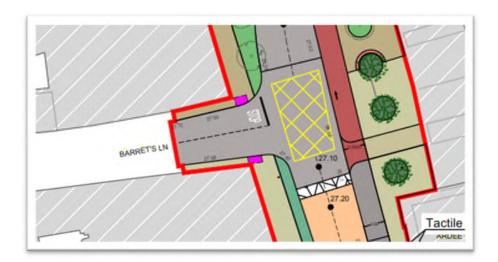
The N52 is a national secondary road which is proposed to bypass Ardee in the future as part of a separate scheme. There is however no guarantee that this scheme will progress and a high volume of HGVs will continue to use the N52 if this scheme progresses. Although the N52 junction is being built out from its current layout it is unclear if HGVs will be able undertake the turning manoeuvres from and to the N2 in both directions. A lack of space would lead to overrunning of the footpaths, cycle track or side swipe/head -on collisions with other vehicles.

It is recommended that a swept path analysis be carried out for HGVs to ensure that turning manoeuvres can be undertaken. If this cannot be achieved a signalised junction may be required.

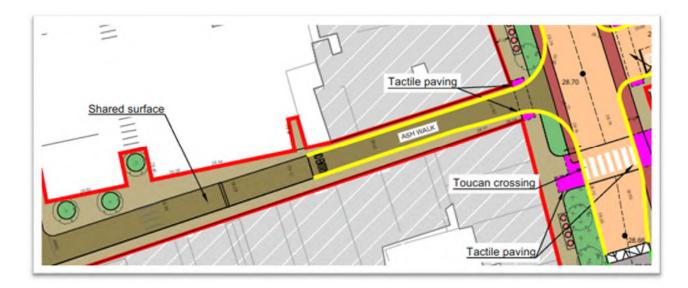
Ask Walk is shown to be a 'Shared Street' It is unclear what distinguishing features or what signage will be provided to indicate this to users, especially drivers, as they enter this area. It appears that the footpaths are to be retained beyond the initial section from the N2 which does not signify a shared street but segregated facilities for pedestrians. A lack of clarity can lead to drivers presuming priority resulting in collisions.

It is recommended suitable details be provided to denote a 'shared street' at its transition from the N2.

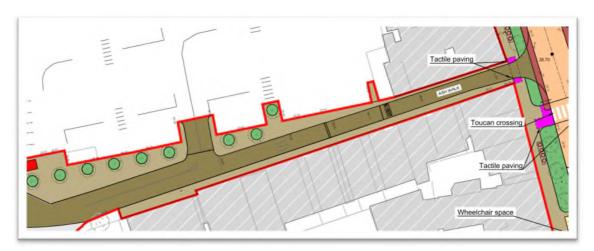
Ash Walk is relatively long and straight and one-way. This could lead to high vehicle speeds. High speeds leads to high injury severity if a vulnerable road users is struck by an errant vehicle.

It is recommended that traffic calming be provided along Ash Walk. (It is unclear if an existing raised table is to be retained)

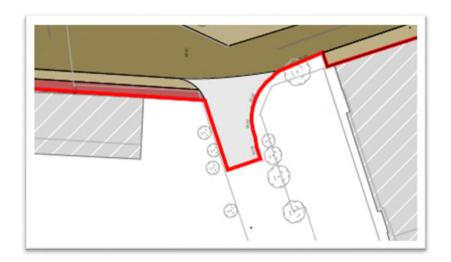
The link road to the N52 from Ash Walk is not shown to be a shared street. A change of street type could increase the risk of collisions with vulnerable road users.

It is recommended that that consistency in street type be provided or that a suitable transition be provided.

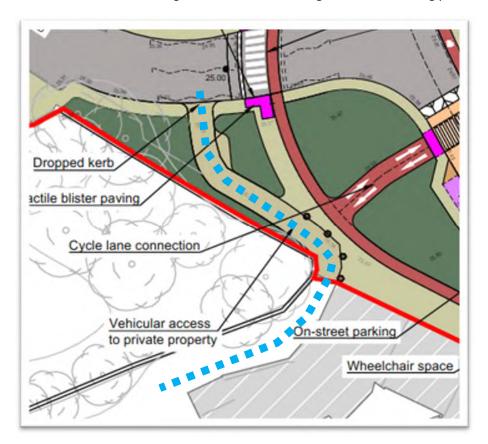
The vehicular access to the car park of the bar at the junction of Golf Links Road is for a single vehicles only. Drivers entering the route will not have inter-visibility to drivers leaving which could lead to reversing onto Golf Links Road resulting in collisions with through traffic or crossing pedestrians.

It is recommended that a passing bay be provided. Depending on the amount of usage this lane may need to be segregated from the pedestrian route.

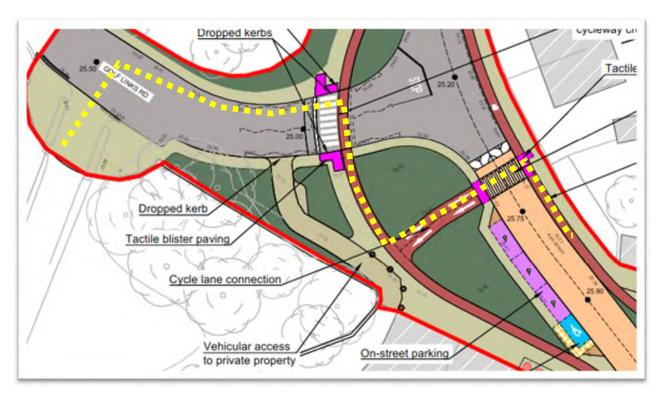
A two-way section of cycle track is proposed to allow cyclists access the southbound cycle track. There is however no link for cyclists coming from Golf Links Road to do so. The new developments on the St. Joseph's site will generate cyclists movements that are not catered for. A lack of facilities will lead to cyclists travelling contra flow on the northbound cycle track which would increase the likelihood of collisions with other cyclists.

It is recommended that a link to the southbound site be provided to avoid cyclists travelling contraflow on the northbound cycle track.

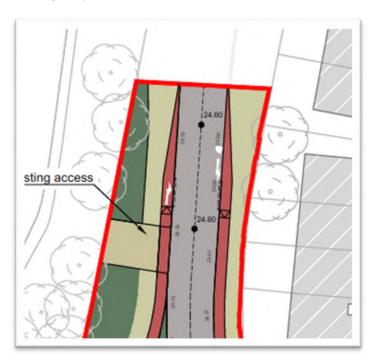
The northbound cycle track tapers gently from off-road to on-road. This could lead to cyclists entering the busy N2 without looking to see if traffic is approaching. This could lead to 'squeezing' and collisions especially as the N2 carriageway width has been reduced.

It is recommended that the cycle track be terminated with a jug turn type arrangement whereby cyclists will be perpendicular to traffic and will have to stop before entering the carriageway.

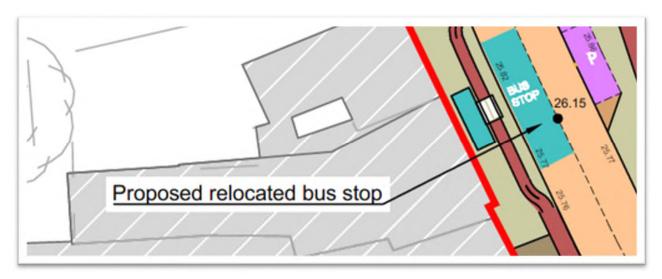
It is unclear what type of bus shelter is proposed at the relocated northbound bus stop. A full panel shelter could lead to a lack of space for pedestrians to pass leading to some pedestrians entering the cycle track where they would be at risk of being struck by passing cyclists.

It is recommended that a suitable type shelter be provided to avoid excessive restrictions in the footway.

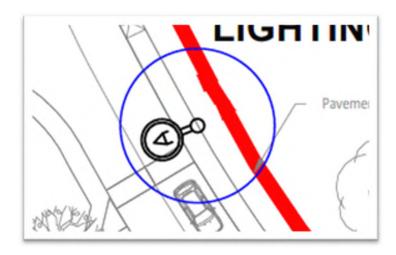
Some lighting column locations are shown on the boundary between the cycle track and the footpath. The columns would be hazards for both cyclists and pedestrians.

It is recommended that the columns be located to the rear of the footpath or in green areas.

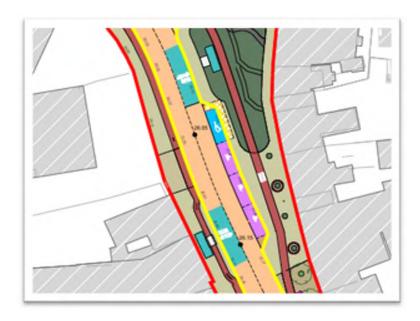
Flush kerbs are shown at the bus stops. This could lead to inaccessibility for some users resulting in loss of balance and falls.

It is recommended that kassel kerbs be provided at the bus stops with suitable transition gradients.

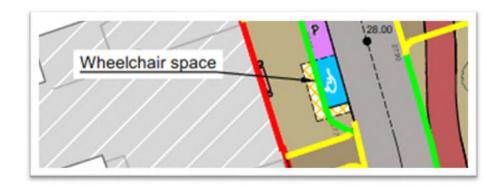
Full height kerbs are shown through the buffer zones of the disabled parking spaces. This could lead to inaccessibility, loss of balance, inability to use wheelchairs and to users entering the carriageway where they would be at greater risk of colliding with passing vehicles.

It is recommended that suitable kerbing and access to the footpath be provided outside the buffer zones.

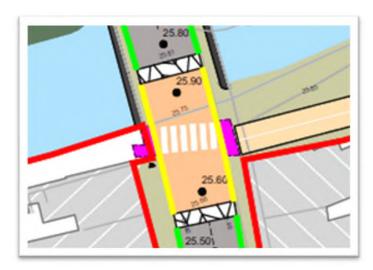
Flush kerbs are shown at the raised table partially over the river Dee bridge. A lack of kerb upstand will lead to no resistance to errant vehicle whose driver may loose concentration even at low sped resulting in a collision with the bridge parapet. This could lead to structural damage.

It is recommended that flush kerbs only be provided at the crossing point.

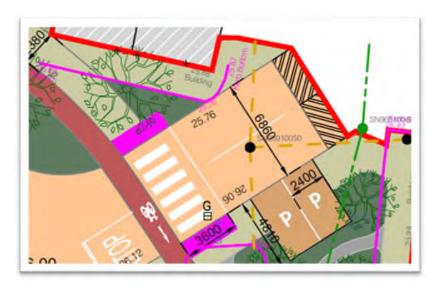
Gullies have not been provided upstream of each raised table and each pedestrian/cyclist crossing. This could lead to surface water ponding, loss of traction and loss of control in icy weather and slips and falls for vulnerable road users.

It is recommended that gullies be provided upstream of all raised area and crossing points to avoid surface water ponding.

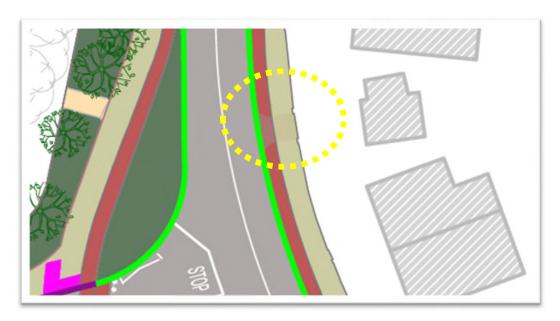
The drawing shows a 125mm high kerb at the proposed vehicular access to the private garage on the eastern side of the N2 just north of the Golf Links Road junction. A high kerb could lead to vehicles 'bouncing back' when trying to access the driveway to the garage resulting in rear-end collisions.

It is recommended that the kerb height be adjusted to facilitate vehicular access.

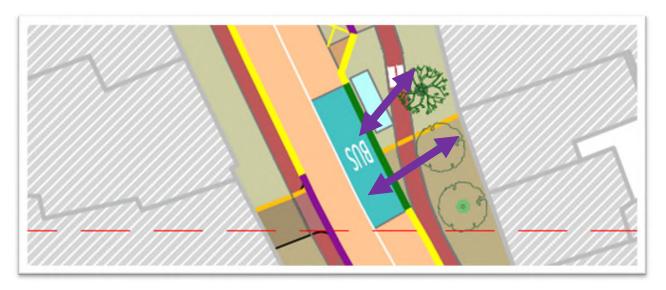
The location of the bus shelter between the bus stop and the pedestrian crossing of the cycle track does not appear to allow enough space for pedestrian movements from the footpath if the shelter will have back or front panels. This could lead to pedestrians crossing the cycle track away from the highlighted striped areas resulting in a higher likelihood of collision with cyclists who do not expect pedestrians to cross. Also, if passengers alight from the front of the bus there is very little space between where they will step out and the cycle track. This could lead to collisions with passing cyclists.

It is recommended that the layout be changed to provide adequate space for bus users without conflict with cyclists.

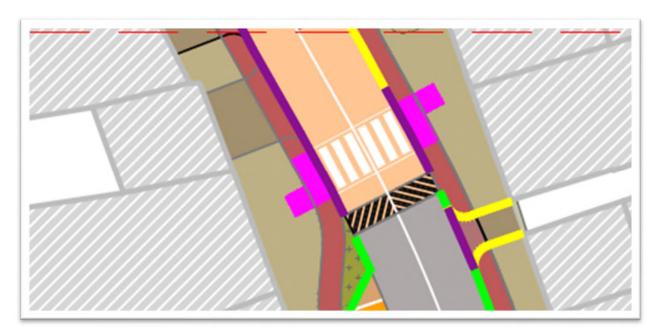
The tactile paving for the zebra crossing is within the cycle lane. It may not be clear to cyclists that pedestrians have priority as they approach the crossing. This could result in collisions between the two user groups.

It is recommended that a shared use area be developed at both sides of this zebra crossing and other similar crossings.

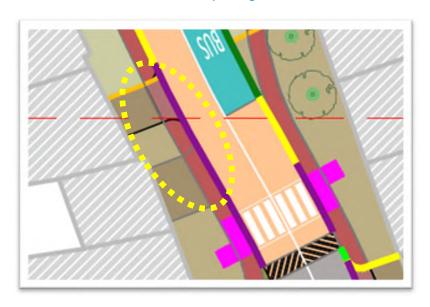
Flush kerbing is provided beyond the extents of the crossing areas at the zebra crossing. A blind or partially sighted pedestrian may inadvertently enter the carriageway if they cannot detect a level difference. This could result in collisions with passing vehicles.

It is recommended that flush kerbs only be provided at crossing points or access areas for pedestrians only.

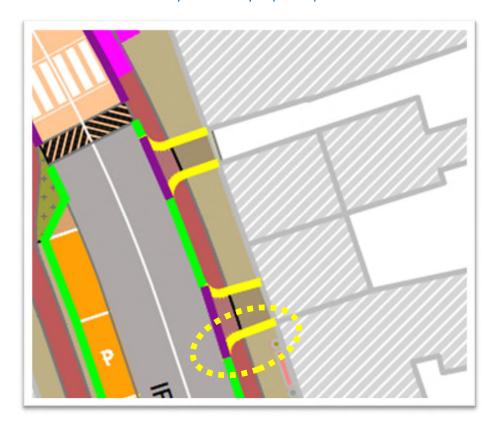
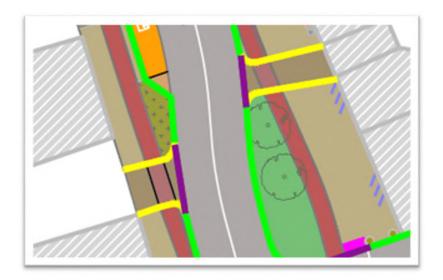
It is proposed to provide 50mm high kerbing at some accesses across the footpath. This would be a trip hazard and would lead to inaccessibility for mobility impaired pedestrians.

It is recommended that flush kerbs be used or no kerbs and that continuous footpath and cycle track facilities be used.

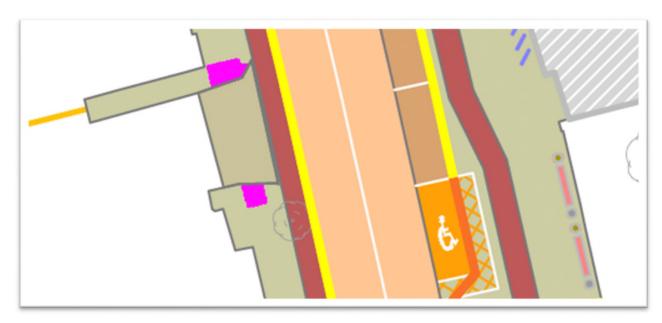
The tactile paving shown at the western side crossing does not match in extent on both sides. There is a risk that blind or partially sighted pedestrians may use the tactile paving as a guide to have completed the crossing however may not detect it is not provided directly across from the start. In addition, the shading for the uncontrolled tactile paving is shown the same as controlled tactile paving. It is assumed that this is just a draughting issue and that buff coloured tactile paving will be used at uncontrolled crossings.

It is recommended that the extent of the tactile paving be matched on both sides.

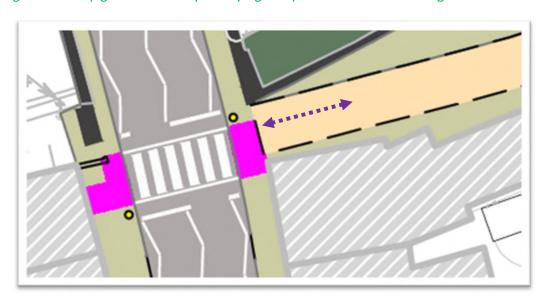
There is a slight misalignment of the extent of the tactile paving associated with the zebra crossing and the shared use path on the eastern side. However this may be required to ensure there is enough room for mobility impaired users to get around the belisha beacon pole. The shape of the tactile paving may be confusing and not help guide a blind or partially sighted pedestrian to the crossing.

It is recommended that a stem be provided on the tactile paving so that such vulnerable road users will know that it is a crossing where they have priority and the stem may be detected by those travelling on the shared use path.

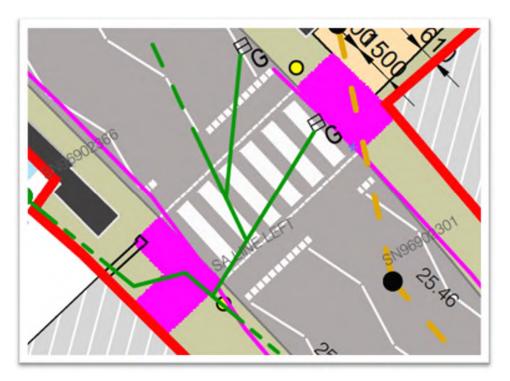
It is proposed to provide a road gully at the zebra crossing. This could lead to narrow wheels getting stuck or to those wearing narrow heels getting stuck and injured. There is also a risk that if the gully becomes blocked that surface water ponding will take place at the crossing location which could result in pedestrians crossing at another location where drivers do not expect or to slips and falls in icy conditions.

It is recommended that gullies be provided immediately upstream of the dropped kerb and not along the path of the crossing.
