Derrylea Road Arborist Report

Arboricultural Report

Project: Derrynadarragh Wind Farm

Underground Cabling

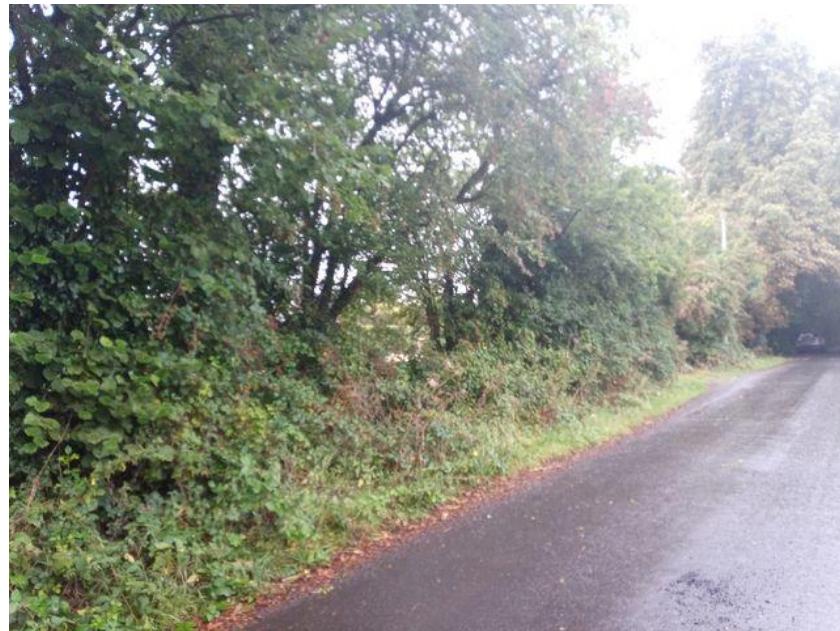
4.3 The road is flanked by hedgerows H001 (fig. 3) and H002 (fig. 4) at the southern extent for approximately 30 metres. A single mature ash T2008 is situated within H001.

Figure 3: H001 Hedgerow at southern extent.

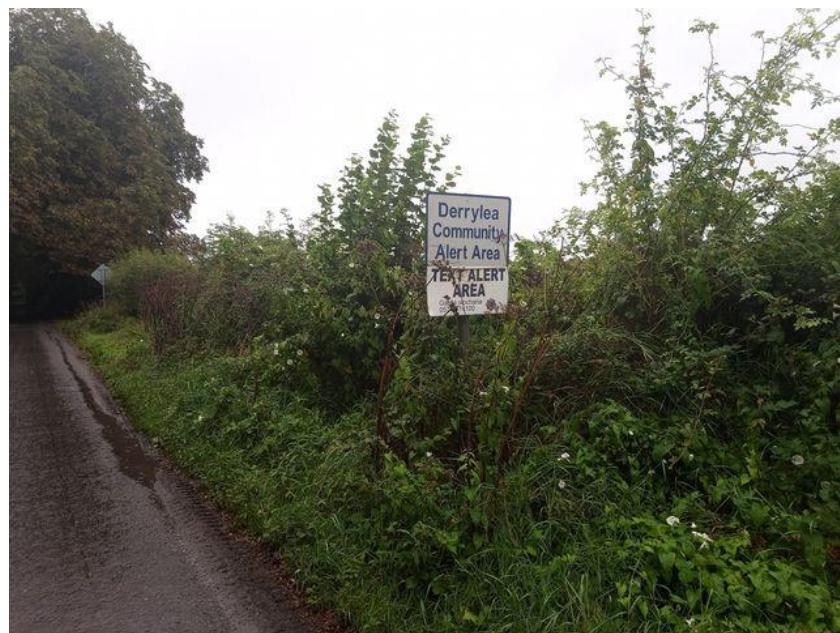
Figure 4: H002 Hedgerow at southern extent.

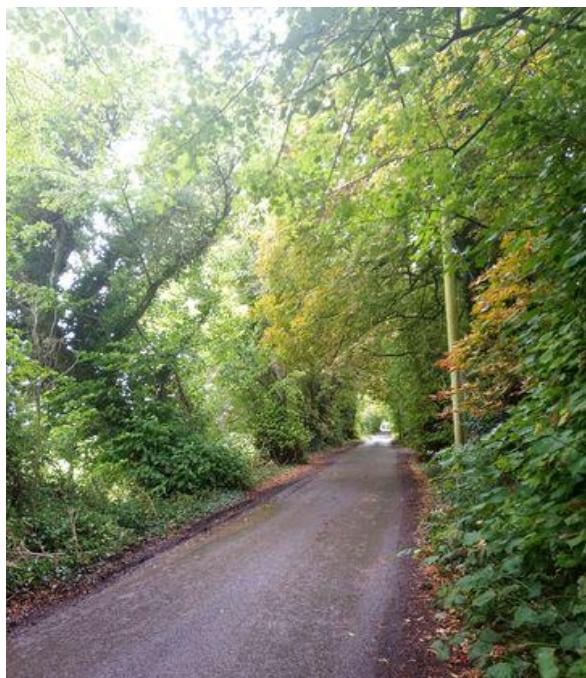
4.4 An avenue of mature trees (fig. 5), horse chestnut and lime, extend northwards for approximately 300 metres, forming a green tunnel. Species rich hedgerows flank the road for a further 150 metres, with mature ash, wych elm, lime and sycamore forming the treeline.

Figure 5: G001 & G004 Avenue of mature trees.

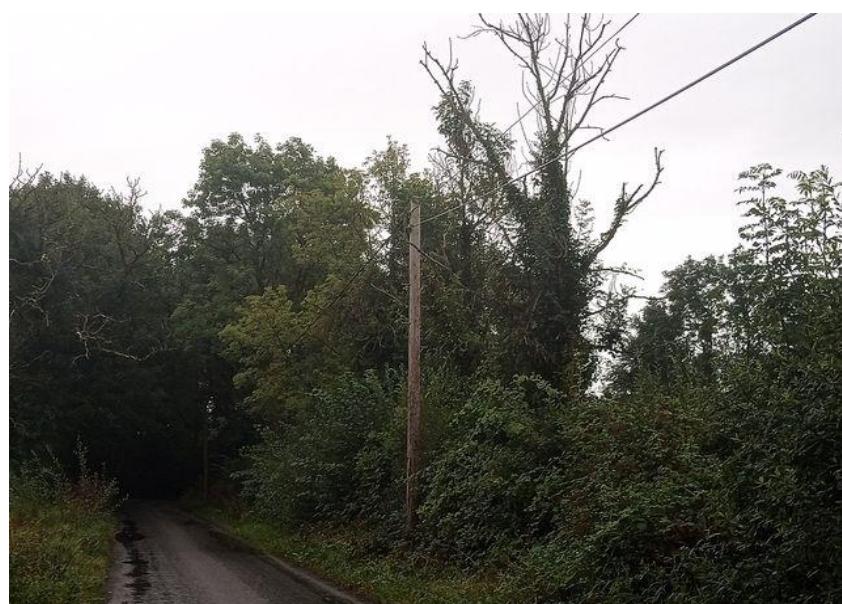
4.5 The majority of the trees are in fair condition, although there is a dead mature horse chestnut within the avenue in G001, a dead ash within G002 (fig. 6) and a dead elm within G003. Some of the ash are infected with ash dieback disease – *Hymenoscyphus fraxineus*, and a number of elm are succumbing to Dutch elm disease – *Ophiostoma novo-ulmi*). The horse chestnut are infested with leaf miner- *Cameraria ohridella*.

Figure 6: G002 Dead ash within group.

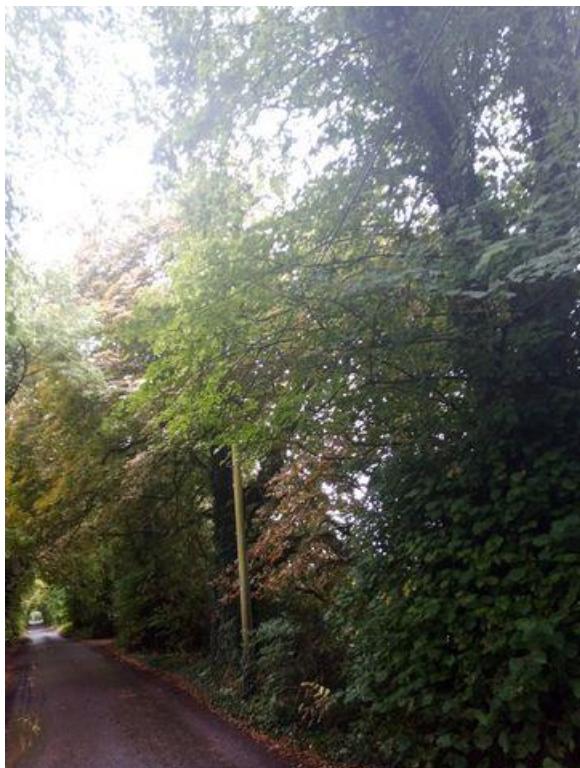
6.2 The trees G001 (fig. 5) and G004 (fig. 6) forming the avenue lining the road are mature, possibly 150 years old. The nominal RPAs of these trees extend into the road; however, tarmac roads and their subbases generally prove an obstacle to root extension due to the compacted and hypoxic conditions present. Due to the age of the trees, it is possible that root extension took place before the existing road surface was laid down, and there may be structural roots, live and dead, extending beneath the carriageway.

Figure 5: G001 Mixed species mature group. **Figure 6:** G004 Mature trees forming part of avenue.

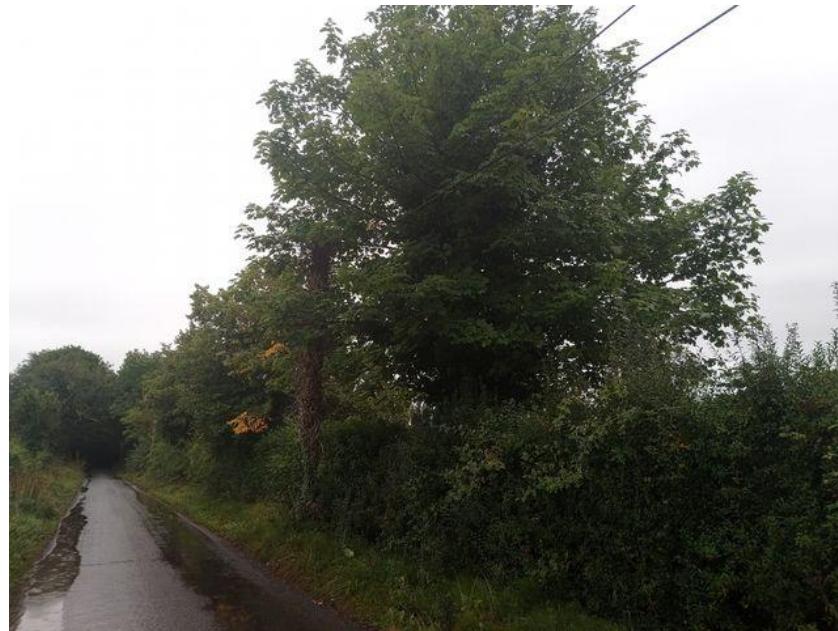
6.3 The remainder of the tree groups G002 (fig. 7) and G003 (fig. 8) adjacent the road are far younger and have probably grown there since the road surface has been in place, therefore, it is unlikely that tree roots have extended beneath the road surface.

Figure 7: G002 Roadside trees displaying good vigour.

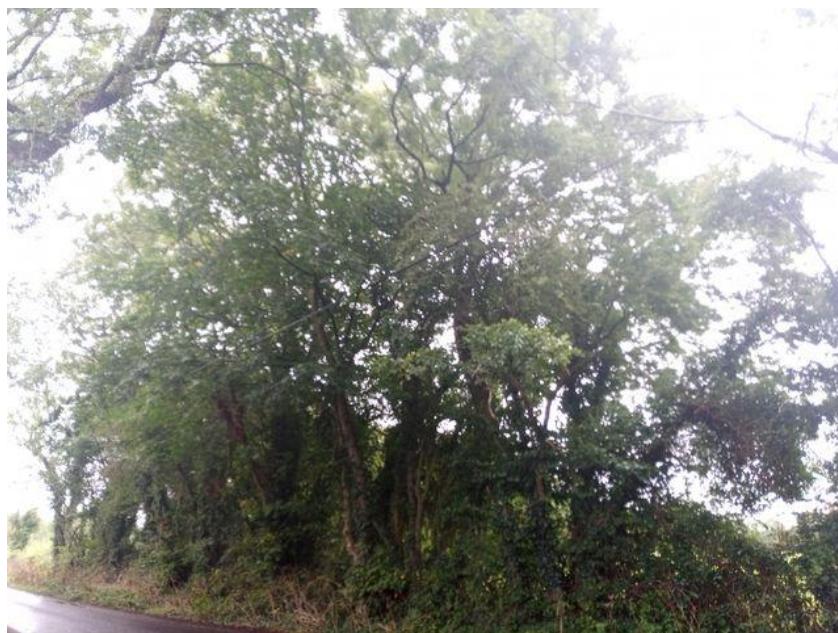
Figure 8: G003 Mixed species roadside group.

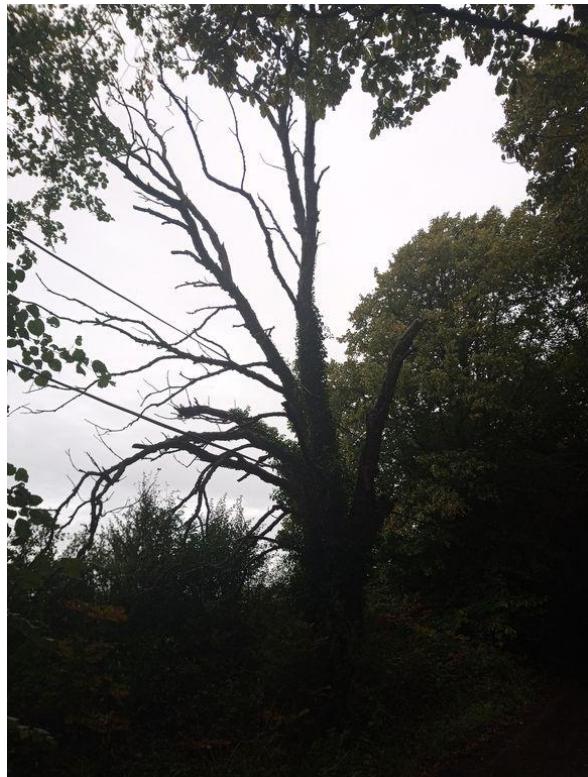
6.4 Four dead and dying trees are within the survey area. These consist of a horse chestnut in G001 (fig. 9), an ash in G002, a dead elm stem in G003, and the ash T2009 (fig. 10).

Figure 9: G001 Dead horse chestnut.

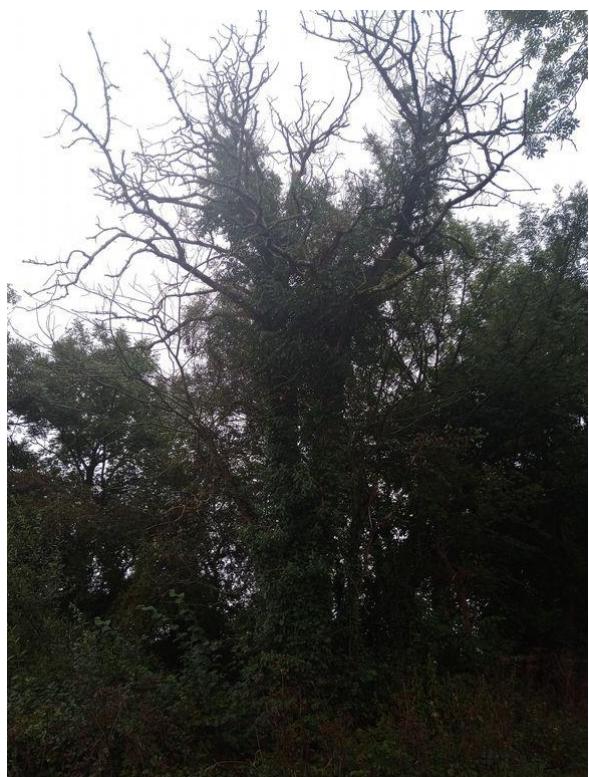
Figure 10: T2009 Dying ash tree.

T2009	Common ash (<i>Fraxinus excelsior</i>)	Tree	Height (m): 16 Stem Diam(mm): 550# Spread (m): 4N, 4E, 4S, 4W Crown Clearance (m): 5 Lowest Branch (m): 5(E) Life Stage: Mature Rem. Contrib.: <10 years	Ivy obscuring stem and main unions. Extensive dieback throughout crown. Pests and Diseases: Ash Health Class 4 - 25%-0% remaining canopy	U	Radius: 6.6m. Area: 137 sq m.	Physiological Condition: Diseased Structural Condition: Collapsing Public Amenity Value: Moderate Inspection Limitations: Vines Bat Habitat: Low	Pre construction: Reduce to 3 metre monolith. During construction: Protect trees with protective barriers - as shown on plans. Post construction: No action required.

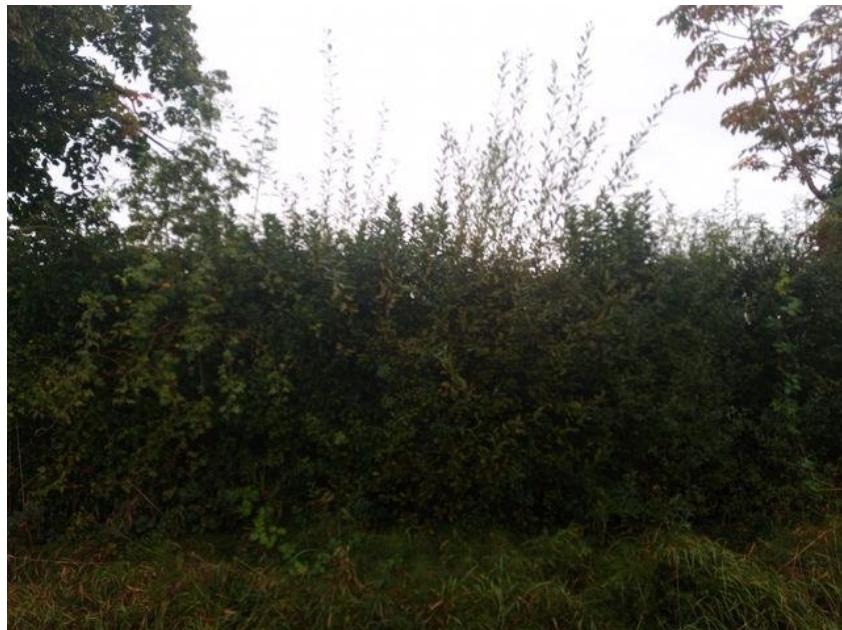
6.5 The species rich hedgerow H003 at the northern extent will not be impacted by proposed works.

Figure 8: H003 Species rich roadside hedgerow.
