Observations on a Strategic Infrastructure Development Application

Case Reference: 324055

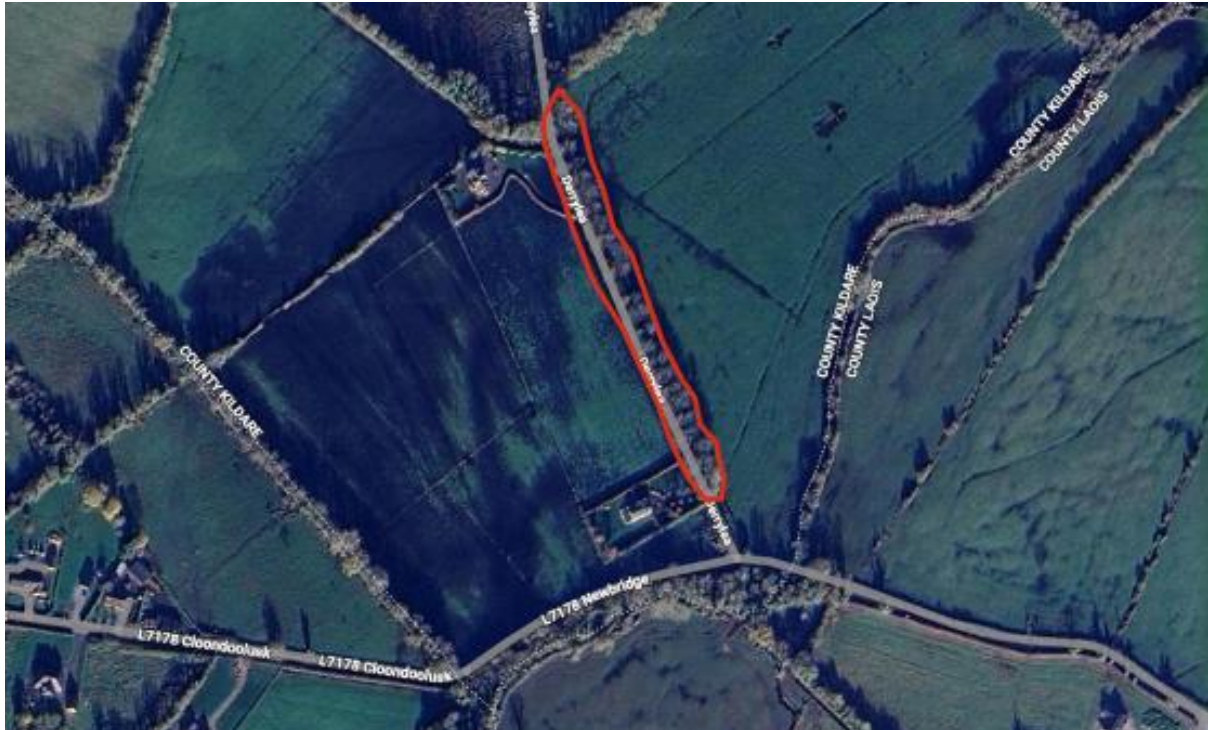
1. Location of the Avenue of trees at Derrylea, Monasterevin, Co. Kildare

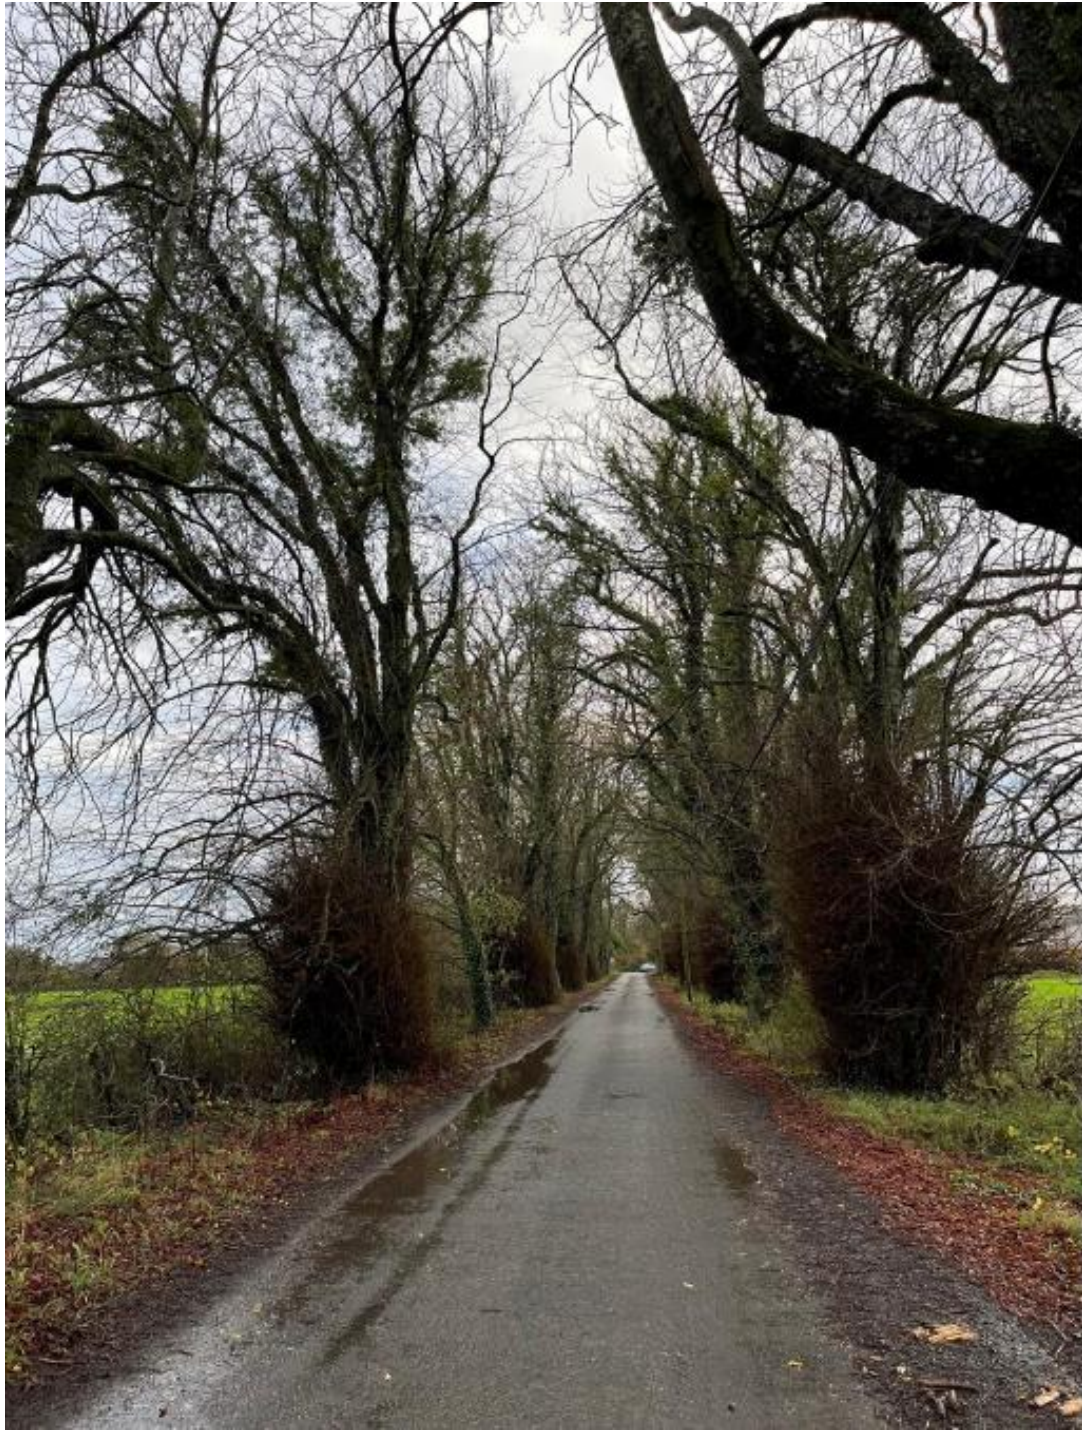
1. View looking north through the Derrylea Avenue; the road surface is approx. 5m wide
