5.3 Tree Survey Report (Independent Tree Surveys, 2025)

Independent Tree Surveys Ltd

Tree Survey Report Cashla Peaker Project Athenry Co. Galway

October 2025

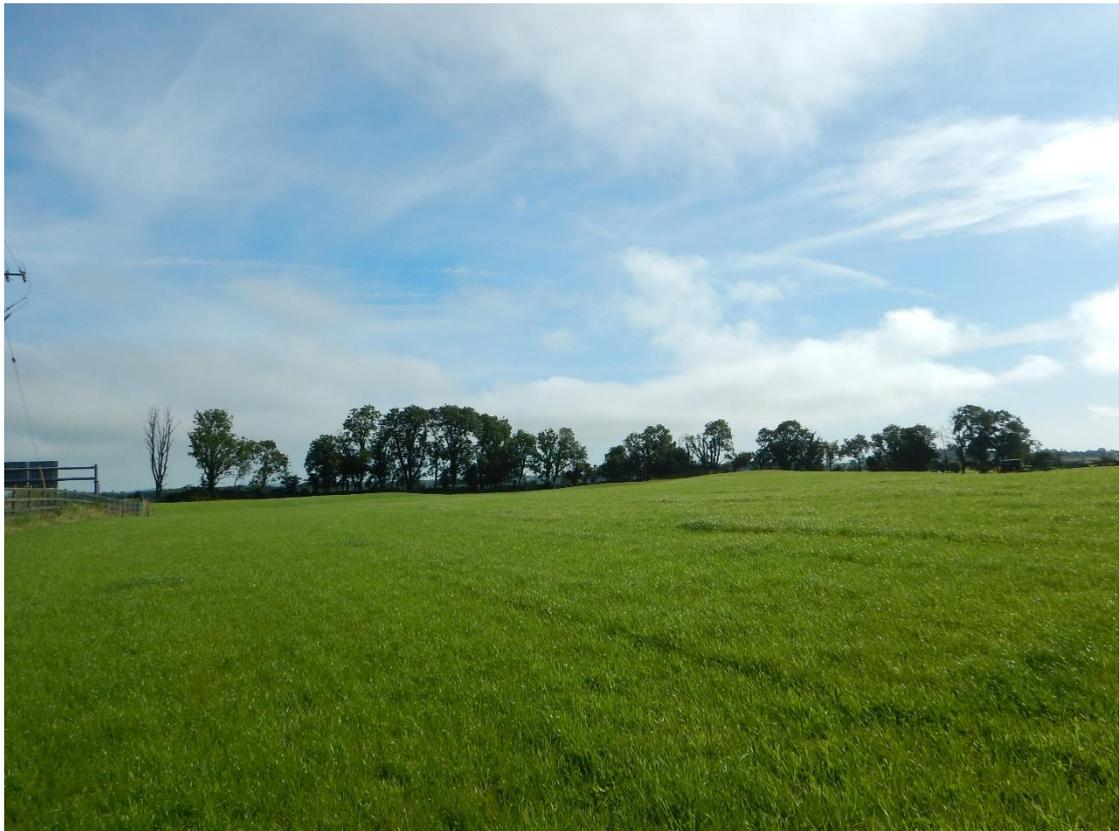
Photo 1 Trees 623-659 along the northern edge of the main site, viewed from the south inside the site.

Because the development would constitute a change in land use and increased occupancy, it is recommended that the trees worst affected by Ash dieback disease and structural defects are felled or coppiced as part of the enabling works for the project. This would include the trees tagged 625,626, 630, 631, 632, 634, 639, 643, 645 and the group of young Ash trees labelled group G1.

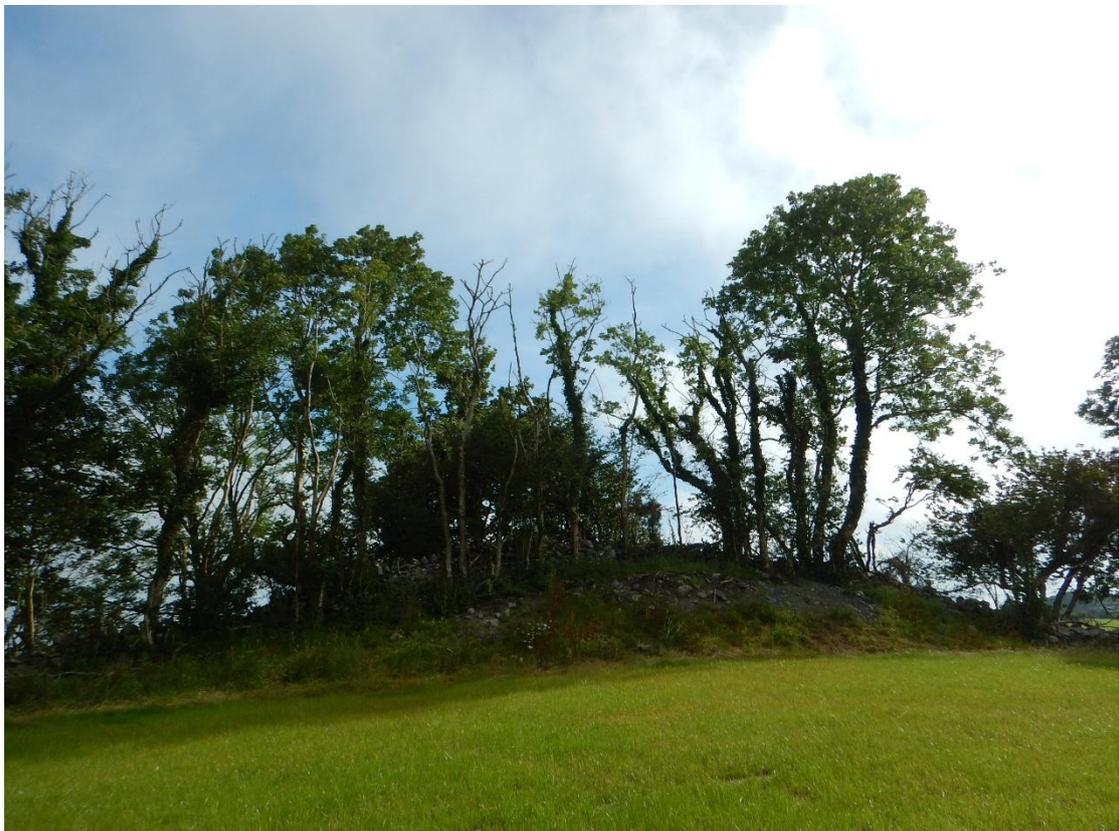
Photo 2 Trees within the treeline along the northern edge of the site, including group G1

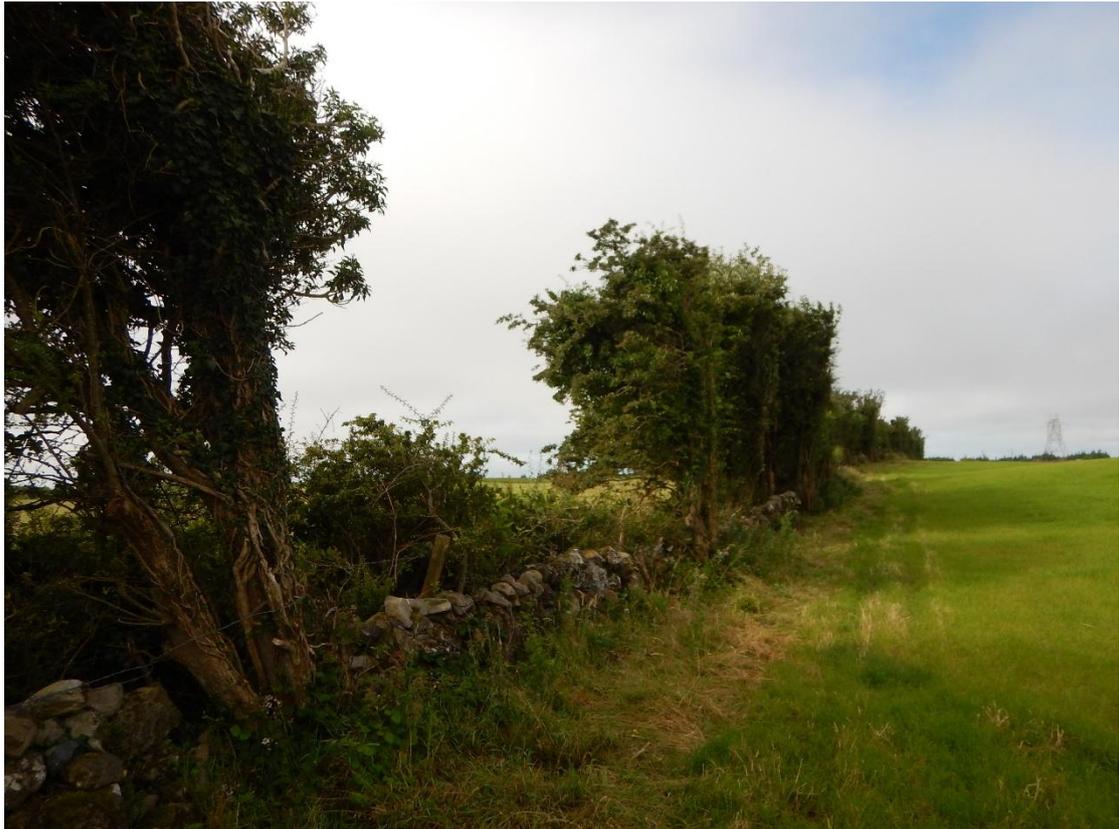
Photo 3 Sporadic bushes making up group G3 along the southeastern edge of the site

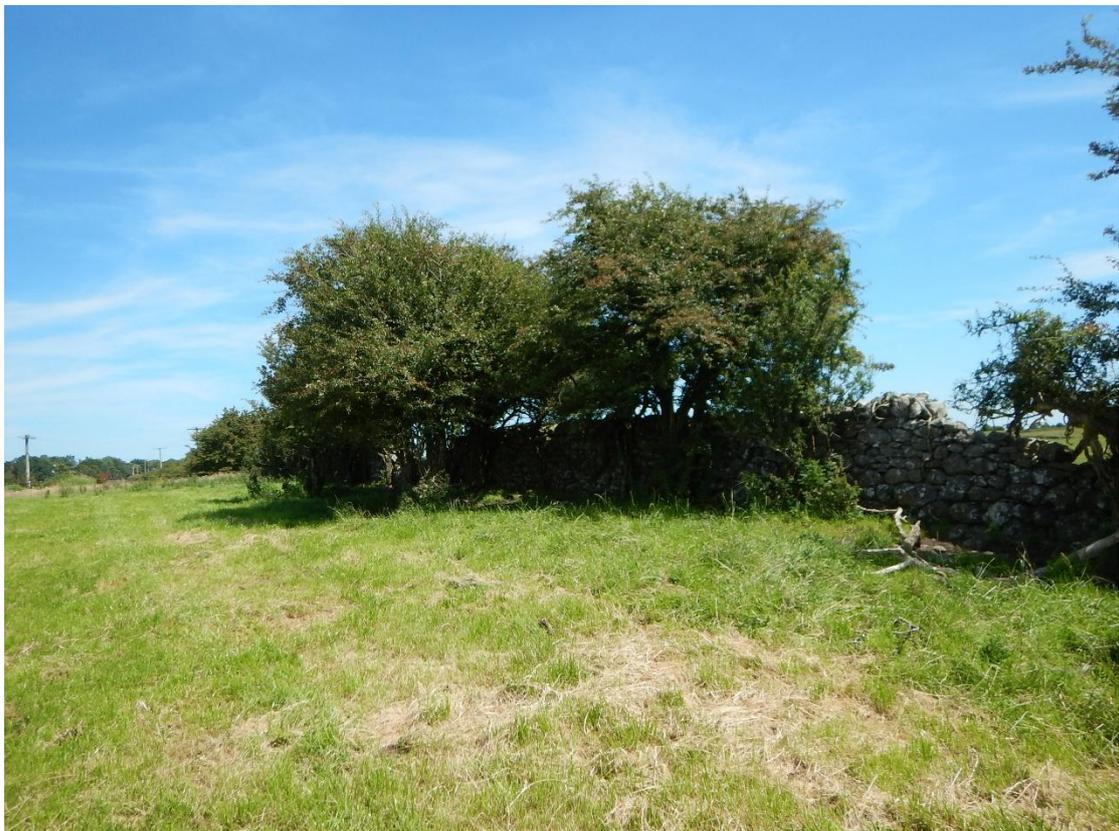
Photo 4 Sporadic bushes making up group G4 along the edge of the proposed cable route

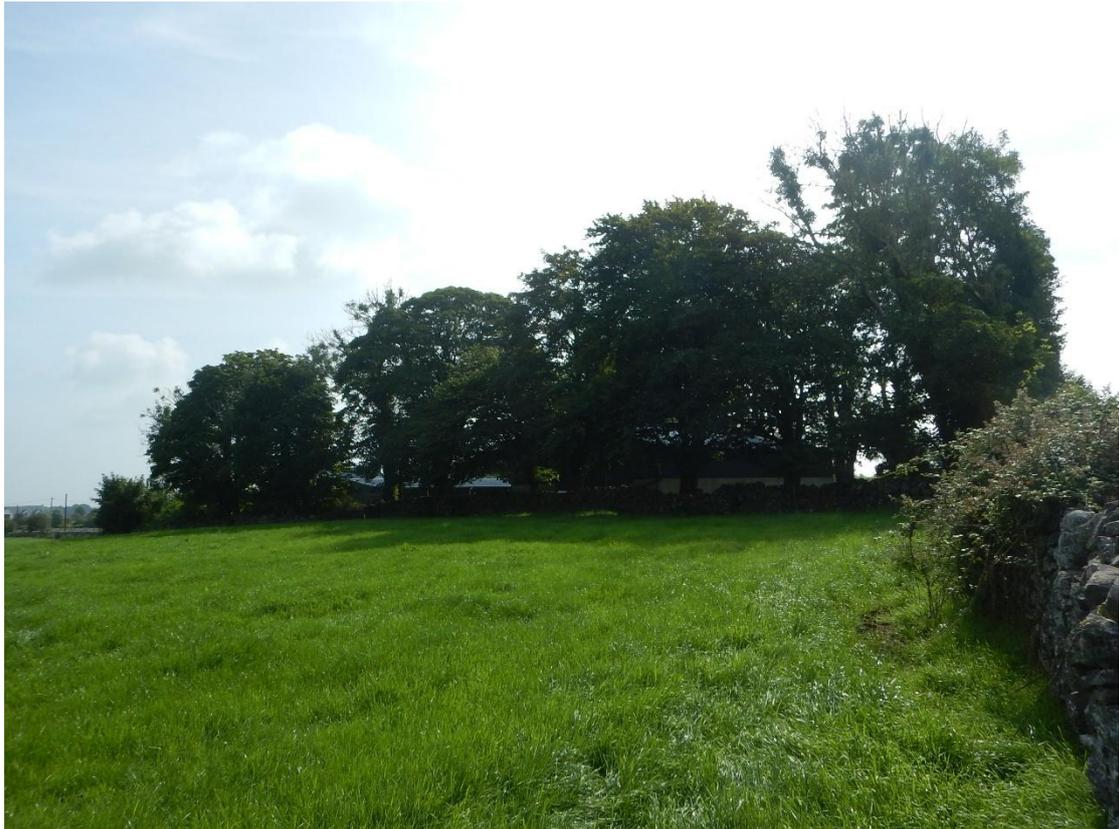
Photo 5. Trees 660-670 to the east of the cable route between the proposed new facility to the road

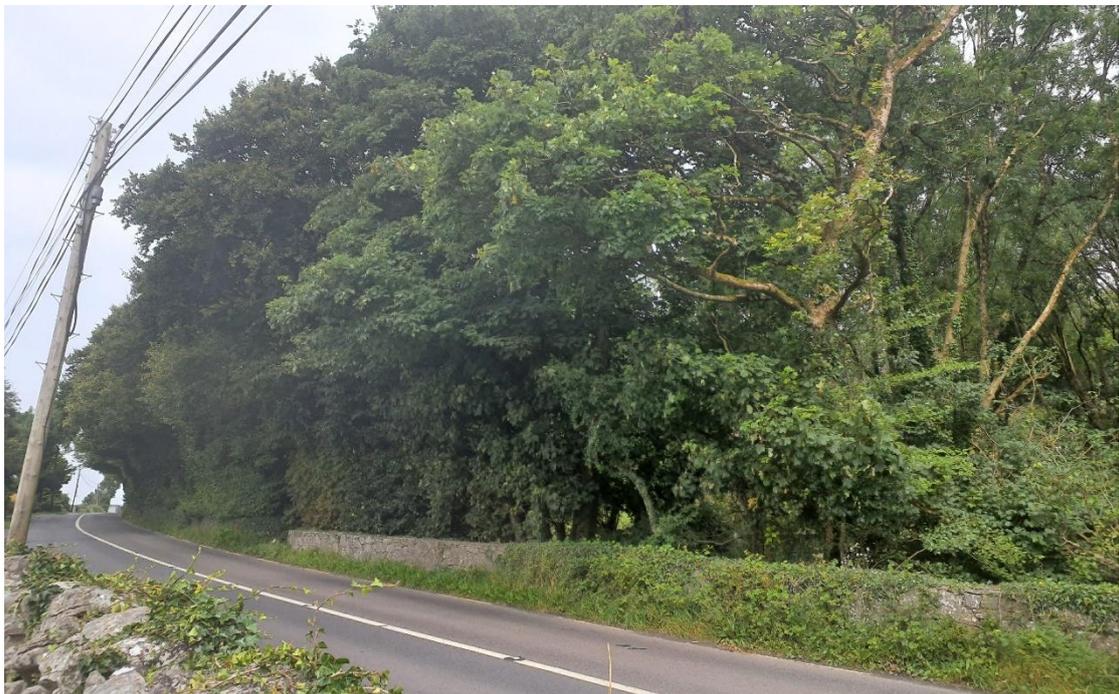
Photo 6. Trees making up woodland W1 to the north of the proposed cable route

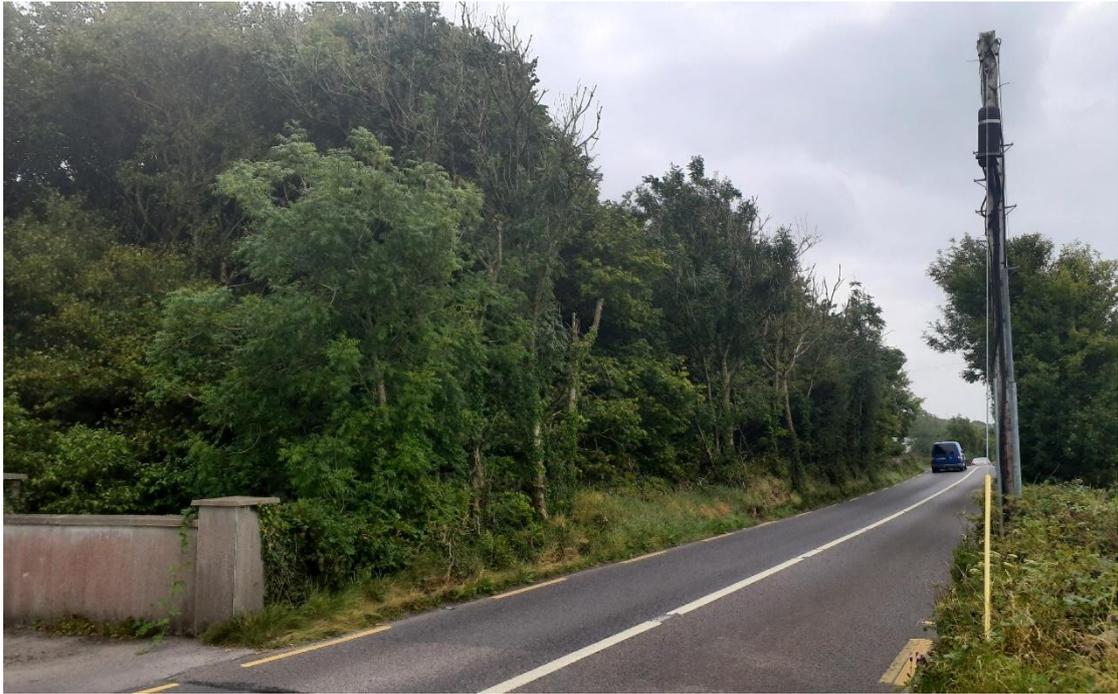
Photo 7. Trees making up group G8 next to the road

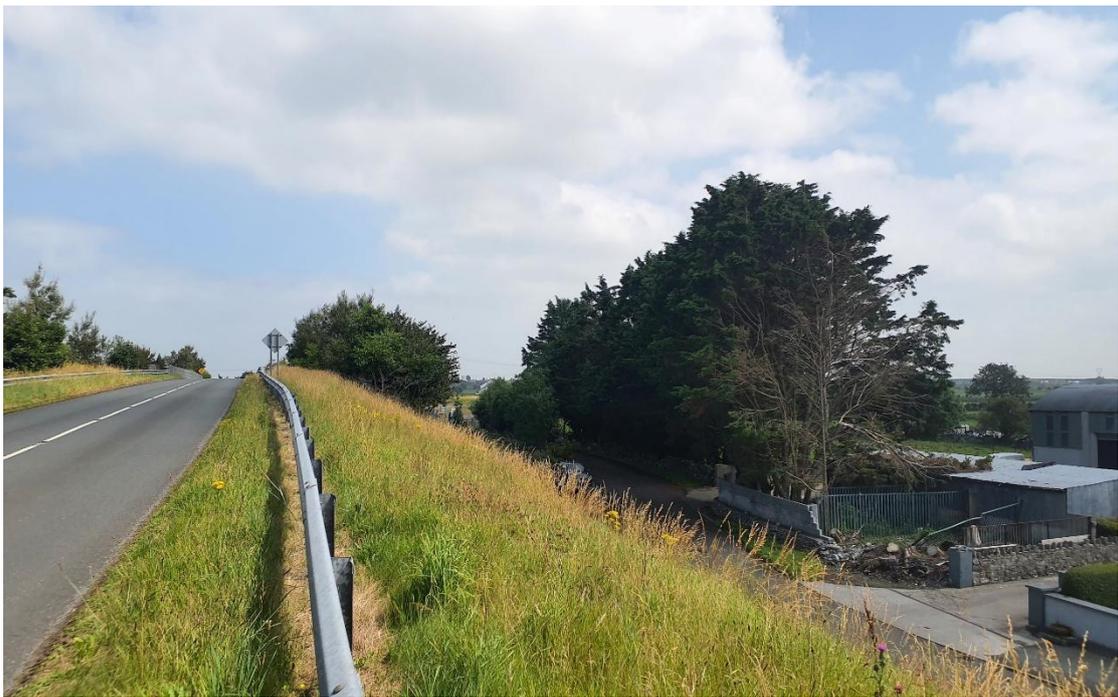
Photo 8. Cypress trees making up group G11

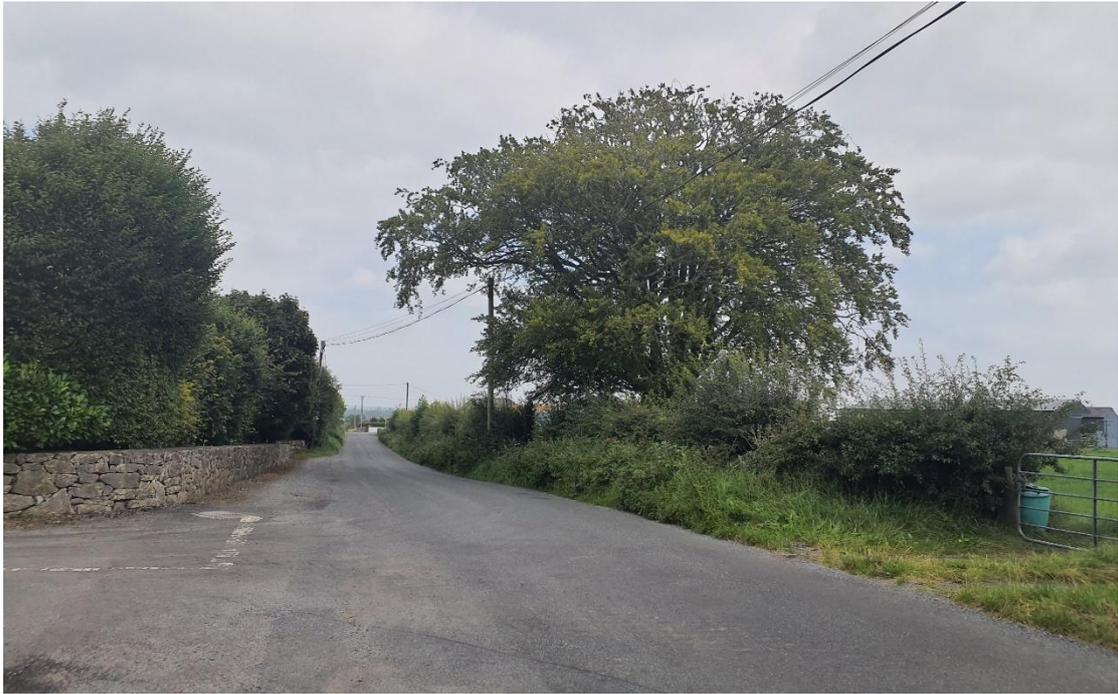
Photo 9. Mature Beech tree T4 close to the road and route of cable

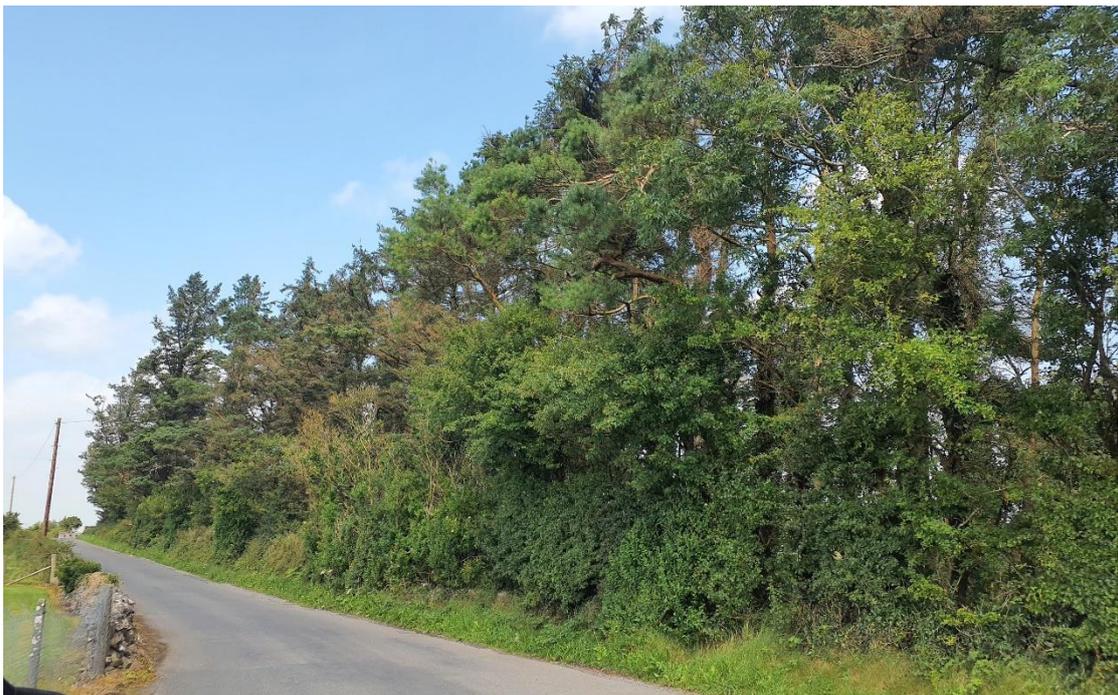
Photo 10. Plantation group G13 next to road and proposed cable route
