RECEIVED: 25/02/2026

Appendix 7.2

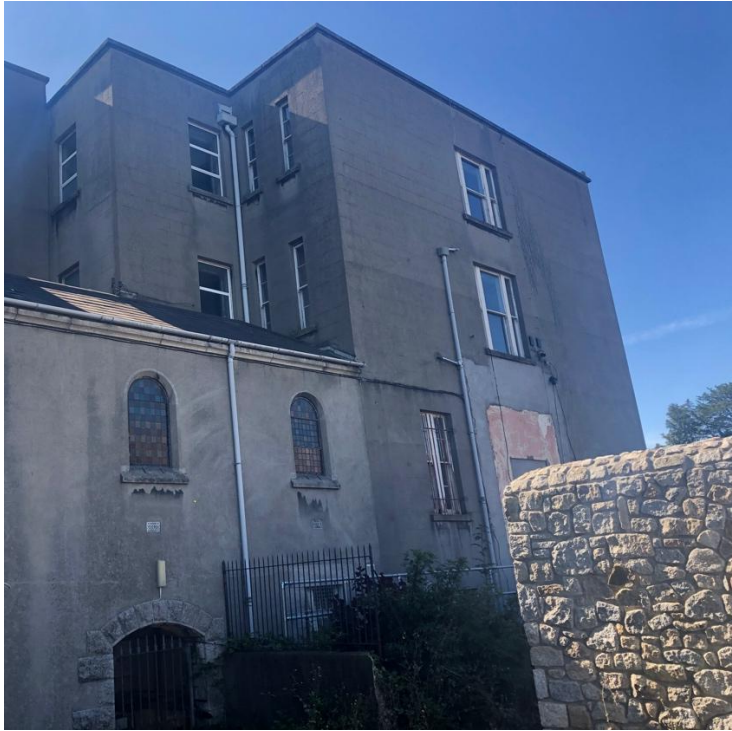
Plate 14: Rear extension with repaired gable following removal of former link structure, recently demolished.

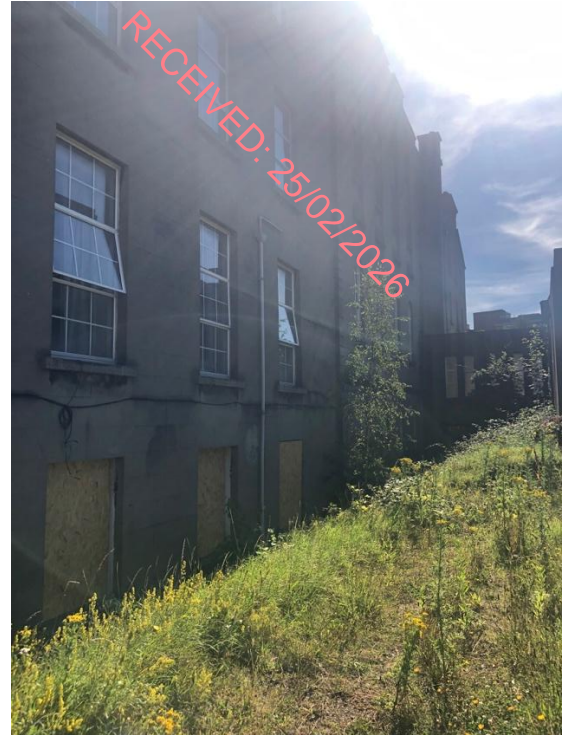
Plate 15: The rendered south elevation of the rear extension

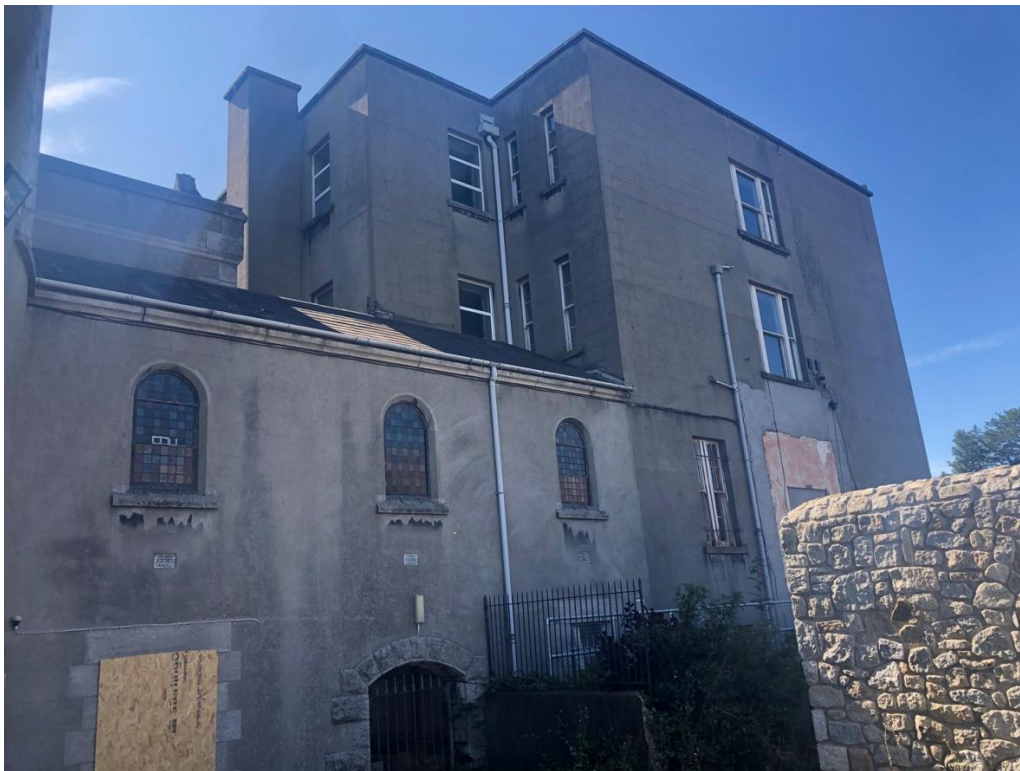
Plate 21: North-west elevation of link between rear of MPH extension and Chapel. Rusticated stone surround to gated passage to central courtyard. New boundary wall, part of recent separation works, in foreground.

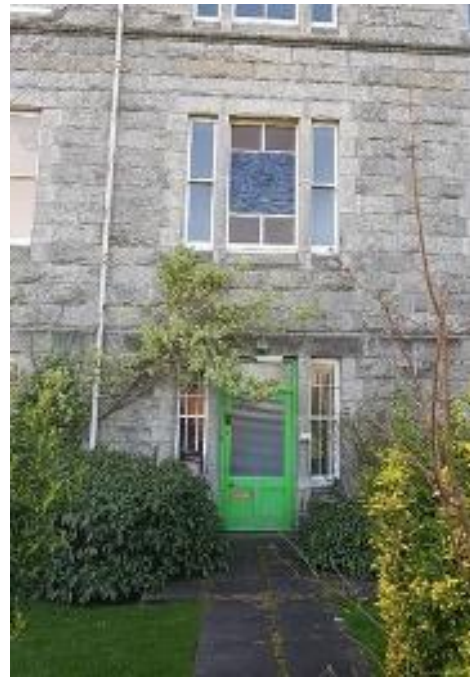
Plate 30: Side door of Tabor House with stained glass on first floor, a later modification

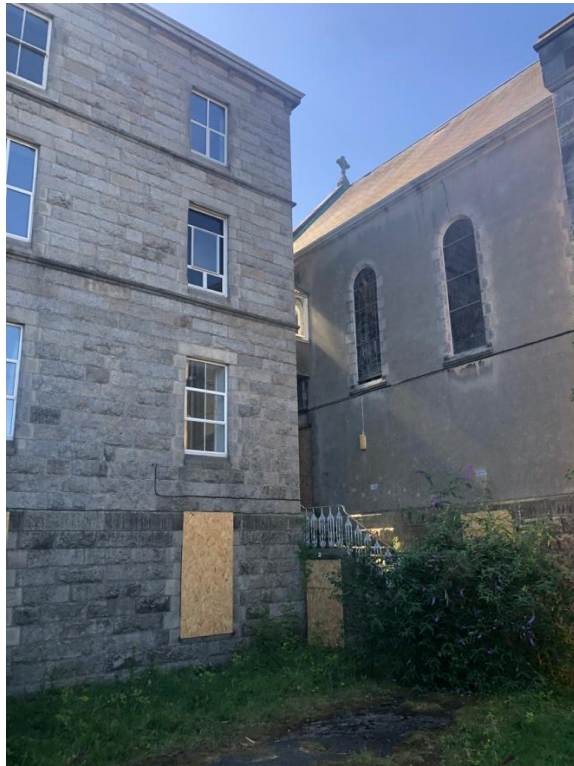
Plate 31: Connection of Tabor House to the later Chapel: comprising a set of stone steps to first floor level, and a glazed link at second floor to the mezzanine at the rear of the Chapel

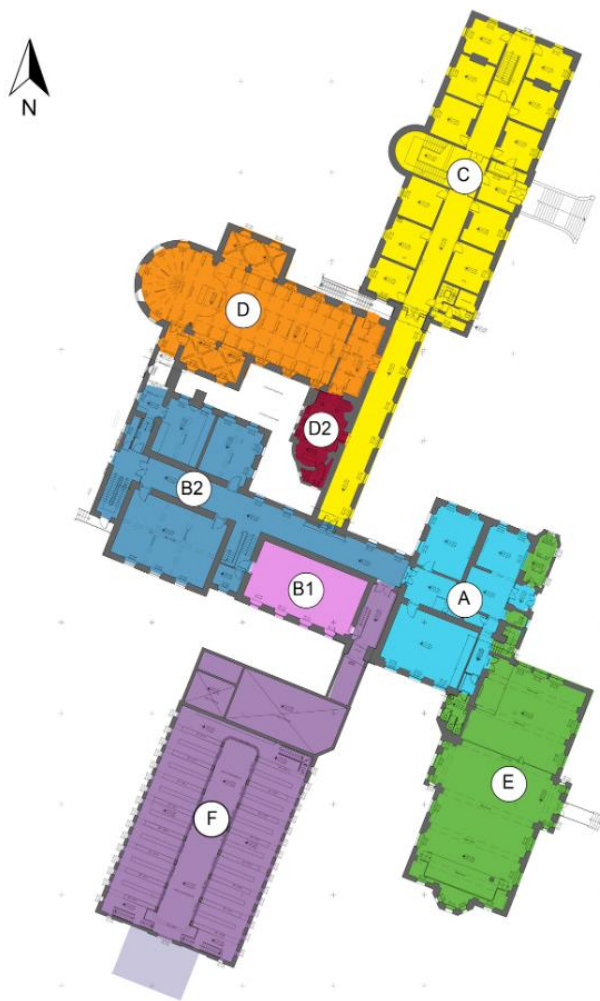
- A Milltown Park House
- B Rear Extension
- C Tabor House
- D Chapel
- E Finlay Wing
- F Archive

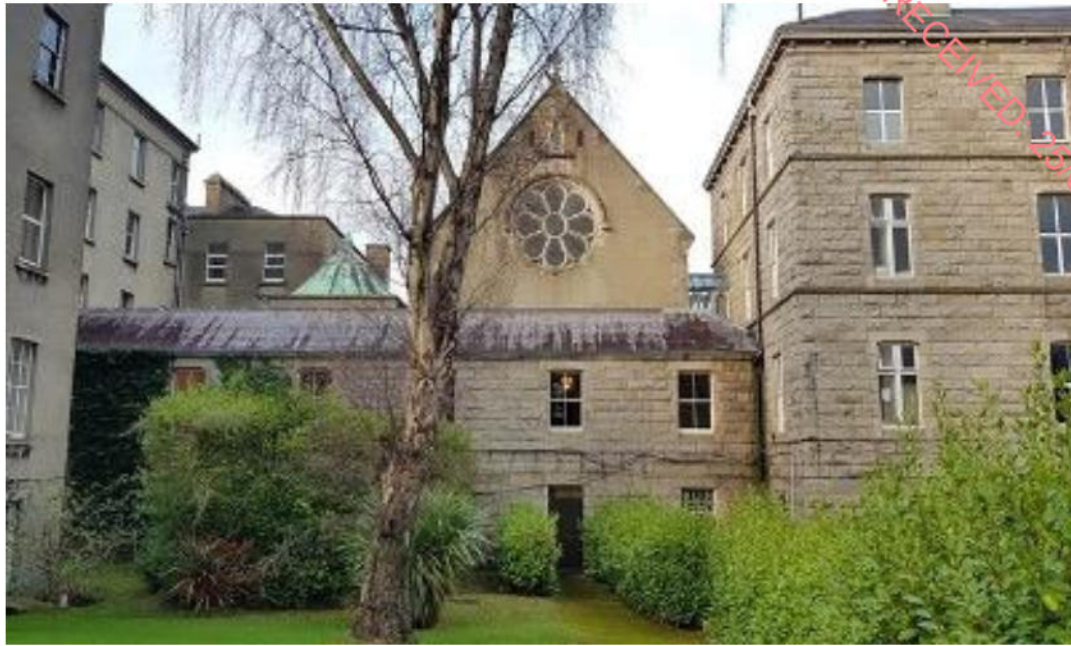
Plate 33: (2023 image included for clarity) Front elevation of Chapel, above linking building, with stained glass Rose window on east gable with copper turret of Sacred Heart Chapel south of it. Both Chapels are accessed from within Milltown Park House.

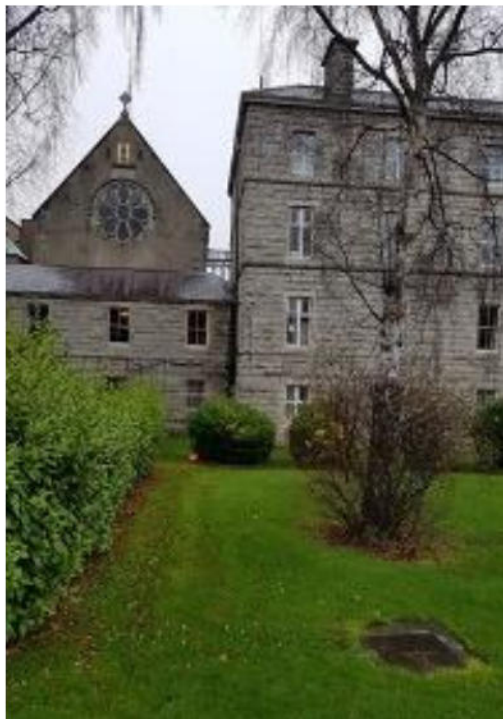
Plate 34: (2023 image included for clarity) Wider view of Chapel link front to Tabor House

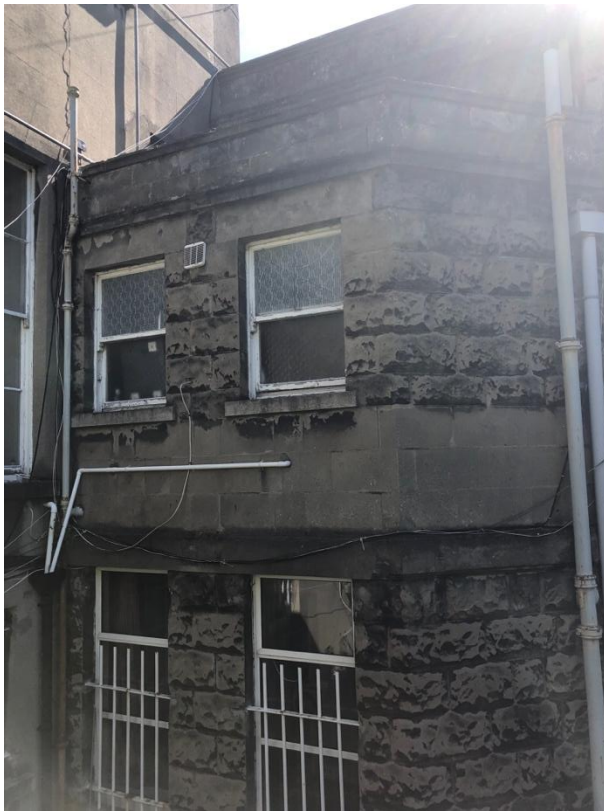
Plate 53: View of NW elevation of Finlay wing and awkward connection to Milltown House. Note stained window panes dating from post 1949 reconstruction

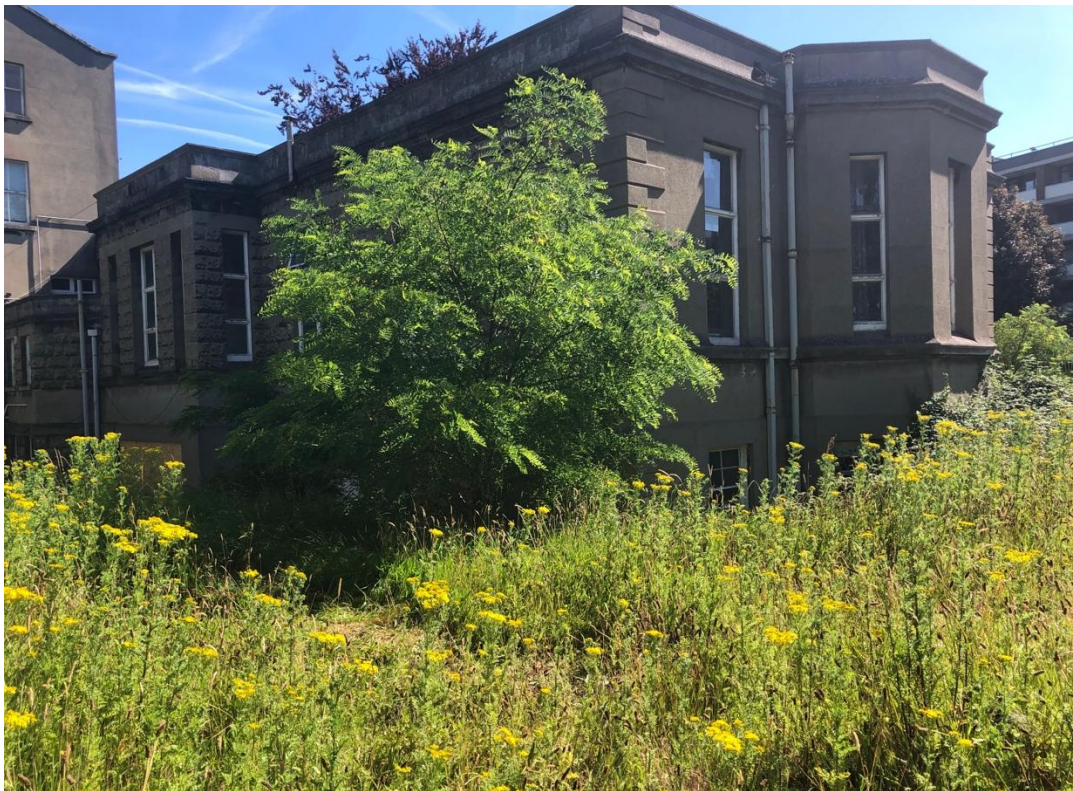
Plate 54: View of west elevation. Smooth ashlar finish to lower ground level with rock-faced finish to upper ground level.

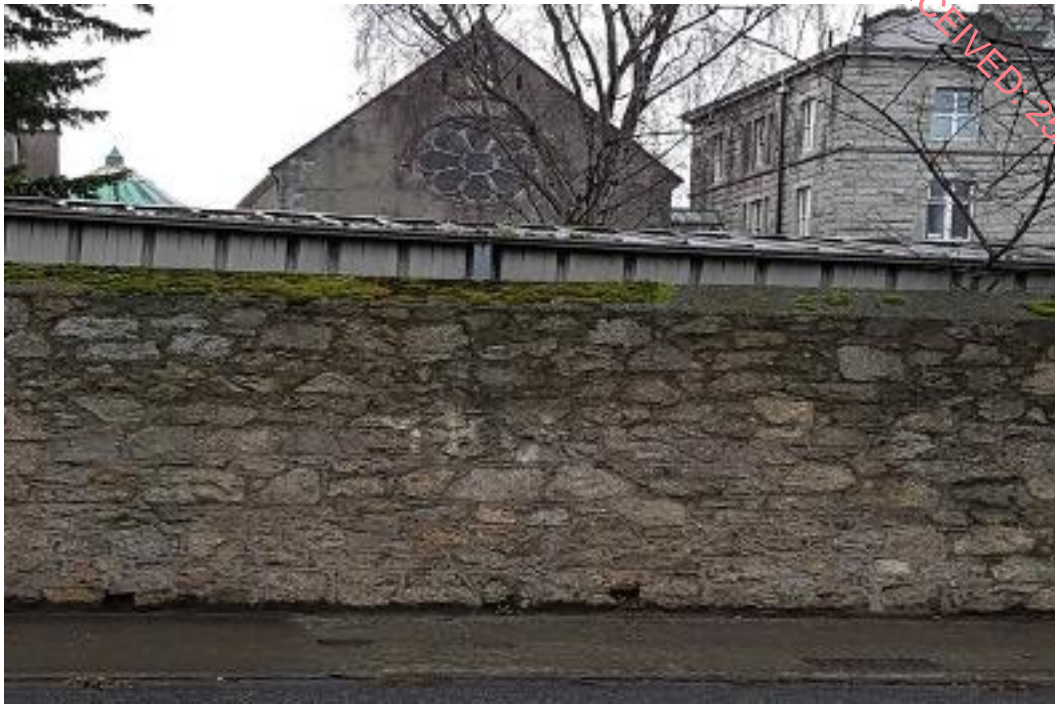
Plate 72: Perimeter rubble wall on Milltown Road with Chapel, stained glass window and Milltown Park House in background

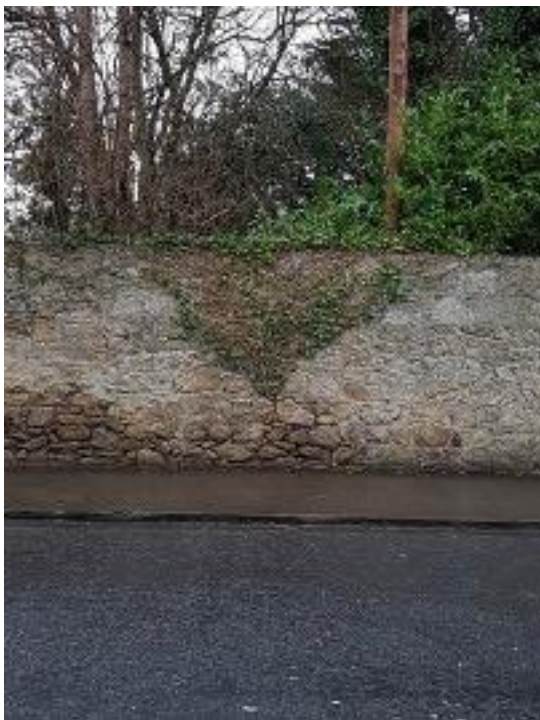
Plate 73: Section of rubble boundary wall on Milltown Road

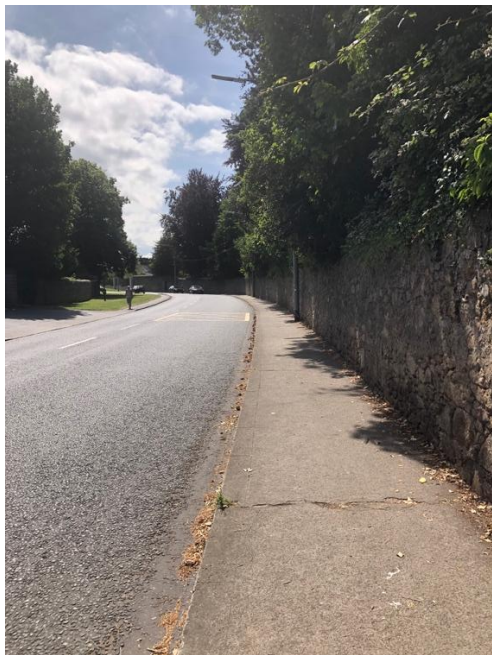
Plate 77: Curve of wall looking up Milltown Road towards new entrance, note multiple pointing types cement repairs to rubble wall

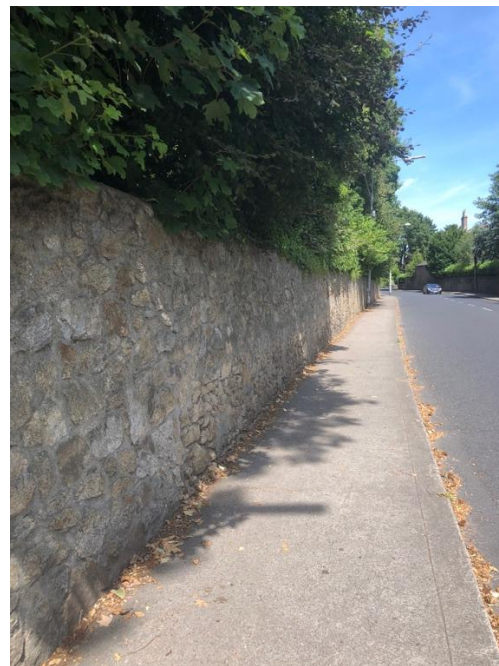
Plate 78: Curve of wall looking down Milltown Road, with pedestrian gate in centre

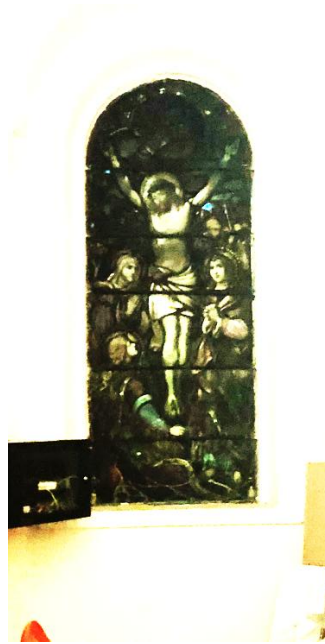
Plate 86: Crucifixion stained glass by Joshua Clarke, Clarke Studios

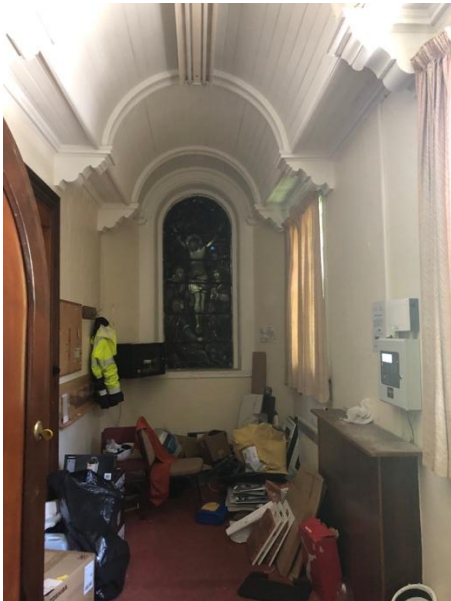
Plate 87: Vestibule/Holy Rosary Chapel, due north towards the apse and stained glass window

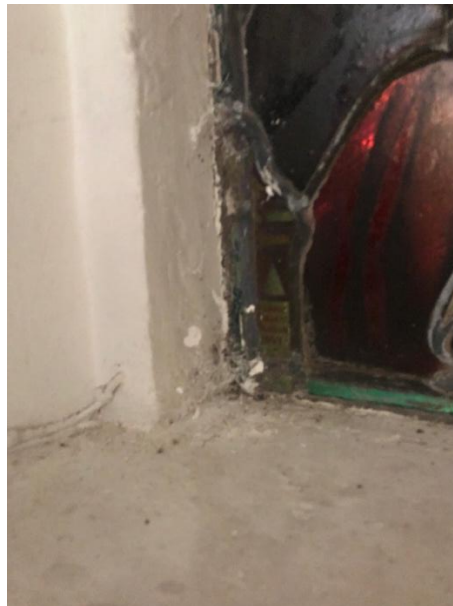
Plate 88: Stained glass signed CLARKE FREDK. ST DUBLIN 1897

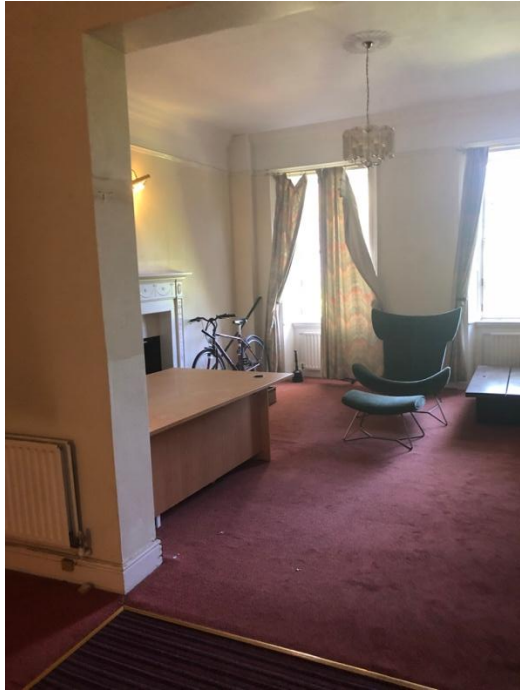
Plate 89: Reception room to northeast off entrance hall. Some original features remain

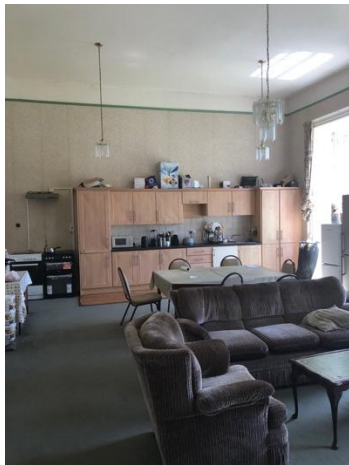
Plate 95: Large room within the former Orangery to the south with full height ceiling, missing fireplace, and more recently in use as kitchen/diner

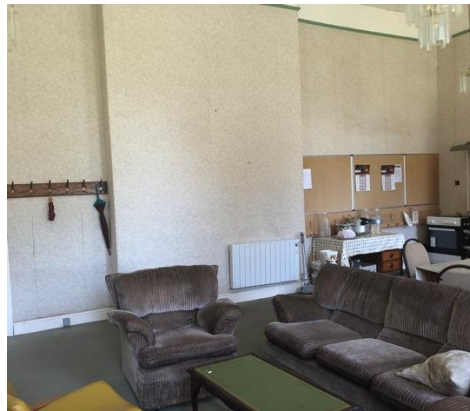
Plate 96: Historical features such as decorative plasterwork and fireplace removed.

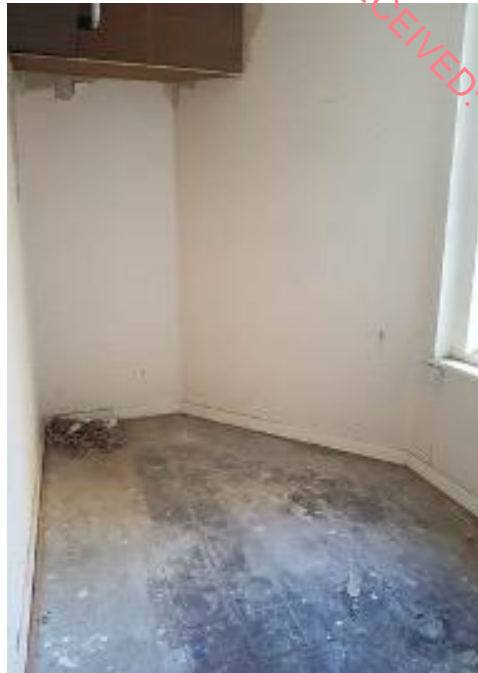
Plate 138: Small room with partitioned wall showing signs of water damage

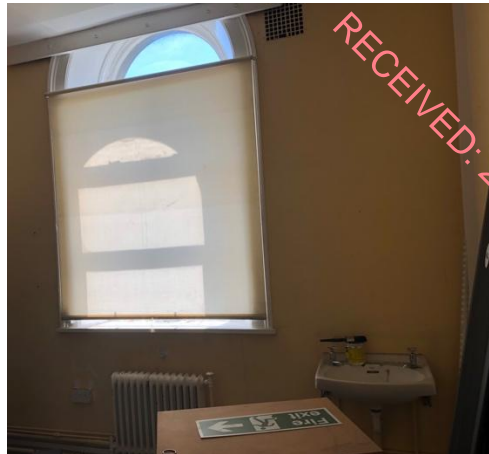
Plate 158: A typical dormitory with replacement arched window

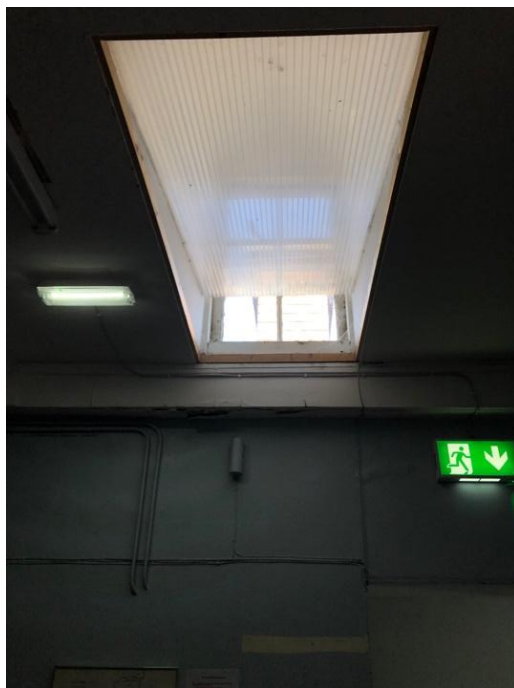
Plate 159: Roof-light at high level at rear of MPH

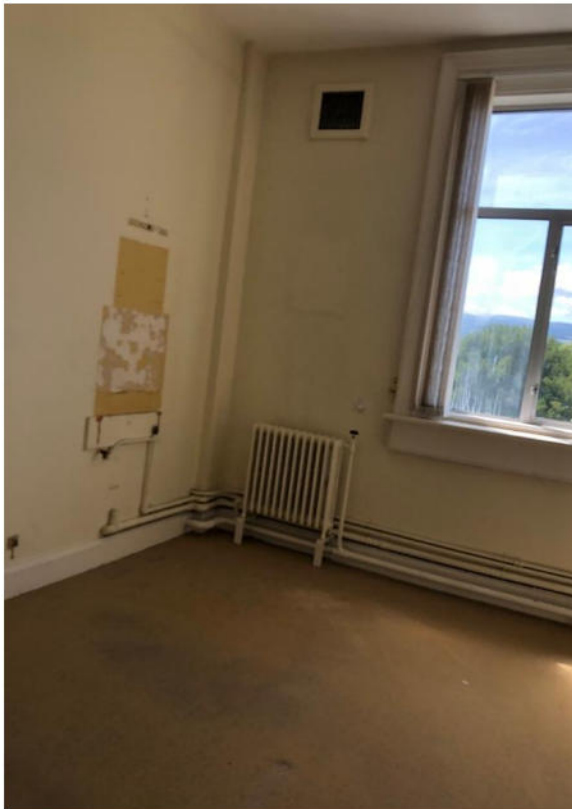
Plate 174: 2nd floor level typical study room to front (east) on first floor with signs of water damage

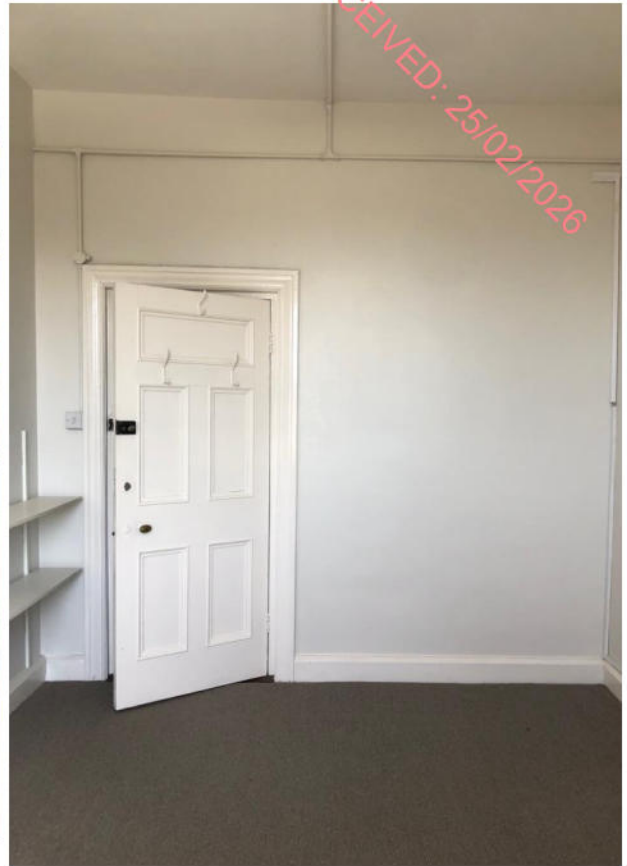
Plate 175: Same level rear room

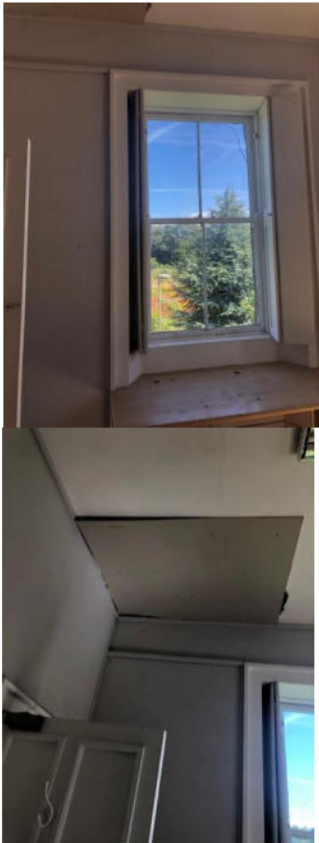
Plate 190: Typical entrance level accommodation with corbelled chimney piece and original door, sashes and window boxes. Replacement window frames to northern elevation.

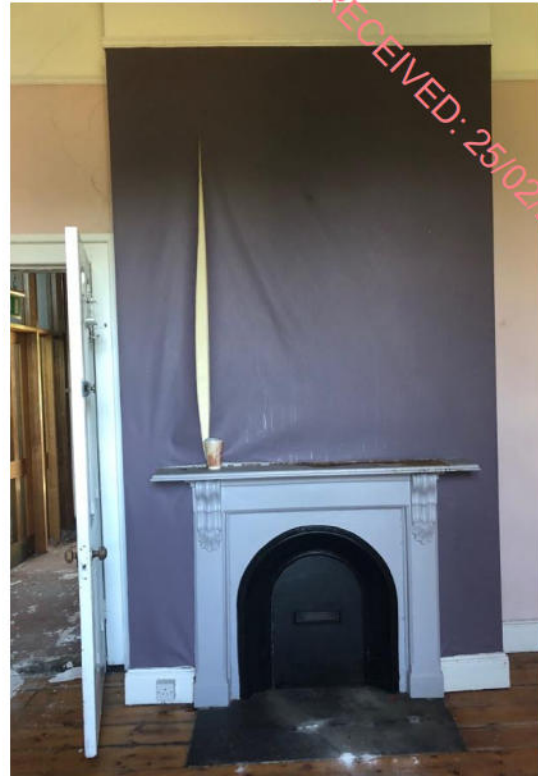
Plate 191: Corbel chimney piece and cast iron insert. Paneled door, molded architrave and picture rail.

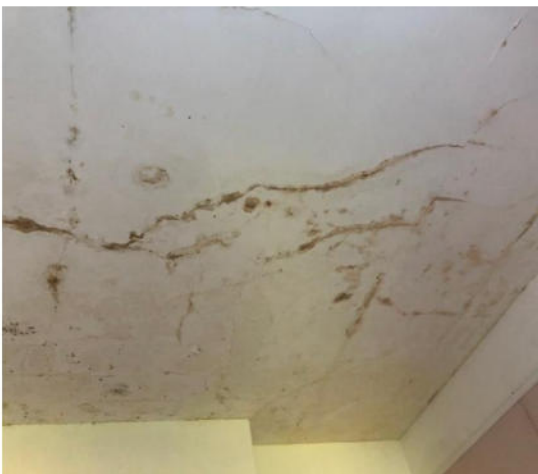
Plate 192: Evidence of water damage to ceiling fabric.

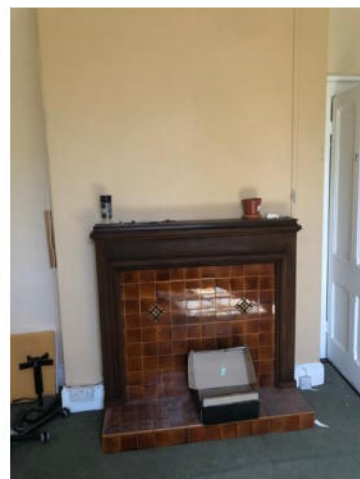
Plate 193: Stepped cornice and picture rail in ground floor accommodation. Timber chimney piece with glazed tile insert.

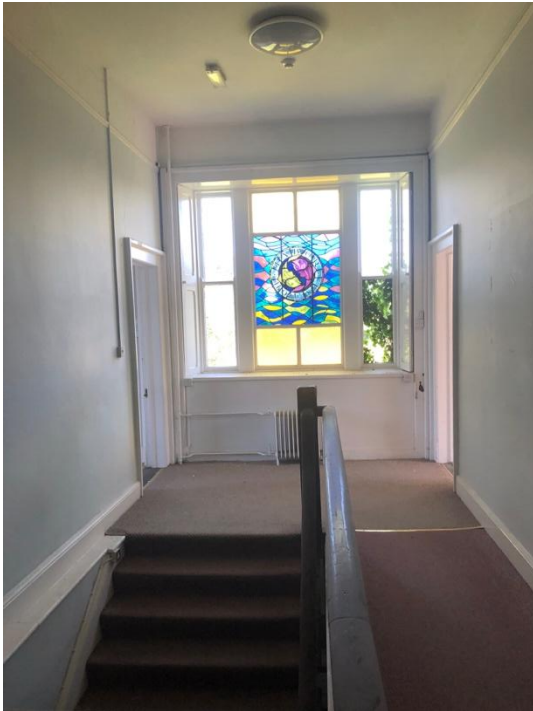
Plate 198: Stairs to entrance level from northeast of basement with stained glass tripartite window at end of corridor.

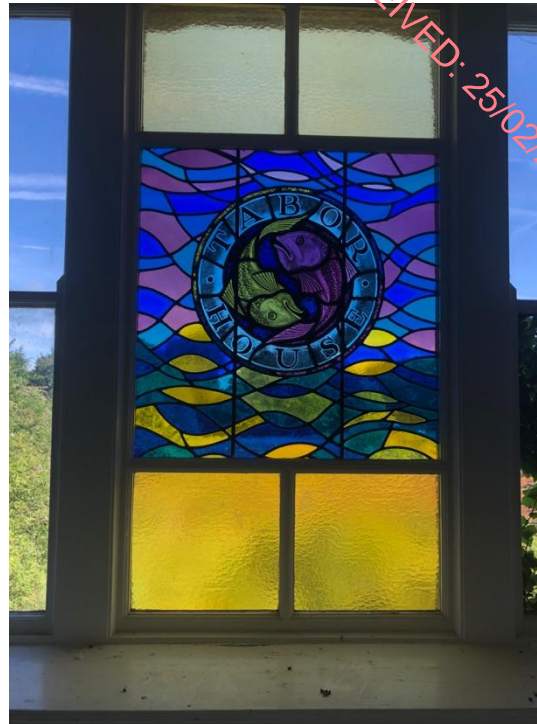
Plate 199: 20th Century stained glass window to north east end of entrance level corridor

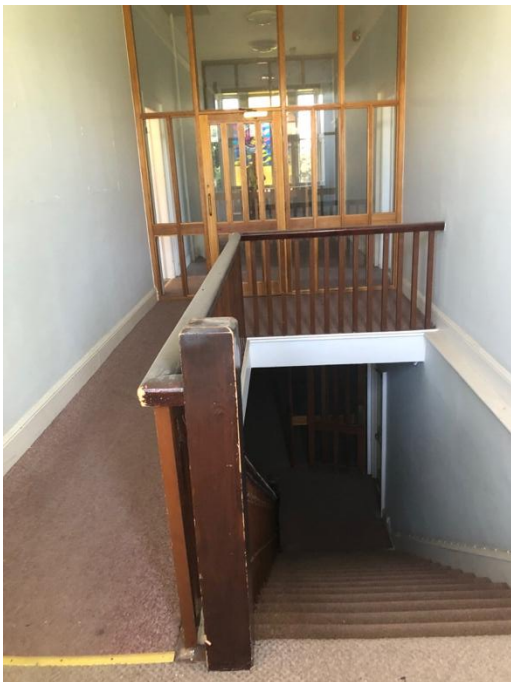
Plate 200: Stairs to entrance level from northeast of basement.

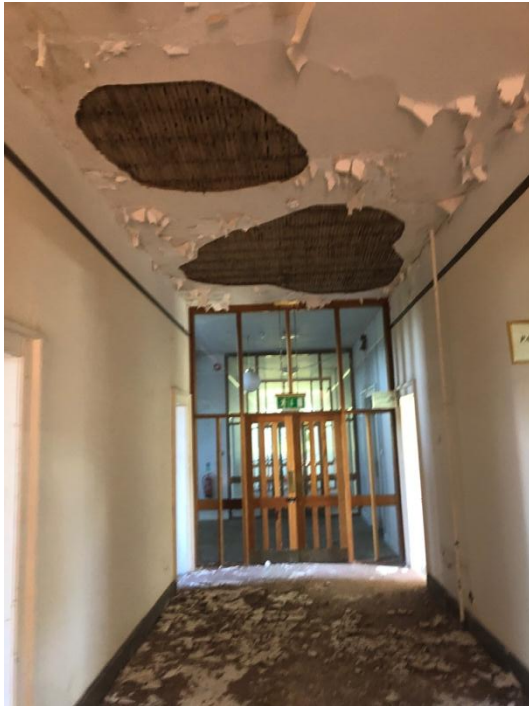
Plate 202: Entrance level corridor with later cross-corridor fire screens. Water ingress damage to ceiling fabric.

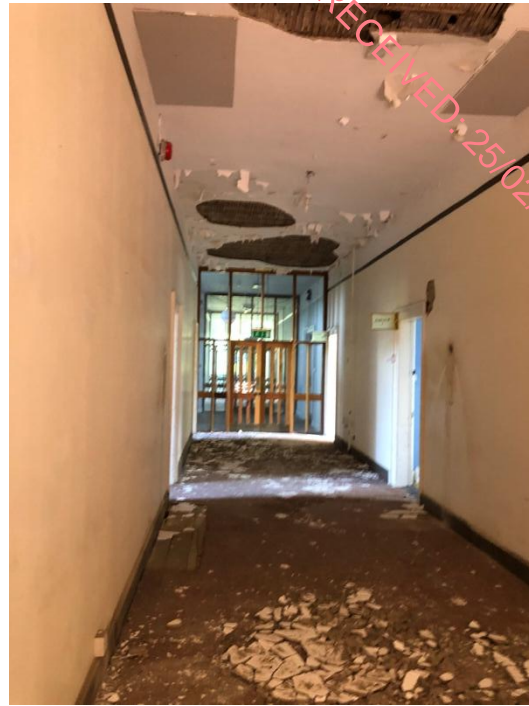
Plate 203: Entrance level corridor with later cross-corridor fire screens. Collapsed ceiling fabric due to water ingress in view.

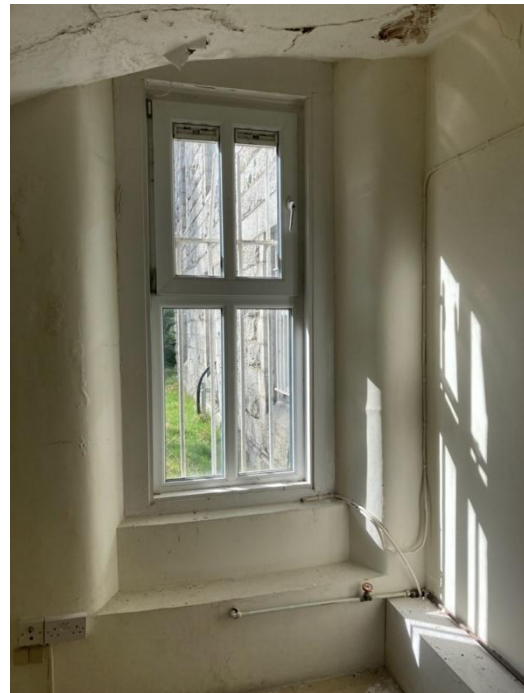
Plate 233: Contemporary uPVC window on lower ground floor. Beneath main entrance. Note deterioration of ceiling fabric indicative of water ingress through exterior steps.

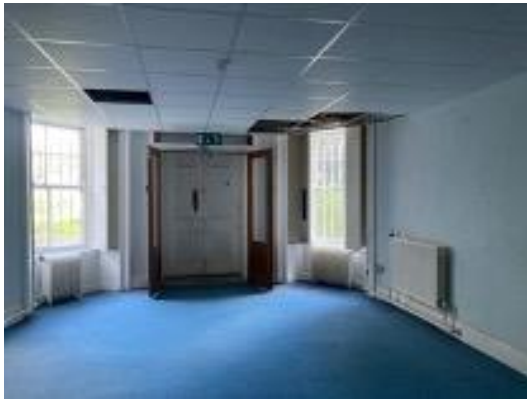
Plate 234: Lower ground floor entry to rear (north) elevation within rounded bay. Later suspended ceiling.

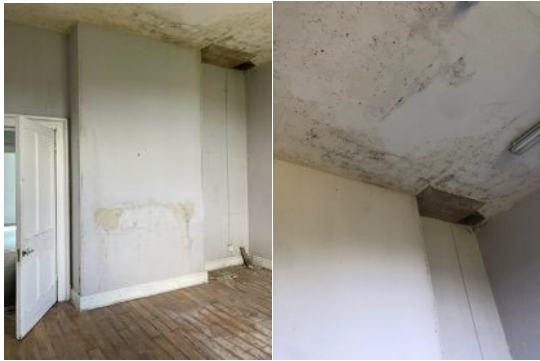
Plate 250: Chimneybreast with chimneypiece removed. Evidence of water damage to ceilings and walls.

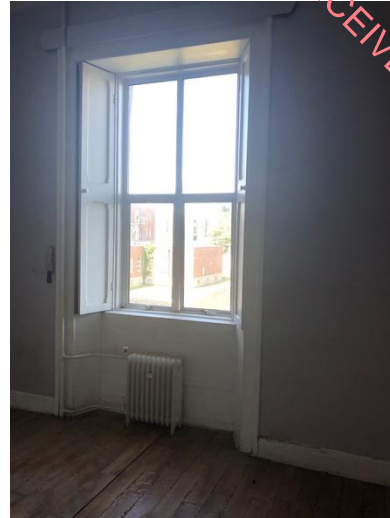
Plate 251: Original window boxes with contemporary uPVC window frame.

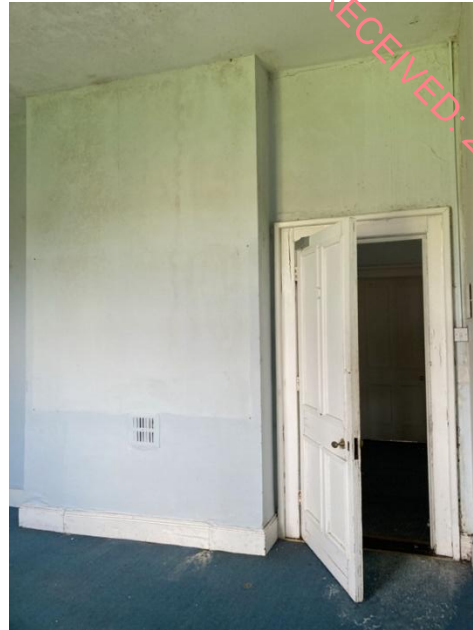
Plate 263: No chimneypiece. Original joinery. Staining of ceiling suggestive of water ingress.

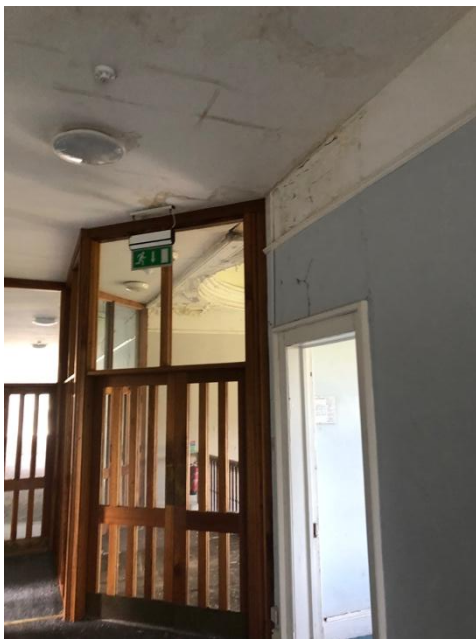
Plate 264: Second floor corridor with later screen doors to central stair and across corridor. Bedroom doors are panelled with moulded architraves.

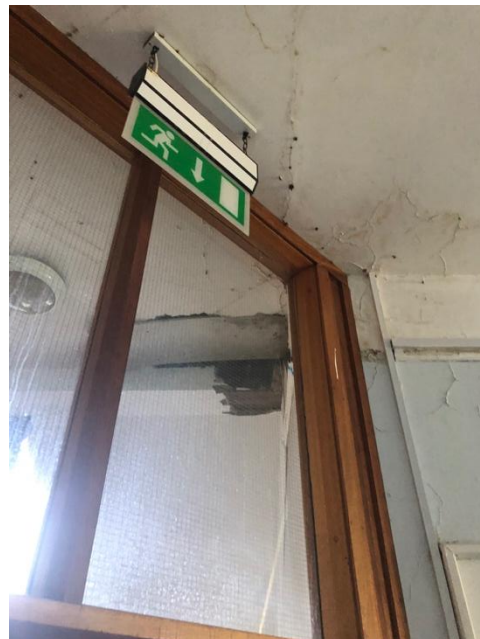
Plate 265: Water ingress damage from roof impacting second floor corridor ceiling

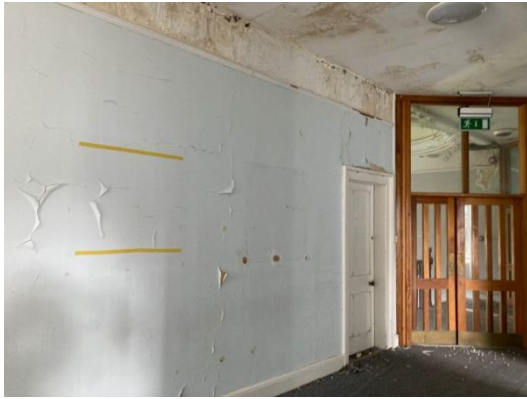
Plate 266: Central spine corridor with water staining evident to ceiling.

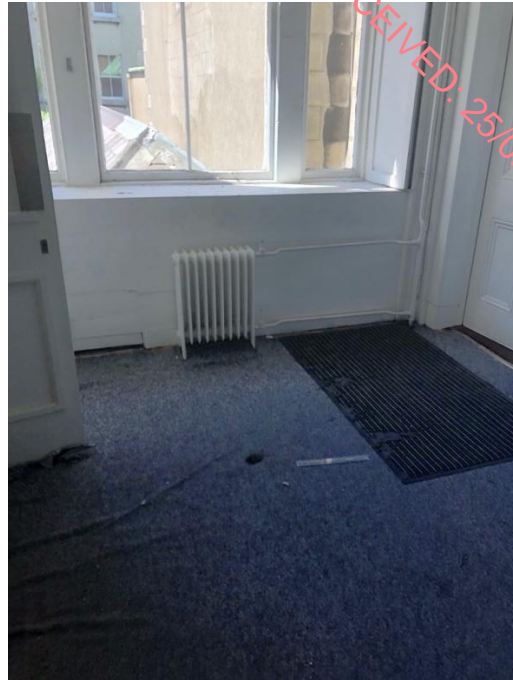
Plate 267: Damage to ceiling and wall fabric due to water ingress.

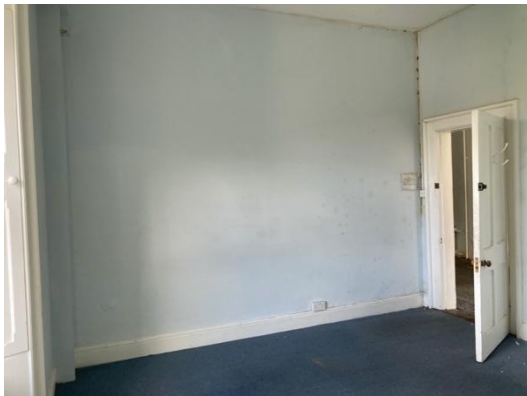
Plate 268: Typical upper floor accommodation. Original four paneled door and architrave.

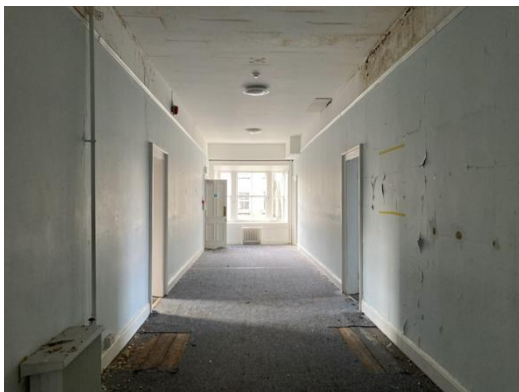
Plate 272: Central spine corridor. Original timber floor under carpet finish. Staining to ceiling evident.

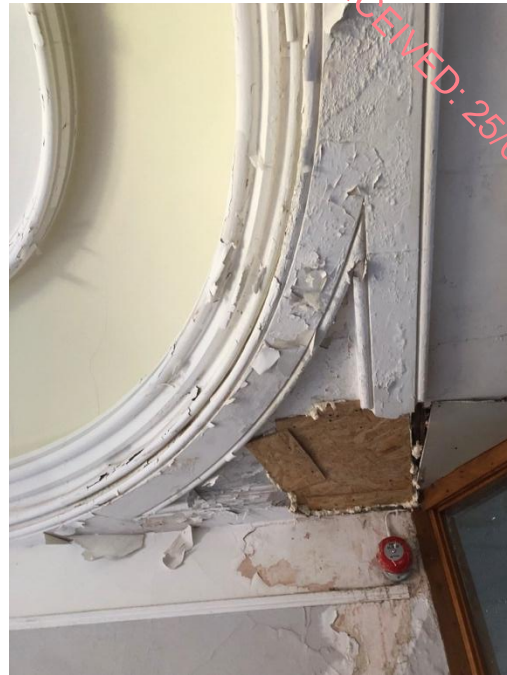
Plate 192: Flaking paint and staining of ceiling due to water ingress.

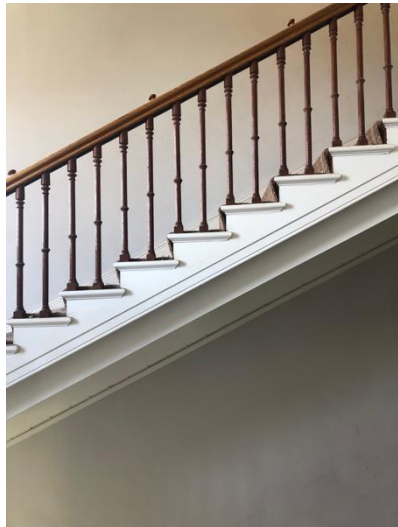
Plate 286: Detail of oak handrail

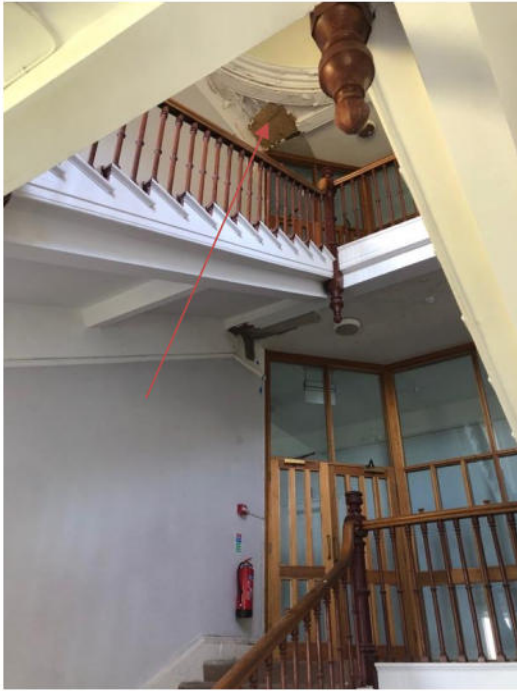
Plate 191: Damage to ceiling above main stairwell.

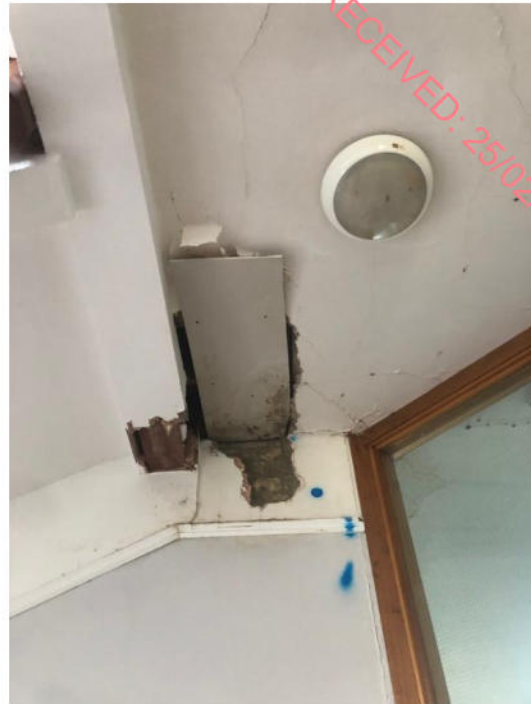
Plate 192: Roof breach in second floor ceiling with roof space exposed.

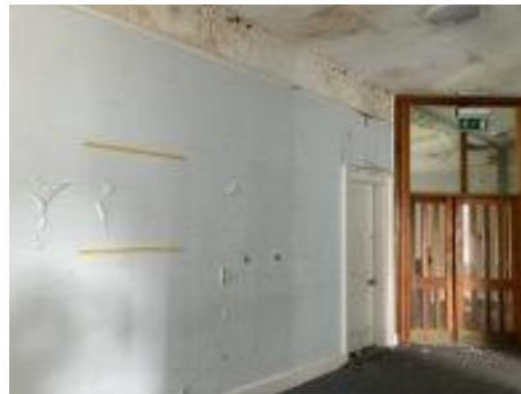
Plate 289: Central spine corridor with water damage evident on ceiling and top of walls.

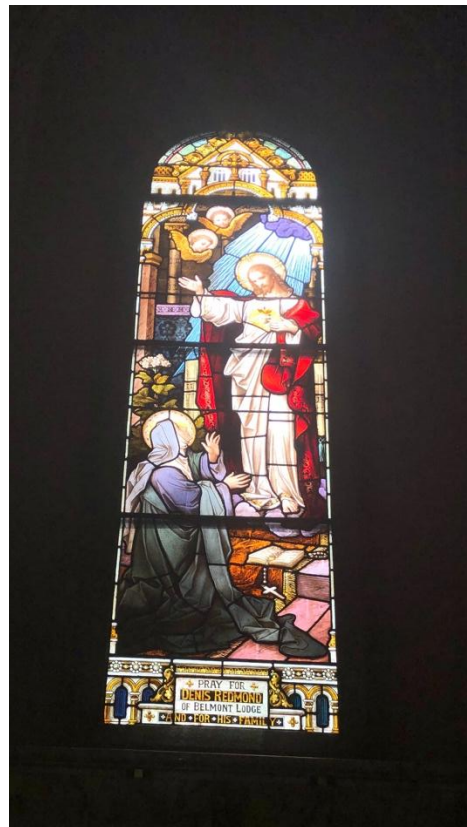
Plate 302: Detail of stained glass window

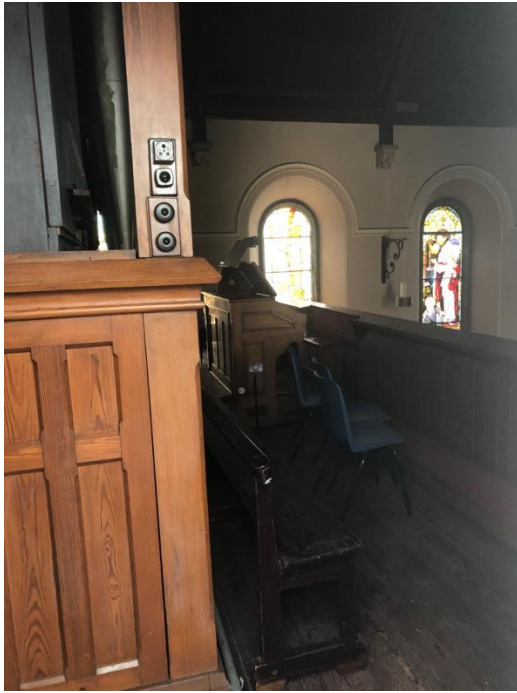
Plate 303: Gallery, facing west, with organ to rear.

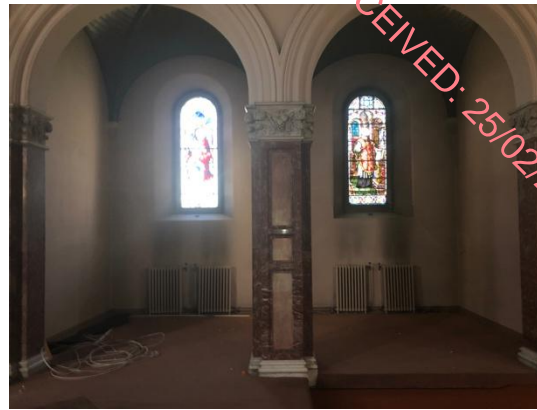
Plate 304: Side chapels with stained glass windows.

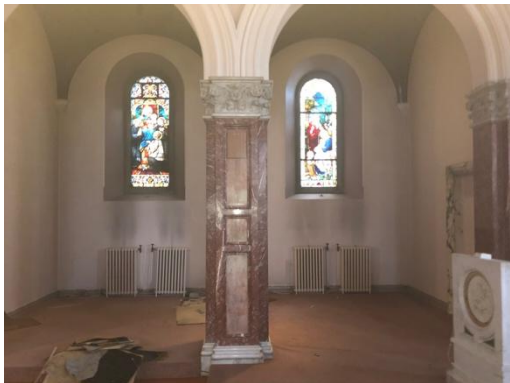
Plate 305: Opposing view, side chapels.

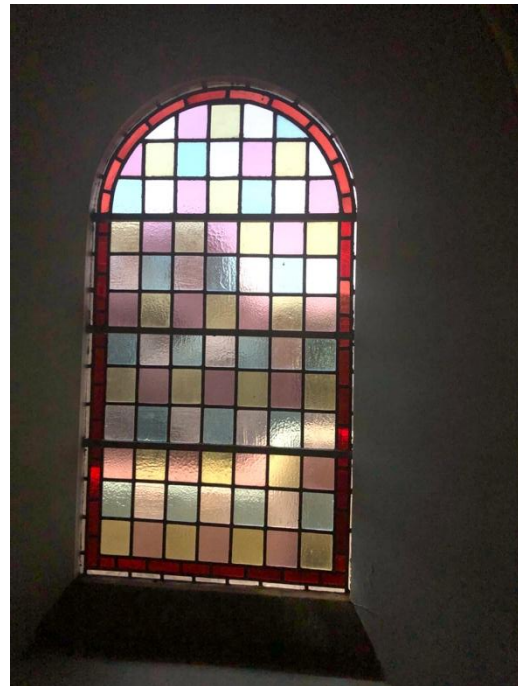
Plate 310: Round-headed window with stained glass. Curved plaster detail on reveal.

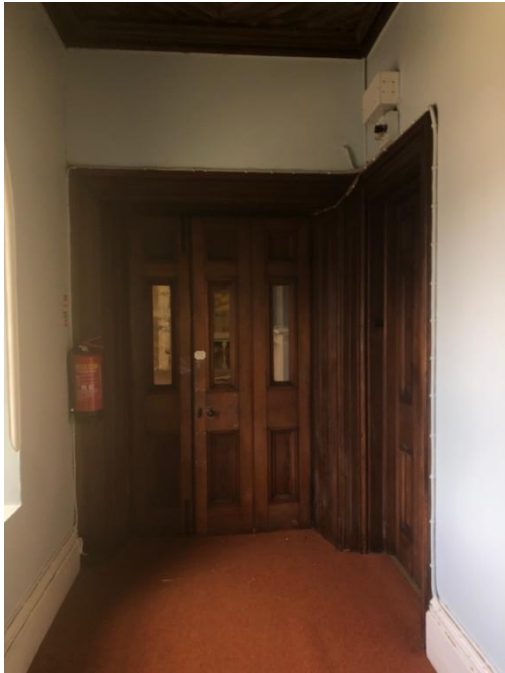
Plate 311: Doorcase from Chapel (left) to sacristy (right) within Building B2

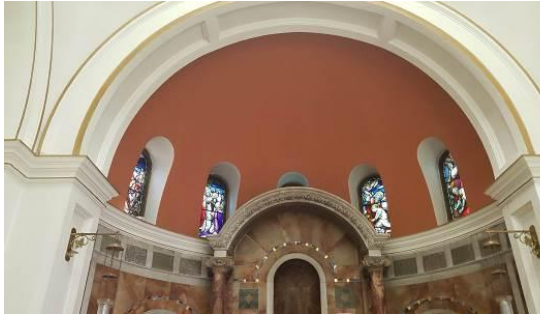
Plate 296: 5 stained glass windows which appear not to be signed or dated. Archive receipts from 1917 state windows, altar and decorations were by Early & Co, Camden Street, Dublin

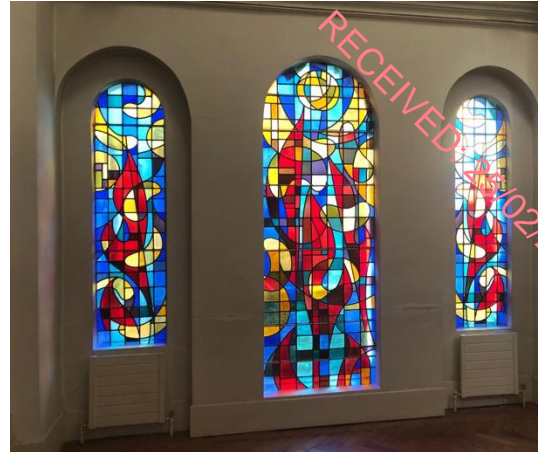
Plate 297: Modern, abstract, stained glass, c1980s appear to have replaced original stained glass

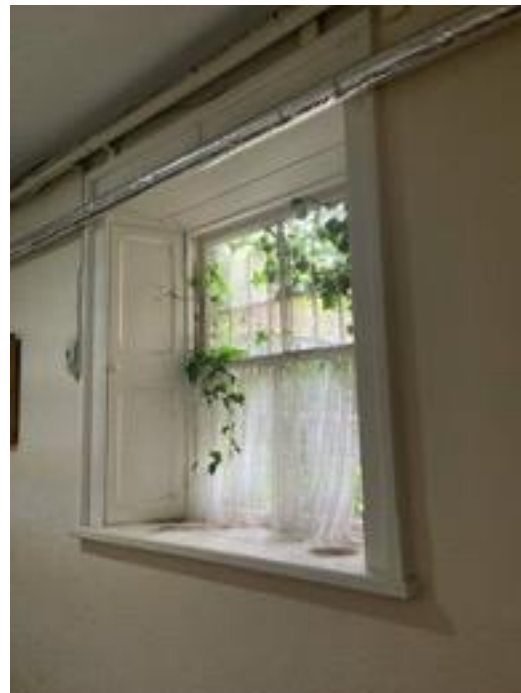
Plate 305: Detail of lower ground floor sash window and panelled shutters. Overgrown vegetation resulting in deterioration of fabric.

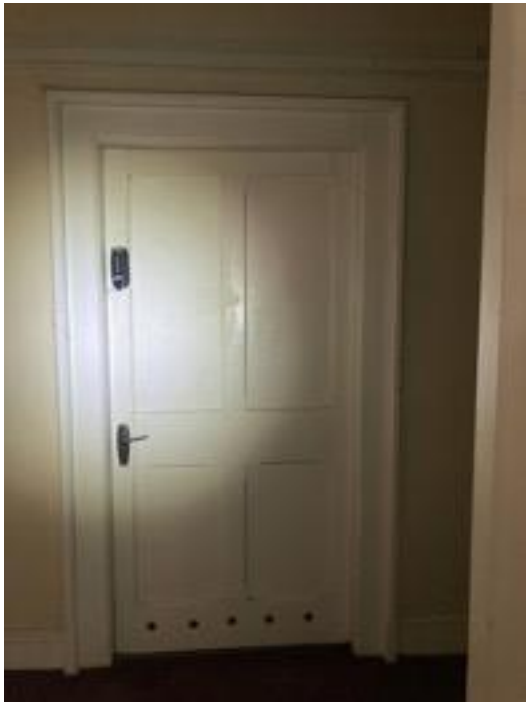
Plate 306: Typical panelled door and architrave at basement level.

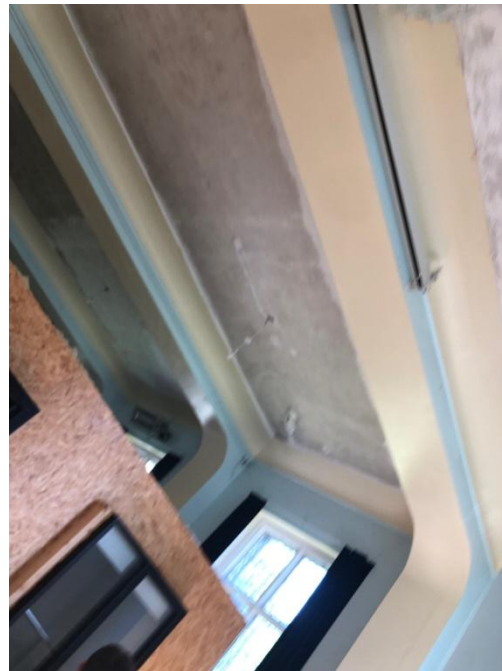
Plate 324: Ceiling showing some signs of water damage
